Future challenges of coastal landfills exacerbated by sea level rise

R.P. BEAVEN\*, A.M. STRINGFELLOW\*, R.J. NICHOLLS\*#, I.D. HAIGH\*\*, A.S. KEBEDE†\* AND J. WATTS^\*

### Abstract

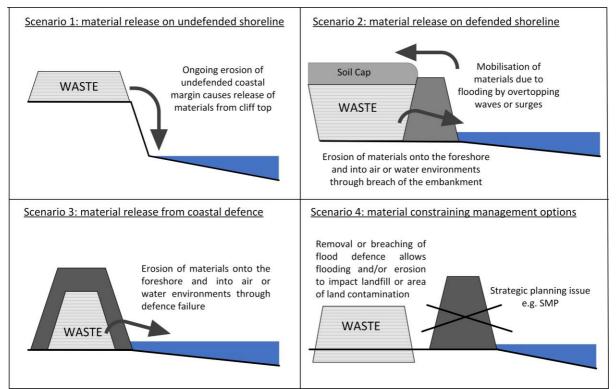
Figure 1. Possible situations (or scenarios) where landfill waste can be released to the sea (adapted from Cooper et al. 2012).

Coastal flooding and erosion risks around the world (and the UK) are growing due to climatic and human factors (e.g., Wong et al. 2014; Sayers et al. 2015; CCC, 2018). These risks present important challenges to coastal planning. Within the UK there is a strong desire to move to more sustainable shoreline management to address these challenges, whilst balancing public investment and benefits. One major constraint on this goal is the legacy of historic coastal landfills (containing potentially hazardous waste) located along UK coasts. It is estimated that there are at least 1700 permitted (licensed) and historic landfills in coastal flood and erosion buffer zones in England and Wales alone (Brand et al. 2017; Wadey et al. 2019). These include landfill sites (1) in low-lying floodplains, (2) on eroding cliff tops and (3) immediately behind coastal defence structures (Figure 1).

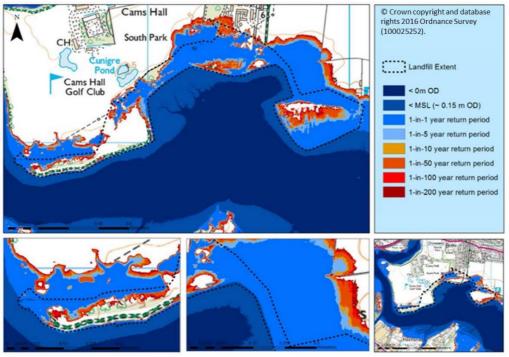
Figure 3. Potential flood zones (by return period) at Wicor Cams under the H++ SLR scenario in 2100 in the absence of defences. (MSL = mean sea level)

Spittles Lane landfill is located at an elevation of ~50 m AOD and is not at any risk of direct flooding from projected sea level rises. The results from bath-tub flood analysis of the Pennington Marshes and Wicor Cams landfill sites is shown in Figures 3 and 4 (method

By 2100 under an extreme high-end SLR (H++ scenario) major parts of Wicor Cams are at risk of flooding regularly (Figure 3). With high SLR and a 1 in 200 year extreme water event 20,000m<sup>2</sup> of Wicor Hard would be inundated, with sea levels during this event being approximately 2 metres above existing leachate levels in Wicor Hard. Assuming the inundation resulted in an increase in leachate levels of 2 metres in the whole of Wicor Hard (6.65ha) and a drainable porosity of 15%, then this could result in a maximum of  $\sim 20,000 \text{ m}^3$ of additional leachate being created. As a worse case if it is assumed that the entire volume of leachate were released over one tidal cycle (in reality leachate would be released over several days to weeks) flow in the upper reaches of Portsmouth Harbour around Wicor Cams would result in a 100 fold dilution of the leachate. Based on concentrations in leachate measured in 2013 (URS, 2013), and assuming zero background concentration of a contaminant in Portsmouth Harbour, this level of dilution would be sufficient to reduce metal concentrations, and most organic contaminant levels (apart from benzo(g,h,i)peryline), below EQS threshold values for saline water (URS, 2013). It is likely that leachate concentrations would be further decreased by 2100 due to dilution of leachate by rainwater and inundation events in the interim period. We did not consider the effect of saline waters which may increase the release of metal contaminants from waste compared to freshwater (Brand, 2017).

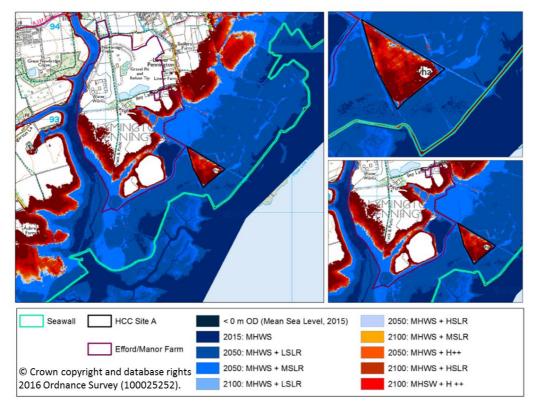
# Figure 4. Indicative 1-in-50 year flood zones in the current day, 2050 and 2100 under projected low (LSLR), medium (MSLR), high (HSLR) and extreme high (H++) sea level rise in the absence of defences at Pennington. (MHWS = mean high water springs )

Analysis by Kebede (2009) showed that the Pennington sea wall is currently at risk of breaching in a 1 in 50 year storm, rising to 1 in 5 years by 2055 with medium sea level rise. Assuming that background leachate levels are at 0.75 m AOD, then a spring tide in 2050 under a medium sea level rise scenario could reach 1.13 m AOD. With a landfill surface area of 7.5 ha and a drainable porosity for the waste of 15%, potentially 4,300 m<sup>3</sup> of leachate could be produced from Pennington landfill. Full inundation of the site, which could occur in 2100 during a 1 in 50 year storm under a high sea level rise scenario (Figure 4), could result in ~15,000 m<sup>3</sup> of leachate being created.

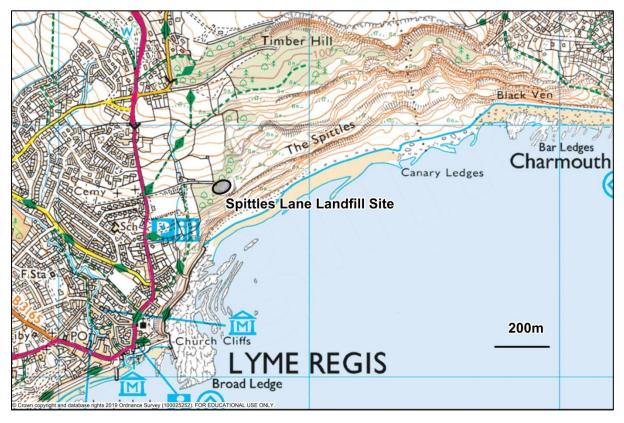
Figure S1: Location of Spittles Lane Landfill, near Lyme Regis

The Spittles Lane landfill at Lyme Regis (Figures 2 and S1) is perched on an eroding cliff face approximately 50 metres above sea level. The cliff is composed of Lias sediments of Lower Jurassic age, with sub-horizontal layers of mudstones interspersed with harder limestones. It is located within the Spittles-Black Ven landslide complex that represents an unstable and active coastal slope that extends for more than 1 km from Lyme Regis eastwards towards Charmouth. Parts of the landfill have already been undercut (principally during a major landslip in 2008) and have fallen into a tumble zone of waste and natural soils within the landslide complex which feeds waste onto the beach below (Gallois, 2009). The lighter fraction of waste arriving at the beach is being washed away, leaving behind the denser fraction – predominantly metals, glass and masonry / concrete-based waste products.

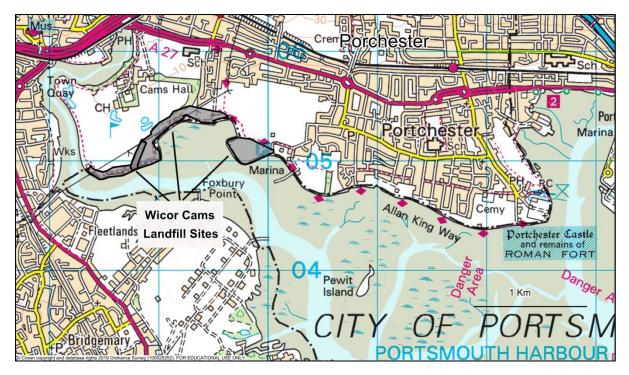
Figure S2. Location of Wicor Cams landfills, near Fareham

The Wicor Cams case study site (Figure 2 and S2) is located in a low-lying/estuarine environment in the north-west of Portsmouth Harbour in the East Solent. The site, owned by Fareham Borough Council, consists of three historic landfills (together referred to as Wicor Cams) and is surrounded by land mainly used for recreational purposes.

The landfill sites occupy a narrow stretch of land following the coastline for approximately 2 km (Figure 2 and S2). The combined overall surface area of all three landfill sites is estimated to be approximately 22 ha. Although there is some ambiguity about the depth of waste, an average value of 4.5m can be estimated from borehole logs, giving an upper estimate of 1 M m<sup>3</sup> waste at Wicor Cams.

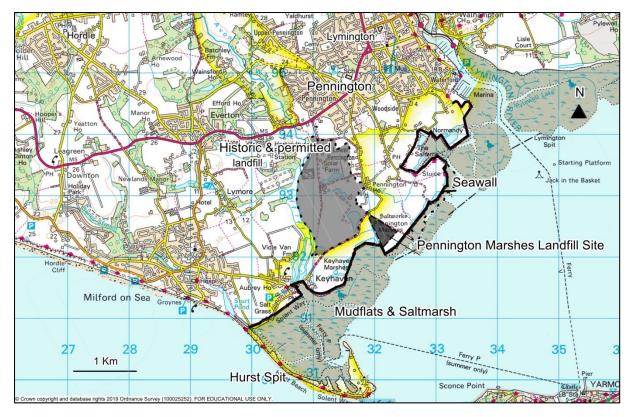
Figure S3. Location of Pennington Marshes landfill, near Lymington. Note the large historic and permitted landfills to the north of this site.

The Pennington study site (Figure 2 and S3) is located between Lymington town and the villages of Keyhaven and Milford-on-Sea at the western end of the Solent region in Hampshire County. The study concentrated on Pennington Marshes Landfill, a closed site, owned and managed by Hampshire County Council (HCC) as a coastal nature reserve. The landfill is located on low lying rural land comprising grassland/coastal grazing marshes and brackish lagoons, and is protected from flooding by a defence line consisting of a well-maintained sea wall (between Keyhaven and Lymington) and intertidal mud/saltmarsh. The landfill is located in a sensitive ecological area and is within a designated SPA, a SSSI, a SAC and a RAMSAR site.
