Oral Presentation (SA-14)

Fracture of the Infraglenoid Tubersity in CanineRama Arge Frismana^{1*}, Albiruni Haryo², Hendrik Saputra²¹FKH Universitas Nusa Tenggara Barat, ²Praktik Dokter Hewan Bersama Satwa Sehat*Corresponding author's email: dvmfrismana@gmail.com**Keywords:** Fracture, Intraglenoid, Scapula, Canine.**INTRODUCTION**

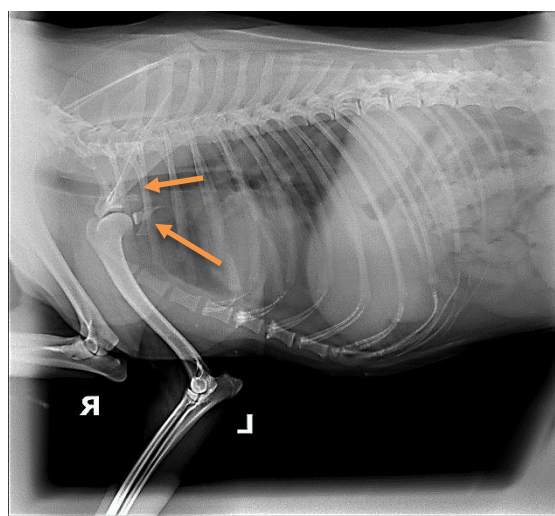
Picture 1a. X-ray lateral sideways, yellow arrow shows the bone fracture.

sideways position as usually called lateral position (picture 1a) and dorsal position (VD) (picture 1b). The x-ray result showed that there was broken leg on the bone of os scapula in fossa glenoid distal side until columnar caudal os scapula.

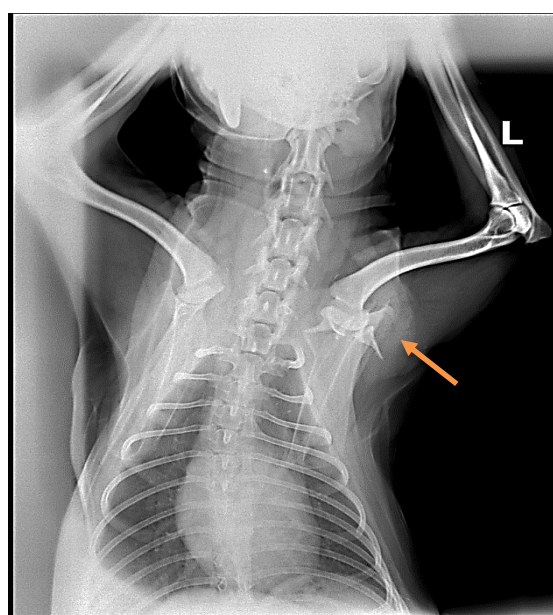
Picture 1b. X ray dorsal sideways (VD), yellow arrow shows the bone fracture.

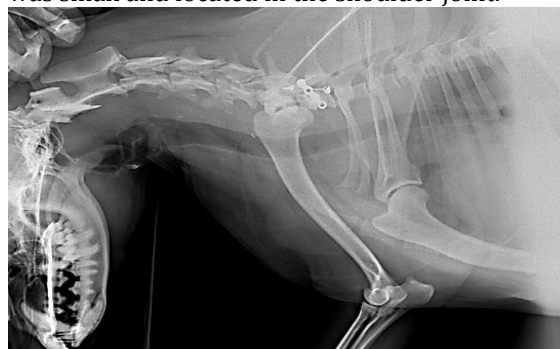
Bone grafting was conducted using combination of locking plate and wire. The plate was attached to the columnar os scapula and tuberglenoid, then to reinforce and make it flexible we added wire mounting across the plate (picture 2). After breaking a bone grafting done, the muscle was stitched by using polyglactin suture as well as in the subcutaneous section. Then for the skin was stitched by using silk suture. This surgery took approximately four and half an hour. This bone grafting was very difficult because the broken bone was small and located in the shoulder joint.

Picture 2. Post-operative after tuberglenoid fixation

Regardless of the treatment method, isolated glenoid fracture generally has a good clinical outcome with good function and less risk of early degeneration[9]. In this case, using two stages of grafting; first by using a screwed bone plate, and the second using a wire. Bone plates are one of the strongest and most effective methods of fixing a fracture. They counteract bending, compression, twisting and pulling force. They are strong not bulky and relatively lightweight. Bone plate is also perfect for animal that are extremely active. The wire for fixation in patients with poor bone quality was made flexible, because the fracture was in the joint area.
