Strengthening of Load Bearing Masonry Wall Panels with Externally Bonded Precast Textile Reinforced Concrete Laminate

S Gopinath*¹, J Prabhakar², C K Madheswaran³ and K G Thivya Devi⁴
CSIR-Structural Engineering Research Centre, CSIR Campus, Chennai, India

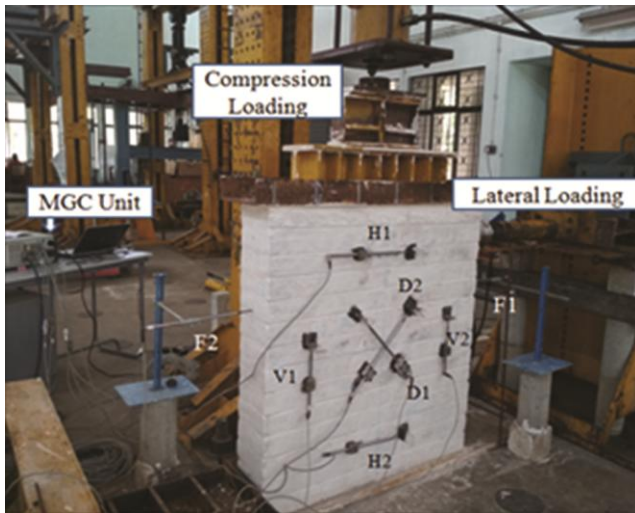
Fig. 1—Test setup

The test setup shown in Figure 1 consists of a frame fitted with jack for loading with clear spacing of 1.8 m between jack and floor. Brick panel is placed in such a way that major axis of panel is perpendicular to frame. Test arrangmenst were made to panel such that premature failure will not happen to it. Channels with 2 hooks at its edges were fabricated and placed on both sides of panel with rubber layer sandwiched between panel and channel so that crushing of brick could be prevented. Girder of 10 Tonne capacity is used to lift the panel and place in the poistion. Center of jack and panel is assured in straight using plumbob. Hydraulic jack with with a separate hand pump is fixed on one side of masonry panel to apply lateral loading. Specimen is arrested at bottom to prevent horizontal movement of

masonry while application of lateral Load. Steel plates and distributor beams are placed on the masonry for uniform distribution of load. Brick masonry panel is instrumented with 8 Linear Variable Displacement Transducers (LVDT) to measure axial, shear and lateral deformations along masonry. The positioning of LVDT's are as follows: F1 and F2 are placed at 1/3rd distance from top of panel in load application face and on opposite face respectively; H1 & H2 are placed in horizontal direction at 200 mm from top and bottom of the panel respectively; V1 & V2 are placed in vertical direction at 200 mm from right and left side of panel; D1 & D2 are placed in such a way that its centre coincides with the centre of the panel. These deformations are used to evaluate strains. L-angles are fixed on masonry panels after

marking gauge lengths using m-seal adhesive. LVDT's are placed in such a way that tip of LVDT is made to touch L-angle. The placement position of LVDT's are chosen based on some of the Literature. All LVDT's are connected to data acquisition system MGC plus. 50 mm LVDT's are used to measure axial deformation and remaining deformations are measured by 100 mm LVDT's. The gauge length of 260 mm for (H1, H2), 130 mm for (V1, V2) and for 300 mm (D1, D2) are used during the investigations. Load cells are fixed to the jack at both top and side for application of compression and lateral load respectively. Lateral load is applied in such a way that center of load cell touches masonry at a point 115 mm from top of wall.

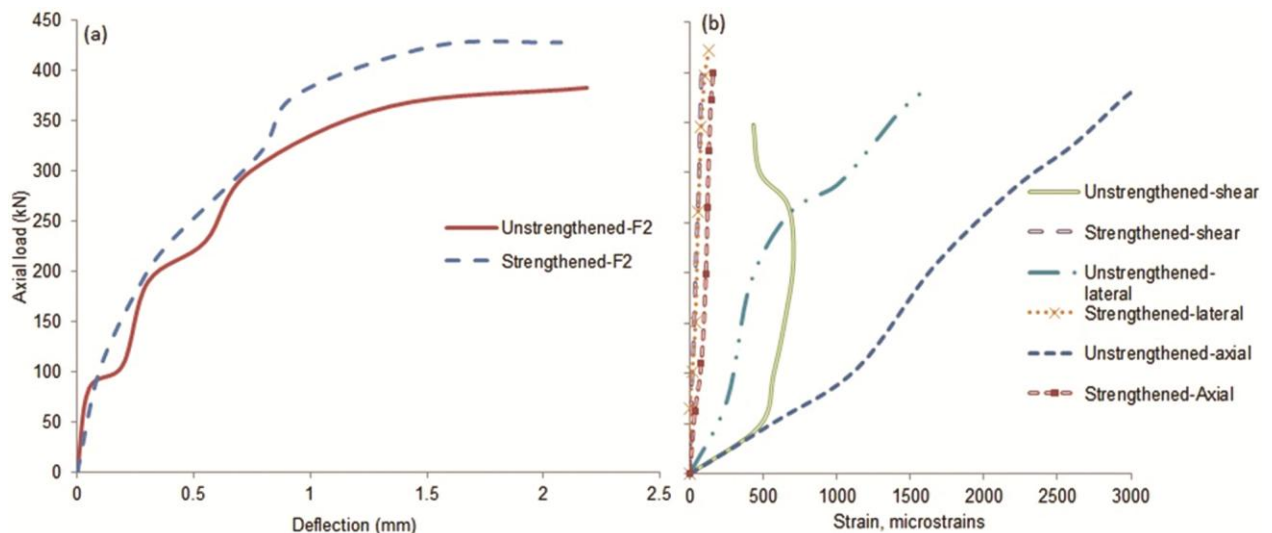
Fig. 2—Response of panels under compressive loading (a)load vs. deflection (b)load vs. strain

The unstrengthened brick masonry panel is loaded under compressive load and the first vertical crack initiated at a load of 306 kN. At 350 kN of load, crushing is observed at middle of base. Experiment is stopped at load of 420 kN, after reaching the maximum capacity of the load cell used. Hence interpretations are made only up to this load level. Among 8 LVDT's placed only 5 LVDT's are able to show deformation. It is observed that the failure is not observed in region where H1, V2 and D1 are fixed. So deformation is not captured in those particular LVDT's. In case of Strengthened panel, the first crack was observed at a load of 400 kN at the back face of the panel. It is noticed that compared to unstrengthened panel, there is around 23% of increase in the first crack load for the strengthened panel. From Figures 2(a) and 2(b), the

comparison for strengthened panel and unstrengthened panels indicate that at a load of 306 kN, which is the cracking load of unstrengthened panel, the lateral, axial and shear strains are decreased by 1.92 times, 1.91 times and 1.86 times respectively. Total load taken by unstrengthened panel wall is 420 kN, which is the maximum capacity of the load cell used. It is observed from Figure 2(b) that in shear, lateral and axial directions the strengthened wall is stiffer. There is a reduction in deflection of 1.75 times on load application face for the strengthened panel is witnessed as well. From the results of compressive test it was observed that high compressive strength and strain values were achieved for strengthened panel. The number of vertical cracks had been observed on faces of the panel for unstrengthened panel. Horizontal cracks were observed at back face of strengthened panel which is in contrary to the vertical cracks which was observed in unstrengthened panel. It should be noted that there was no crack formation in the strengthened face of the panel.

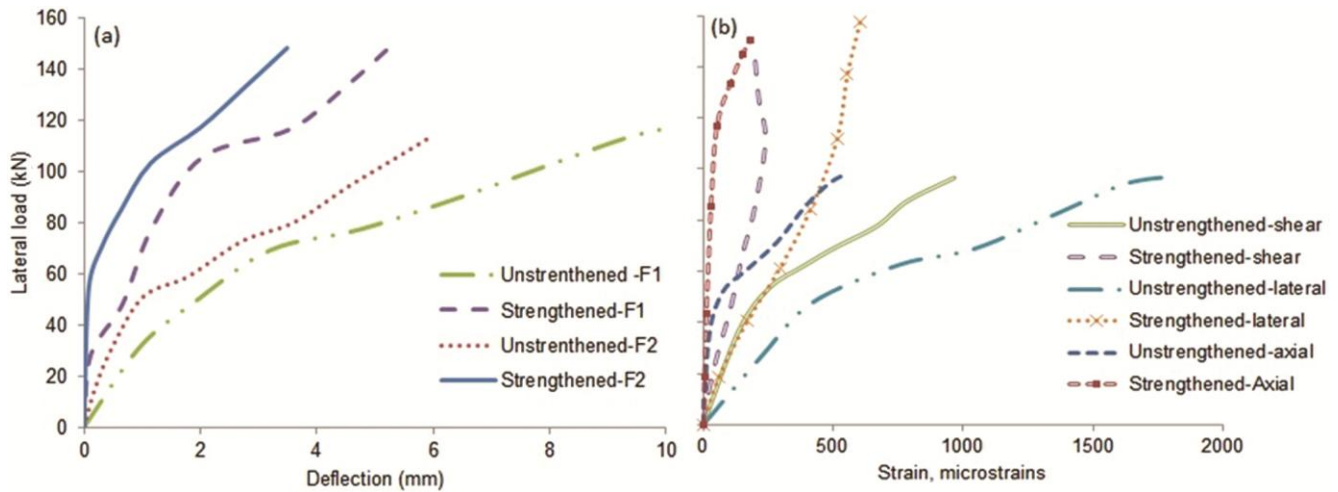
Fig. 3—Response of panels under combined action of compression and shear loading (a) load vs. deflection (b) load vs strain

Behavior of unstrengthened panel specimen under combined compression allied lateral loading is observed by using 8 LVDT's. Compressive load is applied in increments and is made constant after reaching 130 kN (which is around 10% of the maximum compressive stress of brick) then lateral load is manually applied using jack in increments. In LVDT's fixed for capturing vertical strain F1 is in tension and F2 is in compression. Because of opening of crack at a particular region LVDT in that region

may show decrease in deflection and at the same time another LVDT picks up the deflection to be captured. Load is measured from the load cell attached to data acquisition system MGC plus. Since, the test is not conducted upto failure load, no conclusions are derived for the ultimate capacity of the panels. So comparison of strains is made to the maximum lateral load level upto which the test is conducted. In strains measured in 2 LVDT's capturing same deflection i.e., either axial, shear, lateral or vertical one exhibited positive values (compression) and the other which is near to loading face negative values (tension). For the unstrengthened panel, at load 68.47 kN crack at interface of floor and masonry got initiated and started propagating parallel to joint. Spalling of brick at the bottom corner and horizontal crack at middle of back face is observed when load reached 75 kN. For the strengthened panel, at 150 kN, no cracks were observed at strengthened face and few numbers of vertical cracks were observed at unstrengthened face of specimen. No crack in joint was found. From Figure 3(a) it is noticed that the vertical deflection of strengthened panel is reduced by 1.7 times on load application face and 1.83 times on opposite side compared to unstrengthened panel. From Figure 3(b), it is noticed that there is decrease in lateral, axial, and shear strains by 1.47, 1.86 and 1.73 times respectively for strengthened panel compared to unstrengthened panel. An enhancement of 30.7% load is observed for first crack load for strengthened panel compared to unstrengthened panel. From the investigations, it can be concluded that strengthened panels show lesser deflection and high stiffness compared to

unstrengthened panels. Number of cracks observed in strengthened panel is also less than unstrengthened panel. Shear strain is less in strengthened panel and it is observed that failure till load applied is due to formation of vertical and horizontal cracks in both specimens. The shear strength of unstrengthened panel was recorded as 105 kN, where as that of strengthened panel were 150 kN showing an increase of 50 percent. More values of lateral displacement are less for strengthened panel compared to unstrengthened panel.
