Microwave Self-healing Technology as Airfield Porous Asphalt Friction Course Repair and Maintenance System

Amir Tabaković^{*1,2,3}, Declan O'Prey⁴, Drew McKenna⁵ and David Woodward⁵

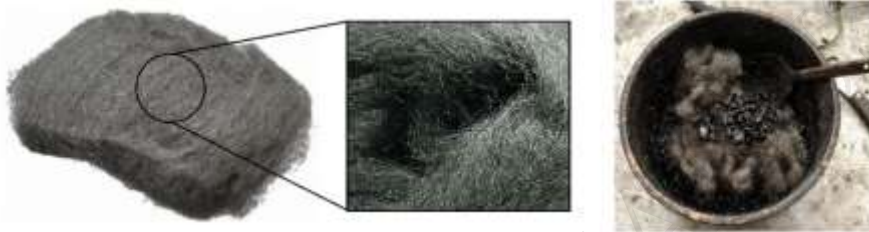
Figure 2 Trollull Grade 3 steel wool.

The steel fibre used was Grade 3 coarse-grained Trollull Steel Wool. Figure 2 illustrates the steel wool fibre used. The fibre diameter was 90 μ m. The fibres were cut using scissors to approximately 10mm in length.

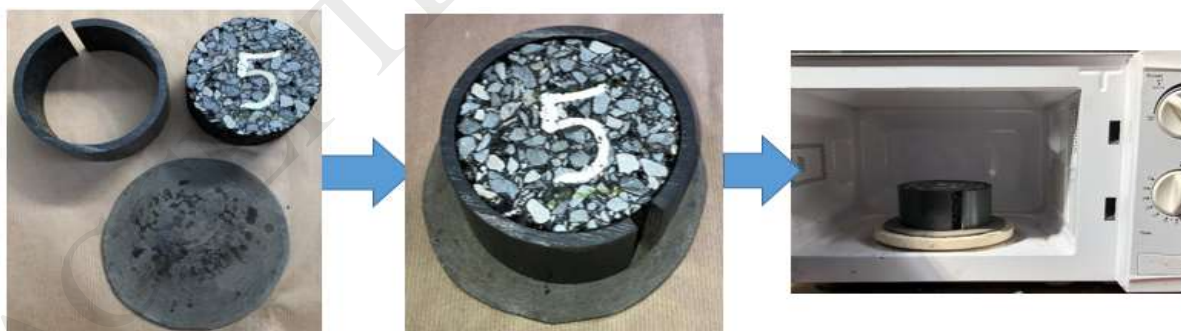
Figure 3. Microwave healing test system set up.

Figure 3 illustrates the main elements of the test programme. The microwave oven used was a Tesco Solo, Model No: MM08 with 700W power output. The defrost setting of 300 watts for 3 minutes was found to be the optimum healing condition for the PFC mix. Some sparks were visible during the first healing cycle probably caused by some of the fibres not being fully coated with bitumen. No sparks were observed for the second healing cycle. This is different to that found in literature where the test specimens are healed by heating for 40 seconds on the highest microwave power setting of 600 watts. The study summarised in this paper observed that at this laboratory microwave setting intense sparks

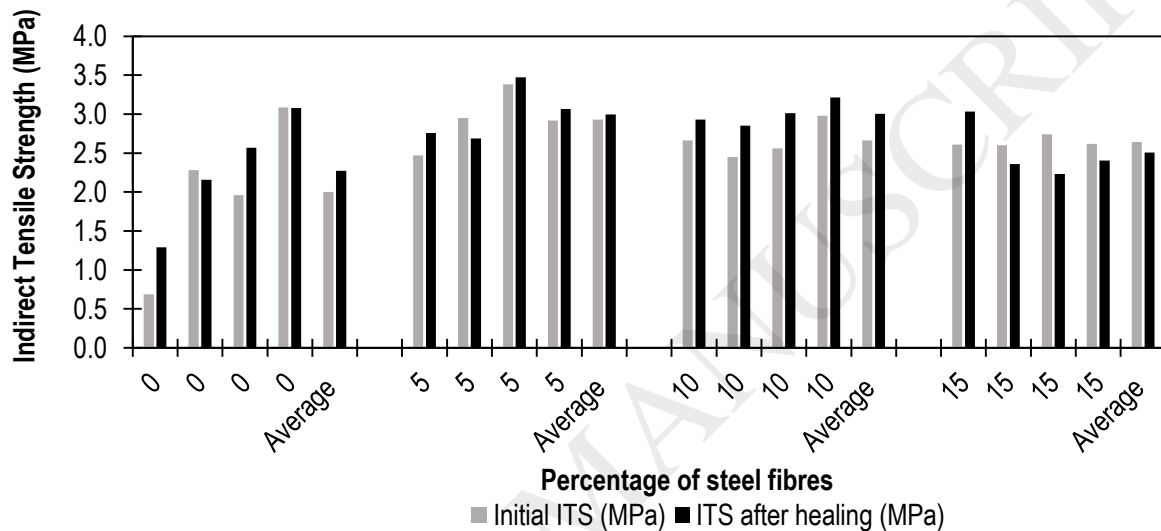
Figure 7. Average Indirect Tensile Strength before and after healing.

Figure 7 plots the ITS data. A summary of the average values is given in Table 3. The ITS data show steel fibre addition has a positive effect on ITS. The control PFC group containing no steel fibres had the lowest ITS values throughout testing. The PFC mixes with 5% steel fibres had the best ITS data similar to the ITSM test data. Increasing amounts of steel fibre gave ITS values greater than the control PFC containing no steel fibre. This is due to how the fibres are distributed throughout the mix.

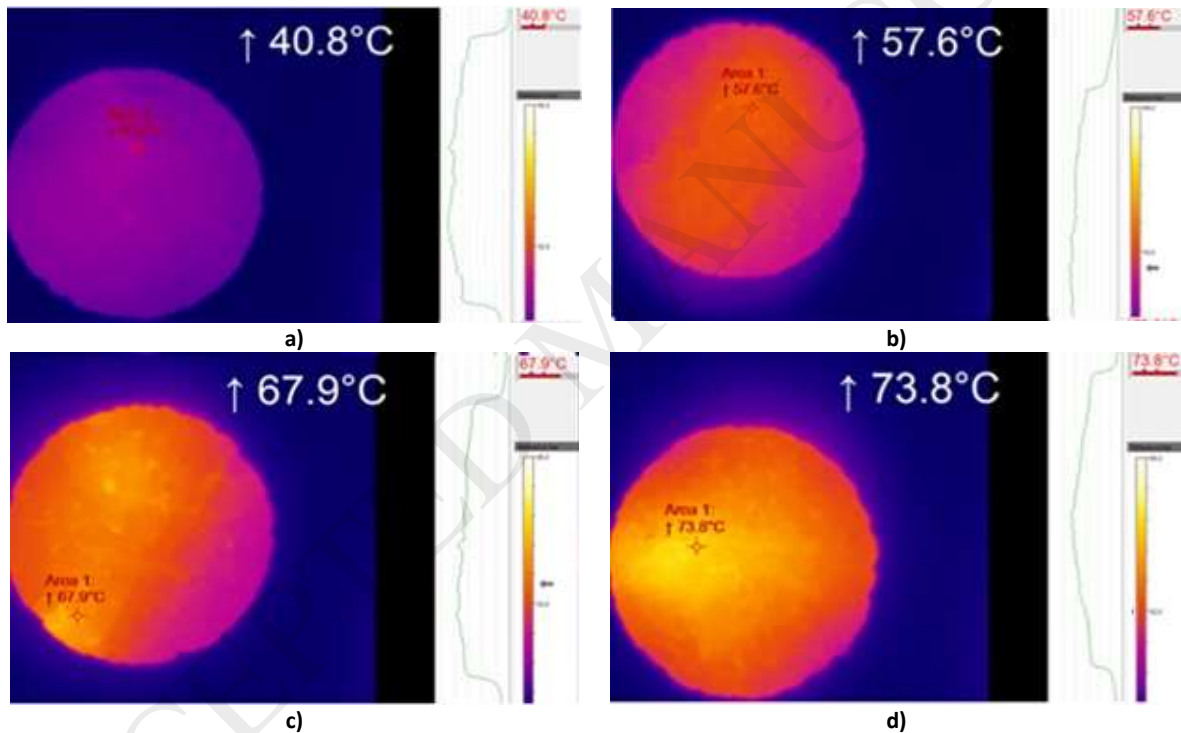
Figure 9 Thermal images showing maximum surface temperature of PFC specimens containing a) 0%, b) 5%, c) 10% and d) 15% of fibres 60 seconds of healing

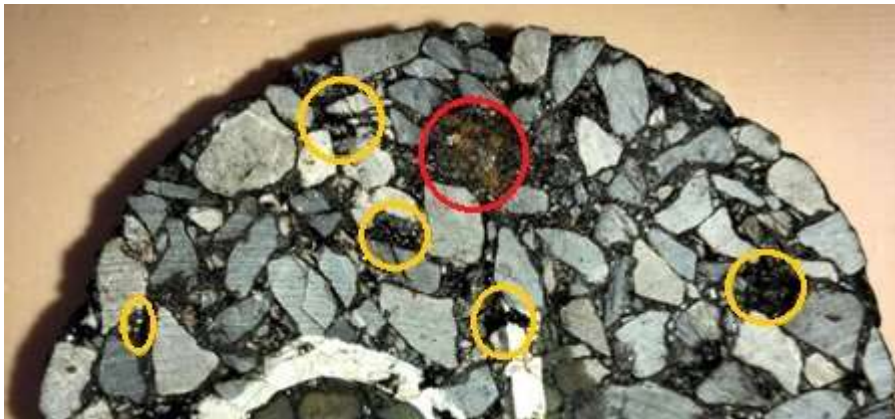
Figure 10 PFC specimen #16 showing localised issues of oxidation and binder damage.

Figure 10 shows an example of steel fibre clustering and subsequent steel fibre oxidation in one of the test specimens. The yellow circles show localised areas of bitumen binder damage due to the excessive heating of steel fibre clusters. The red circle depicts an oxidized steel fibre cluster. Larger steel fibre clusters were recorded as having a heat spike of up to 400°C. Temperatures of this magnitude are above the flash point of the bitumen i.e. approximately 250°C, and would cause it to instantly vaporize. This is what likely caused the flashes and black fumes that were emitted from the 15% PFC mix during

microwave heating. This may have weakened the test specimen structure leading to its poorer test data.

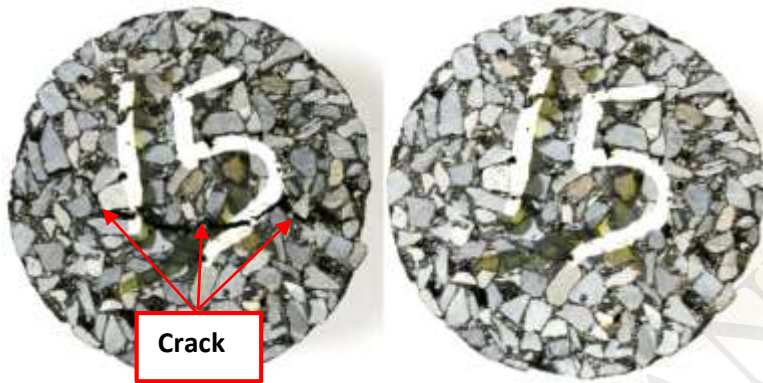
Figure 13. PFC specimen #15 with 15% steel fibre: Left: before healing and Right: after healing with fully repaired crack.

The PFC test specimens with 5% steel fibres increased stiffness value after the healing cycles. Figure 12 shows PFC sample #6 containing 5% steel fibres before and after healing cycle 2. Compared to Figure 11, the crack is completely healed. The increase in heat has probably reduced binder viscosity allowing it to flow not only into the visible cracks but also into other microcracks within the specimen. This agrees with the major healing mechanism of induction healing being capillary flow [23] and diffusion of the asphalt binder at high temperatures. Figure 13 shows PFC sample #15 which contains 15% steel fibres. The crack is fully repaired.
