JOURNAL OF THE AMERICAN WATER RESOURCES ASSOCIATION

STREAM MEANDER RESTORATION¹

Massimo Rinaldi and Peggy A. Johnson²

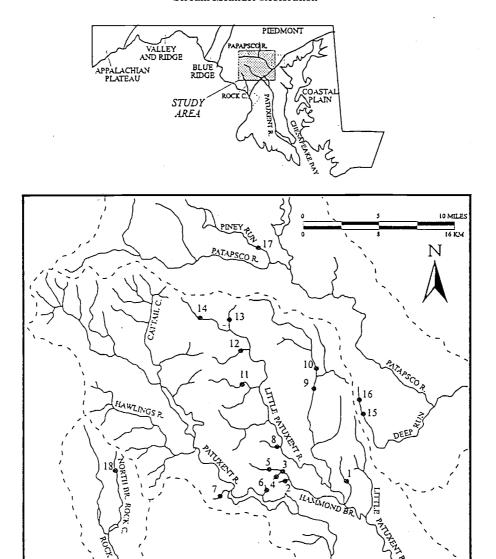
Figure 1. Study Area Location and Selected Stream Sites.

The study area is located in the Piedmont Province, one of five distinct physiographic regions of Maryland, and includes the upper and middle portions of the Patuxent River, Patapsco River and Rock Creek basins (see Figure 1). Bedrock in this region is

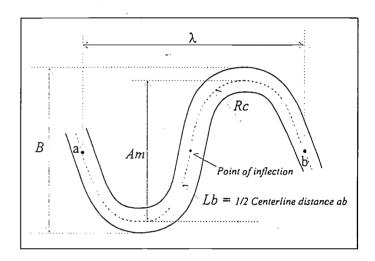
Figure 2. Sketch of Idealized Meander (Leopold & Wolman, 1960, modified).

TABLE 2. Meander Parameters of the Study Streams (see Figure 2 for parameter definition). λ = wavelength; Rc = radius of curvature; Am = amplitude; Lb = bend length; B = belt width; SI = sinuosity index.

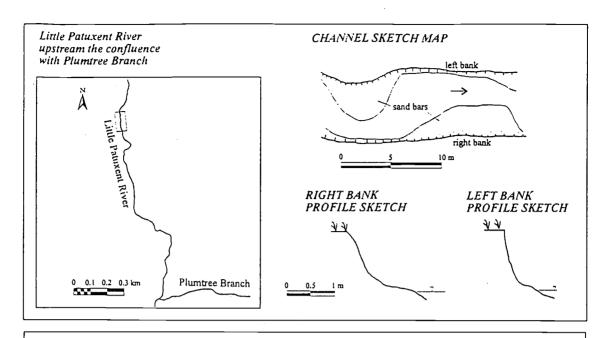
Figure 4. Example of Detailed Stream Reconnaissance: Main Observations Extracted by the Field Reconnaissance Sheet.

Examples of detailed stream reconnaissance were carried out on streams in the study area. Figure 4 shows the main elements and observations collected during a detailed stream reconnaissance. In this example, based on the stream reconnaissance, bank erosion appears to be the most important problem within the reach. Dominant processes are fluvial entrainment at the basal area, planar failure and cantilever on the upper portion of the bank. Bank failure appears to be a very important source of sediment, producing high quantities of fine material, facilitating accretion and construction of bars. Bank erosion on both the banks is also evident, causing a significant widening of the reach. Based on the stream reconnaissance, meander creation in that site appears to be a possible way to dissipate energy and to reduce erosion and sediment supply. Alternatively, control of bank erosion through stabilization efforts and maintenance of channel width could be used to prevent additional widening and to reduce the supply of fine sediments.

Sinuous with irregular meanders

Ave. Bankfull Width: 8.2 m Ave. Bankfull Depth: 1.3 m Ave. Water Width: 3.8 m Ave. Water Depth: 0.7 m Reach Slope: 0.0009 Flow Type: uniform /tranquil Bed Controls: none Width Controls: none

Bed Material: sand
Bed Armour: none
Bed Forms: ripples
Bars: frequent
Bar Types: alternate and point bars

Type: cohesive Bank Materials: sand/silt Ave. Bank Height: 1.2 m Ave. Bank Slope: 60° Protection Status: unprotected Tension Cracks: frequent

Erosion Location: opposite a bar Present Status: eroding; active Processes: impinging flow, piping, sheet erosion
