LINEAR INFRASTRUCTURES THAT CHARACTERIZE A PAST LAND MANAGEMENT: THE MONTAGNOLA SENESE DRY STONE WALLS. A METHODOLOGICAL APPROACH OF ANALYSIS

Emanuele Vazzano, Amato Bonavita, Paolo Pellegrini

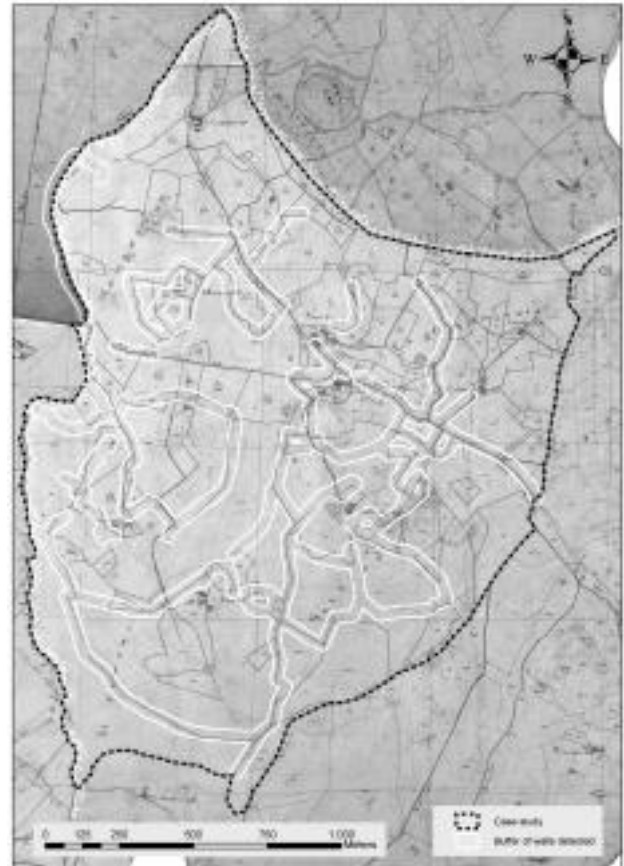
Fig. 1 - General map of the case study showing the matching between Cadastral boundary and the self-standing dry stone walls surveyed where the buffer has been set up.

The general map of the investigation area (Fig. 1), reconstructed from the analysis in a GIS environment, highlights the connection between most of the wall polylines and the historical cadastral parcel boundary lines.

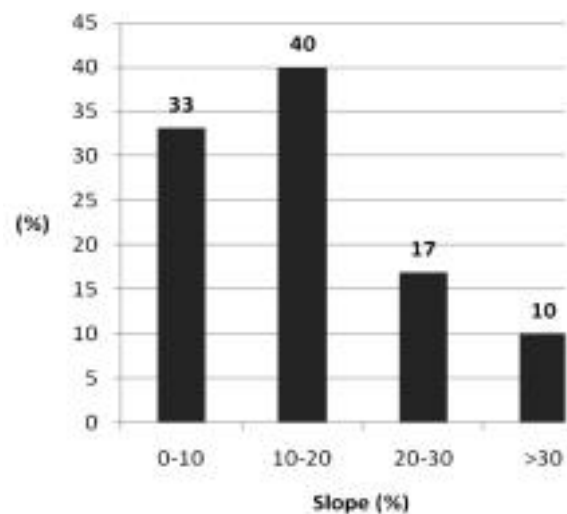
Fig. 2 - Percentage distribution of self-standing walls according to the slope of the land.

Starting from the morphology of the investigation area we analysed the wall distribution according to the land slope. Figure 2 shows the results of the slope analysis, it is worth noting that most of the walls were built on land with a slope of less than 20% and only a small percentage on land steeper than 30%.

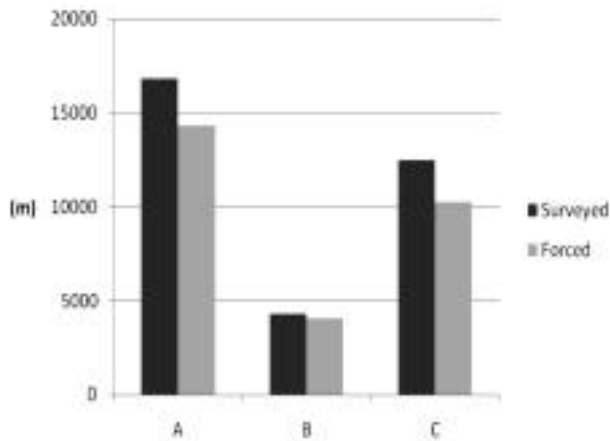
Fig. 3 - Length of self-standing dry stone walls. The surveyed and the forced ones: Total Walls (A), Roadside walls (B), Other Walls (C).

As for the functional historical analysis (Fig. 3),

we have noted that the “Forced Walls” reach a total length of 14.354 m, of which 4.105 m are associated to roads of historical importance (Forced walls 1), and 10.250 m are spread in the rest of the investigation area (Forced walls 2).

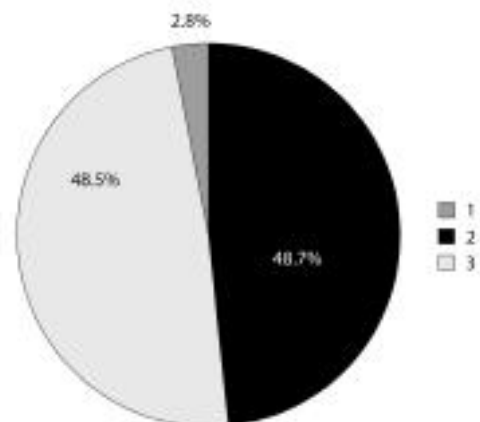
Fig. 6 - Percentage distribution of Forced walls referred to the agricultural or forest sector: 1 - Dividing two agricultural areas; 2 - Dividing an agricultural from a wooded area; 3 - Dividing two wooded areas.

The results of the functional historical analysis of the Forced walls 2, relating to the land uses that they divided in the early nineteenth century (Fig. 6), show that the walls performed two main functions, in

roughly the same proportion: they separated an agricultural area from a wooded area or separated two wooded areas; only a small percentage of the walls separated two agricultural areas.

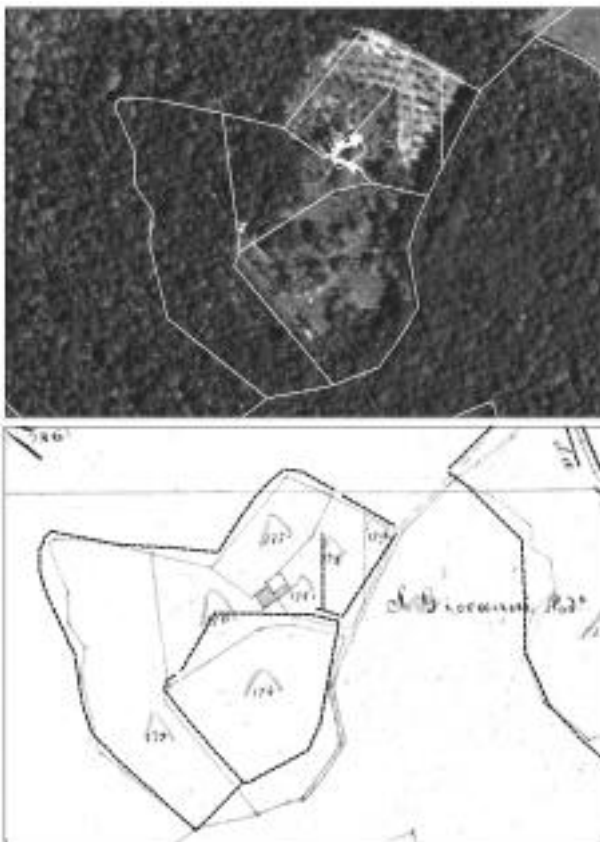
Fig. 7 - S. Giovanni holdings. The picture at the top shows the overlapping, in the GIS environment, of the historical cadastral parcel boundaries of 1825, with the aerial photo of 2007. The other picture shows the path of the surveyed walls (marked by a black dotted line) overlapped with the historical cadastral map.

The analysis of the self-standing dry stone wall distribution in the study area, shows that these artifacts were strictly linked to the various activities conducted in the holdings. Indeed, the use of this type of artifact to partition agricultural and forestry land, is particularly evident in Figure 7 and Figure 8, which concern “S. Giovanni” and “Ebbio” holdings.

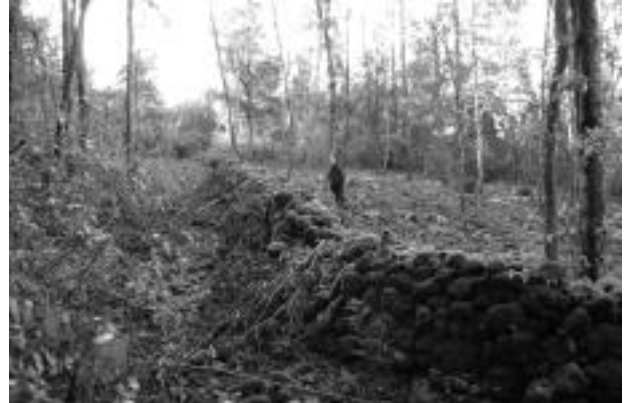
Fig. 10 - Section of self-standing dry stone wall made visible by forest harvesting activities.

nola Senese territory (Fig. 10), with higher densities around the historical estate-complexes. In addition, the historical cadastral maps analyzed at a local level for the whole of the Montagnola area, show that the parcel division around these historical estate-complexes is similar to the test area.
