**SECOND EUROPEAN CONFERENCE ON EARTHQUAKE ENGINEERING
AND SEISMOLOGY, ISTANBUL AUG. 25-29, 2014**

**PERFORMANCE ANALYSIS OF SEISMICALLY EXCITED STATUES
IN FIXED-BASE AND BASE-ISOLATED CONDITIONS**Stefano SORACE¹ and Gloria TERENCE²**ABSTRACT**

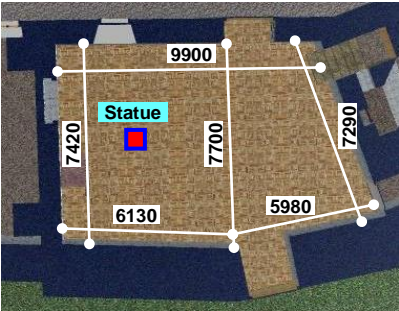
The ground floor design plan is illustrated by the drawing in Figure 3, where the position of the case study statue in the exhibition set is highlighted with a square.

Figure 3. Architectural plan of the ground floor (dimensions in millimeters) and position of the case study statue

The plan is shaped as an irregular pentagon, with a surface area of about 85 m². The floor is made of 55 mm-high HI-bond corrugated steel sheets, with a 55 mm-thick on-site cast reinforced concrete (R/C) slab on top. The main structure consists of primary and secondary beams in HEB 180 and HEB 100 Italian profiles, respectively, made of S235JR grade steel. Each primary beam spans over the shorter (transversal) dimension in plan, ranging from about 7.3 m to about 7.7 m, as shown in Figure 3, and is supported approximately at its midspan by a R/C column built on the basement level. This allows strongly reducing the bending moment, shear and vertical displacements induced by gravitational loads, and thus the cross section of the beams. This solution is mutually adopted for the fixed-base and base-isolated layouts of the floor. In the former case, each beam is joined to the

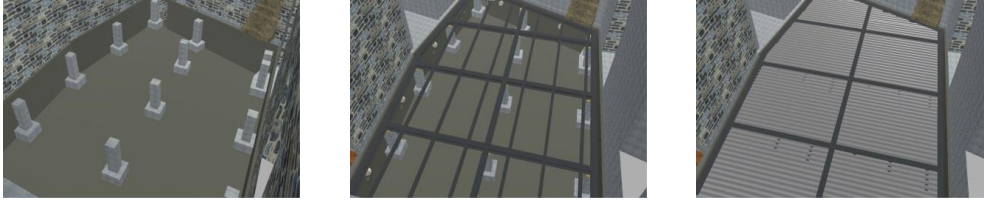
relevant midspan column by a horizontal steel plate bolted to the column top section, and is borne at both ends by the perimeter masonry walls of the hall. In base-isolated configuration, two other rows of R/C columns are built, for a total of 15 columns, to support 15 DFP sliders to be placed below the five main beams. These additional ten columns represent the only difference between the two design hypotheses for the floor. Renderings of the construction steps of the floor steel structure for the base-isolated solution, before casting the R/C slab, are illustrated in Figure 4.

Figure 4 Construction steps of the ground floor steel structure in base-isolated configuration, before the casting of the R/C slab

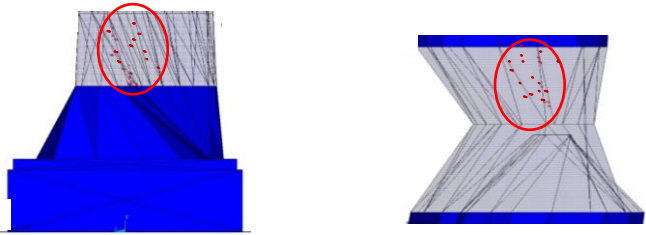
Figure 7. Cracked configurations of the left leg knee (left image) and the rear portion of the neck for the limit conditions of Damage control/Artistic value safety obtained from the most demanding among the seven groups of accelerograms

As way of example of the responses obtained at the limit conditions of the four PLs, the following drawings and graphs are reproduced in Figures 6 through 9, for the most demanding among the seven groups of accelerograms used in the analysis: for Rest and No rocking, the normal stress distribution in the model, with the two areas subjected to the highest tensile stresses, that is, the left leg knee and the rear portion of the neck, highlighted by red ellipses (Figure 6); the cracked configuration of the same two critical zones, plotted in zoomed view and coloured in light grey, for Damage control/Artistic value safety (Figure 7); the ultimate cracked configuration of the front and rear portions of the neck, again in zoomed view, for Collapse prevention (Figure 8); and the vertical displacement time-histories of the joint situated on the rear left corner of the pedestal, for No rocking and Collapse prevention (Figure 9).

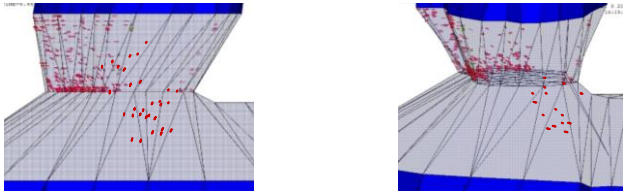
The cracked configuration depicted in Figure 8 clearly illustrates that numerical collapse, and thus the achievement of the limit condition for Collapse prevention PL, is caused by the local failure of the base section of the neck, which is the most vulnerable area of the model.

Figure 8. Cracked configurations of the front (left image) and rear portion of the neck for the limit conditions of Collapse prevention obtained from the most demanding among the seven groups of accelerograms

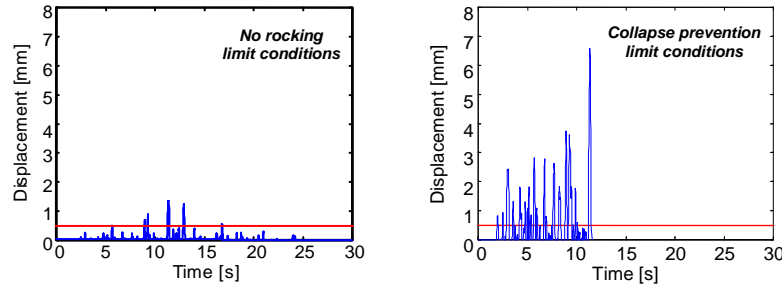
The vertical displacement time-history corresponding to the achievement of the limit conditions for No rocking, plotted in the left graph of Figure 9, shows six peaks greater than the assumed threshold of 0.5 mm (highlighted by a red horizontal segment in the graph), with a maximum of 1.3 mm. Each of the remaining six groups of input motions produced five peaks greater than 0.5 mm, giving rise to a mean maximum peak of 1.1 mm over the seven groups. As illustrated in the right graph of Figure 9, the time-history relevant to the limit conditions of Collapse prevention stopped immediately after the attainment of the maximum uplift, equal to 6.6 mm, as a consequence of the

divergence of the numerical solution at the subsequent step. Similar results are observed for the remaining six groups of accelerograms.

Figure 9. Vertical displacement time-histories of the joint situated on the rear left corner of the pedestal for the limit conditions of No rocking and Collapse prevention obtained from the most demanding among the seven groups of accelerograms
