## 9<sup>th</sup> International Masonry Conference 2014 in Guimarães

# Stability and Stiffness Contribution of the masonry in the Borbone Anti-seismic System

GALASSI, STEFANO<sup>1</sup>; RUGGIERI, NICOLA<sup>2</sup>; TEMPESTA, GIACOMO<sup>3</sup>; ZINNO, RAFFAELE<sup>4</sup>;

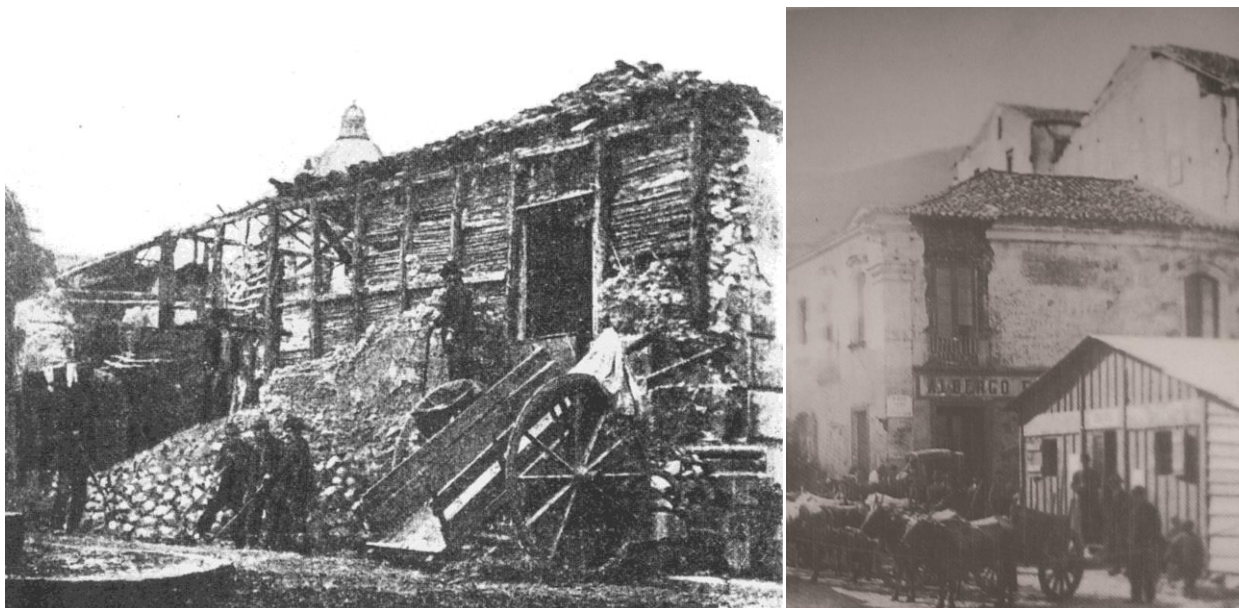
**Figure 2.** Seminara (Rc), 1908 earthquake; Palmi (Rc), 1908 earthquake. Overturning of the outer part of the wall, in *baraccato* buildings.

Façade out-of-plane collapse in old constructions is a crucial issue, nevertheless few studies are present in the scientific literature (Figure 2).

An analysis on typical failures has been carried out by the University of Calabria, based on historic photos and chronicles depicting masonry buildings reinforced with timber frames after the earthquakes of 1905 and 1908. This research has demonstrated proper behaviour of the Borbone constructive system under seismic action and in general negligible damages, limited to the partial overturning of part of the wall [9]. This kind of failure is strictly linked to the fabric features; in fact the *Baraccata* masonry type, characterized by the lack of transversal connection stones, does not ensure a monolithic behaviour of the wall with a consequent vulnerability to out-of-plane collapse even with low intensity earthquakes. The moment equilibrium, between the overturning tendency due to the seismic excitation and the stabilizing moment generated by the friction effect and the geometrical properties of the too thin leaf, means stability is not maintained.

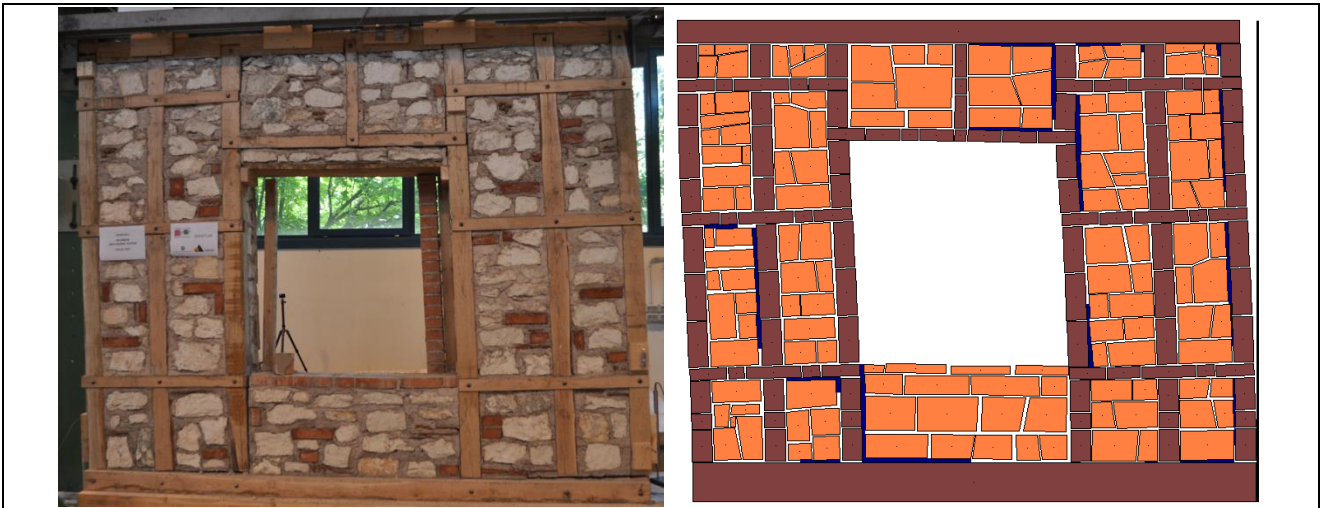
**Figure 9.** Ultimate deformed shape and cracking pattern. Comparison between experimental test and numerical modelling.

The final results for a load applied at the top equal of 103,64 kN were achieved after 311 iterative steps of the calculation algorithm with a final horizontal displacement, measured at the top of the specimen, equal to 59,90 mm, very close to the actual one.

It is interesting to notice how, in terms of fracture and detachment, the crack pattern produced as the output of numerical analysis has shown a significant similarity with the real one (Figure 9).
