Andriy VASIN, Yuri GOMENIUK, Audrey RUSAVSKY, Alexey N. NAZAROV, V.S. LYSENKO, Petro M. LYTVYN, O.G. GONTAR, Sergii P. STARIK, Corinne NOUVEAU, S. ASHOK - Nano- and micro-scale morphological defects in oxidized a-SiC: H thin films - Physica Status Solidi (C) Current Topics in Solid State Physics - Vol. 10, n°4, p.619-623 - 2013

# Nano- and micro-scale morphological defects in oxidized a-SiC:H thin films

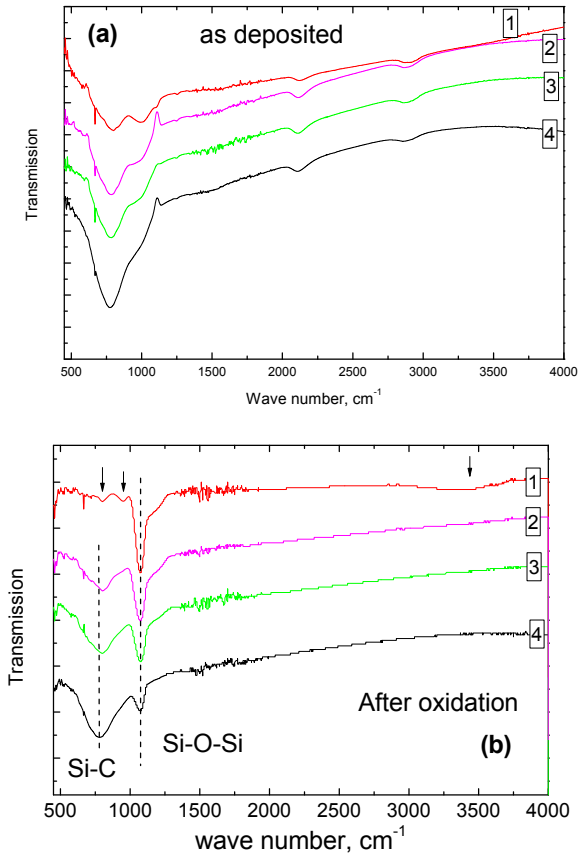
FTIR transmission spectra of as-deposited and thermally treated samples are presented in Fig. 1. Spectra of as-deposited samples (Fig. 1(a)) are composed of four main absorption bands typical for a-SiC:H layers: 800 cm<sup>-1</sup> (Si-C stretching), 1000 cm<sup>-1</sup> (Si-C-H<sub>2</sub> bending), 2100 cm<sup>-1</sup> (Si-H<sub>n</sub> stretching), and 2800–3000 cm<sup>-1</sup> (C-H<sub>n</sub> stretching) [7, 8]. In the 1000–1100 cm<sup>-1</sup> region some contribution to the absorption due to oxygen contamination is expected.

It is evident from the figures that the principal effect of increase in discharge power is increase of the relative intensity of the Si-C related absorption band at 800 cm<sup>-1</sup>, in comparison with the hydrogen related band at 1000 cm<sup>-1</sup>. It can be interpreted as increase of the concentration of Si-C bonds and decrease of SiC-H<sub>n</sub> associated mainly with hydrocarbon radicals in the nano-voids. Such interpretation is in good agreement with increase of the density of the films observed with increasing of discharge power.

The FTIR spectrum of the sample after oxidation in O<sub>2</sub> atmosphere at 550 °C is presented in Fig. 1(b). No Si-H<sub>n</sub> (2100 cm<sup>-1</sup>) and C-H<sub>n</sub> (2900–3000 cm<sup>-1</sup>) stretching vibration bands were detected after dry oxidation. In the spectrum of the sample deposited at lowest discharge power (i.e. lower density of the material) there are four pronounced absorption bands at 446 cm<sup>-1</sup>, 805 cm<sup>-1</sup>, 945 cm<sup>-1</sup>, 1070 cm<sup>-1</sup> (with shoulder at 1200 cm<sup>-1</sup>) all of which known to be related to oxygen bonds: Si-O-Si (symmetrical stretching), Si-OH (stretching), Si-O-Si (asymmetrical

stretching), and O-H (stretching) respectively. One can see that relative intensity of the main silicon-oxygen absorption bond (1070 cm<sup>-1</sup>) is reduced as the density of the film increases.

**Figure 1** FTIR transmission spectra of as-deposited (a) and oxidized (550 °C) a-SiC:H samples deposited at RF-discharge power of 180 W (1), 200 W (2), 250 W (3), and 330 W (4).

**3.1 Nano-scale defects** Atomic force microscopy measurements show that surface of as-deposited films is smooth and uniform. But after oxidation of the low density sample (the sample deposited at lowest discharge power, see spectrum 1 in Fig. 1) at 550 °C we observe formation of island-like inhomogeneities (Fig. 2(a)). Such morphological defects were not observed after oxidation at 650 °C. IR spectra of these samples (not presented here) do not differ significantly. The size of island-like morphological

In FTIR spectrum of this sample (Fig. 1, spectrum 1) we see only silicon oxide related absorption bands so we can say the a-SiC material is “completely oxidized”. IR absorption cross section of Si-C and Si-O bonds is different but of the same order. From the surface image we see that relative contribution of the volume of island-like regions is quite significant so that we can attribute the absence of the Si-C related absorption in FTIR spectra to the absence of corresponding a-SiC material. Basing on this suggestion we can attribute island-like regions to carbon-enriched highly defective SiO(x) structural fragments.

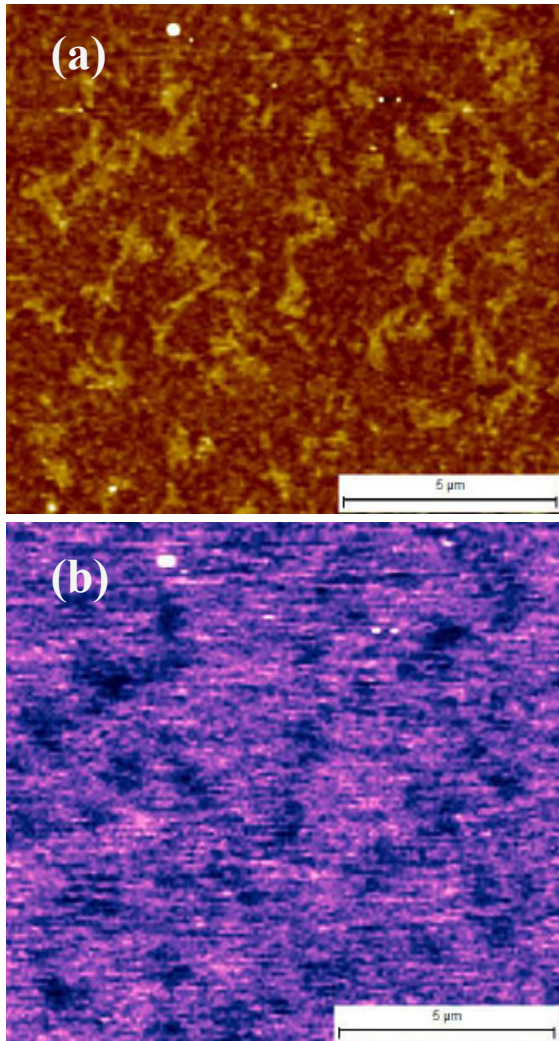
defects ranges from several hundred nm to several  $\mu\text{m}$ , and islet defects protrude above the surface of the main body of the films by about 10 nm.

**Figure 2** (a) AFM topology (contrast of height in range of 10 nm) and (b) KPFM map (contrast of surface potential in range of 30 mV) of the surface of low density a-SiC:H films after oxidation at 550 °C.

Kelvin probe force measurements exhibit that the surface potential of the defects is significantly lower than that of the surrounding matrix (Fig. 2(b) indicating that electrical properties of the material is also inhomogeneous..

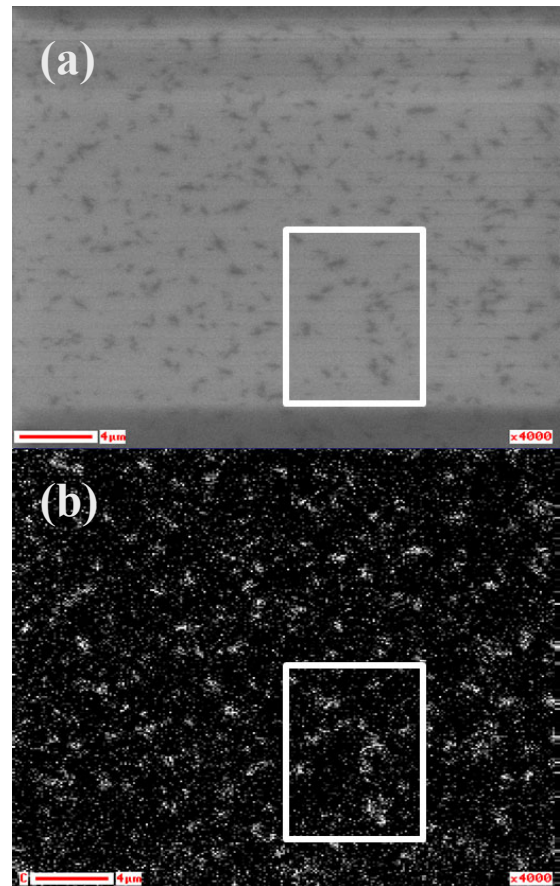
Figure 3 shows the SEM image generated by secondary electrons of the surface of the sample after annealing in oxygen at 550 °C (Fig. 3(a)) and the corresponding distribution of carbon on the surface of the

sample (Fig. 3(b)). It is seen that carbon distribution replicates the morphological map, thus indicating that the island-like defects are enriched by carbon in comparison with the surrounding surface. Local nano-probe measurements show that the flat surface contains much more oxygen than island-like defects. Thus island-like defects can be attributed to non-oxidized regions.

**Figure 3** SEM (regime of secondary electron detection) image (a) and carbon distribution map generated by Auger-electron scanning probe (b) of the low density sample after oxidation at 550 °C. Contrast of carbon distribution map corresponds to the range from background signal of the C(KVV) line (black) to maximum of the amplitude of C(KVV) line (white).

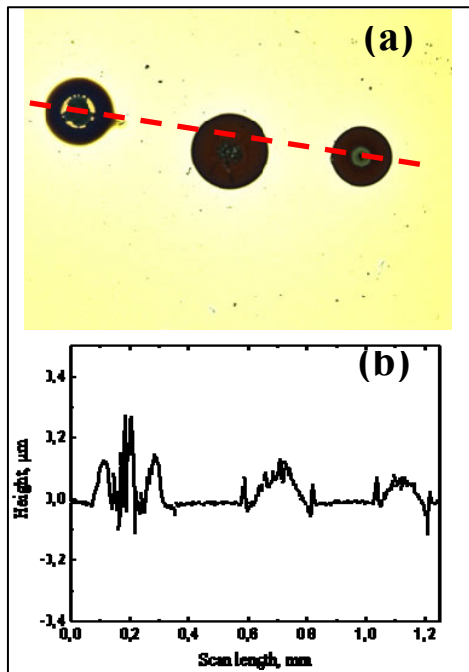
Figure 4(a) shows a typical optical microscopy image of such spots. Optical profilometry showed that these spots are the projections (Fig. 4(b)) with a complex structure of the edge and the center. Usually these defects are formed around pin-holes or near the edges of the silicon substrate.

**Figure 4** Optical microscopy image of the micro-defects (a) and corresponding surface profile (b).

When measuring the profile of the distribution of elements, the ion etching conditions were identical so the delayed arrival to a silicon substrate in the case of measurement over the dark spot is obviously due to the greater thickness in this location, which is consistent with optical profilometry data (see Fig. 4(b)).

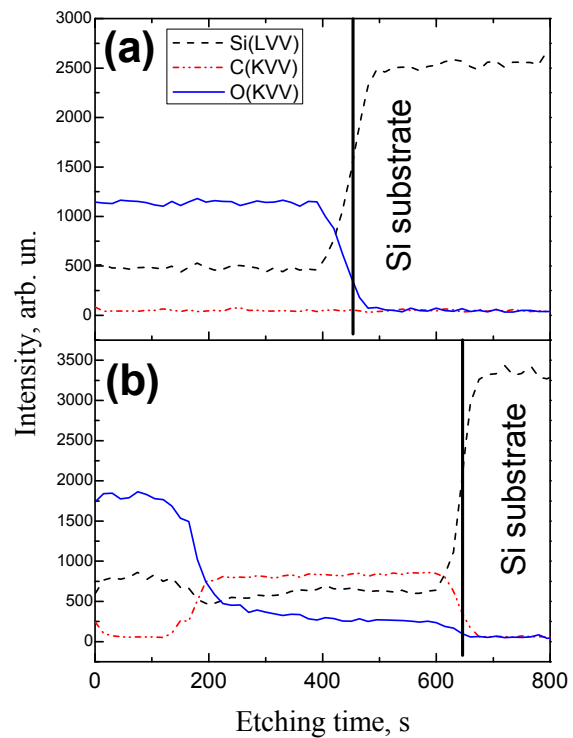
Nano-probe Auger electron profiles of silicon, carbon and oxygen in the dark spot and in the open surface are shown in Fig. 5. It can be seen that in a homogeneous area of the film the distribution of the elements in depth of the film is homogeneous and corresponds to amorphous silica.

In the dark spot the profile of the composition is represented by two areas: (1) the upper area with a high concentration of oxygen, and (2) the lower area, with high carbon content. The oxygen concentration drops at the boundary and then slowly decreases toward the silicon substrate. The silicon concentration in these two areas differs little. Thus we can conclude that dark spots are represented by a bi-layer: upper layer of silicon oxide and underlying nano-composite layer composed of amorphous silicon carbide and amorphous carbon precipitates.

**Figure 5** AES depth profile of the distribution of silicon, carbon and oxygen in the region of uniform surface (a) and “dark hole” defect (b).

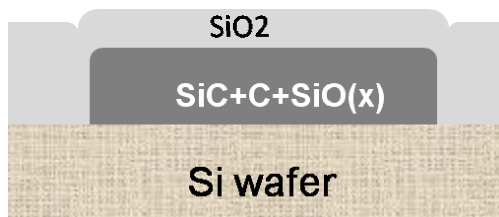
Summarizing the experimental data, we suggest a topological model of the dark defects as presented in Fig. 6. Significant increase of the thickness in the region of dark spot is probably associated with condensation of large amounts of carbon in the porous SiC matrix.

**Figure 6** Topological model of the “dark hole” micro-defect.
