Vanessa RODRIGUEZ, Jacob SUKUMARAN, Yeczain PEREZ DELGADO, Mariana STAIA, Alain IOST, Patrick DE BAETS - Scratch evaluation on a high performance polymer - Mechanical Engineering Letters - Vol. 9, p.76-84 - 2013

# Scratch evaluation on a high performance polymer

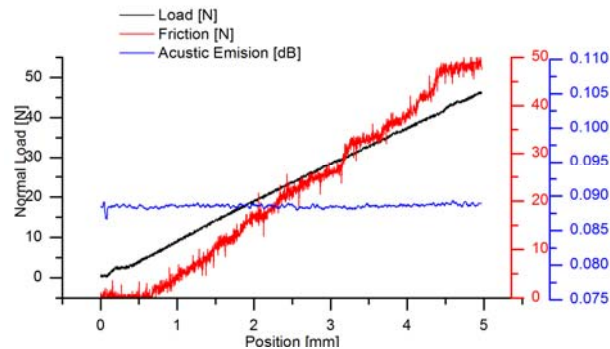
The figure 2 is a typical testing curve for polymers under progressive load scratch test of the PEEK-E02 sample, where the tangential force curves show small magnitude of fluctuations at the beginning and at the middle of the test due to the inertial effects of instantaneously accelerating the scratch head to the designated scratch speed. But after this, the tangential force increase slightly and in a digressive manner to its final level, influences at the end by the movement of the indenter.

Figure 2. Typical course of the scratch loads versus scratch length measure in PEEK-E02 with a progressive load of 50N

Various properties were observed in this study such as penetration depth, tangential force, surface damage as a function of load, there are plotted in the figure 2 and 5 for the two PEEK filled with composites were shows the experimental results of scratching test. In both figure, it can be observed that the scratch force is increased as the load increased. From the Coulomb's law, it is evident that there is a linear relationship between scratch force and applied load. In previous investigations by Sujeet Sinha (Sinha and Lim 2006) finds that the scratch forces for all polymers that their investigated such as polypropylene,

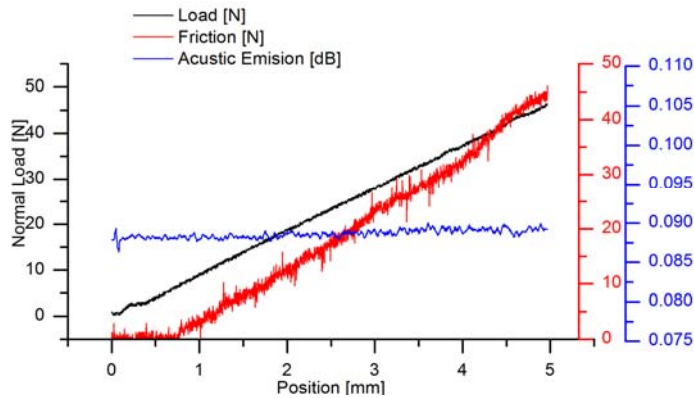
For the PEEK-S01 material filled with carbon fibers, graphite fibers shows smaller differences in the curve under the progressive load of the scratch test compared with the PEEK-E02 polymer as it can be seen in the testing curve under load scratch test figure 5, the appearance of the scratches on the both materials is rather similar but in this case with less fluctuations and smooth changes during the scratching test. The scratch frictional force, and contact zone size increased almost linearly with applied load.

Figure 5. Typical course of the scratch loads versus scratch length measure in PEEK-S01 with a progressive load of 50N.
