Henri BAILLERES, Louis DENAUD, Jean-Claude BUTAUD, Robert MCGAVIN - Experimental approach of coconut peeling process - In: 22nd International Wood Machining Seminar, Canada, 2015-07-14 - 22nd International Wood Machining Seminar - Volume 2 - 2015

EXPERIMENTAL APPROACH OF COCONUT PEELING PROCESS

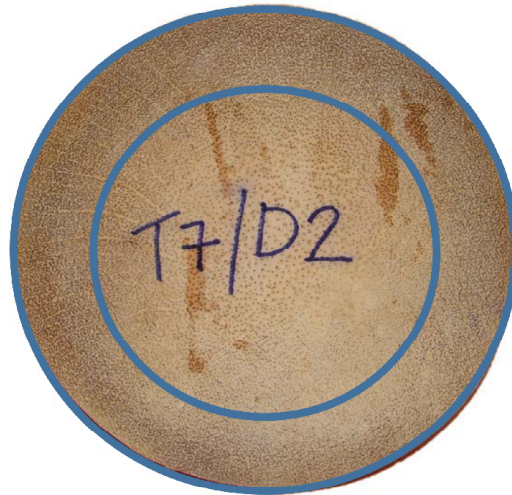
Figure 1: Coconut disc showing that the most valuable area for high density veneer production lies between the blue circles

The fibrovascular bundle architecture follows an interlocked helix formation as it ascends the trunk. The specific architecture of cocowood has been described as a triple helix structure (2, 3, 4). Unlike the dicotyledonous trees traditionally used by the forest products industry, coconut palm (*Cocos nucifera* L.) is a monocotyledon. Due to the huge variation in cocowood's density, production of high-quality veneers from the external part of coconut palm logs appears to be the most attractive way to use this resource (Figure 1). However, the unique structure of cocowood requires tight control of peeling parameters.
