# Earth-based construction material field tests characterization in the *Alto Douro Wine Region*

**Abstract:** The *Alto Douro Wine Region*, located in the north-east of Portugal, a UNESCO World Heritage Site, presents an abundant vernacular building heritage. This building technology is based on a timber framed structure filled with a composite earth-based material. A lack of scientific studies related to this technology is evident, furthermore, principally in rural areas, this traditional building stock is highly deteriorated and damaged because of the rareness of conservation and strengthening works, which is partly related to the non-engineered character of this technology and to the knowledge loosed on that technique. Those aspects motivated the writing of this paper, whose main purpose is the physical and chemical characterization of the earth-based material applied in the *tabique* buildings of that region through field tests. Consequently, experimental work was conducted and the results obtained allowed, among others, the proposal of a series of adequate field tests. At our knowledge, this is the first time field tests are undertaken for *tabique* technology. This informat

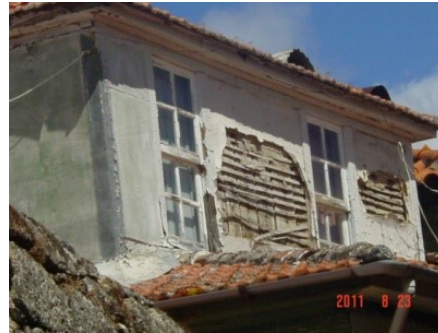
Figure 1: *Tabique* building and wall.

A *tabique* building component as a wall, (Figure 1), is formed of a timber structure made up of vertical boards connected by laths (horizontal slats) which are connected

with metal nails, [6]. This structure is then filled and coated with a CEBM, [1, 3, 5, 8].

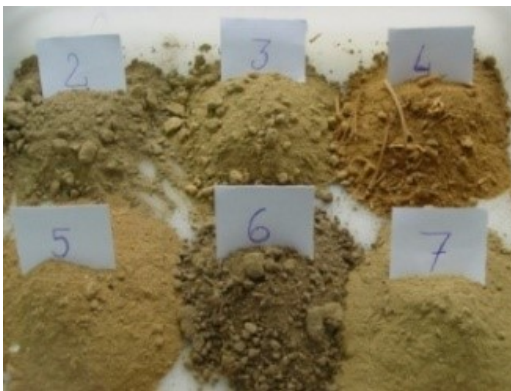
Figure 2: *Tabique* building studied.

These *tabique* buildings are rural *tabique* dwellings of two floors with exterior and partition *tabique* walls. In each building, one EBM sample with an average weight of one kilogram was collected and the adopted sample designation correspond to C2, C3, C4, C5, C6 and C7, (Figure 2). The sampling locations can be found in [3, 12].

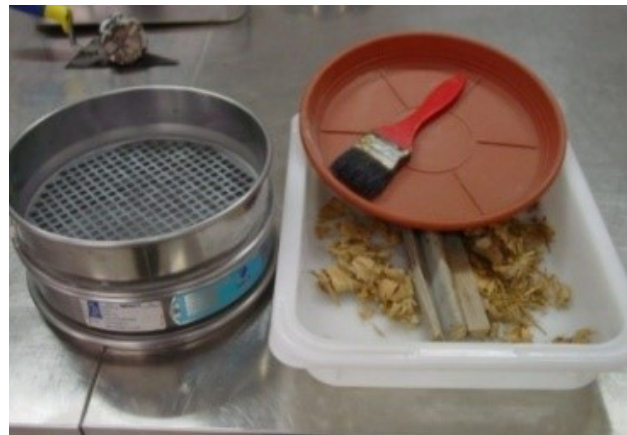
Figure 3: Equipment used in the grain size characterization.

The field tests are manual and need simple equipment for example a spoon, a brush, a plastic container, three ASTM series sieves and a spatula illustrated in Figure 3.

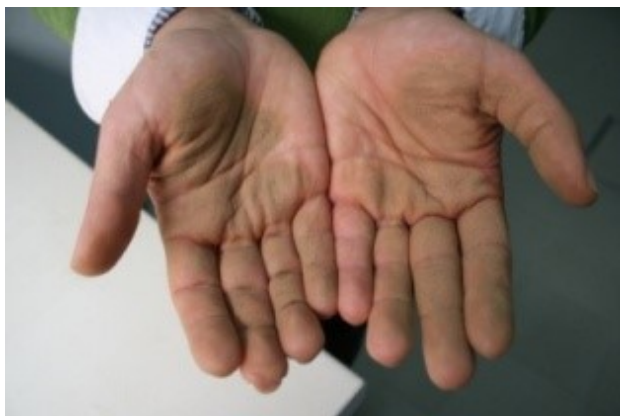
**Figure 5:** Washing hands test.

In the nibble test, a very small quantity of the EBM samples is crushed lightly between the teeth, a sandy soil grinds between the teeth and produces a disagreeable sensation, if it can be ground between the teeth, without a disagreeable sensation the soil is silty. Clayey soils, on the other hands, gives a sticky, smooth or floury sensation [17]. In the washing hands test, a humid EBM sample is rubbed between the hands, if the grains can be distinctly felt, it indicates sandy or gravelly soil, if the sample is sticky, but the hands can be rinsed clean fairly easily the EBM is silty, if the EBM has a soapy feel and the hands cannot be rinsed easily the EBM is clayey, [17]. Figure 5 illustrates the hands aspect after this operation.

As indicated in Table 4, the nibble test and washing hands test classified the EBM samples as silty, except for sample C4 who was classified as clayey.

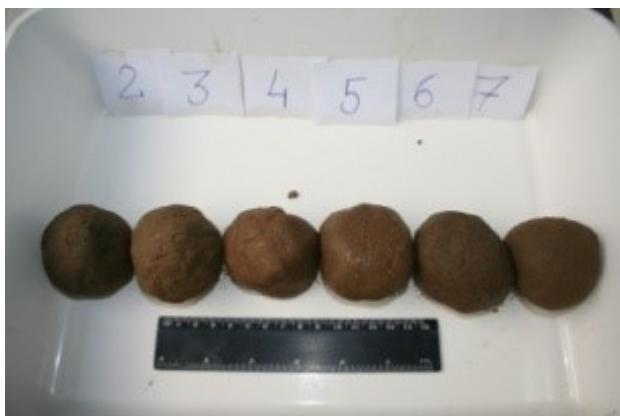
**Figure 6:** EBM balls.

consistency test, a moist portion of each EBM sample is formed into a 3 cm ball diameter so that it sticks together but does not stick to the fingers, Figure 6 illustrates these ball samples.

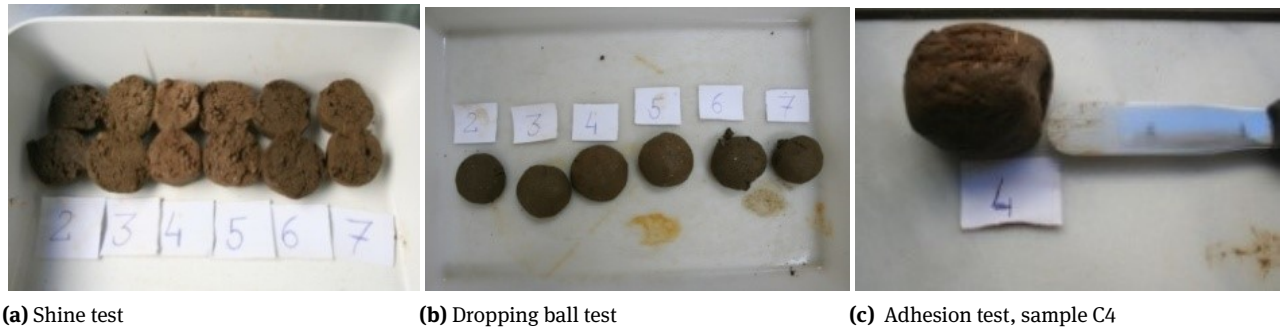
Figure 7: Shine, dropping ball, adhesion and water retention tests.

For the shine test, the EBM balls are cut in half with a knife and the cross section of the ball is observed. A shine cross section indicates clay content, a dull cross section indicates higher silt or sand content, (Figure 7-a)). In the dropping ball test, (Figure 7-b)), the balls are dropped from

a height of 1.5 m into a flat surface, if the ball flattens only slightly and shows few or no cracks, it has a high binding force due to a high clay content, this is the case for the six samples.

In the adhesion test, a spatula is inserted in each ball, (Figure 7-c)), if the spatula penetrates with difficulty and EBM sticks to it upon withdrawal the EBM is extremely clayey, if the spatula can be pushed into it without difficulty but a bit of EBM remains on the spatula upon withdrawal the EBM is moderately clayey, if the spatula can be pushed into the mass without encountering any resistance at all, even if the spatula is dirty upon withdrawal the EBM contains only a little clay [17]. The results regarding the adhesion test are presented in Table 6.

As it can be observed the shine test classified the sample as silty earth and the dropping ball test as clayey earth. Since the dropping ball test results are different from the shine test and the other previous tests and also regarding the laboratory tests realized in [12], we recommend not to use this test to characterize EBM applied in *tabique* technology.

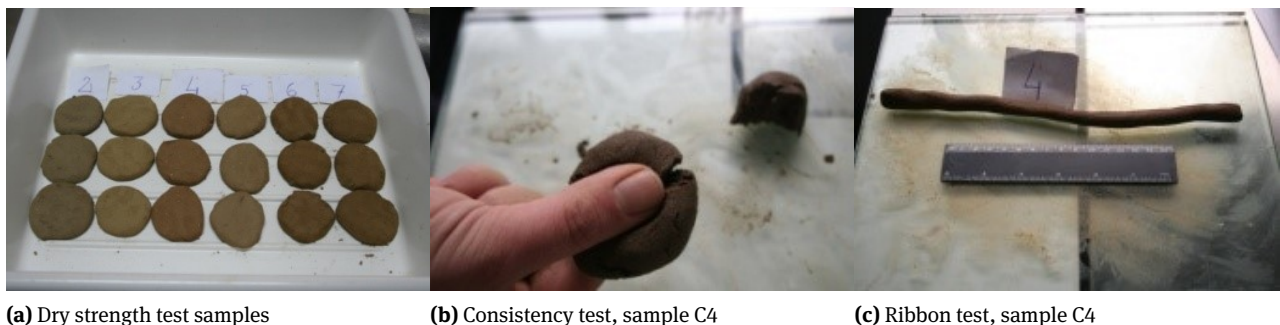
Figure 8: Dry strength, consistency and ribbon test.

The plasticity evaluation of samples C2, C3, C4, C5, C6, C7 was concluded with the dry strength test, consistency test and ribbon test. For the dry strength test, we form three pats of EBM for all six samples. The pats were put in an oven until they were completely dried, (Figure ??-a)). Then we observe how easy the pats are to pulverize between the thumb and index finger. If the pat pulverizes easily, the EBM is silty or fine sand and has a low clay content, if the pat can be crushed to a powder with little effort, the EBM is silty or sandy clay, finally if the pat is hard to break and will not pulverize, the EBM has a high clay content, [17].

In the consistency test, (Figure ??-b)), the EBM samples are formed into a ball. If it crumbles before forming a ball, then the EBM as a high silt or sand content. If the ball can be crushed between the thumb and forefinger only with a lot of force, the clay content is high. If the ball cracks and crumbles, then the EBM as a low clay content, [16]. In

For the ribbon test, (Figure ??-c)), each EBM sample is carefully rolled in the form of a sausage with the maximum length that the EBM sample will support. A long ribbon is indicative of the high clay content, a short ribbon on the other hand indicates a low clay content.

The adhesion test classified the EBM samples as sandy. Nevertheless in this test it is very difficult to measure the variation of the force applied to the spatula, since it is a manual operation. This generates questions about the precision of the results. The dry strength test classified almost all the samples as silty-clay. We observed that when the pats broke they divided into three parts, except sample C4 which broke into four parts.

The results of the consistency test and ribbon test are presented in Table 7. We observed that the ribbon length varies between 16 cm and 26 cm, which in means they correspond to medium plasticity.

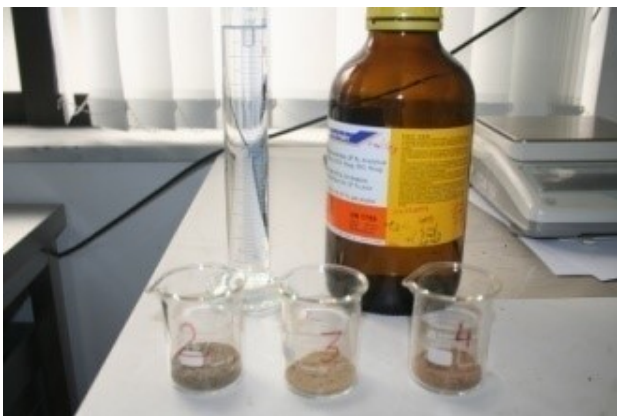
**Figure 9:** Acid test samples.

It is common practice in the *Alto Douro* region to use EBM enriched with hydraulic lime in the *tabique* walls since lime does not exist in that region. Which means lime can be present in the EBM applied in *tabique* constructions or rehabilitation. In order to define the lime content, one drop of a 20% solution of chloridric acid, presented in Figure 9, is added to the samples using a glass or a timber rod.

The efflorescence indicates the presence of lime, if there is no efflorescence, the lime content is less than 1%. If there is a weak, brief efflorescence, the lime content is between 1% and 2%; if the efflorescence is significant though

brief, the lime content is between 3% and 4%; and if the efflorescence is strong and long lasting, the lime content is more than 5%. The acid test results presented in Table 8 reveals that the samples do not react with the chloridric acid thus they do not have lime in their composition or if they have it is in a very small quantity. The results are the same as those obtained with EDS analysis results reported in [3, 12].
