## Research Article

# Clinical Classification of Bone Augmentation Procedure Failures in the Atrophic Anterior Maxillae: Esthetic Consequences and Treatment Options

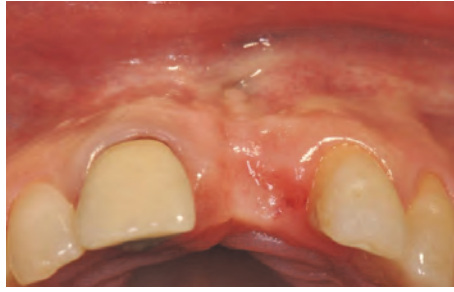
FIGURE 3: Clinical view showing a lack of the upper left central incisor.

**2.2. Treatment Option for a Class I Complication.** This case shows the loss of the upper left central incisor due to endodontic failure (Figure 3).

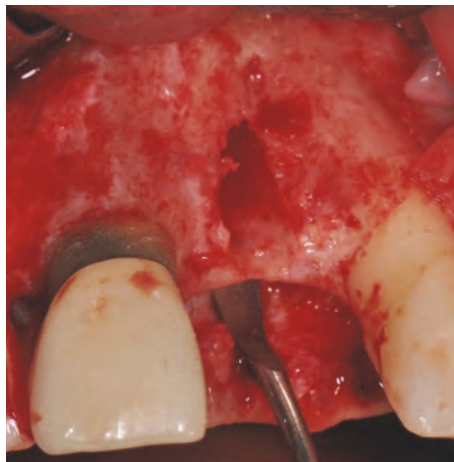
FIGURE 4: Surgical view of the socket; the whole buccal bony wall is missing.

Four months after the extraction, a full thickness flap was raised; the socket was still present, but the whole buccal bony wall was missing (Figure 4).

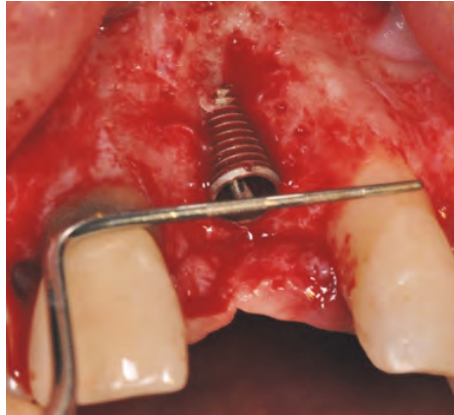
FIGURE 5: One implant is placed in the socket with all its coronal buccal part exposed.

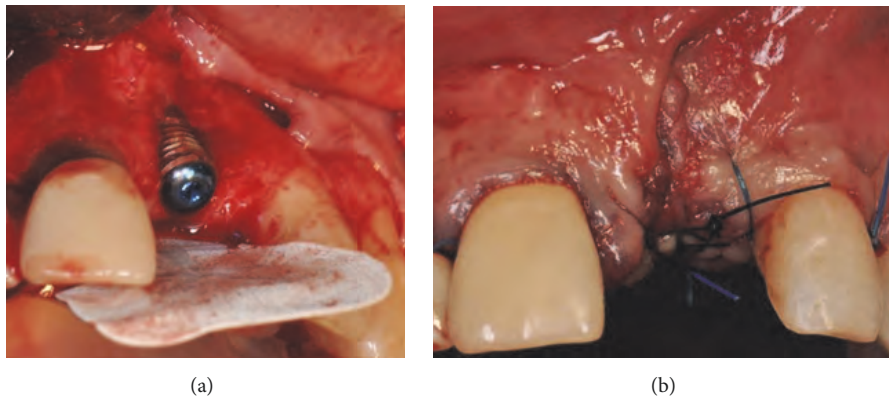
FIGURE 6: (a-b) GBR procedure performed using a microtextured titanium-reinforced PTFE membrane, fixed by one pin.

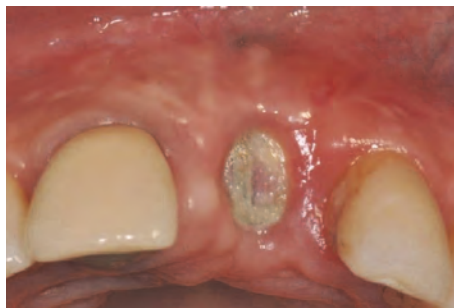
FIGURE 7: Membrane exposure after three weeks of healing.

After three weeks of healing, the membrane was exposed in its coronal part (Figure 7).

The area was treated with applications of chlorhexidine gel (Corsodyl gel, GlaxoSmithKline, UK) twice a day for seven days. After this period, a full thickness flap was raised

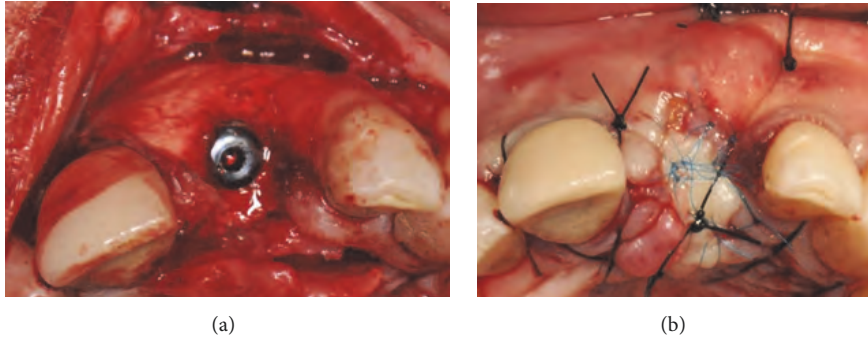
FIGURE 8: (a-b) Connective tissue graft harvested from the left palate in order to close the flap fenestration.

and a connective tissue graft was harvested from the left palate and placed coronally to the implant in order to close the flap fenestration (Figures 8(a) and 8(b)).

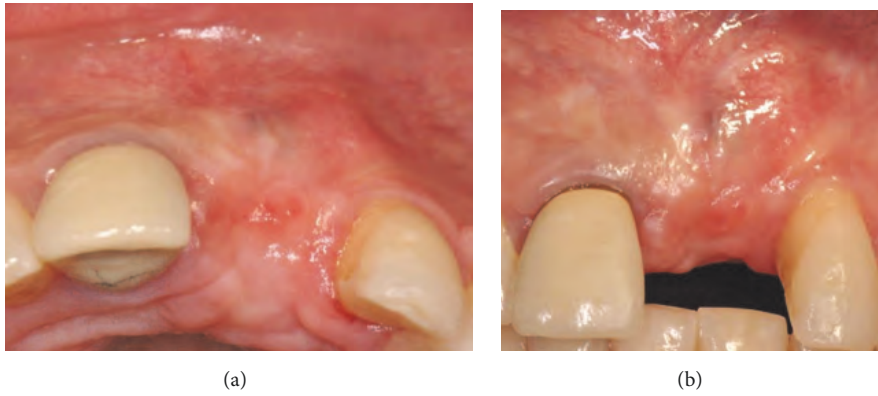
FIGURE 9: (a-b) Healing of the soft tissues with a reduced thickness of buccal profile.

After 45 days of healing, the soft tissues were healthy and keratinized tissue was present, but the buccal profile was still not sufficiently thick (Figures 9(a) and 9(b)).

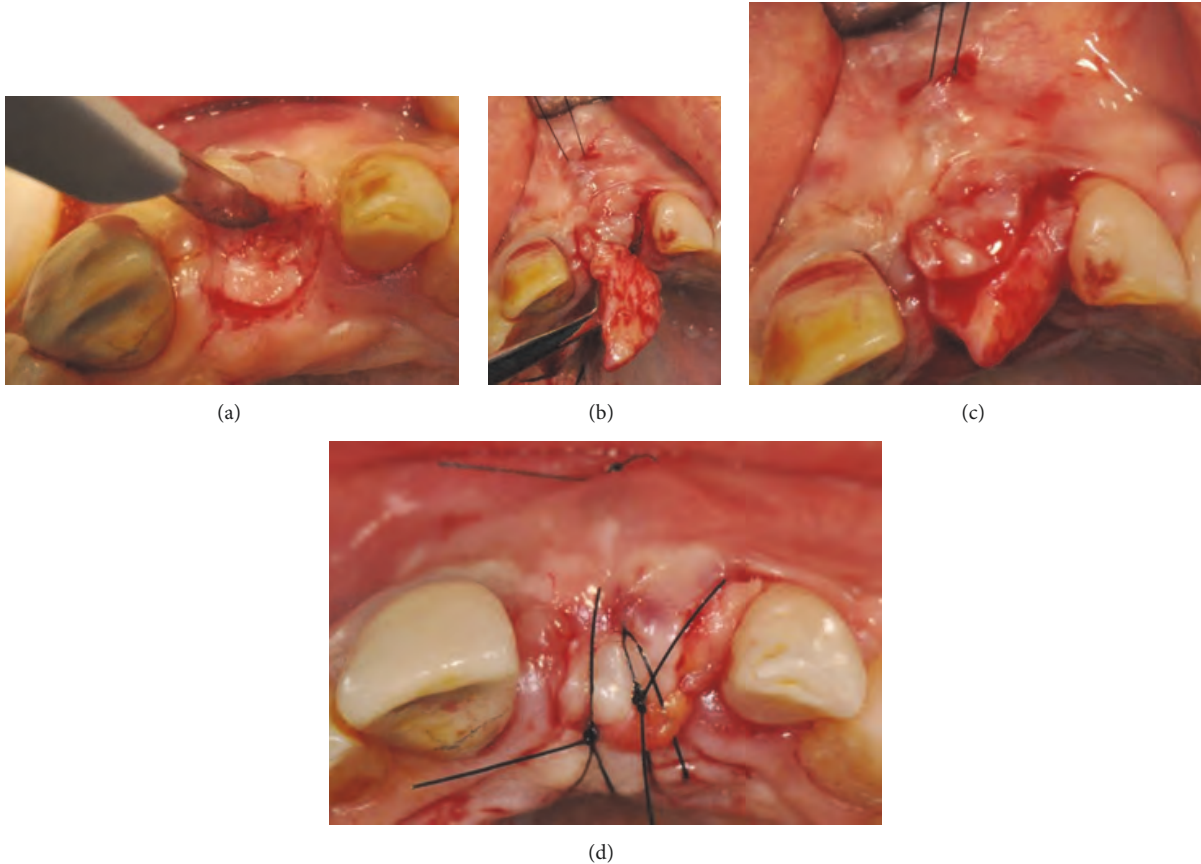
FIGURE 10: (a-b-c-d) A partial thickness flap is created to house a second connective tissue graft, harvested from the right palate and placed buccally.

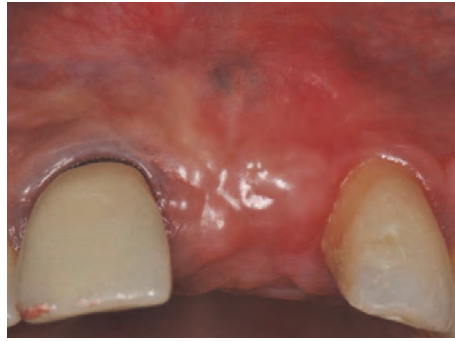
FIGURE 11: Clinical view of the edentulous area: reduced soft tissue volume at the level of the distal papilla.

After two months of healing, the edentulous area of the upper central left incisor finally achieved a good buccal profile but was still lacking sufficient soft tissue volume in relation to the distal papilla (Figure 11).

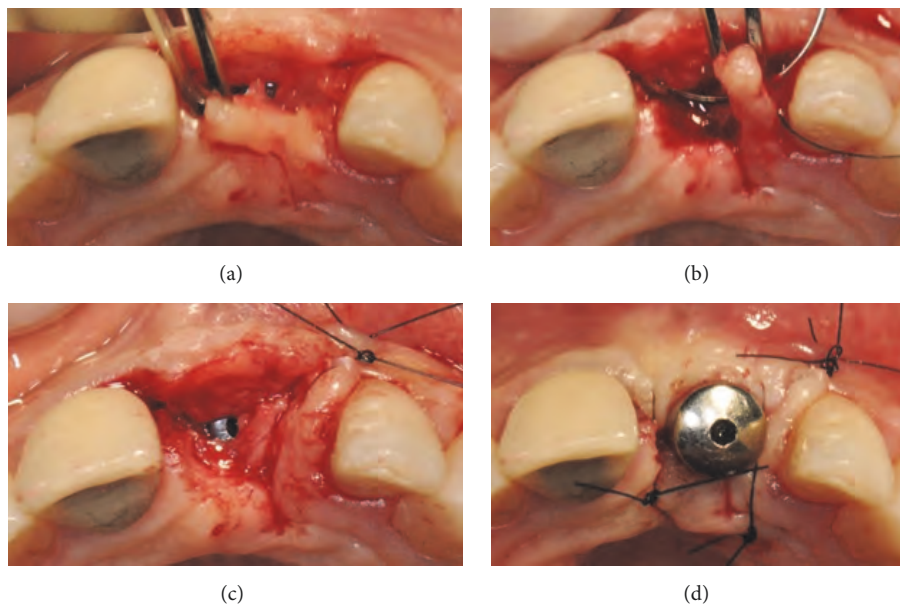
FIGURE 12: (a-b) A narrow part of the palatal flap is cut to half-thickness and rotated distally against the lateral upper left incisor. (c-d) The papilla mesial to the lateral incisor is disepithelialized and the microflap is sutured over the original papilla.

To solve this final problem, which may have prejudiced the final esthetic result, a laterally translated microflap was created (Figures 12(a), 12(b), 12(c), and 12(d)).

A narrow part of the palatal flap was cut to half-thickness (Figure 12(a)) and rotated distally to the lateral upper left incisor (Figure 12(b)). The papilla mesial to the lateral incisor

was disepithelialized and the microflap was sutured over the original papilla (Figures 12(c) and 12(d)).

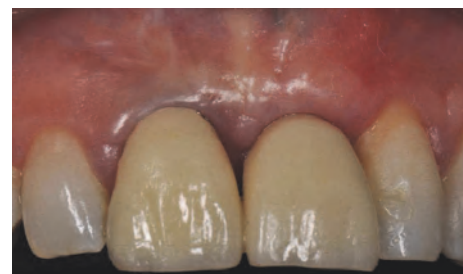
FIGURE 13: Provisional crown delivered with a slight compression on the newly formed papilla, after three weeks of healing.

After three weeks of healing a provisional crown was inserted with only a slight compression on the newly formed papilla (Figure 13).

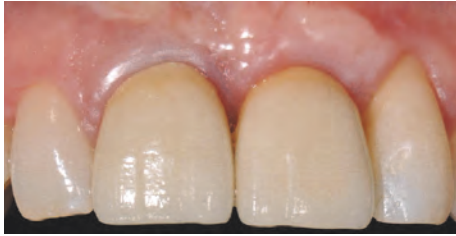
FIGURE 14: Definitive ceramic crown is placed after two months.

Finally, two months later, a definitive ceramic crown was placed, surrounded by healthy soft tissues, with a good amount of buccal keratinized tissues and the presence of the papilla between the central and lateral left incisors (Figure 14).

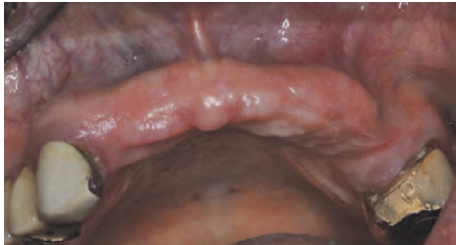
FIGURE 15: Clinical view of the upper anterior maxilla showing an absence of all the anterior teeth combined with a lack of adequate buccal thickness.

**2.3. Treatment Option for a Class 2 Complication.** This case shows an absence of all the anterior superior teeth combined with a lack of adequate buccal thickness (Figure 15).

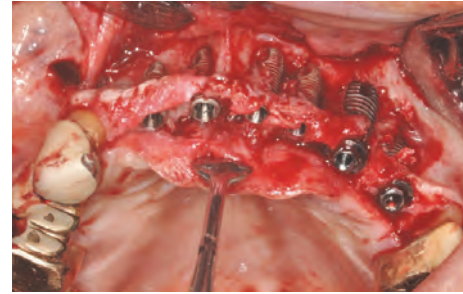
FIGURE 16: Placement of six dental implants with the bone surrounding only their coronal part.

Taking advantage of the presence of a thick amount of crestal cortical bone, six dental implants (ExFeel, Megagen®, Korea) were placed with the bone surrounding only their coronal part (Figure 16).

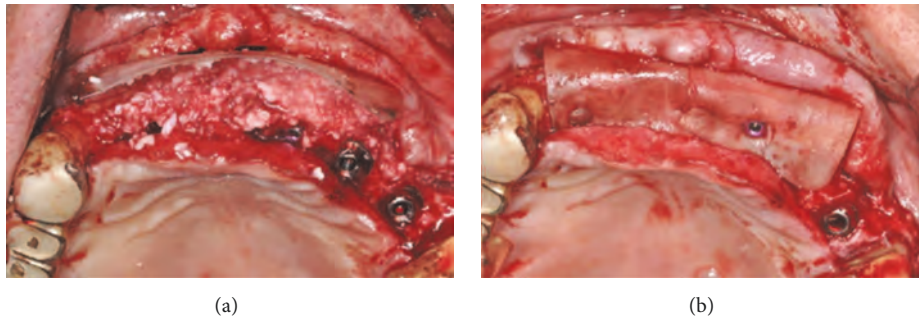
FIGURE 17: (a-b) Granules of biomaterial are placed between the implants and in excess on the buccal side, covered by a semi-rigid resorbable poly(lactide acid) membrane and fixed with implant cover screws and resorbable tacks.

To cover the buccal aspect of the implants and in order to compensate for the lack of regenerate bone, granules of biomaterial (Mp3, Osteobiol, Italy) were placed between the implants, in excess on the buccal side, covered by a semi-rigid resorbable polylactic acid membrane (GTR Biodegradable membrane, Inion®, Finland), fixed with both implant cover

screws and resorbable tacks (GTR Tack, Inion®, Finland) (Figures 17(a) and 17(b)).

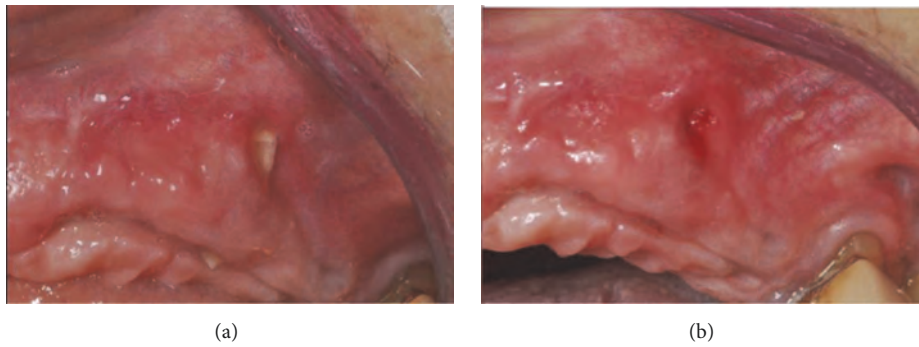
FIGURE 18: (a-b) Partial exposure of an angle of the membrane, which occurred after four months and was treated with a little plastic.

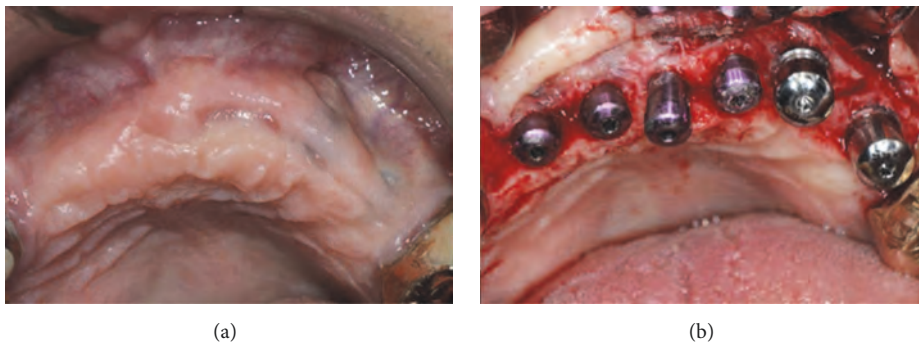
FIGURE 19: (a-b) Eight months after the implant therapy, the implants appeared stable and well osseointegrated, but the buccal profile was still not sufficiently thick.

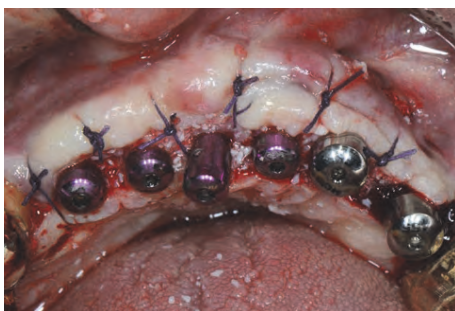
FIGURE 20: Grafting material is placed buccally under the flap to improve the thickness of the profile and the flaps are left to heal for a second intention.

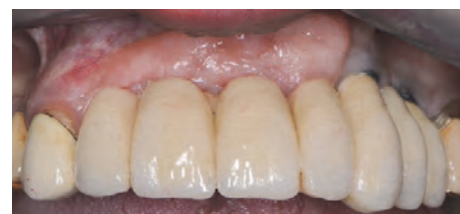
FIGURE 21: Final prosthesis delivered to the patient.

Despite these attempts to increase the buccal profile of the maxilla, the final result was satisfactory only from a functional point of view since no good esthetic result was obtained (Figure 21).

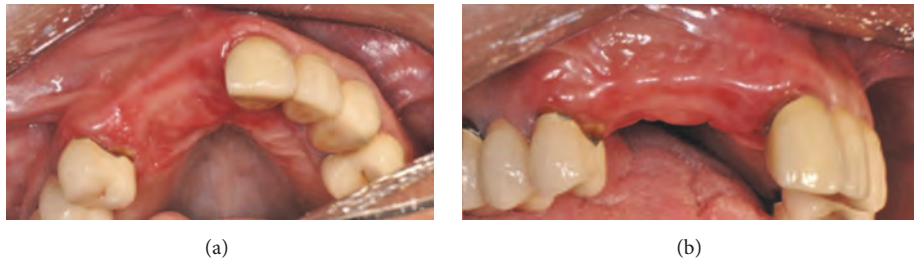
FIGURE 22: (a-b) Clinical frontal and occlusal views of the atrophy in the upper right frontal area.

**2.4. Treatment Option for a Class 3 Complication.** This patient presented a loss of teeth #11, 12, and 13 due to severe periodontal disease (Figures 22(a) and 22(b)).

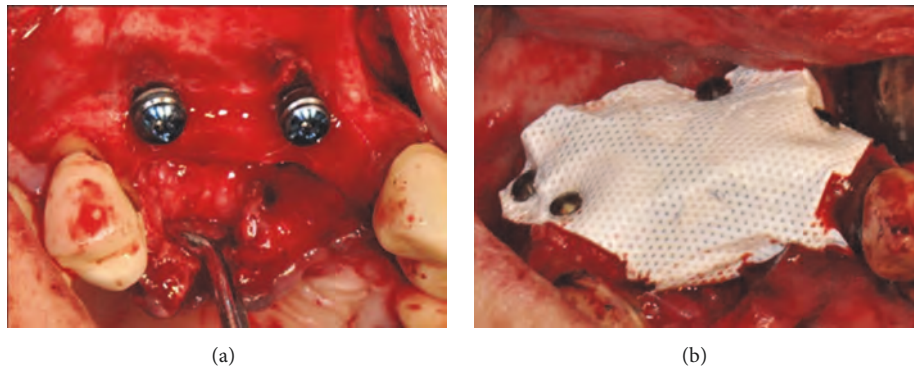
FIGURE 23: (a) Two implants placed supracrestally in sites #13 and #11. (b) The lack of crestal and buccal bone volume is compensated for with a 1:1 mixture of particles of bovine derived xenograft and autogenous bone harvested from the premaxilla and the palate with bone scrapers. The bone graft is covered with a microtextured titanium-reinforced PTFE membrane and fixed by pins and miniscrews.

Implants (AnyRidge, Megagen, Korea) were placed supracrestally in sites #13 and #11 and the lack of crestal and buccal bone volume was compensated for with a 1:1 mixture of particles of bovine derived xenograft (Bio-Oss®, Geistlich, Switzerland) and autogenous bone harvested from the premaxilla and the palate with bone scrapers. The bone graft was then covered with a microtextured titanium-reinforced

PTFE membrane (Cytoplast® Ti-250, De Ore®, Italy) and fixed by pins and miniscrews (Pro-fix® Membrane Fixation System, Osteogenics Biomedical, Texas, USA) (Figures 23(a) and 23(b)).

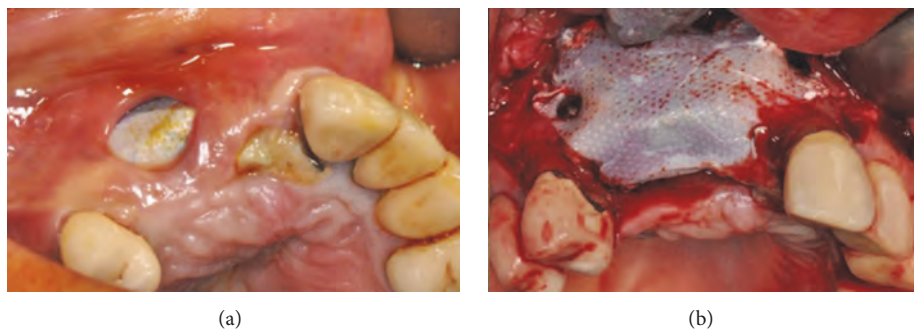
FIGURE 24: (a) Exposure of the membrane on the buccal aspect of the area after five months of healing. (b) Clinical situation after reopening the flap; the membrane, pins, and screws were removed.

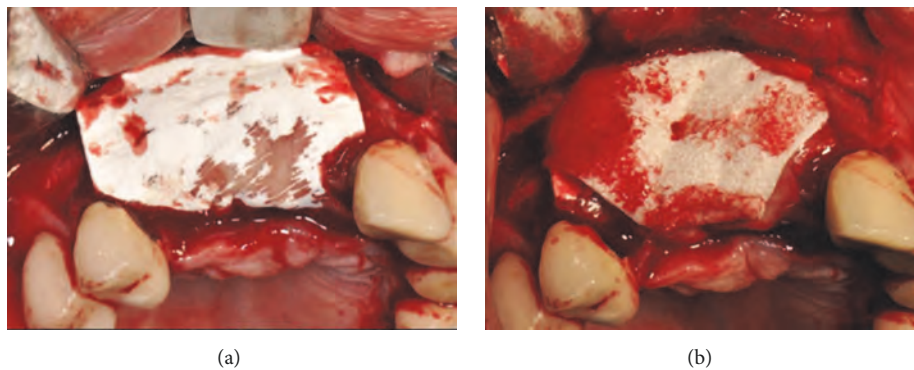
FIGURE 25: (a-b) A resorbable membrane is placed, covered by a collagen sponge, in order to create a double-layered barrier protecting the bony area that required regeneration.

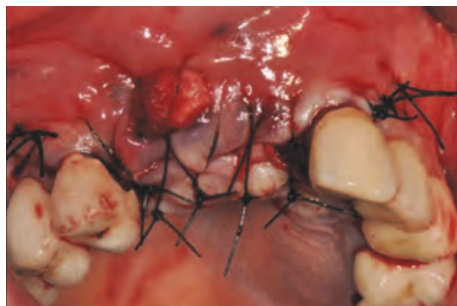
FIGURE 26: Closure of the flap is obtained after suturing with a deliberate lack of first intention; the fenestrated buccal area is left to heal for a second intention over the collagen sponge.

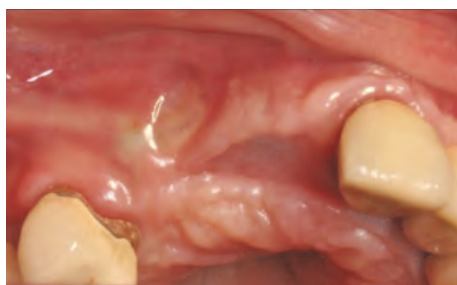
FIGURE 27: Clinical view of the closure of the fenestration after one month of healing.

After one month of healing, the fenestration of the mucosa was no longer present and all the area was completely reepithelized again (Figure 27).

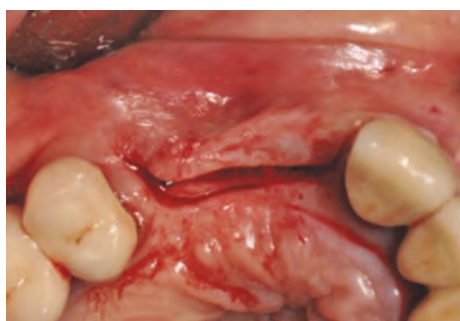
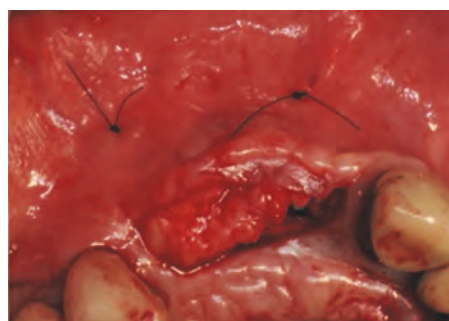
FIGURE 28: (a-b) A connective tissue graft is harvested from the palatal left premolar area and placed buccally under the epithelium to compensate for the lack of volume of the buccal alveolar crest.

In order to finalize the procedure, a connective tissue graft was harvested from the palatal left premolar area and placed buccally under the epithelium to compensate for the lack of volume of the buccal alveolar crest (Figures 28(a) and 28(b)).

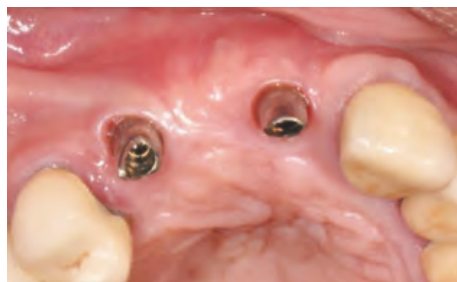
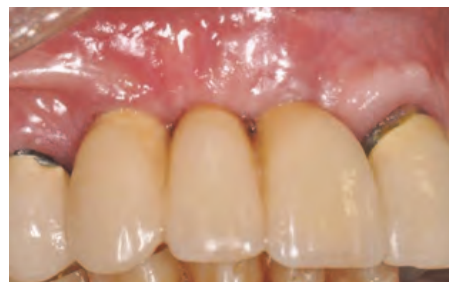
FIGURE 29: (a-b) Final prosthesis delivered after four months.

After five months of healing of the soft tissues, healing screws were placed on the two implants and a provisional restoration was achieved. The final prosthesis (Figures 29(a) and 29(b)) was performed after another four months, in a healthy and keratinized gingiva but with a clear lack of interdental papillae.

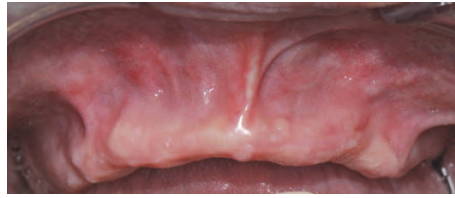
FIGURE 30: Clinical view of the severe bone resorption of the upper maxilla.

**2.5. Treatment Option for a Class 4 Complication.** This case presents a severe bone resorption of the upper maxilla due to early tooth loss (Figure 30). The treatment plan considered an onlay block graft procedure followed by implant placement.

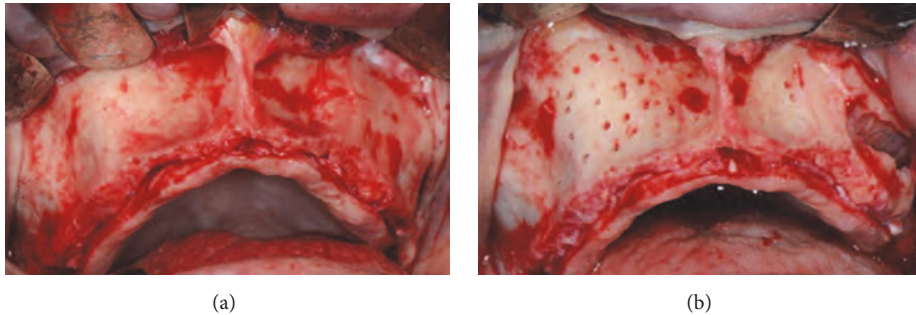
FIGURE 31: (a-b) Surgical view of the resorbed area and bone refreshing.

After a full thickness raising of the flap and bone refreshing (Figures 31(a) and 31(b)), four cancellous bone blocks (OX Block, Bioteck®, Italy) were adapted to the recipient site and fixed to the basal bone through miniscrews (Micro System, Martin GmbH, Germany) (Figure 32(a)). The whole grafted

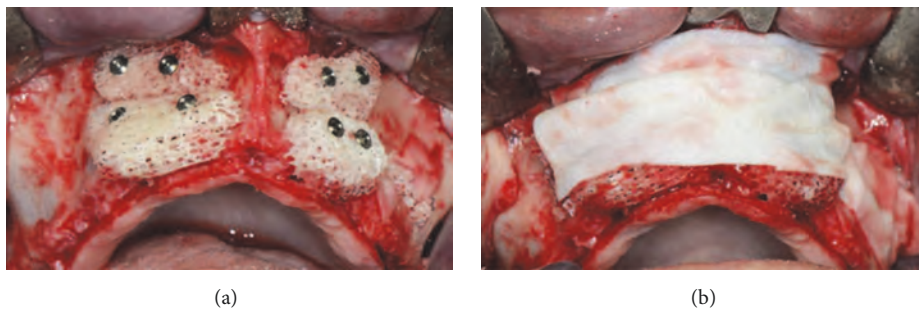
FIGURE 32: (a) Placement and adaptation of four cancellous bone blocks to the recipient site, fixed to the basal bone by miniscrews. (b) The whole grafted area is covered by a resorbable membrane.

area was covered by a resorbable membrane (OX Membrane, Bioteck, Italy) (Figure 32(b)).

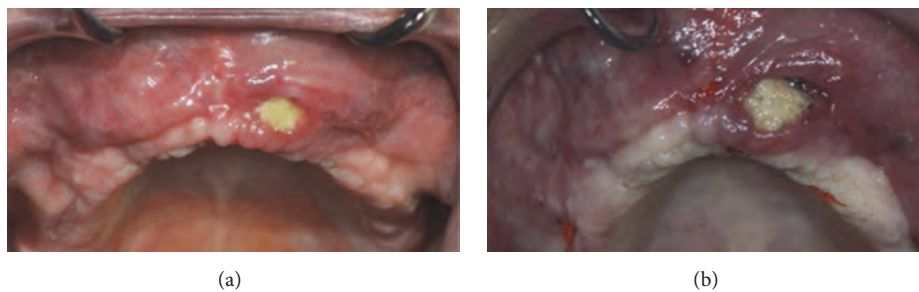
FIGURE 33: (a) Dehiscence of the flap after six months of healing. (b) Clinical view of the dehiscence: a part of one of the blocks is exposed.

After six months of healing, a dehiscence of the flap was reported and, two weeks later, part of one block was exposed (Figures 33(a) and 33(b)).

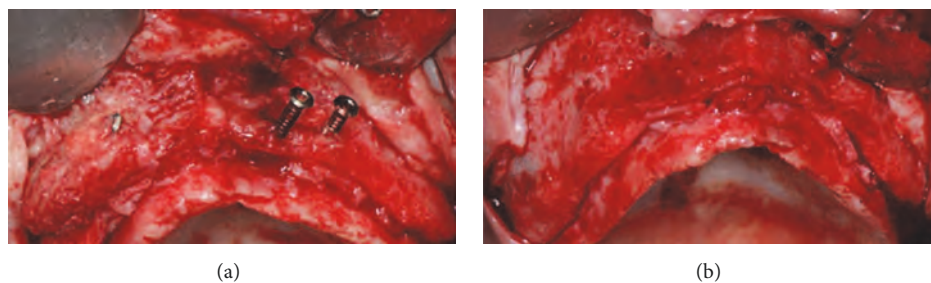
FIGURE 34: (a-b) During surgical reentry, the grafted blocks appear to be not integrated and the presence of infection and fibrous granulation tissue is evident. The blocks and screws were removed and the whole area was cleaned.

The flaps were raised again and, from a clinical point of view, the grafted blocks appeared not integrated with the presence of infection and fibrous granulation tissue. The blocks and screws were removed and the whole area was cleaned (Figures 34(a) and 34(b)).

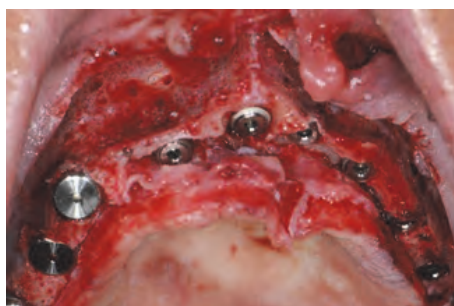
FIGURE 35: Placement of ten implants in the residual patient native bone.

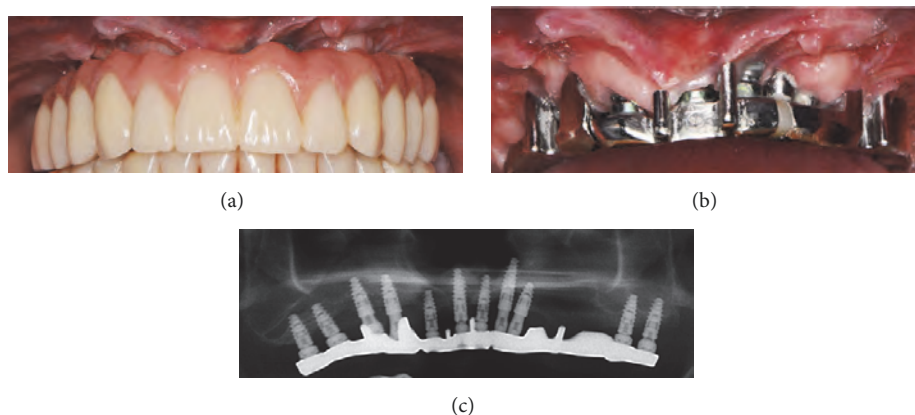
FIGURE 36: (a-b) The implant-retained combined fixed-removable denture delivered to the patient four months after implant therapy. (c) Panoramic X-ray of the final prosthesis.
