# 171. Human-induced vibration serviceability of arch pre-stressed concrete truss system

**Abstract.** Human-induced vibration has become a serious serviceability problem due to the larger opening of girder, lighter floor systems and longer spans designed and used in practice. Vibration tests were undertaken in laboratory to research the vibrational characteristics of the arch pre-stressed concrete truss (APT) system spanning 16.0 m. Results from ambient vibration, impulse excitations (heel-drop and jumping) and steady-state incentives (walking and running) were presented. Dynamic characteristics such as natural frequencies, damping ratios, mode shapes and acceleration responses were studied and checked against the existing codes. Experimental results show that the investigated APT girder possesses high fundamental frequency and low damping ratio. Moreover, the perception factors based on the root-mean-square acceleration, vibration dose value (VDV) and psychological comfort data were obtained. Lastly, the threshold accelerations and VDV were suggested for evaluating the human-induced vibration.

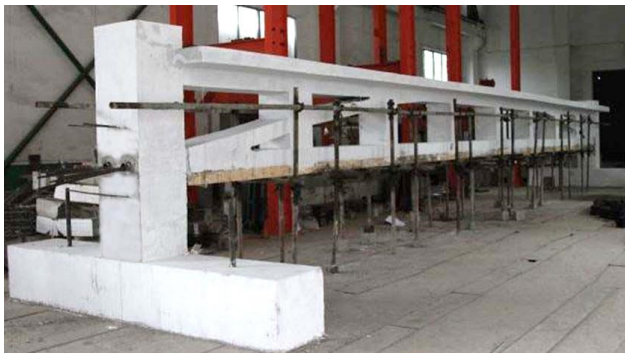
Fig. 3. Typical photo view of the APT specimen

To evaluate and control the excessive vibration on the APT girder under human activities, experimental tests are the most expensive and complicated but the most reliable way to determine the dynamic properties. Therefore, the vibration tests were carried out and the APT girder considered in this study is 16 m long consisting of the RC floor of 120 mm thick by 1200 mm wide and 7 RC webs spaced at 2 m, as shown in Fig. 3. The upper RC chords (of 270 mm height and 400 mm width), the RC arch members and lower PC chords (both of 150 mm height and 400 mm width), the RC web members (of 200/300/400 mm×400 mm), and the RC columns (500 mm×500 mm) were casted in the Chongqing University Structural Research Laboratory. The detailed main cross sections and material properties will not be repeated here because of the limitation of space. For more details, please see paper [1].
