Laboratory tests on mineral deposition under sea water electrolysis

Margheritini, Lucia; Simonsen, Morten Enggrob; Bjørgård, Trine Larsen

DCE Technical Report No. 268

February 2019

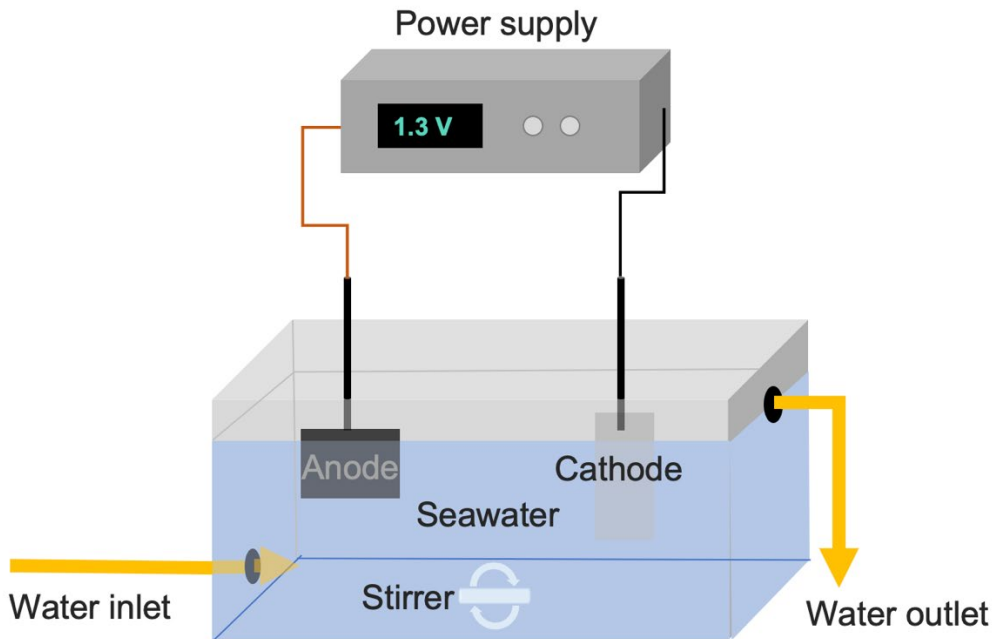
Figure 1 Overview of experimental setup

The setup for electrodeposition of CaCO_3 from seawater consisted of a plastic tank (20 x 20 x 31 cm), containing approximately 9 L of water, with stirring, water inlet and outlet and a pump for water exchange. The water inlet was placed 4 cm from the bottom of the tank, while the outlet was placed 15 cm from the bottom. The tank was either placed in room temperature or in a fridge, depending on the temperature of the experiment. The experimental setups for room tempered water and cold water are shown in Figure 3.

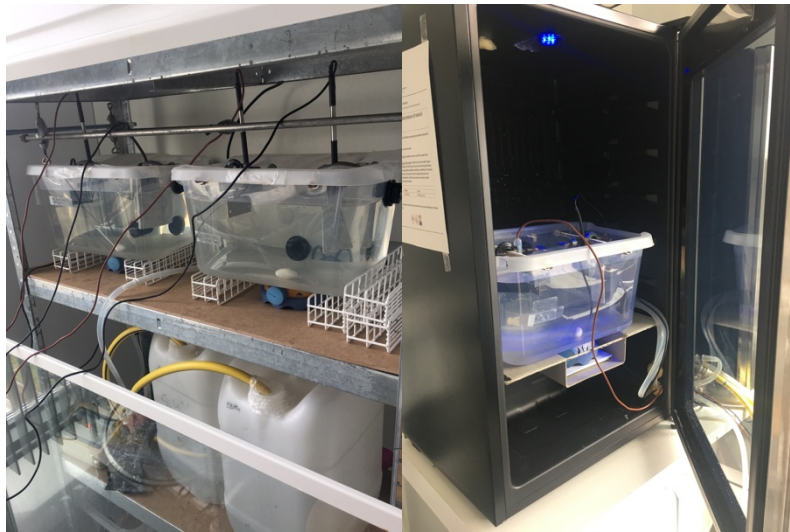
Figure 3 Experimental setup in room temperature and cold water, respectively

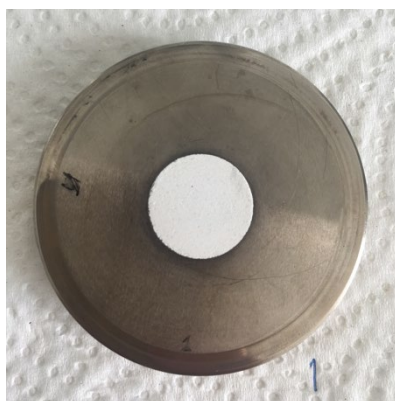
Figure 6 Tablet prepared for XRD analysis

When sufficient amounts of material were available a tablet was prepared as shown in Figure 6, but if less material was available the powder were spread on a zero-background plate shown in Figure 7.

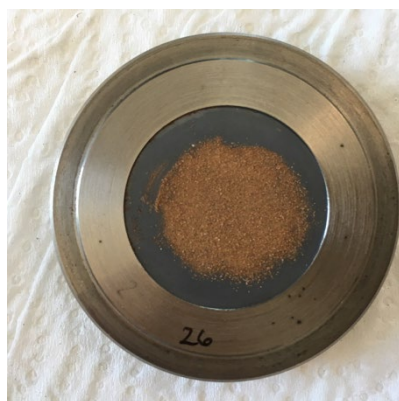
Figure 7 Powder sample prepared for XRD

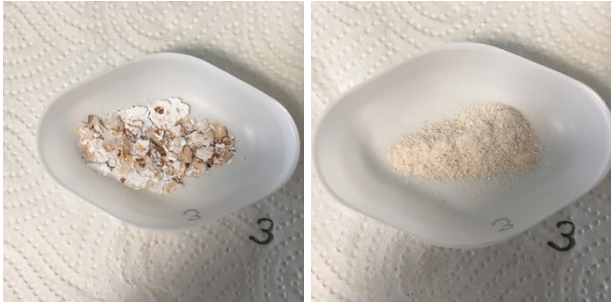
Run 3

A part of the electrode is covered by a white material. The rest of the cathode is covered by corrosion material. The thickness of the material is approximately 1 mm, and sticks out of the cathode. The white material was removed. The material is easy to remove and consist of an outer material and an inner material. The outer material is easy to remove and the inner layer is harder to remove from the cathode. 0.9471 g was removed from one side of the cathode for XRD-analysis.

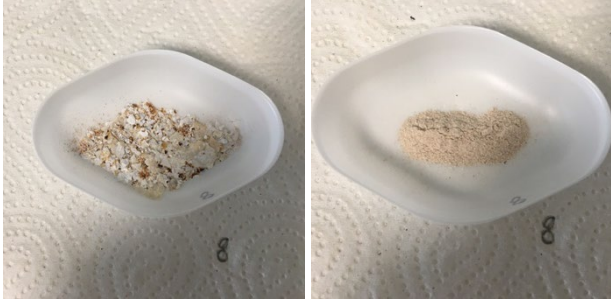
Table 10 Run 8

The material was thin and was relatively easy to remove. The material is white with some corrosion. 0.6879 g was removed for XRD-analysis.

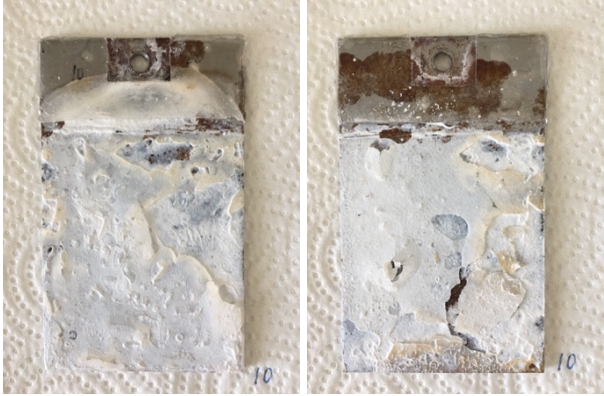
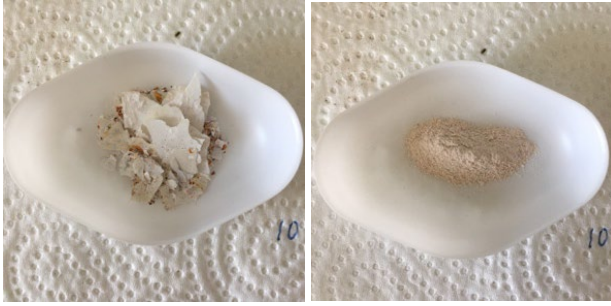
Table 12 Run 10

The material is white, there is some corrosion on the cathode. The material consists of a brittle outer layer that is easy to remove. An inner layer is hard and harder to remove. 0.9288 g was removed from one side of the cathode for XRD-analysis.

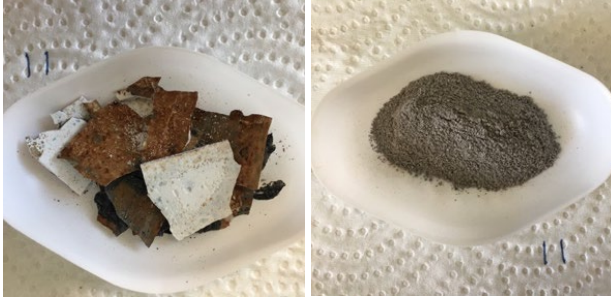
Table 13 Run 11

The cathode seemed to be corroded, and the produced material was very dark in color compared to all the other samples. On one side, parts of the material are completely black. The material is also thicker than the other samples. White material is hidden below the outer layer. The inner layer is very porous. 3.0176 g was removed from the cathode for XRD-analysis. The material is thick and it is more difficult to make it into a powder compared to the other samples.

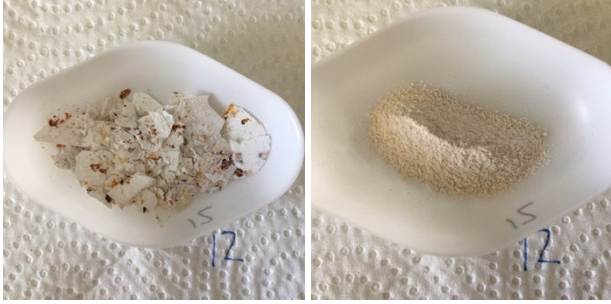
Table 14 Run 12

The material is white and brittle. It was easy to remove. There was an inner and an outer layer. Small amount of the inner layer that is relatively hard to remove. Some corrosion under the material. 1.7810 g was removed from one side for XRD-analysis.

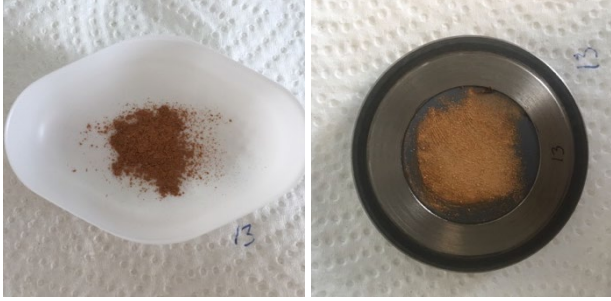
Table 15 Run 13

The cathode is corroded with only a thin white material. It seems like there has been a disconnection from the power supply. The material is relatively easy to remove, but in small amounts. Material removed from one side for XRD-analysis.

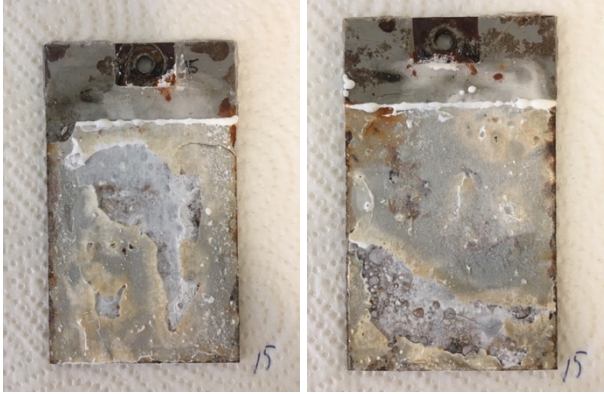
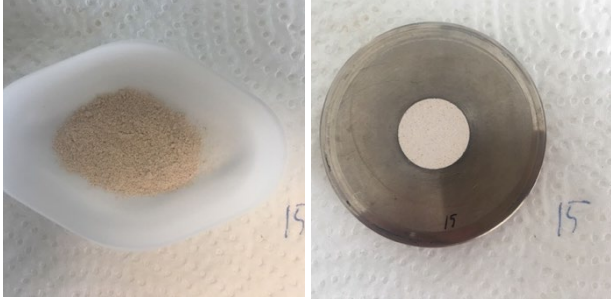
Table 16 Run 15

The material is easy to remove from the cathode. It is divided into two layers, an outer brown (corrosion) layer and an inner white layer. The inner layer is thicker and more porous (brucite?), while the outer is thinner and brittle. 1.0826 g was removed from one side of the cathode was removed for XRD-analysis.

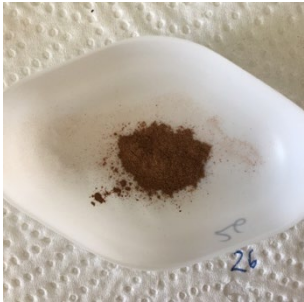
Table 19 Run 26

The cathode is totally corroded. Small amount of material, but it is all brown (corrosion material). A small area of the cathode is covered by a white material (0.5x0.5 cm). 0.2988 g was removed for XRD analysis (material from one side of the cathode). The material is brown, possibly corrosion.

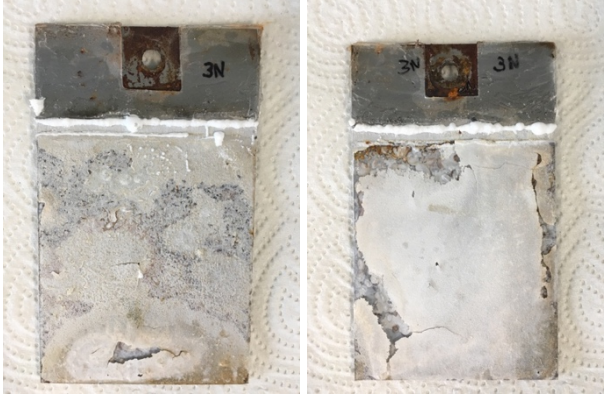
Table 22 Run 3N

The material consists of an inner and an outer layer. The outer layer can easily be removed in one single piece. The outer layer was light orange in color. Not much corrosion on the cathode. The inner layer is whiter than the outer layer and is thinner. The inner layer is harder to remove opposite the outer layer. 0.8394 g was removed for XRD analysis and was taken from the inner and the outer layer.
