Turbocharger Structural Integrity

Simon Barrans¹✉ – John Allport² – Goodarz Khodabakhshi³

¹School of Computing and Engineering, Turbocharger Research Institute, University of Huddersfield, Email: s.m.barrans@hud.ac.uk

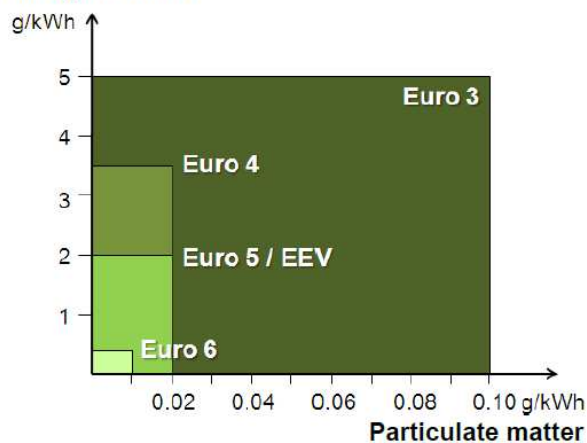
Figure 1 Heavy goods vehicle diesel engine emissions regulations (taken from [2])

Since 1st January 2014 all new commercial vehicles sold in the European Union have had to comply with the Euro 6 emissions regulations laid out in EU Regulation 595/2009 [1]. This latest version of the emissions regulations has placed even more stringent requirements on vehicle manufacturers with regard to nitrogen oxides of nitrogen and particulate matter measured at the exhaust. The dramatic reduction in emissions since Euro 3 was introduced in 2006 is illustrated in Fig. 1. In order to comply with these regulations, engine manufacturers have used a dual approach of exhaust gas after treatment and optimization of the air-fuel mixture with the use of turbocharging, as shown in Fig. 2.

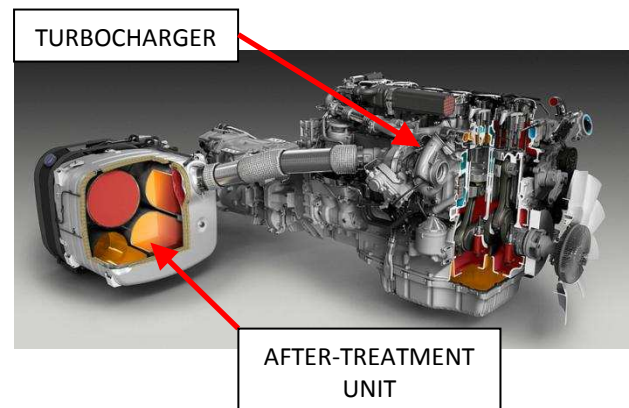
Figure 2 Scania Euro 6 engine and after-treatment system (taken from [2])

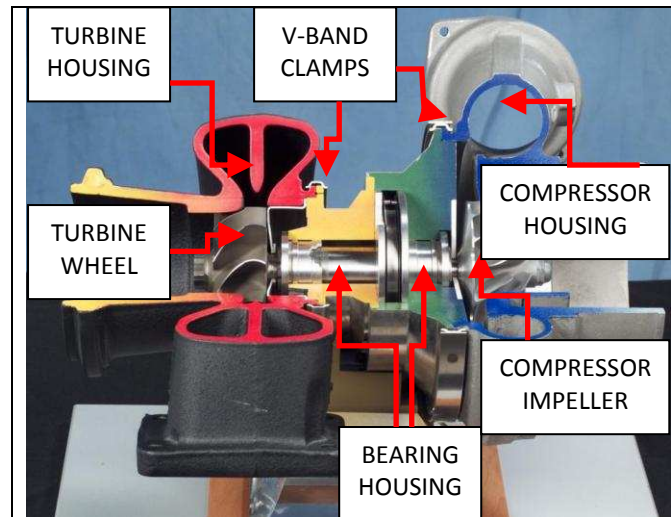
Figure 3 Turbocharger structural problems areas

The major structural components of a typical turbocharger are identified in Fig. 3. It is worthwhile considering how these components interact with the various loading mechanisms.

Turbine housing: As outlined above, this component will be subjected to substantial external loads as it forms an integral part of the exhaust system load path. It will also be subjected to very high thermal loading that is cyclical in nature. These loads will combine to generate fatigue failures. However, the highest loads that the turbine housing will be subjected to are those resulting from the failure of the turbine wheel. Whilst it is accepted that the housing will almost invariably be damaged beyond repair by such an incident, it is essential that the housing contains all the turbine rotor fragments.

Compressor housing: Again, there are significant external loads on the compressor housing due to vibration of engine components. Internal pressure must also be contained and any resultant loads accommodated. However, the largest loads are again those due to rotor failure. The damage that can result from a compressor impeller burst is shown in Fig. 4 which shows the result of a deliberately induced compressor impeller burst. Whilst the impeller fragments have been successfully contained, the damage to the housing is considerable.

Bearing housing: In some applications the bearing housing may be bolted directly to the engine. It will therefore be in the path of external vibratory loads applied to both the turbine and compressor housings. In applications where the attachment to

the engine system is achieved by the turbine housing being attached to, or being integral with the exhaust manifold, the bearing housing is still subjected to loads applied to the compressor housing. In addition, during either turbine wheel or compressor impeller burst, considerable axial and torsional loads may be applied to the relevant housing which must in turn be reacted by the bearing housing.

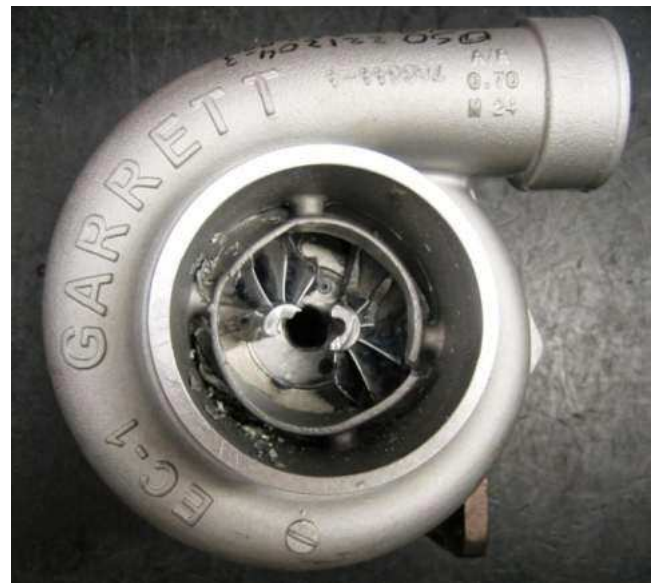
Figure 4 Compressor impeller failure (taken from [5])

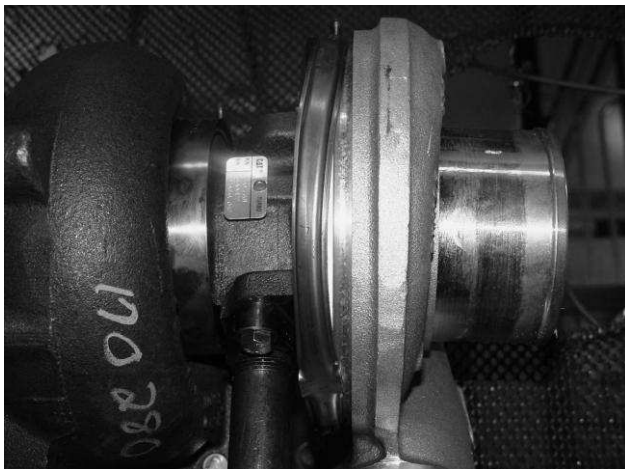
Figure 5 Compressor end V-band failure during burst and containment test (taken from [5])

V-band clamps: These apparently simple components are now widely used on modern turbochargers to attach the three housings together. As such they are an essential part of the same load path as the bearing housing both for external loads and burst and containment loads. An example of the failure of a V-band clamp during a burst and containment test is shown in Fig. 5.

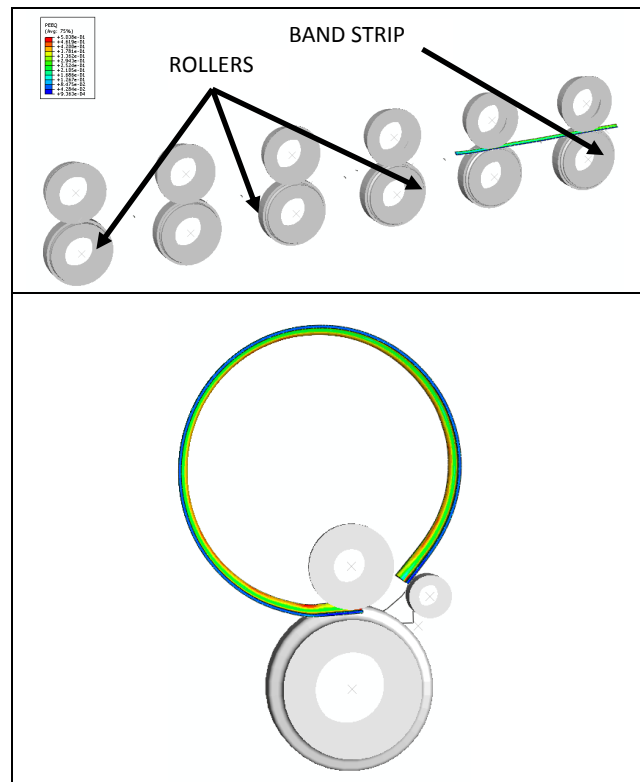
Figure 6 a, b V-band rolling process showing plastic strain (a – 6 pass first stage, b – hoop forming second stage)

Muller [16] recognized that fatigue failure of V-band clamps, as noted in the field would be impacted by the band manufacturing process. Work was therefore undertaken to determine the residual stress and plastic strain generated in the band cross section as it was created by the 6 pass rolling process using an explicit FEA. The end of the first stage of the analysis is shown in Fig. 6(a) and the final, hoop forming stage shown in Fig. 6(b). However, this work was not progressed to the stage where fatigue failure of bands in service could be analysed or predicted.
