# Seismic Retrofitting of RC Frames with RC Infilling

## SUMMARY:

The effectiveness of seismic retrofitting of multi-storey multi-bay RC-frame buildings, by converting selected bays into new walls through infilling with RC, was studied experimentally at the ELSA facility at JRC, Ispra, and the results are reported here. The full-scale model tested with the pseudo-dynamic method consisted of two parallel frames, linked through 0.15m slabs, having three bays each (8.5m long), with the central bay (2.5m) infilled with RC wall, and being four storeys tall (12m). The frames were designed and detailed for gravity loads only and are typical of similar frames built in Cyprus in the 1970's. Different connection details and reinforcement percentages for the two infilled frames were used in order to study the effects of these parameters. The results of the pseudo-dynamic and cyclic testing performed are presented and conclusions are drawn.

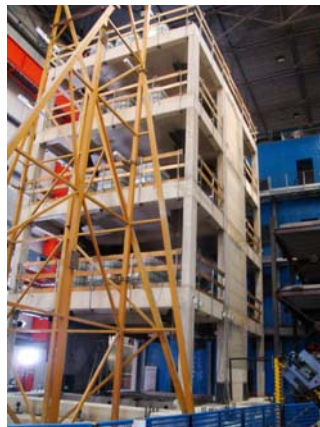
**Figure 2.3.** Elevation of the specimen in the lab. The wall shown on the right of the picture is the south wall and the one on the background is the north wall

The specimen, as it was explained above, consisted of two parallel frames connected through a slab and it had the central bay infilled. In order to facilitate the study of as many parameters as possible, the walls in the two frames were reinforced with different amounts of reinforcement, with the north one being the stronger of the two (Fig. 2.3.).

The testing campaign consisted of two pseudo-dynamic tests and a “funeral” cyclic test. Two 1000 kN actuators were used in the two top floors of the specimen and two 500 kN ones at the lower two floors. The gravity load on the structure was the one corresponding to the dead and reduced live loads, as specified in section 2.1, and it was equal to 192 kN per floor. This was achieved through 15 plastic barrels per floor that were filled with water and were distributed on the slabs of the test specimen (Fig. 2.3.).

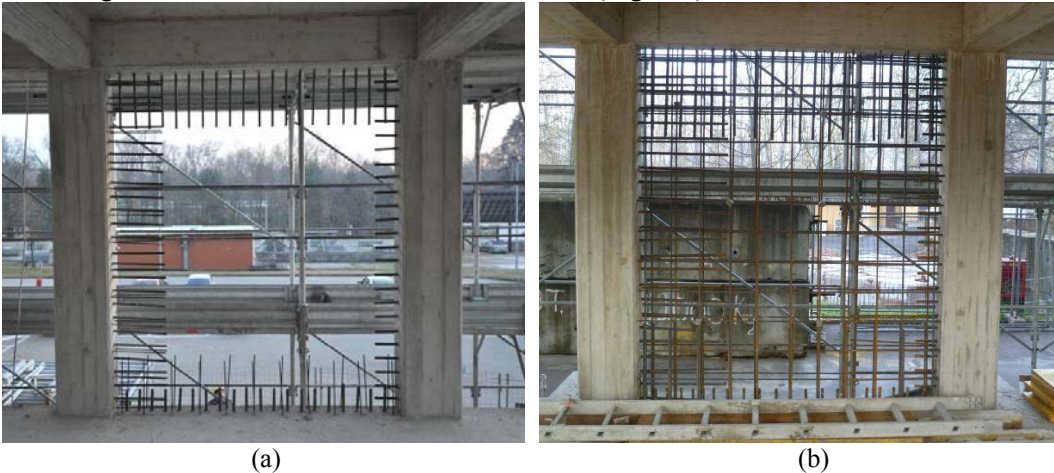
**Figure 2.4.** (a) Dowels and starter bars, (b) Dowels, starter bars and web reinforcement

Two parameters were examined: a) the amount of web reinforcement in the walls and b) the connection detail between the wall and the bounding frame. The web reinforcement in the two walls is shown in Table 2.1. Regarding the connection detail, two distinct connection details were used. In the first detail, the web bars are connected to the surrounding frame through lap-splicing with the same diameter starter bars epoxy grouted into the frame members. Short dowels are then used in order to transfer the shear at the interface between the wall and the frame member. This detail was used to connect the wall at the bottom beam and right column at the 1<sup>st</sup> and 2<sup>nd</sup> floors of the specimen (Fig. 2.4a).

In the second detail, longer dowels were used to double as dowels as well as for anchorage of the web panel to the surrounding frame; to this end, the dowels are considered as lap-spliced with the nearest – smaller diameter – web bars. However, in this case, the clear distance between the dowel and the nearest web bar, violates the maximum clear distance of 50 mm or 4Φ between lapped bars, specified in Eurocode 2. This detail was used to connect the wall at the top beam and left column at the 1<sup>st</sup> and 2<sup>nd</sup> floors of the specimen (Fig. 2.4a). In the 3<sup>rd</sup> floor of both the north and south frames only the second detail was used, while for the 4<sup>th</sup> floor only two dowels per wall interface were used to provide safety against falling of the wall out of plane. The reinforcement details for the dowels and the starter bars are shown in Table 2.1. The completed wall reinforcement (including web, starter bars and dowels) for the 1<sup>st</sup> floor of the south wall is shown in Fig. 2.4b.

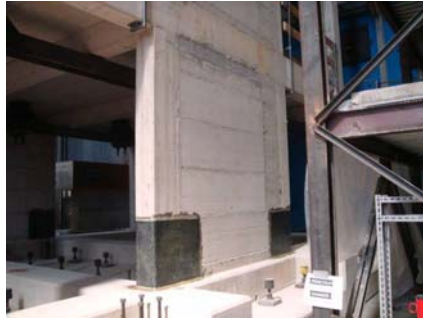
**Figure 2.5.** Reinforcing of the column with CFRP to safeguard against column lap-splice failure

Since the lapping of the column reinforcement could take only compression, then it was obvious that there would be lap splice failure, which could be detrimental to the whole experiment. Therefore, in order to safeguard against this type of failure and allow the experiment to be performed without any premature failure, it was decided to reinforce the edges of the wall at the 1<sup>st</sup> floor with three-sided CFRP for a height of 0.60m from the base of the column (Fig. 2.5).

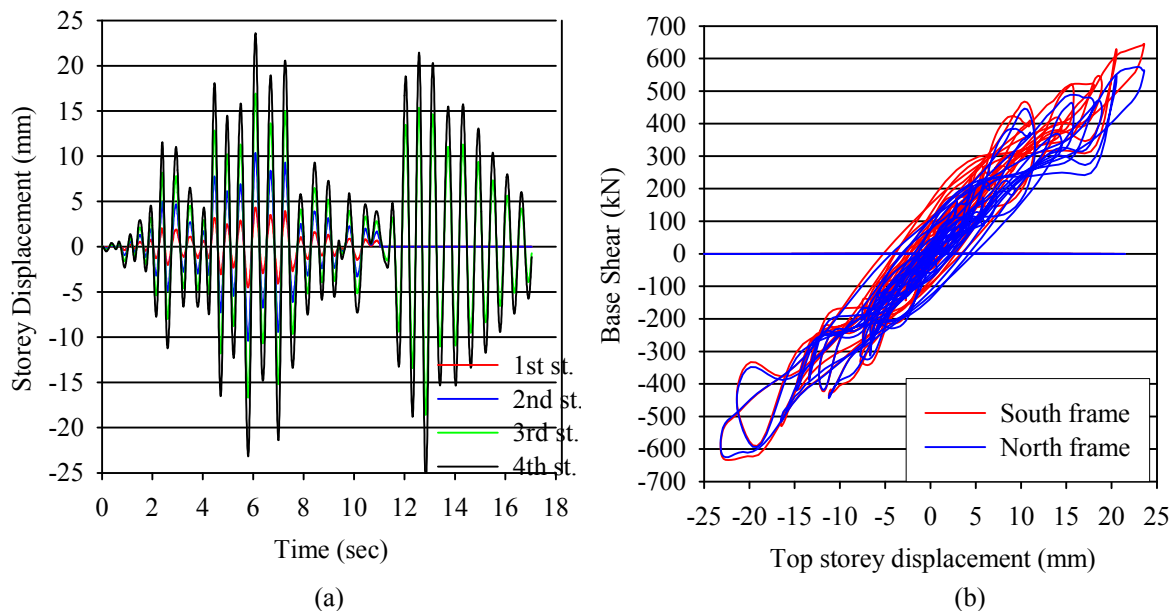
**Figure 3.1.** Experiment at 0.10 g acceleration (a) Variation of the storey displacements with time, (b) Base shear versus top storey displacement for the north and south frames

For the low level acceleration, the structure behaved very well. There were no visible cracks either on the columns or the walls. Some hairline cracks that appeared on the surface of the wall closed down when the experiment was finished. The maximum top storey displacement was 24 mm and the

displacement in the opposite direction was 26 mm (Fig. 3.1.a). These displacements were the same for both the north and south frames, since the forces in the south frame were imposed in such a way so as to keep the displacements of the two frames equal, and hence avoid any torsional effects on the specimen. It should be noted that the variation of the displacements at the first and second stories are shown only up to about 11 seconds, since a problem was encountered with the data acquisition system. The variation of the base shear with the top displacement in each of the frames is shown in Fig. 3.1.b. As it can be observed from the figure, there is very little difference between the two frames. The maximum positive shears were 645 kN and 574 kN for the south and north frames, respectively, and the maximum negative shears were -634 kN and -625 kN for the respective frames. It was considered that both walls have reached their cracking moment, and this was the purpose of this experiment.

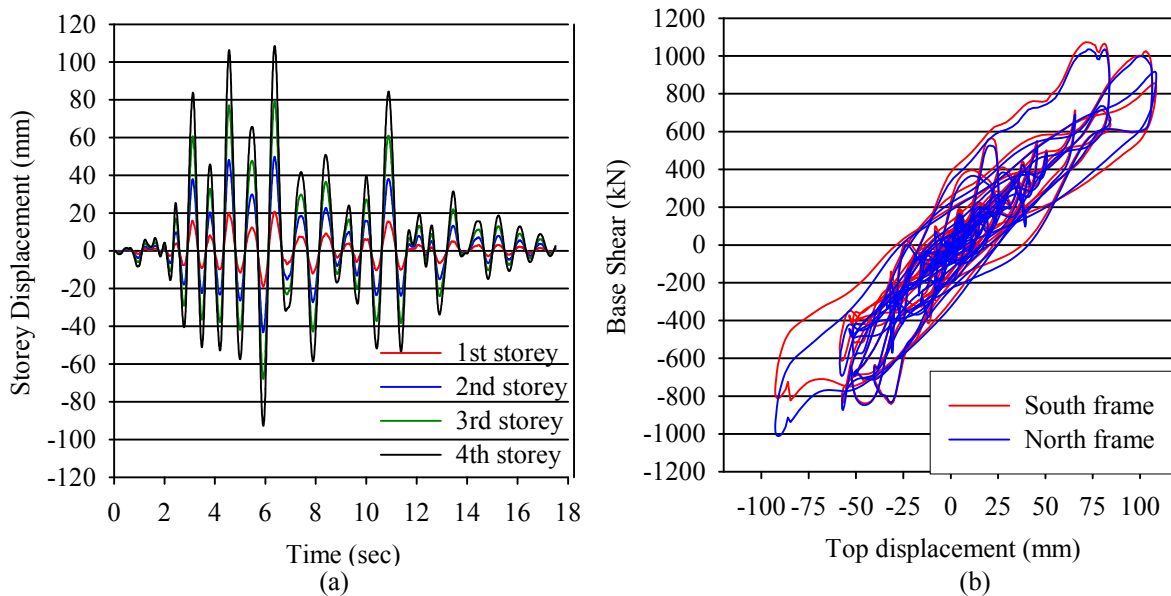
**Figure 3.2.** Experiment at 0.25 g acceleration (a) Variation of the storey displacements with time, (b) Base shear versus top storey displacement for the north and south frames

The 0.25g test was performed the day after the first test, and it was designed to bring the specimen at its ultimate capacity. The maximum top storey displacement was 109 mm and the displacement in the opposite direction was -93 mm (Fig. 3.2.a). Some difference was observed in the base shear between the two frames. As it can be observed from Fig. 3.2.b, the maximum base shear in the positive direction was 1074 kN for the south frame and 1036 kN for the north, which are about the same, while a negative base shear of -843 kN was recorded for the south frame and -1011 kN for the north one. This was an indication that the south frame has suffered some damage and it could not take further load. The only visual indication of this was a crack that opened in the ground beam at the base of the wall and the lap-splice failure of the outer column on the east side of the south frame. It should be noted that the presence of the CFRP on the bounding columns of the wall, have prevented a similar failure and it allowed the completion of the experiment.

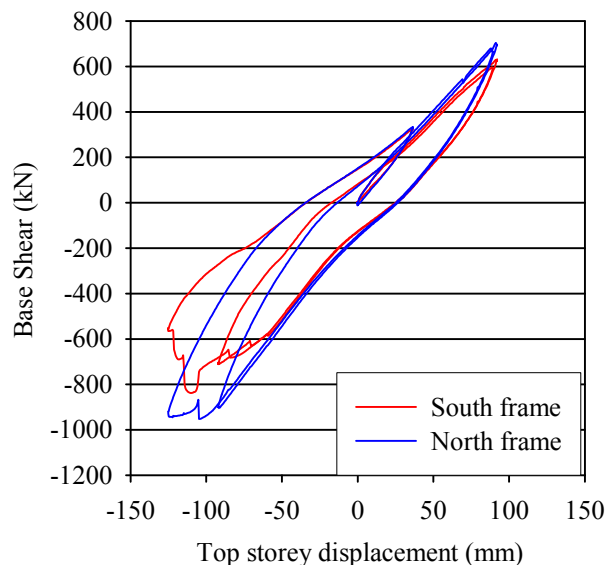
**Figure 3.5.** Base shear versus top storey displacement for the south and north wall for the cyclic test.

Finally, in the “funeral” cyclic test a displacement history was imposed at the top storey (92, -92, 89, -125, 37, 0 mm) and a triangular distribution of forces was imposed. The objective of the test was to obtain a 15% reduction of the peak strength of the infill, so as to establish the strength envelope of the specimen. The base shear versus the top storey displacement is shown in Figure 3.5. As it can be observed in the first cycle the structure could reach 92 mm in both directions. In the second cycle the attempt was to reach 125 mm, but in the positive direction only 89 mm was possible to be reached,

while in the negative direction 125 mm was reached. This though had as a result a sudden drop of the strength of the south frame from 838 kN at -110 mm to 553 kN at a displacement of -125 mm. This amounts to a drop in strength of 34%. After that, the displacement was reduced to 37 mm in the positive direction and from there to zero.
