Subsurface Geophysical Investigation and Physiochemical/Microbial Analysis of Groundwater Contaminant in Ota, Southwestern Nigeria

Abstract Geoelectrical imaging of the subsurface to investigate groundwater contaminants in a sedimentary environment like Ota, South-western Nigeria was carried out. The 2 – Dimensional electrical resistivity survey method for the subsurface imaging was done by engaging the Wenner array configuration using PASI Resistivity Meter in the surface measurement. The vertical electrical sounding (VES) was also done using the Schlumberger array configuration to determine the depth to the aquifer layer. The DIPRO software and the WIN-Resist application software were used for the interpretation of the 2 – D resistivity data and VES data respectively. Both Hydrochemical and Microbial analyses were done to test for the presence of heavy metals and the estimation of Total Aerobic Bacteria (TAB). From the VES results the depth to the aquifer lies around 20.1m (60.33ft.) of resistivity of 34.1 Ω -m and the 2-D results showed the resistivities as 28.0 Ω -m and 47.0 Ω -m respectively showing that the study area has groundwater potential. For the hydrochemical analysis

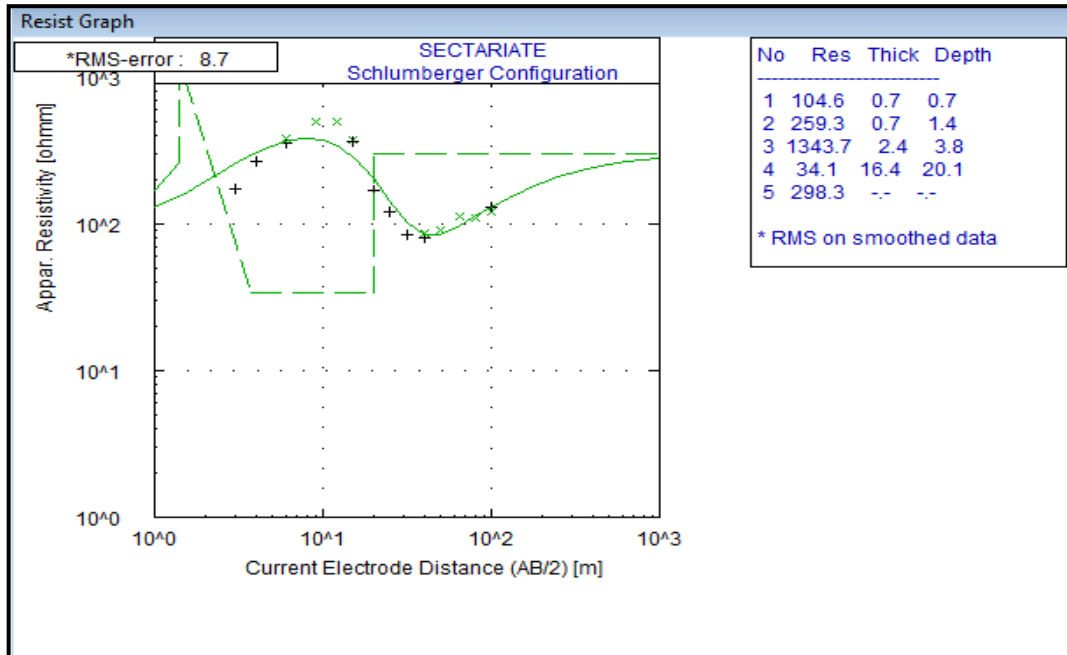
Figure 1. Vertical Electrical Sounding (VES) Survey

From Figure 1, the total depth gives 20.1m (60.33ft.) of resistivity of 34.1 Ω-m and the 2 – D results showed the resistivities as 28.0 Ω-m and 47.0 Ω-m respectively (Figure 3 and Figure 4) showing that the study area has groundwater potential. Here the resistivity from the VES reading lies in between the resistivities gotten from the 2 – D results. From the study it can be seen that the depth to the aquifer is not too

From the VES results the depth to the aquifer lies around 20.1m (60.33ft.) of resistivity of 34.1 Ω -m and the 2 – D results showed the resistivities as 28.0 Ω -m and 47.0 Ω -m respectively showing that the study area has groundwater potential. For the hydrochemical analysis on heavy metals, the result lies within World Health Organization (WHO) standard for drinking water. But for the microbial analysis, total aerobic plate count of 2.3×10^6 for drinking water is high and above WHO standard specification for drinking water. The presence of coliform at count of 2.4×10^4 and isolation of *Escherichia Colipoint* to faecal contamination of sample is suspected. This could be from underground seepage or direct contamination of storage tanks and pipes. The presence of *Staphylococcus aureus* is also suspected.

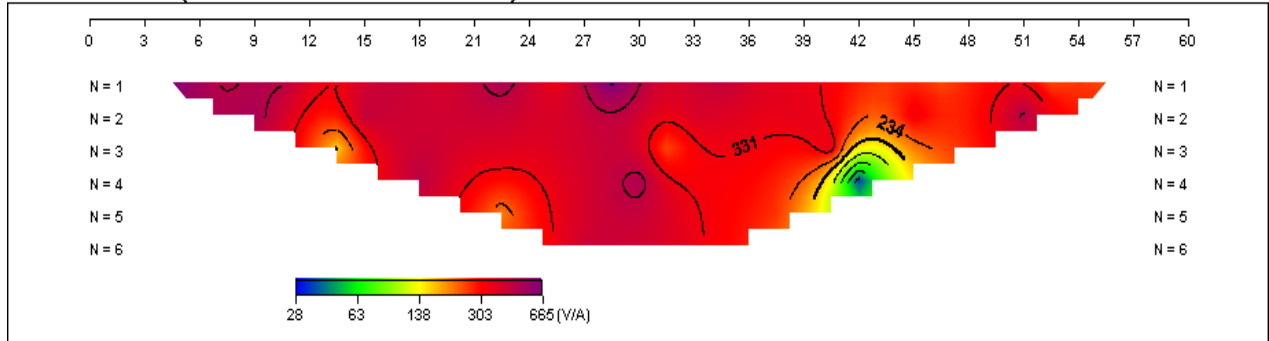
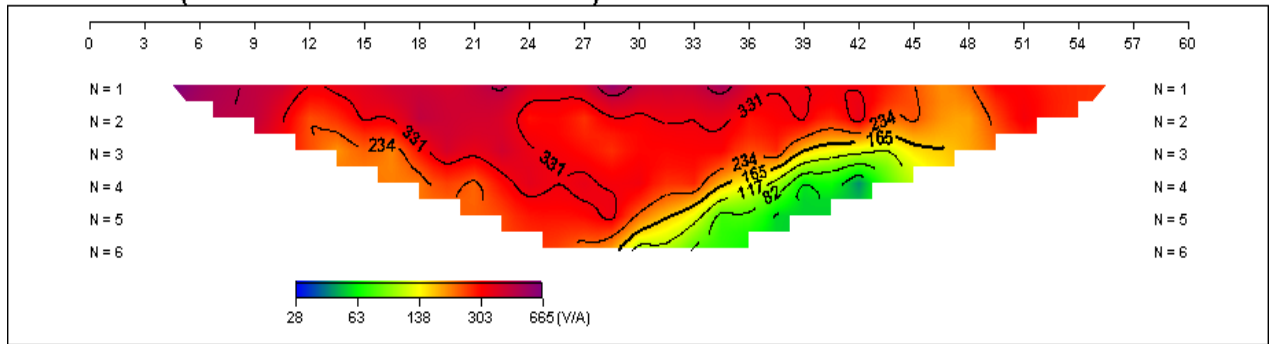
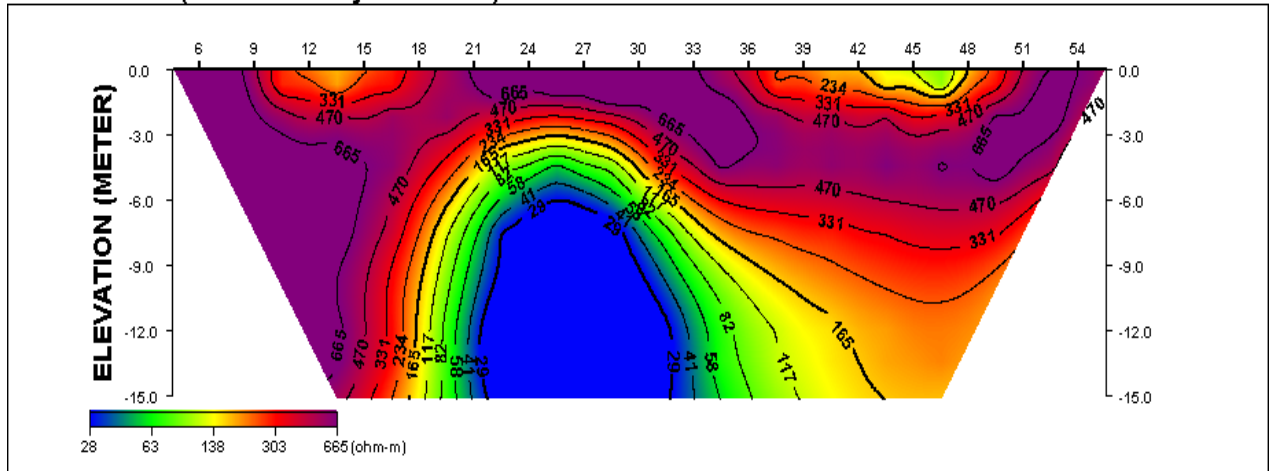
TRAVERSE 1 (Field Data Pseudosection)

TRAVERSE 1 (Theoretical Data Pseudosection)

TRAVERSE 1 (2-D Resistivity Structure)

Figure 3. 2 – D Resistivity Survey (Traverse 1)

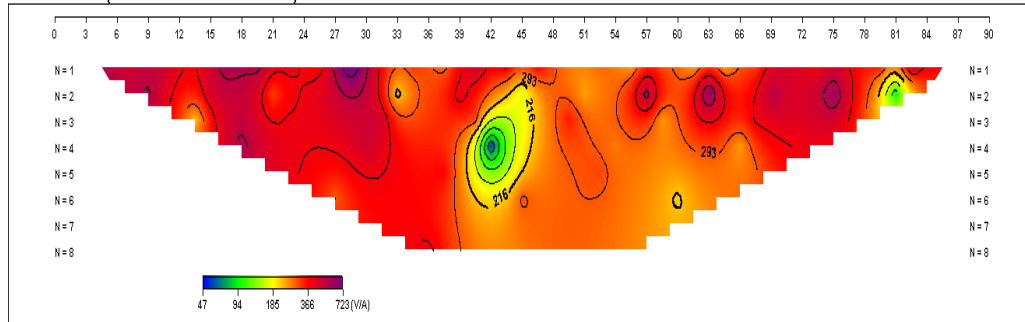
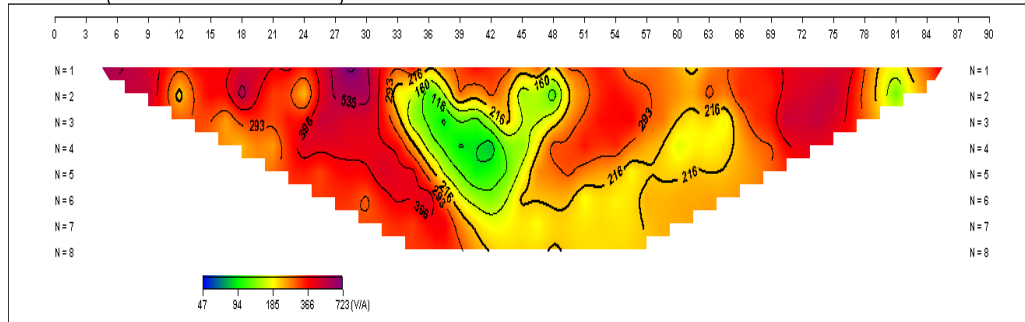
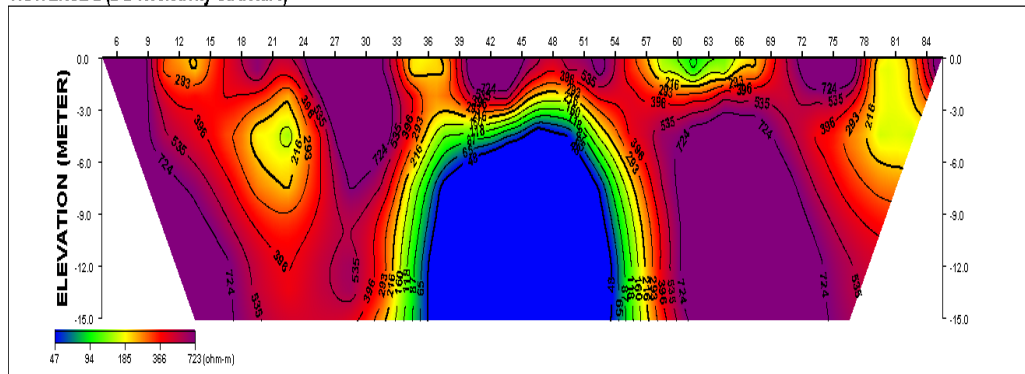
TRAVERSE 2 (Field Data Pseudosection)

TRAVERSE 2 (Theoretical Data Pseudosection)

TRAVERSE 2 (2-D Resistivity Structure)

Figure 4. 2 – D Resistivity Survey (Traverse 2)

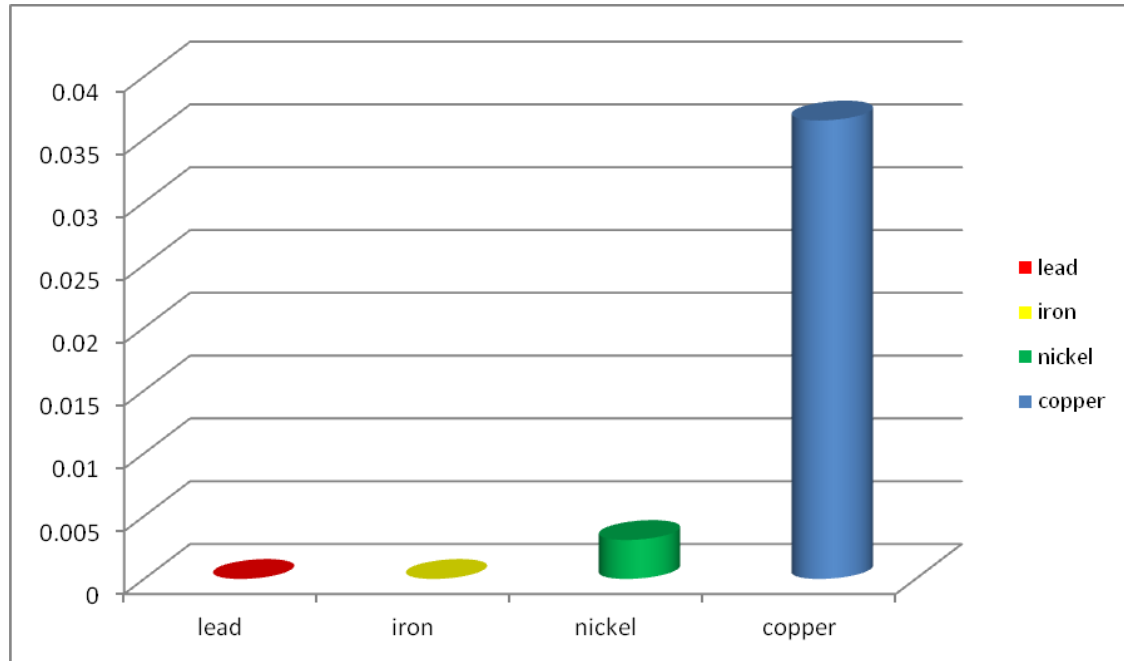
Figure 5. Chart Showing Level of Heavy Metals in Samples

It was observed that for all the water samples that was tested for the concentrations of heavy metals, all were within the WHO standard for drinking water. We therefore, advice that the authority in charge of water management in Ota,
