Anthropometric characteristics of roadside auto-mechanics: a case study

Oluranti Adetunji ABIOLA*, Adekola Olayinka OKE, Olufemi Adebola KOYA

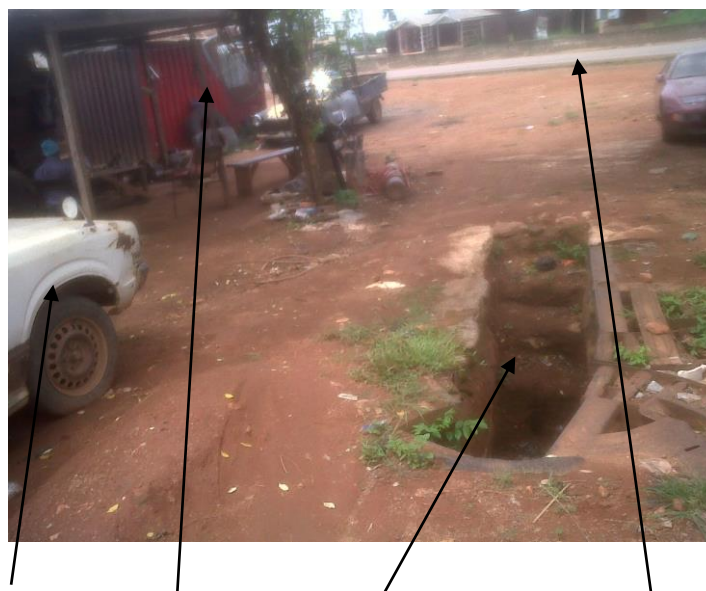
Car parked
For repair Tools
Container Inspection-pit
(Irregular shape
& dimension) Expressway

Figure 1. A typical automobile mechanic workstation along Lagos-Ibadan expressway

The health of the automotive industry in Nigeria depends on the effectiveness and capabilities of roadside auto-mechanics. In Nigeria, auto-mechanics are usually low-waged people, illiterate or semi-illiterate workforce, (those without formal education), often without adequate innovative and managerial skills for the trade [1, 2]. The male workforce dominates the trade and it is associated with high rates of occupational health hazards compared to workers in other professions [3]. Engine-repair auto-mechanics move around to carry out on-the-spot repair of broken down vehicle, and where on-the-spot repair is not possible they tow such vehicle to workstations along the road for repair. A typical workstation used by the roadside auto-mechanics is shown in Figure 1.

the need for the mechanics to work in the awkward postures. Keyserling et al. [4] have made similar submission. The inspection-pits were self-made with irregular shape and dimension, tools are kept far from the repair points and car-for-repair parked at irregular intervals. Incidentally, standards for the treading auto-mechanics inspection-pit dimension are scarce in literature; the only one found is from Beccastrini [5] who stated that the depth of inspection-pit should be between 140 and 160 cm with a ladder or steps for access. Auto-mechanics perform tasks such as lifting, reaching, hammering, cutting, boring, turning, scraping, riveting, tapping, threading, screwing, bolting, bonding, gluing, clamping, chipping, dipping, inserting, lubricating, pressing, pulling, replacing of components, washing or cleaning, welding, grinding, filing or chiseling, heating, burning, blowing, dismantling, aligning, assembling, servicing, general work, inspection and test driving.
