Fatigue Characteristic of Automotive Jounce Bumper

Aidy Ali, R.S. Sidhu and M.S.A. Samad

*Department of Mechanical and Manufacturing Engineering
Faculty of Engineering, Universiti Putra Malaysia
43400 Serdang, Selangor,
Malaysia*

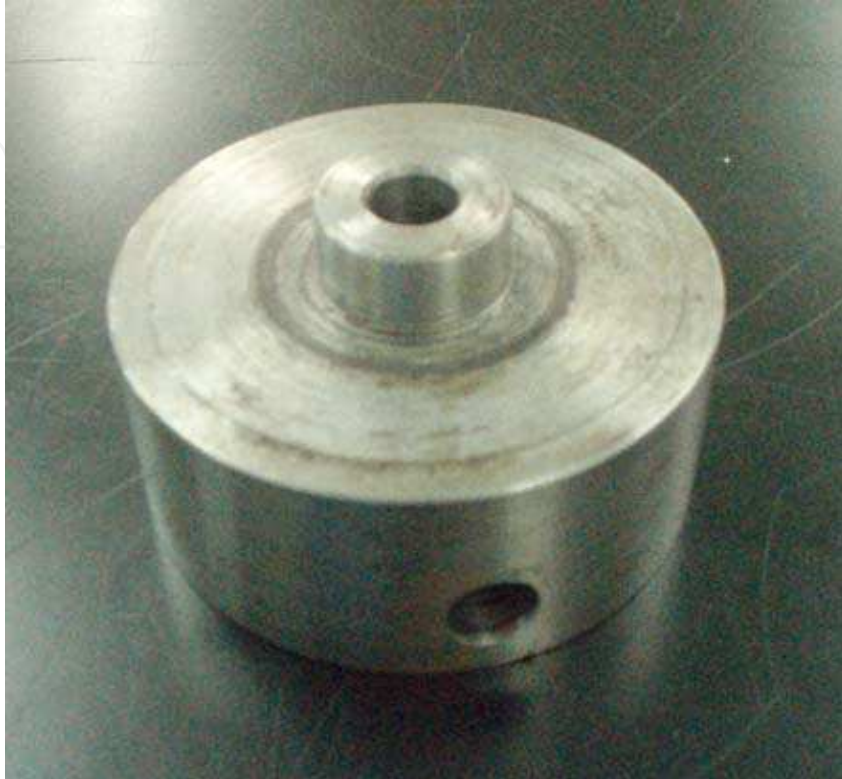
A jig made out of mild steel is design to accommodate the loading condition by allowing the air to flow out while the jounce bumper is compressed. It also mimics the shock rod where it keeps the jounce bumper in line and prevents slips. The jig is shown in Figure 2.

Fig. 2. Jig

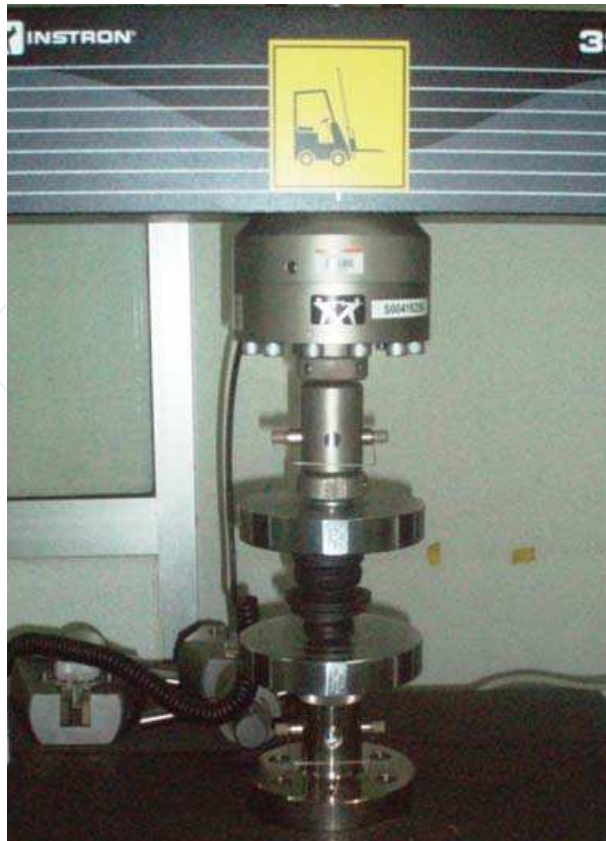
The monotonic compression test was conducted using the Instron 3382 Floor Model Universal Testing System as shown in Figure 3. The test was done at a rate of 10mm/min to determine the maximum force of the jounce bumper and to obtain the Load versus Deflection response (L-D). For the fatigue compression test, twelve samples with different displacements were tested in an ambient temperature of 20 °C. The tests were carried out using the Instron 8871 table top model fatigue systems (Figure 4) with a sine waveform at frequency of 2 Hz at a load ratio of 0.

Fig. 3. Instron 3382 Floor Model Universal Testing System

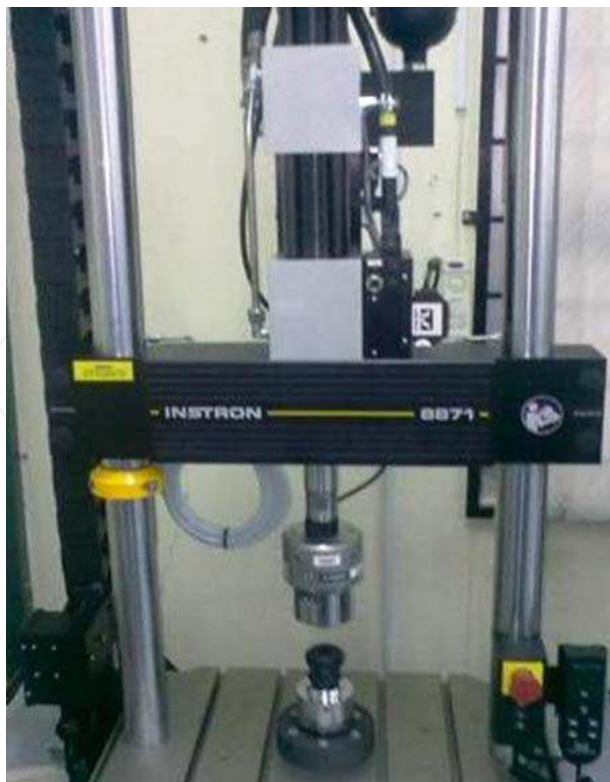
Fig. 4. Instron 8871 table top model fatigue systems

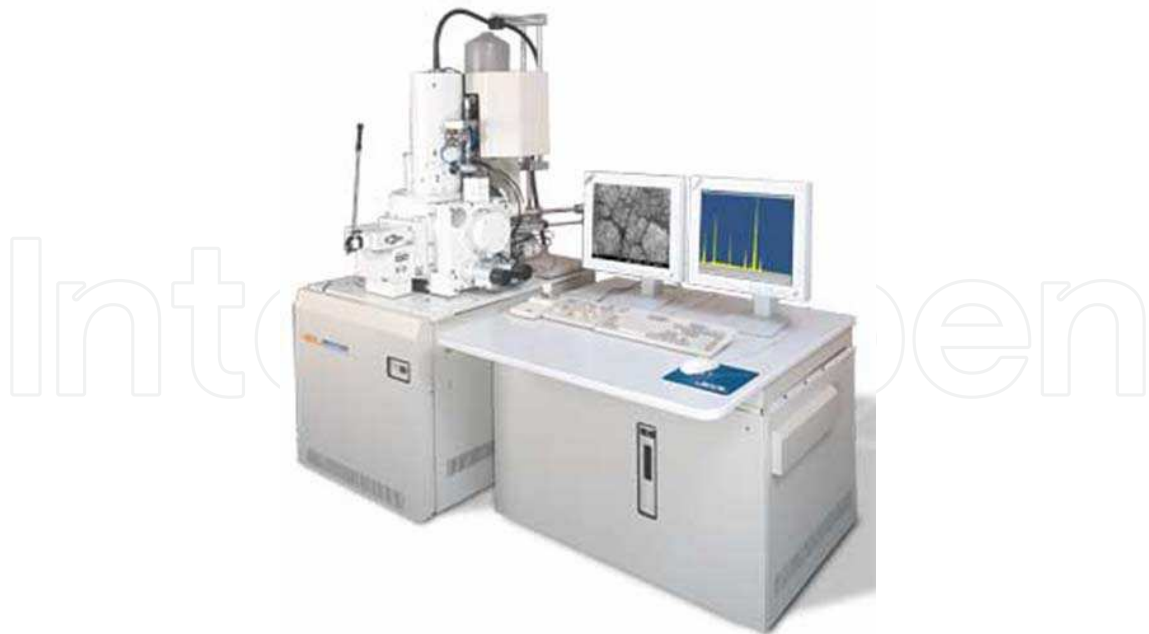
Fig. 5. JEOL FE-SEM JSM-6701F

The jounce bumpers were cycled for 30 rounds to eliminate the Mullins effect before the number of cycles to failure is taken into consideration. Mullins Effects can be described as an initial softening that occurs at the start of the fatigue test (Diani et al., 2009). The determination of fatigue failure is based on the 15 % load drop. For the SEM and EDS testing, the samples were cut from the failure surface (after fatigue) and also a controlled surface (before fatigue) and placed onto specimen stub with carbon double-sided tape. Then the specimens were coated by evaporative coating with ultra-thin layers of Platinum under high vacuum. This process creates a conducting layer that permits SEM examination to take place. The JEOL FE-SEM JSM-6701F as shown in Figure 5, was operated at 20 kV with 15 mm working distance. For elemental analysis, Energy dispersive x-ray (EDS) was used.

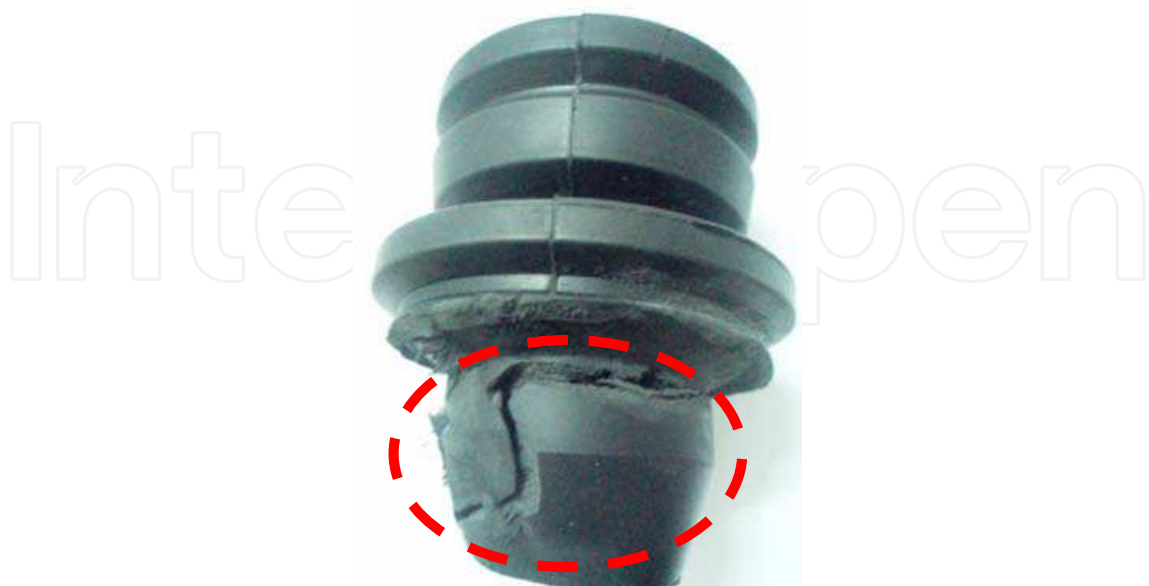
Fig. 8. Cracked jounce bumper

Figure 7 shows the strain versus fatigue life curve. The fatigue curve can be categorized into three zones. Zone one has the highest strain range between 0.88 - 1.14 mm/mm. Strains in this zone should be avoided at all cost as it yields very low fatigue life. Jounce bumper undergoing strains in zone two (0.53 - 0.79 mm/mm) will have a much longer fatigue life. However a regular replacement is necessary since it would not last for more than a 100000 cycles. Zone three is the safest zone with strains below 0.43 mm/mm. Strain values in this zone have fatigue life ranging from 675000 cycles and goes above 1.5 million cycles. Tests conducted on strains above 0.8 reveals significant fracture in the jounce bumper. The cracks originate from the lower part of the jounce bumper as highlighted in Figure 8.
