Early Complications after Pacemaker Implantations

Kabayadondo Maidei Gugu and de Meester Antoine
*Jolimont Hospital
Belgium*

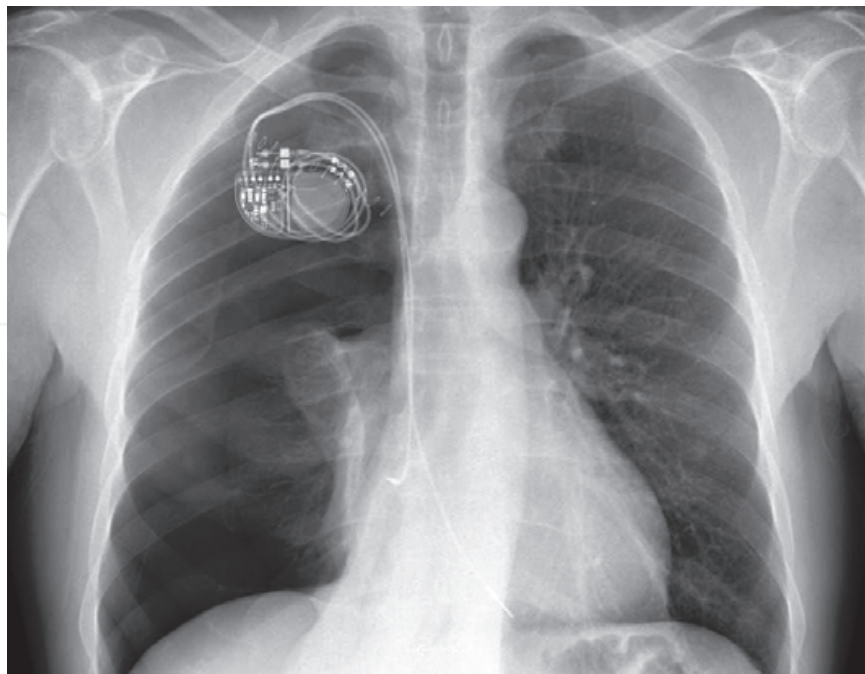
Fig. 1. Chest X-ray showing complete right pneumothorax, which was treated with a chest tube.

Comments: Iatrogenic pneumothorax after subclavian venous access is a rare complication whose incidence varies from 1-5% depending on the series, on the realisation of routine post-procedural chest X-ray and on the exact definition of this complication (consideration of both complete and partial pneumothorax, the need for chest tube insertion, hemothorax or gas embolism) (Res et al., 2004). It is usually an immediate complication and is rarely witnessed after discharge. To avoid this complication, access through a central cephalic vein is possible. However, this technique is subject to failure in approximately 20%. The operator's anatomical knowledge and experience reduce this risk. Pneumothorax is usually asymptomatic and resolves spontaneously in most cases. It is to be suspected in all patients presenting with dyspnoea, unexplainably low blood pressure and variable or elevated stimulation thresholds. Chest tube placement with aspiration is necessary if pneumothorax exceeds 10% of lung volume, if tension pneumothorax or hemothorax are diagnosed.

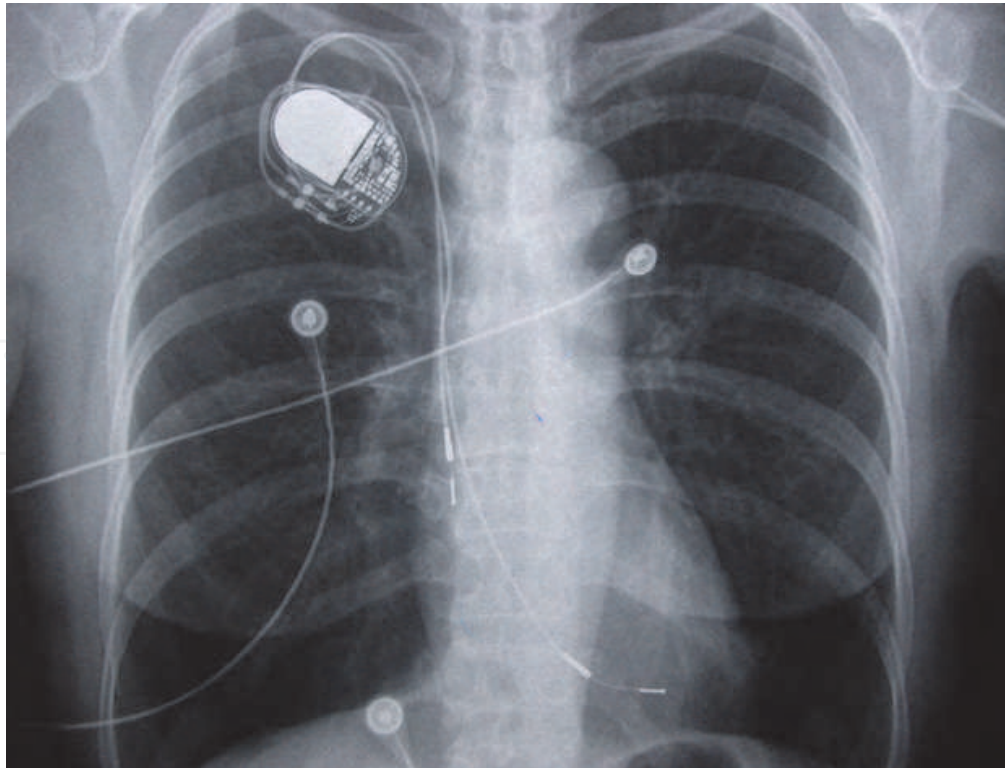
Fig. 3. Chest X-ray showing migration of both atrial and ventricular leads.

Comments: Lead displacement can be found in 2-10% of cases depending on the series (Kiviniemi et al., 1999 ; van Eck et al., 2007). Atrial leads migrate more often than ventricular leads. Active fixation reduces the risk, especially in patients having undergone cardiac surgery. Manifestations include undersensing, failure to capture and increase in pacing thresholds. Repositioning of leads is primordial. Causes of undersensing include lead displacement, fibrosis at the site of fixation of the lead, myocardial ischemia and necrosis, some antiarrhythmic agents (flecainide), dyskalemia, or transient undersensing following an electric shock (Table I) (de Meester, 2008). When lead displacement is induced by the patient, following a repetitive rotational movement (twisting of the box) and leading to winding of the leads around the generator, we talk of Twiddler's syndrome; this is observed in certain psychiatric cases, or when the pocket is too big for the pacemaker generator.

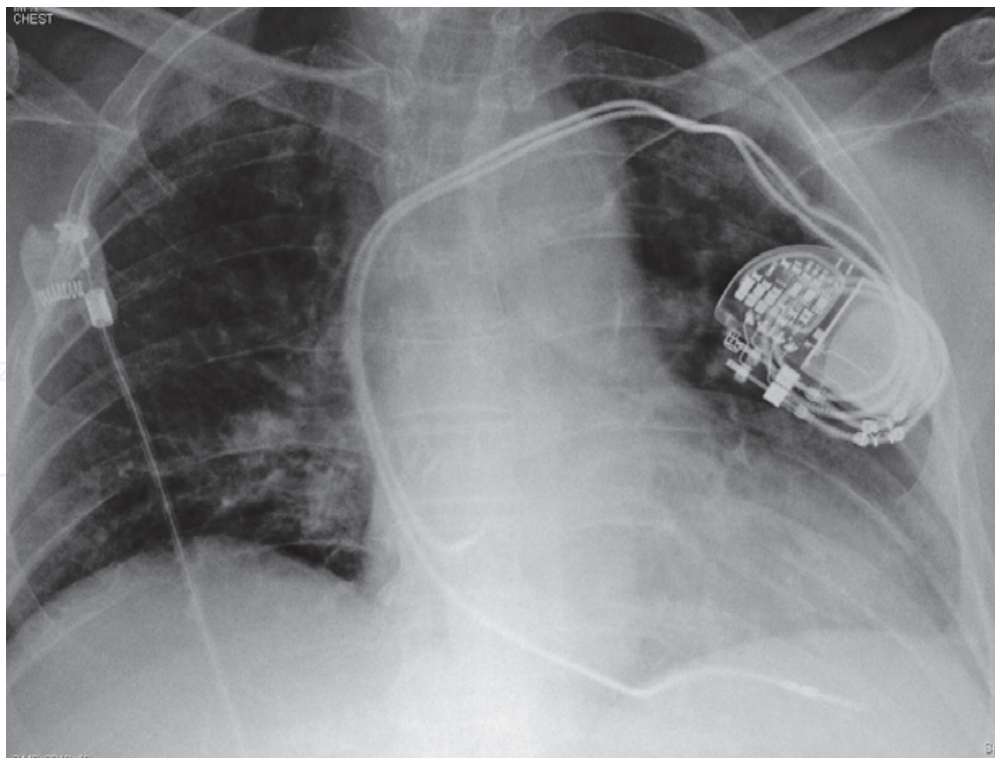
Fig. 4. Chest X-ray showing atrial and ventricular leads, with the ventricular lead clearly beyond the cardiac shadow

Comments: Cardiac perforation is a serious complication, with risk of tamponade and death. It occurs in less than 2% of cases (Ellenbogen et al., 2002). Clinical symptoms are variable, including chest pain, shortness of breath and more rarely hypotension and shock. Advanced age, use of active fixation leads and operator inexperience are contributing factors (Mahapatra et al., 2005). Furthermore, atrial leads seem to perforate more frequently (Hirschl et al., 2007). The new Magnetic Resonance Imaging (MRI)-compatible leads are more rigid, but increased frequency of perforation does not seem to be induced by the use of these leads. Treatment is not standardised, but removal (and replacement) of these leads is crucial in the case of tamponade and shock. Pericarditis without perforation has been observed in 5% of cases and must lead to close follow-up. Figure 5 illustrates a case of tamponade. The patient remained stable after drainage.

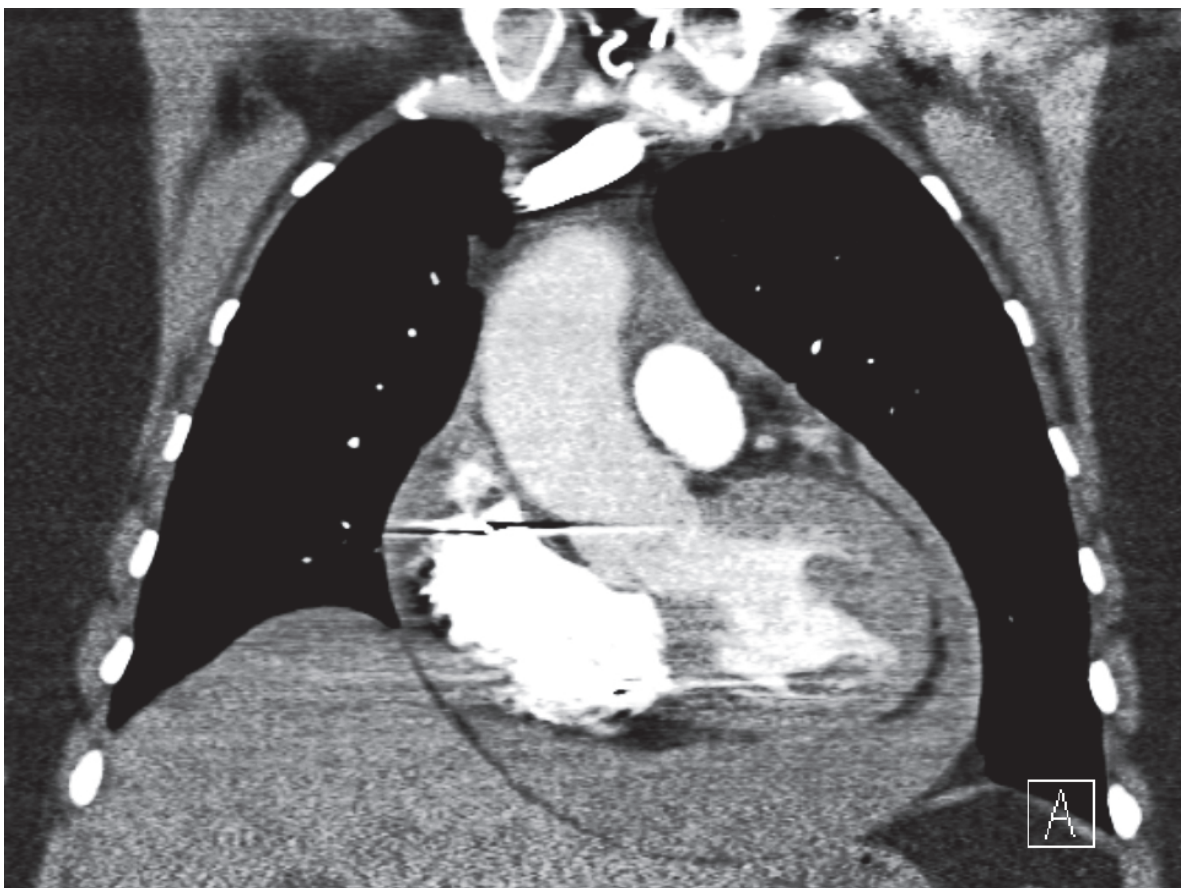
Fig. 5. Chest scan showing significant pericardial effusion, responsible for pre-tamponade and shock.

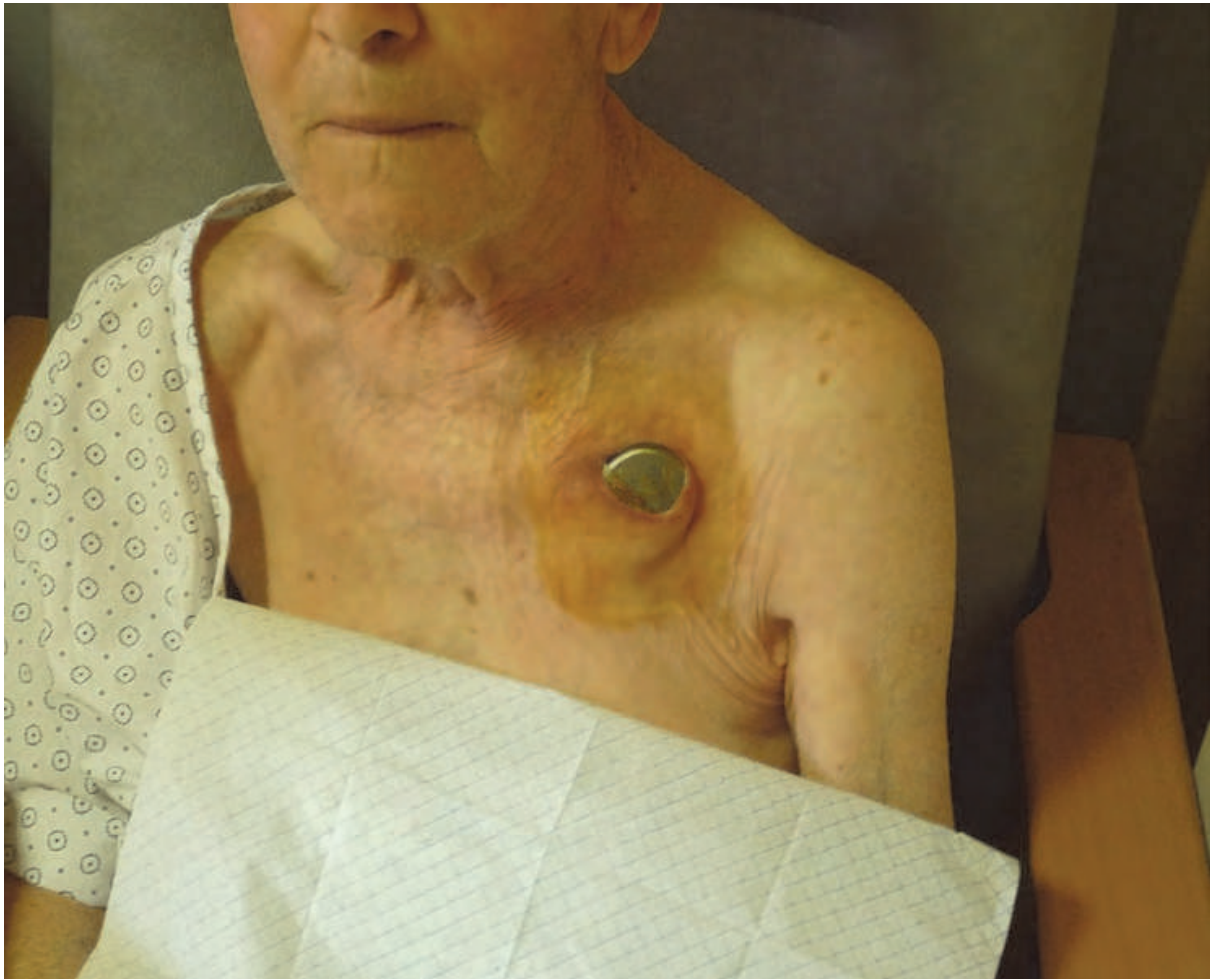
Fig. 6. Erosion and exteriorisation of pacemaker generator in our elderly patient.

exteriorisation of the pacemaker generator (Figure 6). Due to the high risk of infection in this case, the device is removed and a new device is implanted on the contra-lateral side after six weeks of antibiotherapy and with negative hemocultures.

Comments: Skin erosion is caused by the pacemaker generator, and is usually a result of pocket infection. Other precipitating factors can be present, for example, the extremely fragile skin of elderly patients, a pocket that is too small, precarious subcutaneous fat, chronic use of corticoids, and use of abrasive disinfectants (Kiviniemi et al., 1999). Exteriorisation of a generator, and/or a lead, is always associated with bacterial contamination, making removal of the material an obligation, accompanied by antibiotherapy and eventually re-implantation on the contra-lateral side. Skin erosion is hence to be sort for and detected before exteriorisation. This is rarely an early complication, and incidence is estimated to be 1%.

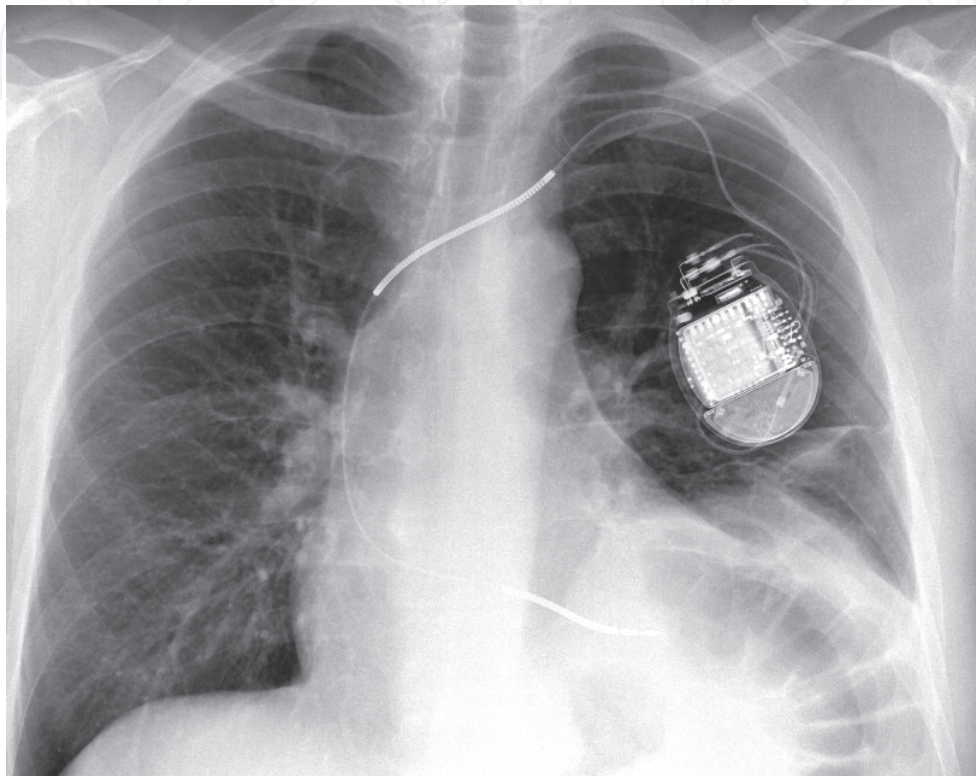
Fig. 7. Chest X-ray showing a ventricular lead that is located higher than usual; this lead is in the left ventricle, having gone through a patent foramen ovale.

Comments: an erroneous lead placement is extremely rare. It remains possible in patients with a patent foramen ovale or an atrial septal defect. Less than twenty cases are reported in the literature (Allie et al, 2000; Blommaert et al., 2000 ; Van Gelder al, 2000; Le Dolley et al, 2009). An EKG during stimulation and chest X-ray in an upright position (antero-posterior and lateral takes) are recommended. The risk of thrombo-embolism, including stroke, of mitral insufficiency should be evaluated. Repositioning of the lead or long term anticoagulation should be considered. When right bundle branch block pacing morphology appears in a patient with a permanent or temporary transvenous right ventricular pacemaker, myocardial perforation or malposition of the pacing lead must be ruled out, even though the patient may be asymptomatic. The overall causes of right bundle branch block morphology include:

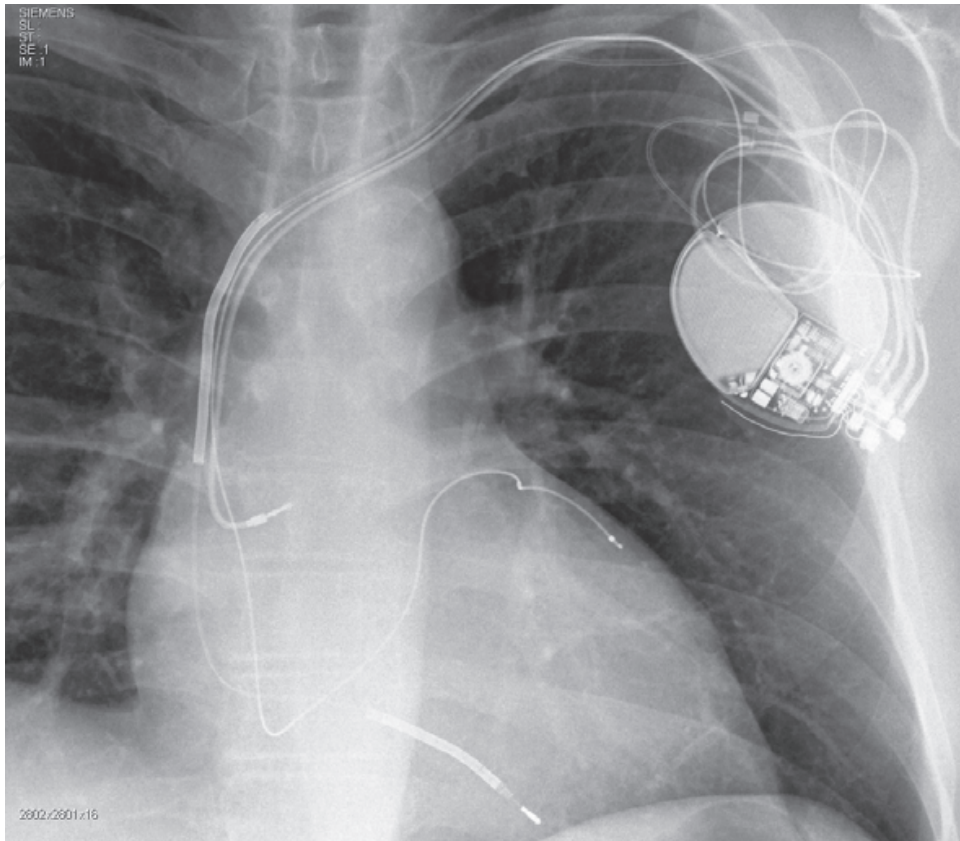
Fig. 8. Chest X-ray showing implantation of 3 leads including a left ventricular lead placed in a branch of the coronary sinus (cardiac resynchronisation therapy).

- erroneous left ventricular lead placement in patient with an atrial septal defect
- biventricular stimulation or cardiac resynchronisation therapy (CRT) (Figure 8)
- epicardial lead placement.
- some cases of “normal” right ventricular apical stimulation

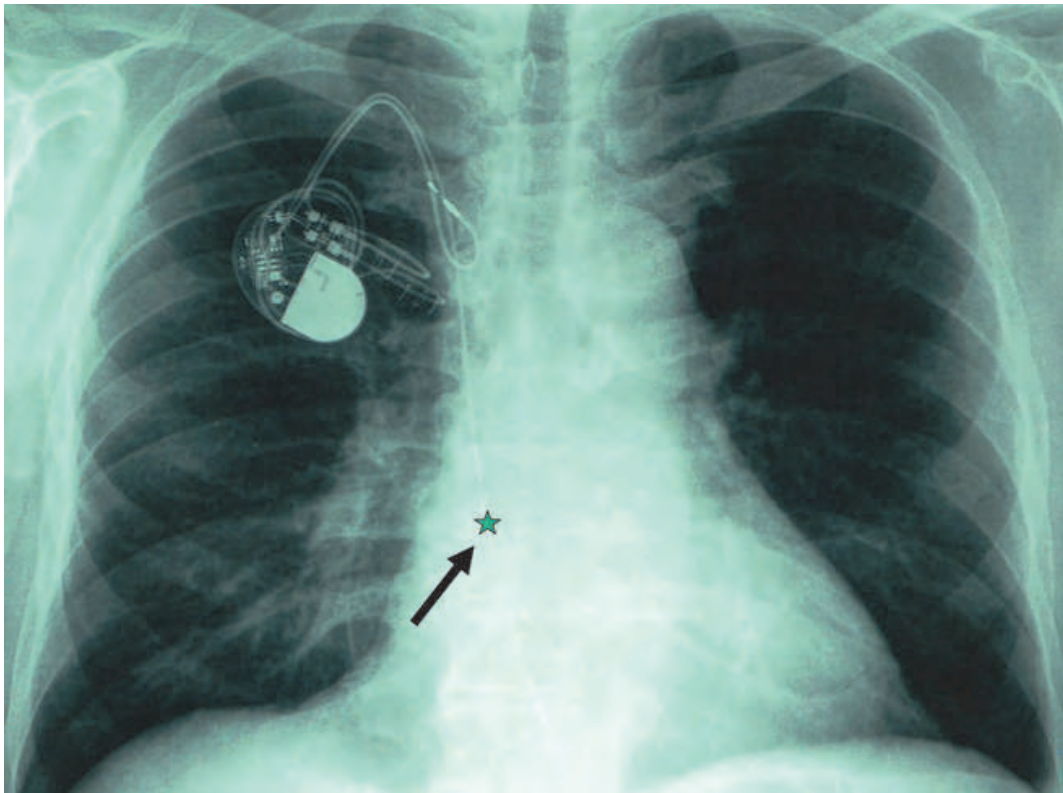
Fig. 9. Chest X-ray showing displaced lead (ventricular lead tip indicated by the star).

Comments: Twiddler's syndrome is describes as the migration of cardiac stimulator leads due to repetitive rotatory movements of the generator in its pocket, secondary to manipulation by the patient himself, which may be intentional or non-intentional (for example, sportsmen). In certain cases, the stimulation of displaced leads can cause pectoral muscle contraction, or life-threatening symptoms in the case of pacemaker dependency (Nicholson et al, 2003; Castillo & Cavusoglu, 2006; Essoh et al., 2010) (Figure 10).

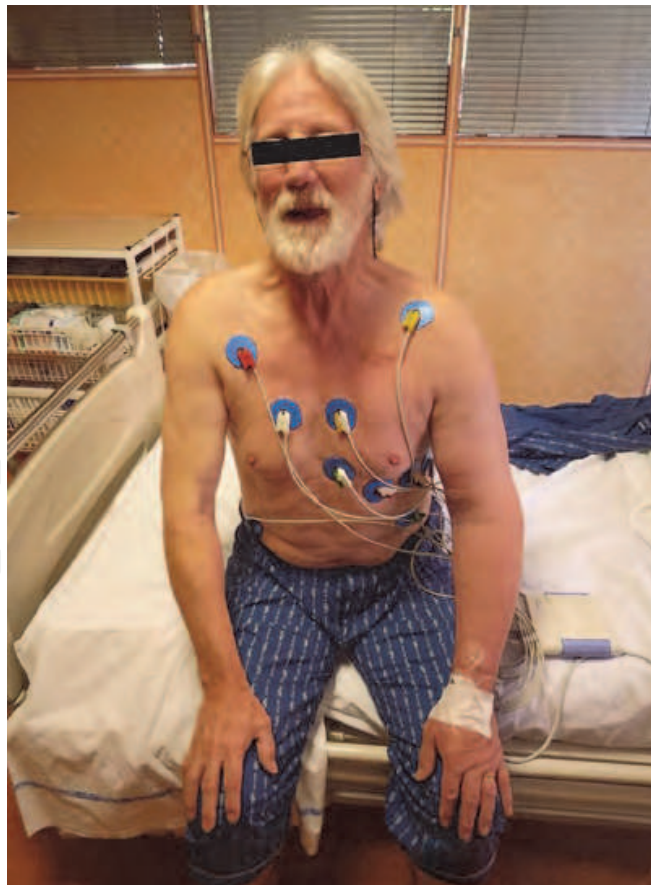
Fig. 11. Oedema of the left arm, forearm and hand caused by massive thrombosis of the subclavian vein after defibrillator with Cardiac Resynchronisation Therapy (CRT-D).

Comments: Subclavian vein thrombosis is not uncommon. It can occur in about 30% of cases, but usually remains asymptomatic due to the rapid development of collateral circulation (Oginosawa et al., 2002). Less than 5% of patients are symptomatic, presenting mainly with pain or oedema of the arm closest to the implantation site. Risk is higher in cases where three leads are implanted (Cardiac Resynchronisation Therapy (CRT), when the patient is under hormonal therapy, when personal history of thrombo-embolic event is present, with temporary ipsilatérale transvenous lead, during upgrade of a simple pacemaker to a pacemaker with resynchronisation, dual coil leads, and when the ejection fraction is less than or equal to 40% (Da Costa et al., 2003 ; Rozmus et al., 2005). The risk of thrombosis does not differ for pacemakers and implantable cardioverter-defibrillators. Preventive measures may be necessary (platelet aggregation inhibiting drugs or anticoagulation therapy).

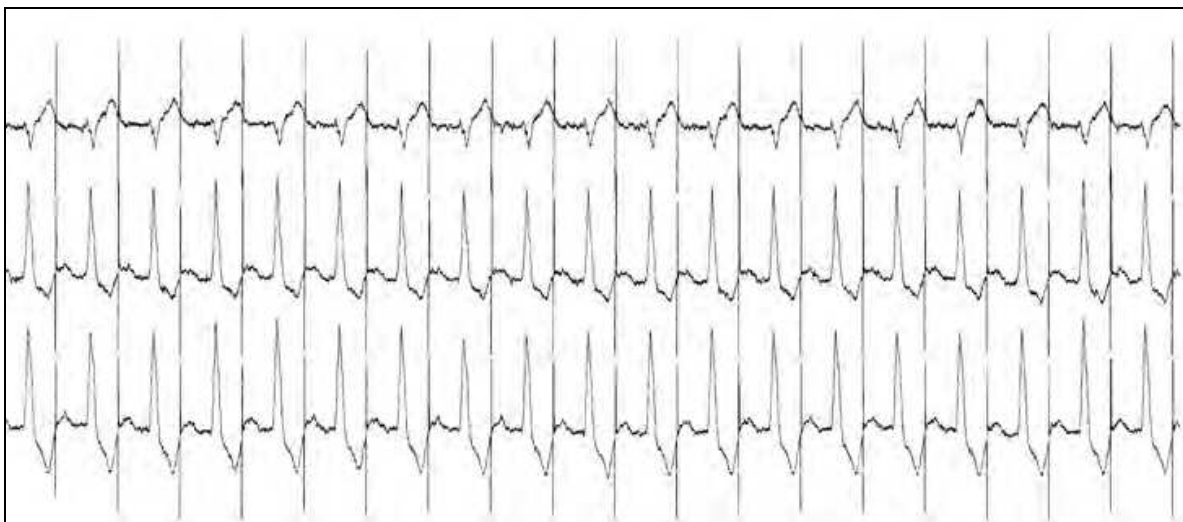
Fig. 12. Tachycardia due to an error in the connection of the atrial and ventricular leads. We note the same QRS configuration as with VVI pacing from the apex.

Comments: Atrial and ventricular lead connection errors are rare at implantation, but have already been documented (Barold et al, 2010). Programming verification allows rapid detection of the switch (“green wire on the green button and red wire on the red button”). A control of the programming of a stimulator is mandatory before patient discharge. It

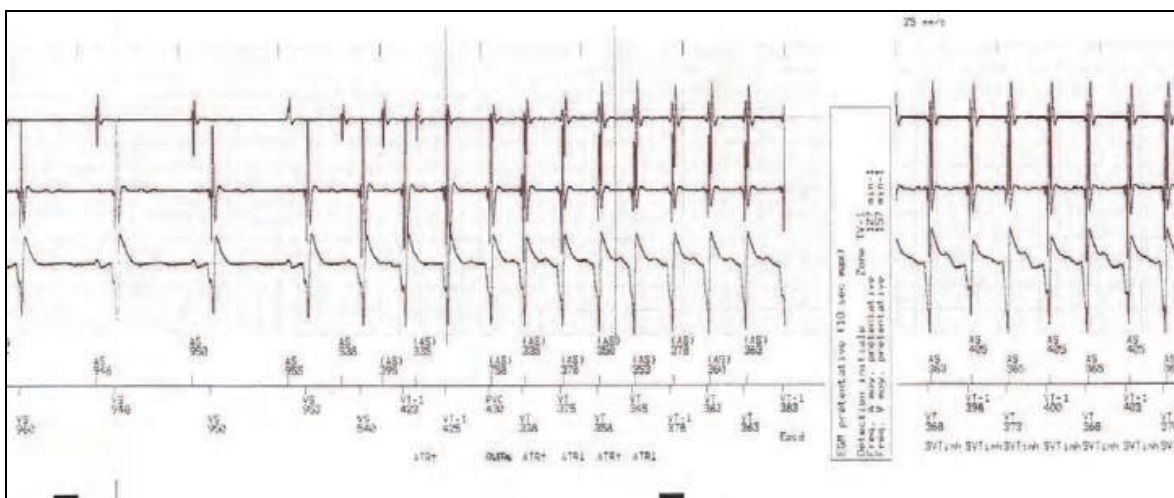
Fig. 13. Baseline rhythm strip showing atrial, ventricular and shock intracardiac electrogram leads, and marker atrial and ventricular channels. This is an example of initiation of common atrioventricular node reentrant tachycardia; see text.

- figure 13 shows the initiation of the common type (slow-fast) of atrioventricular nodal reentrant tachycardia ; this is a typical example where the arrhythmia is triggered by an atrial extrasystole which blocks the rapid pathway of the atrioventricular node and allows flow through the slow pathway and thus initiation of the supraventricular tachycardia circuit

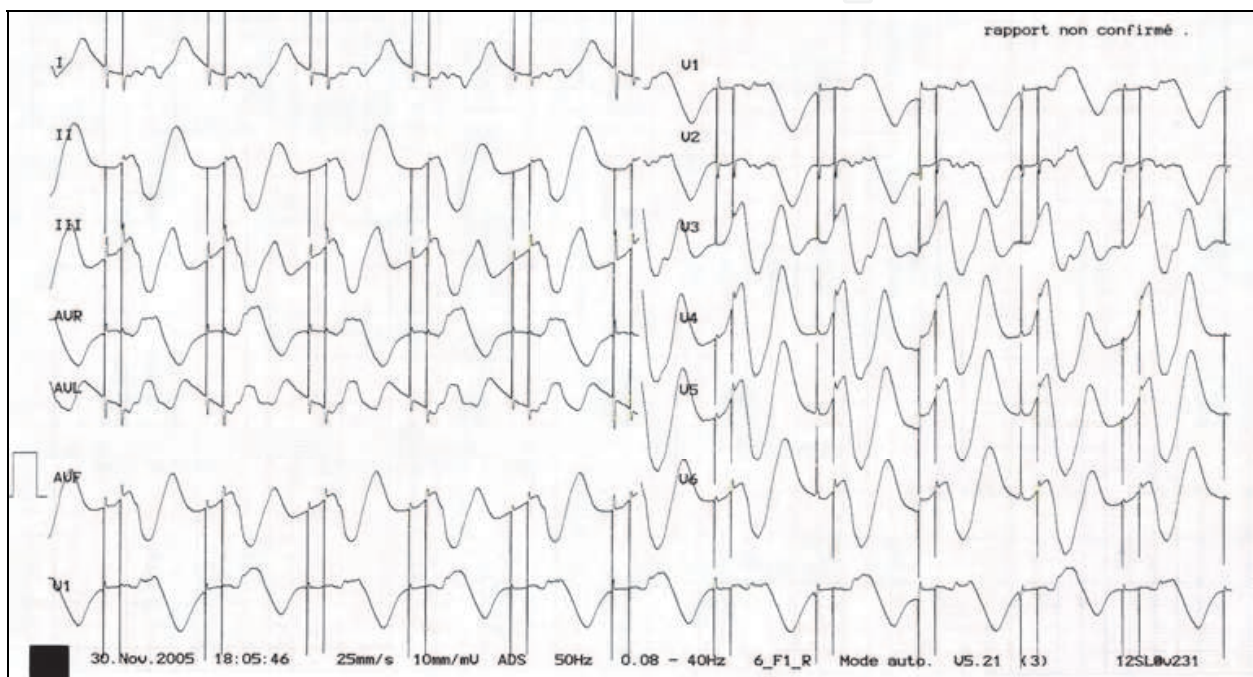
Fig. 14. Twelve-lead EKG showing signs of hyperkalemia and defiant AV detection and stimulation.

Comments: Causes of atrioventricular underdetection and failure to capture are shown in table I. Hypokalemia is another cause of life-threatening undersensing (de Meester et al, 1996). Correction of the cause is essential for adequate pacemaker function. The risk of triggering ventricular fibrillation, due to a ventricular stimulation during the vulnerable T wave period (R-on-T phenomenon), is present, as is present in asynchronous VOO stimulation or the use of a magnet (Oupadia et al., 1998).

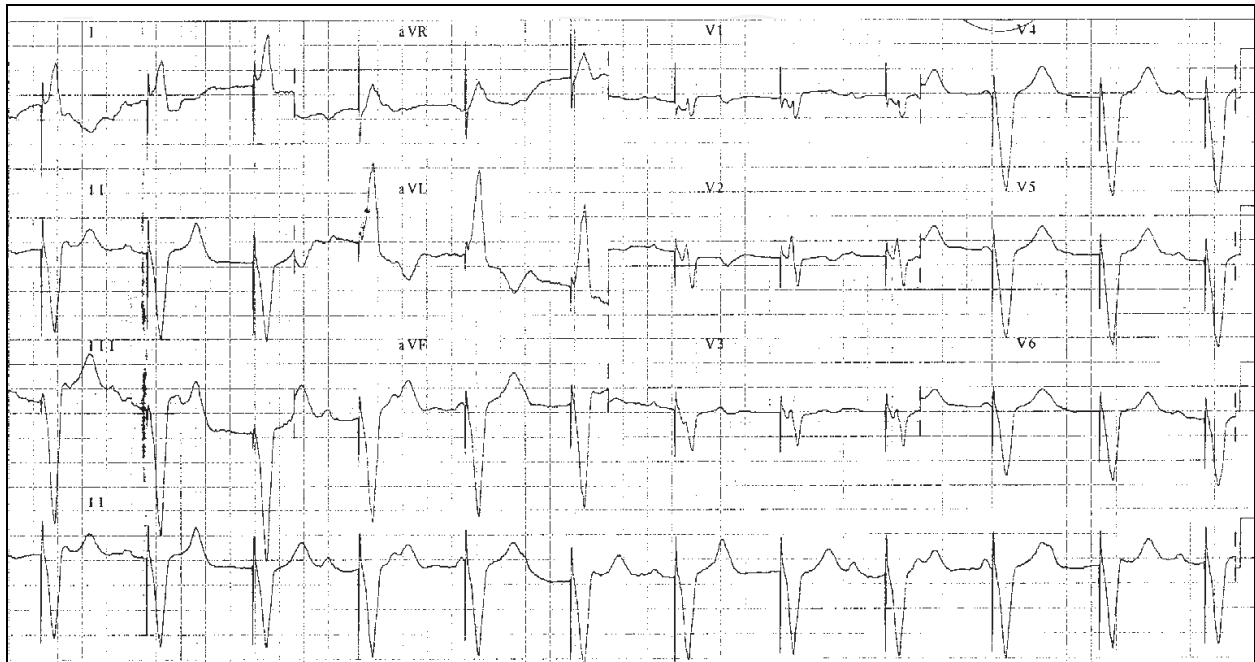
Fig. 15. Twelve-lead EKG showing a dissociated sinus rhythm with right ventricular stimulation.

Comments: This is not a veritable implantation complication but the erroneous choice of a single chamber pacemaker whereas a physiological (or double chamber) stimulator would have avoided the problem. Pacemaker syndrome is described as a combination of symptoms evoking cardiac failure and hypotension in a patient with a cardiac stimulator (Chalvidan et al., 2000). It is caused by the loss of atrioventricular synchronism leading to a drop in cardiac output, elevated atrial pressure and hypotension. The Mode Selection Trial (MOST) investigators defined pacemaker syndrome as occurring if either one of two different criteria occurred (Link et al., 2004). The first criterion was new or worsened dyspnea, orthopnea, elevated jugular venous pressure, rales, and oedema with ventricular (VA) conduction during ventricular pacing. The second criterion was symptoms of dizziness, weakness, presyncope, or syncope, and a >20 mmHg reduction of systolic blood pressure when the patient had VVIR pacing compared with atrial pacing or sinus rhythm. Its incidence is 7-20% of stimulators in VVI mode with a sinus rhythm. Pacemaker syndrome can also be seen in AAIR mode and in double chamber modes (VDD, DDI, DDD) if the stimulator if programming is sub-optimal or the stimulation mode is incorrectly selected. Dyspnoea should, besides pacemaker syndrome, evoke:

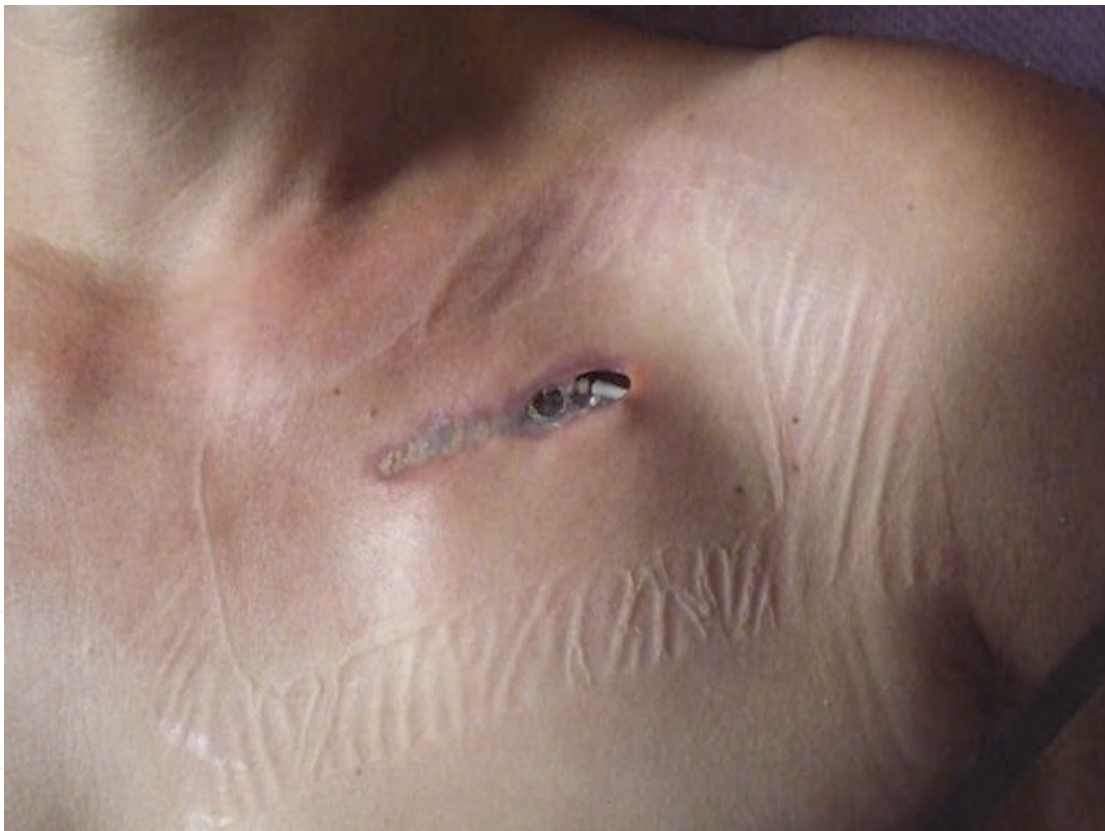
Fig. 16. Photograph showing suppurative wound with visible pacemaker leads. Ablation of all material was necessary.

Comments: Suture or pocket infection is not a rarity during the first month and incidence is estimated to be 1% (del Rio et al., 2003 ; Klug et al., 2007). Principal risk factors are re-intervention, diabetes, old age, corticoids, operator inexperience, and renal failure. Antibiotic prophylaxis prior to pacemaker implantation has a protective effect. In the case of very early infection, a per-operative contamination by cutaneous flora (*staphylococcus aureus*) is the principal source of infection (Kearney et al., 1994 ; Da Costa et al., 1998).

Successful treatment of an infected device requires removal of the entire system and administration of antimicrobials. Infection after one month usually originates from the lead (and not the pocket). Sepsis is uncommon and diagnosis includes positive blood cultures (80% of cases) and transesophageal echography showing lead anomalies. Skin erosion at pocket site and other local signs of infection are common. *Staphylococcus epidermidis* or other gram negative bacteria are most commonly found.
