# A Novel Approach to Spent Fuel Pool Decommissioning

R. L. Demmer

*Idaho National Laboratory, Idaho Falls, Idaho  
USA*

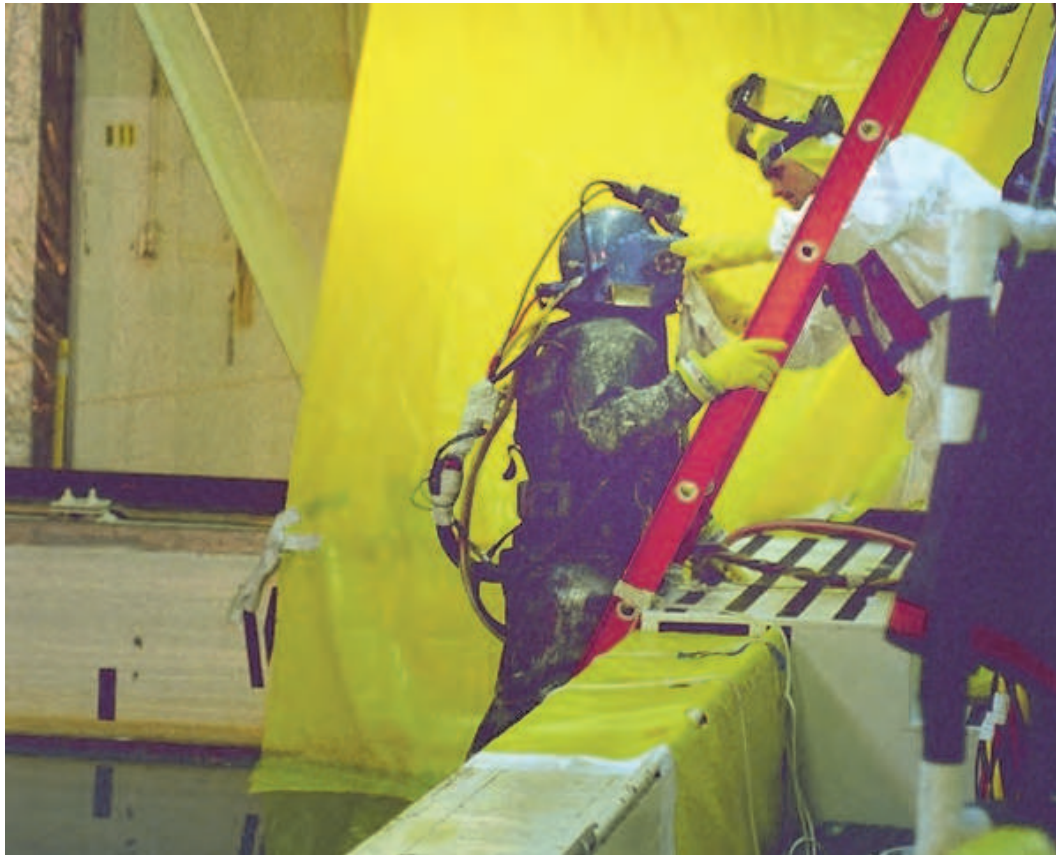
Fig. 1. Diver at INL completing entry into basin for underwater cleaning and coating.

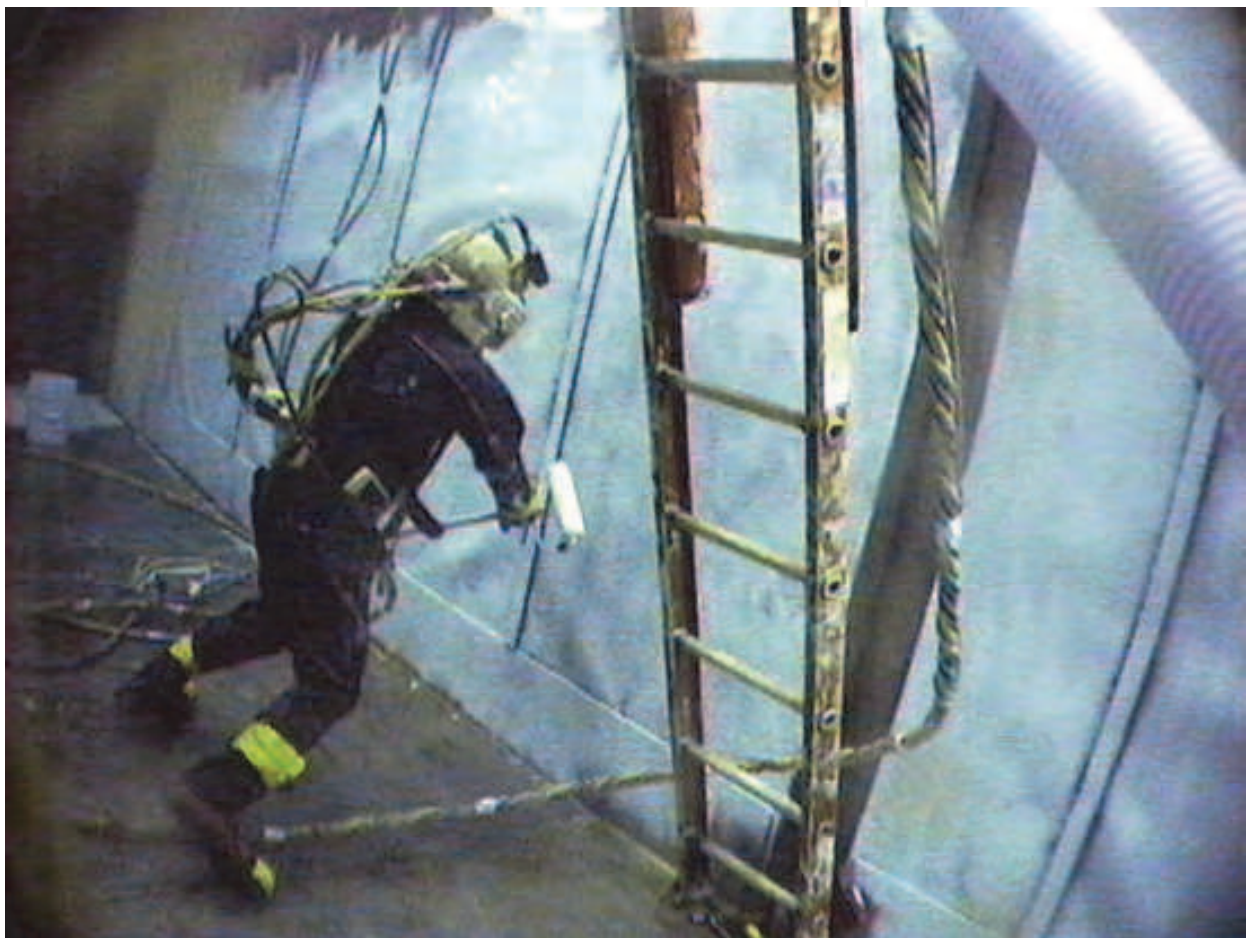
Fig. 2. Special two hose roller system used for wall coating at the MTR pool.

A special type of paint roller system was used for underwater application of the epoxy coating, which is shown being applied underwater in Figure 2. The system had two separate pumps for the epoxy resin and hardener, which were pumped through separate hoses to a mixing manifold about 1.5 m from the roller. The roller/extruder system was flexible up to that point, and like a solid wand from there to the roller head.

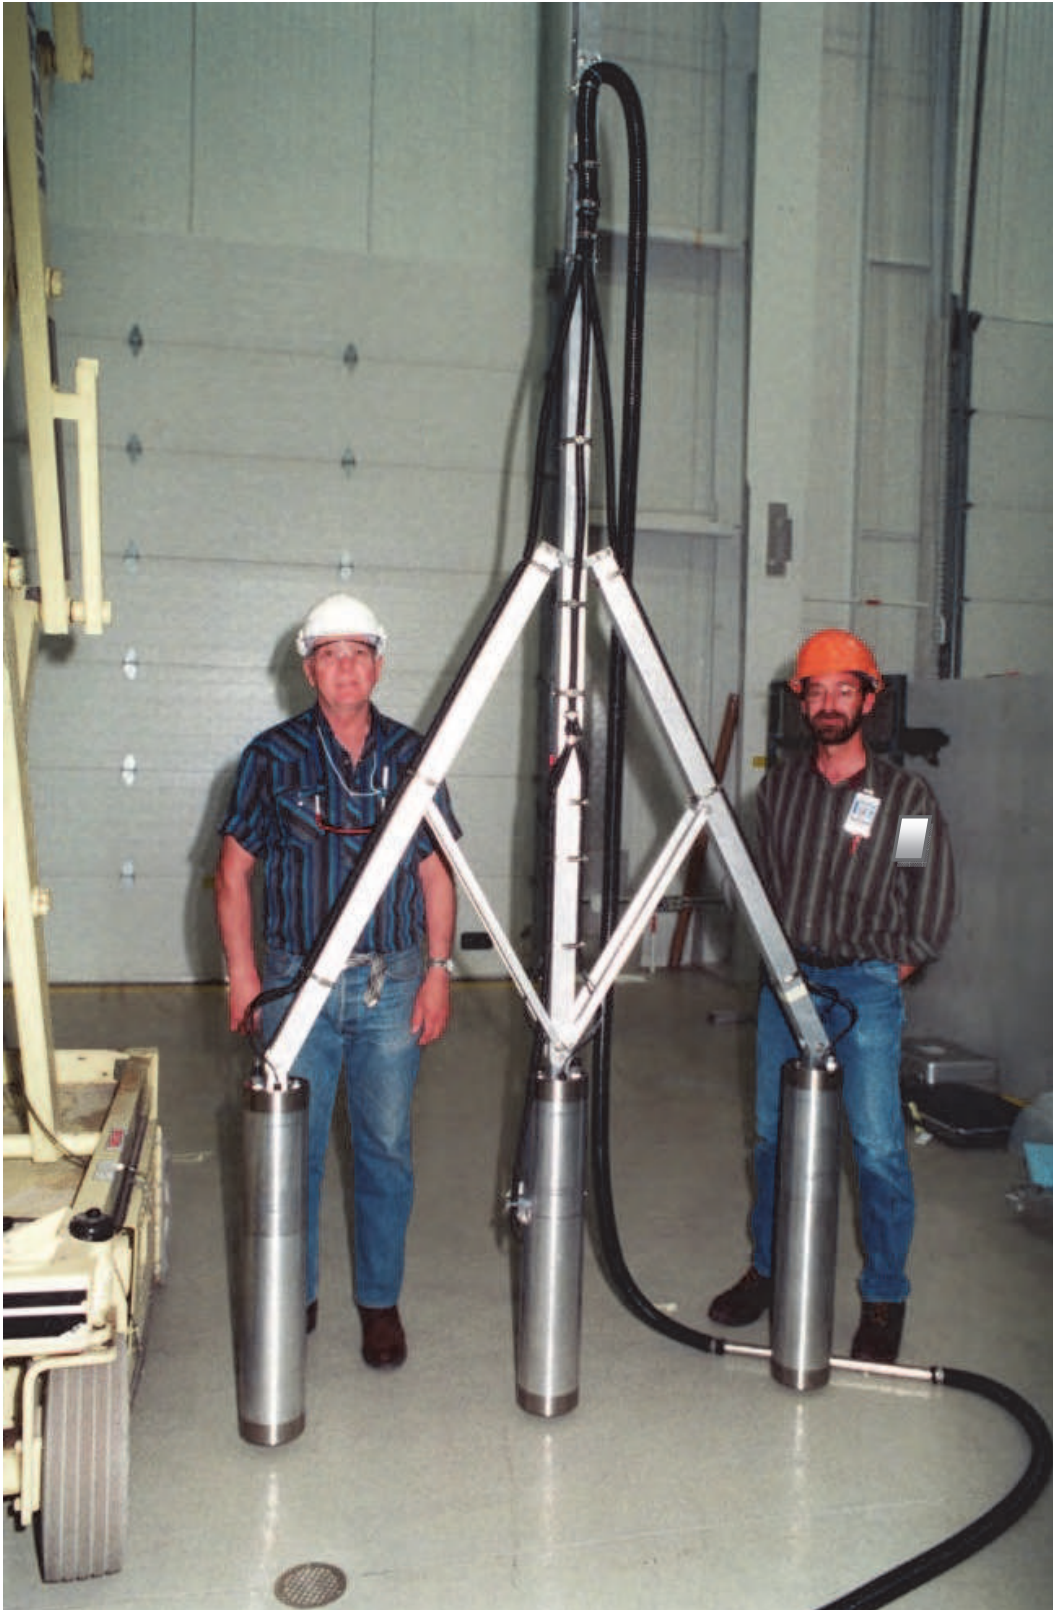
Fig. 3. Multi Detector Basin Scanning Array for INTEC-603.

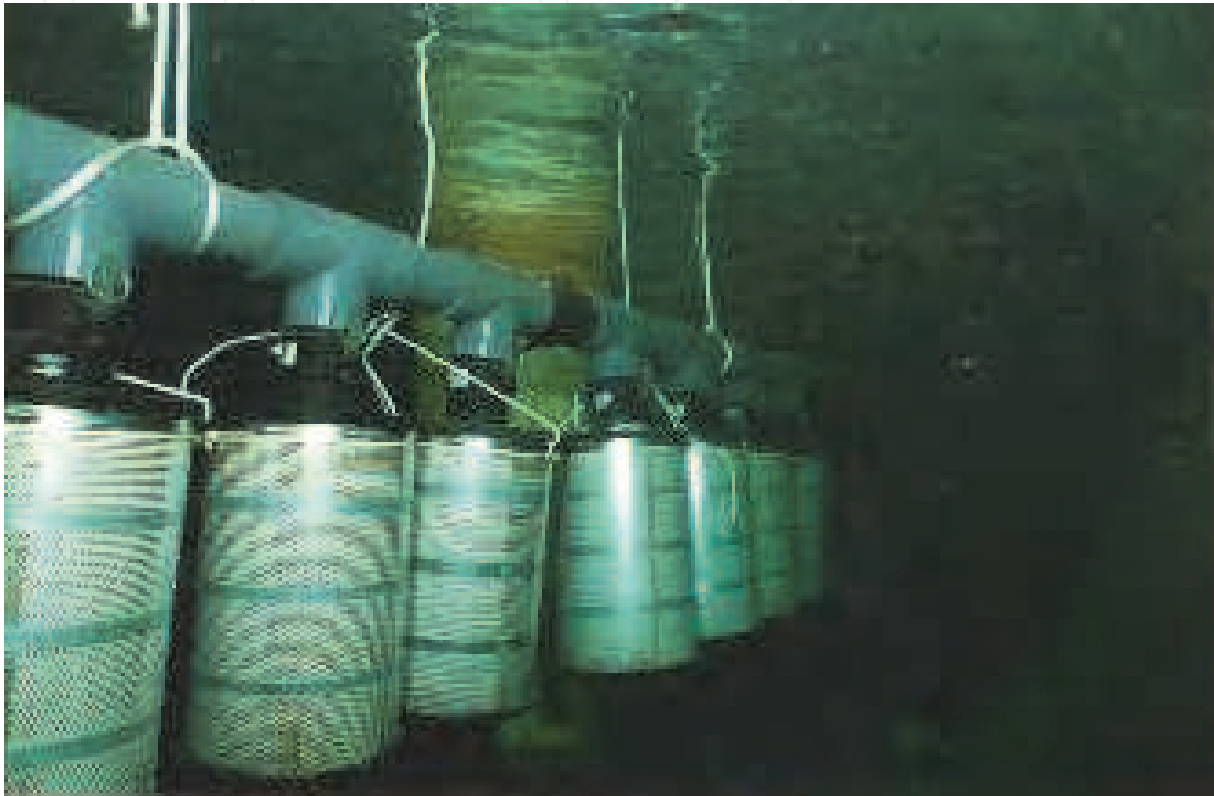
Fig. 4. UCC vacuuming filtration system underwater manifold.
