Machinability of Titanium Alloys in Drilling

Safian Sharif¹, Erween Abd Rahim² and Hiroyuki Sasahara³

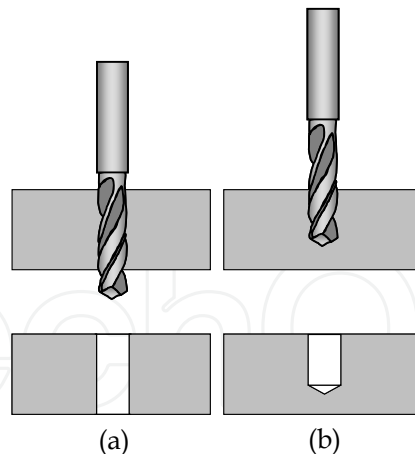
Fig. 1. Type of hole, (a) Through hole and (b) blind hole

Hole making is an essential process in the structural frames of an aircraft and contributes to 40 to 60% of the total material removal operations (Brinksmeier, 1990). This process is commonly divided into short hole or deep hole drilling. Short hole drilling typically covers holes with a small depth to diameter ratio having diameter up to 30 mm and a depth of not more than 5 times the diameter. Meanwhile deep hole drilling caters for holes greater than 30 mm in diameter and the depths are usually greater than 2.5 times the hole diameter. Drilling deeper hole with conventional drills requires pecking method to enable easy flow of the chips out of the hole. Deep hole drilling is more difficult especially when hole straightness is the main concern. Therefore, a usual method is to make a circular cut using a hollow-core cutting tool. This technique allows larger hole diameter to be drilled with lesser power. In addition, holes can be produced in many forms which include through holes or blind holes (Fig. 1). Through hole is one which is drilled completely through the workpiece while a blind hole is drilled only to a certain depth.

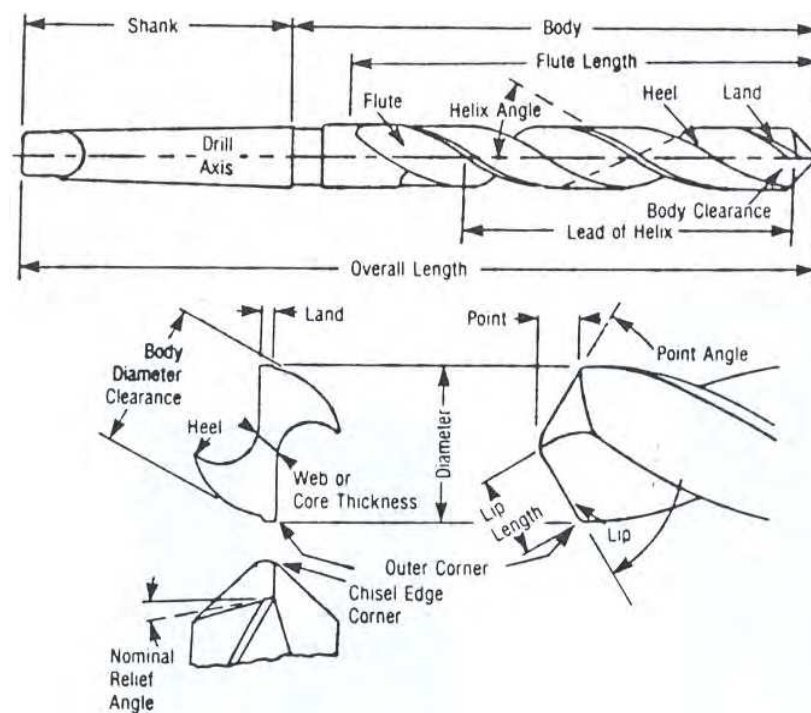
Fig. 2. Drill geometry (Lindberg, 1990)

A twist drill is fabricated with 3 major parts as shown in Fig. 2. The most important features from the analytical point of view are rake angle, point angle, web thickness, nominal clearance angle, drill diameter, inclination angle and chisel edge angle. The rake angle is usually specified as helix angle at the periphery. The direction of the chip flow is attributed to the point angle. The torque decreases with increasing point angle due to the increase of orthogonal rake angle at each point on the main cutting edges. Furthermore, the thrust force always increases with increasing point angle.

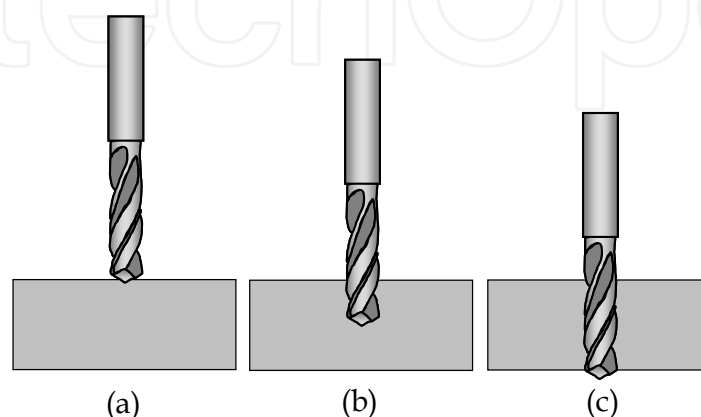
Fig. 3. Drilling phases, (a) centering phase, (b) full drilling phase and (c) break through phase

Fig. 3 shows the phases involved in a drilling operation, first is the start and centering phase, second is the full drilling phase and finally the break through phase (Tonshoff et al., 1994). To ensure good surface quality and accuracy of the holes are achieved, the first phase is very important (Fig. 3 (a)) in order to avoid the occurrence of premature wear and breakage of the drill. In this phase, the torque and force on the tool constantly increase. The full drilling phase starts once the main cutting edges are fully engaged (Fig. 3 (b)). The break through phase begins when the drill point breaks through the underside of the work piece and the process is stopped when the drill body passed through the work piece (Fig. 3 (c)).

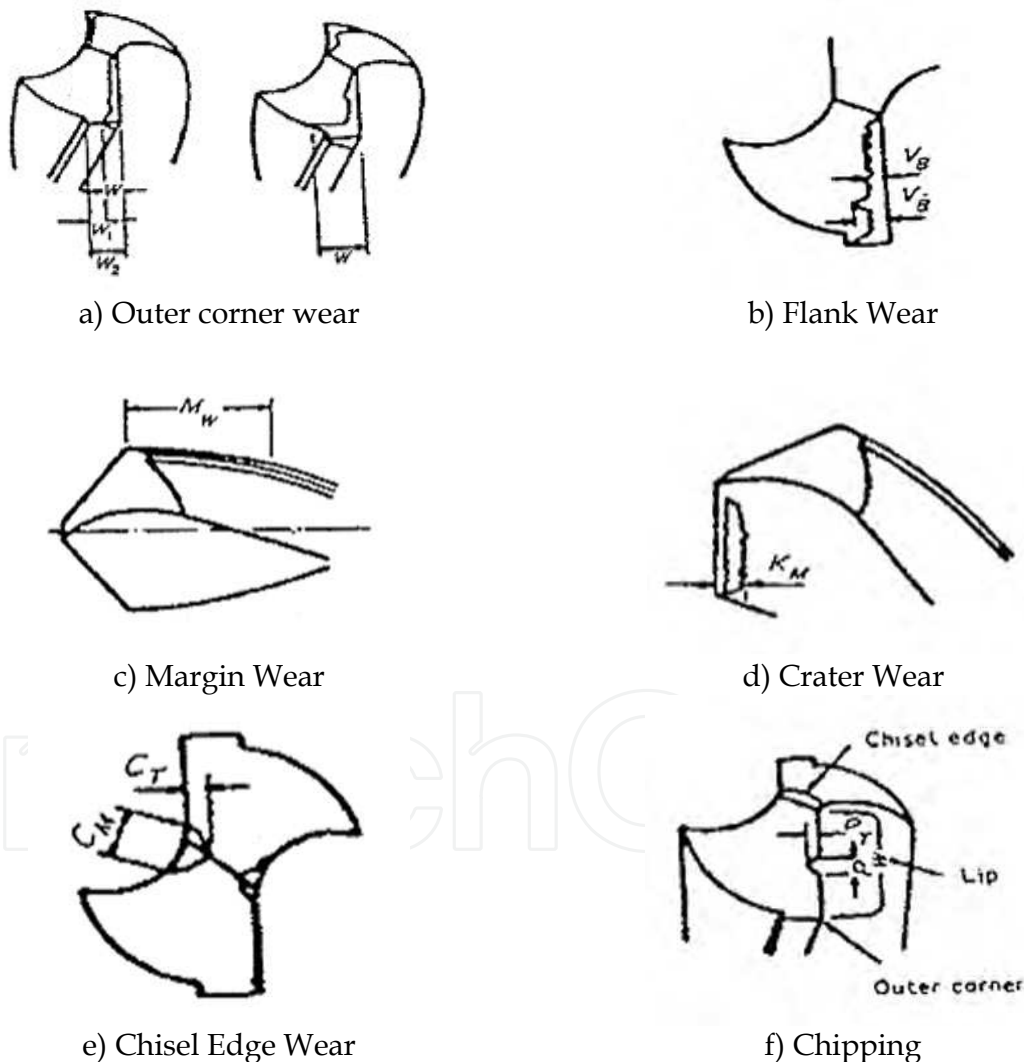
Fig. 4. Types of drill wear (Kanai et al., 1978)

Heat generation, pressure, friction and stress distribution are the main contributors of drill wear. The drill wear can be classified into (Kanai et al., 1978): outer corner (w), flank wear (V_b), margin wear (M_w), crater wear (K_M), along with two types of chisel edge wear (C_T and C_M) and chipping at the cutting lips (P_T and P_M). Fig. 4 shows the aforementioned types of wear. Wear starts at the sharp corners of the cutting edges and distributed along the cutting edges until the chisel and drill margin (Schnieder, 2001). Flank wear is considered as one of the criterion to measure the performance of a drill. It occurs due to the friction between the workpiece and the contact area on the clearance surface. However, Kanai et al. (1978) suggested that outer corner wear should be used as the main criteria of tool performance because of the relative ease of measurement and the close relationship between this type of wear and the drill life.

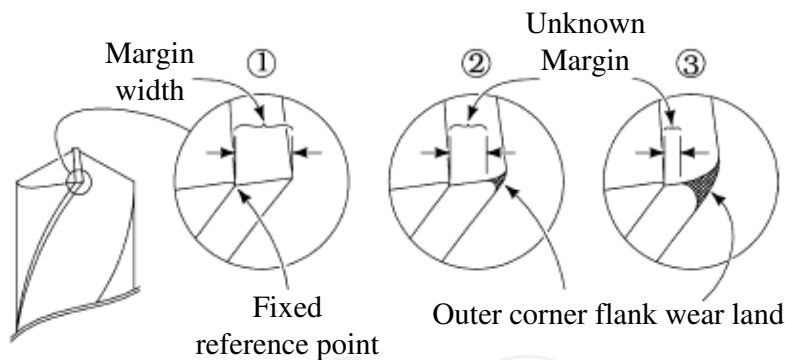
Fig. 6. A method to measure outer corner wear from a fixed reference point (Harris et al., 2003)

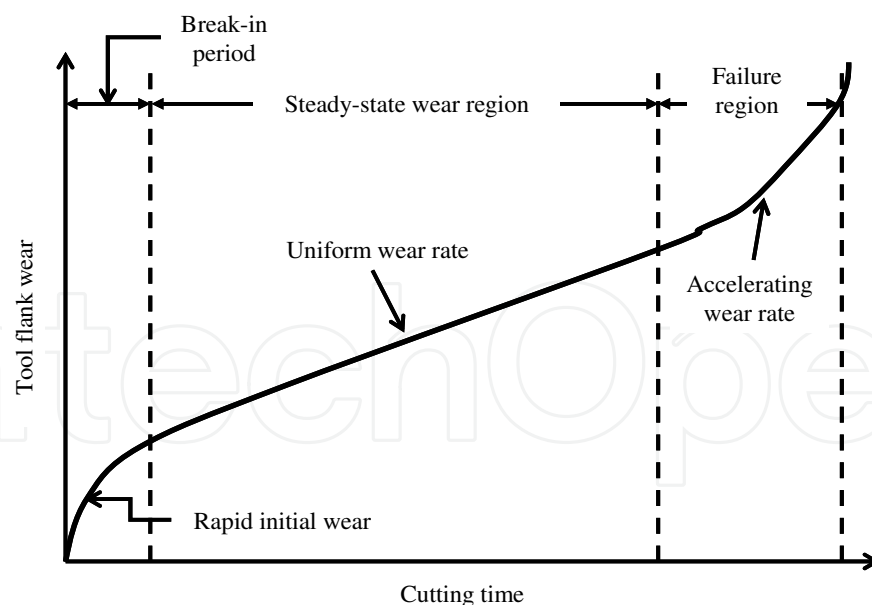
Fig. 7. Typical stages of tool wear in machining (Vaughn, 1966)

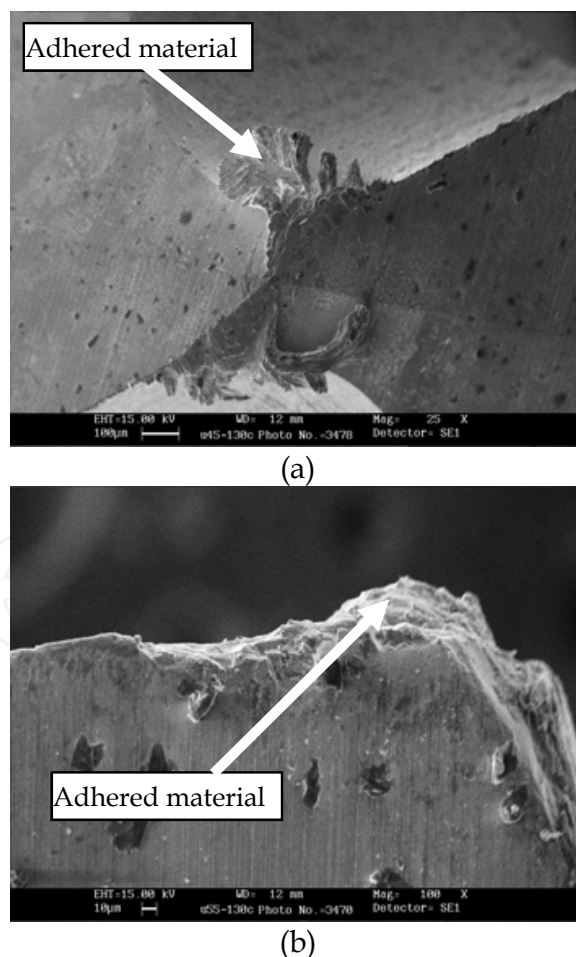
Fig. 8. Adherence of workpiece materials observed at: (a) chisel edge and (b) cutting edge of after drilling Ti-6Al-4V (Rahim, 2005)

During drilling of Ti-48Al-2Mn-2Nb, Mantle and co-workers (Mantle et al. (1995)) found that the workpiece material adhered to the chisel and the cutting edges. The adherence of Ti-48Al-2Mn-2Nb was thinner than Ti-6Al-4V and after verification under the SEM, they concluded that the adhered material was the main contributor to the tool failure. Titanium is highly chemically reactive with the tendency of welding onto the cutting tool during machining. In the beginning, the adhered material may protect the cutting edges from wear as shown in Fig. 8. In this figure, the adherence occurred mainly at the cutting edge, near the periphery and on the chisel edge. However with prolonged drilling, the adhered material becomes unstable and breaks away from the tool carrying along small amount of tool particles. This situation may lead to severe chipping on the cutting edge.

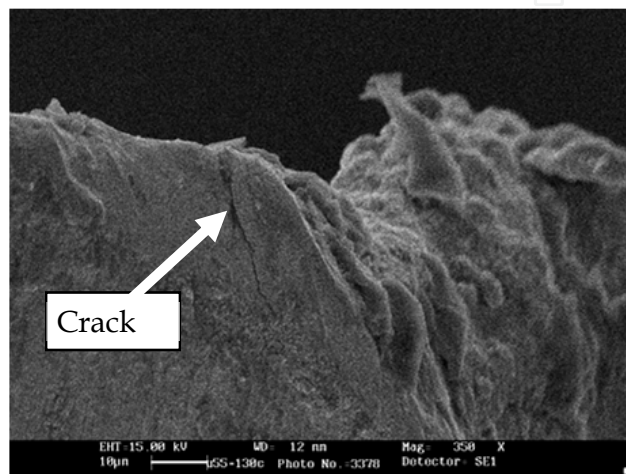
Fig. 9. Crack on the flank face after drilling Ti-6Al-4V for 1 minute at 55 m/min and 0.06 mm/rev (Rahim, 2005)

Fig. 9 shows a thermal crack on the flank face of the drill (Rahim, 2005). It can be seen that the crack line propagated perpendicularly to the cutting edge. Cracks on the cutting tool and fracture of the entire cutting edge were mainly observed when machining titanium alloys at higher cutting conditions (Ezugwu et al., 2000; Jawaid et al., 2000). Cracks usually originate from the chipped area and gradually propagate along the worn flank face. Chipping at cutting edges is attributed mainly by the generation of cyclic surface stresses during drilling, which may lead to the stress cycling results in the formation of cracks parallel on the cutting edge. The propagation of cracks with prolonged machining, leads to chipping along the cutting edge. Chipping can also occur without the presence of crack formation, especially at the initial stages of the wear progress. If cracks become very numerous, they may join and cause small fragments of the cutting edge to break away.

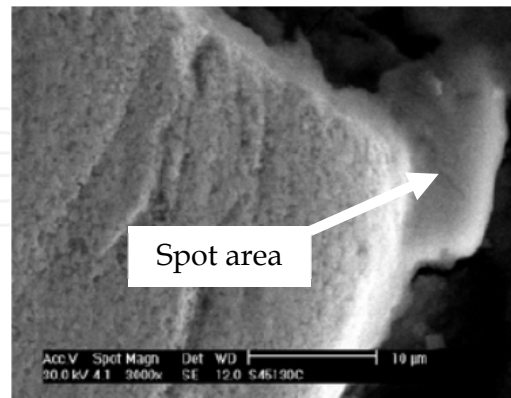
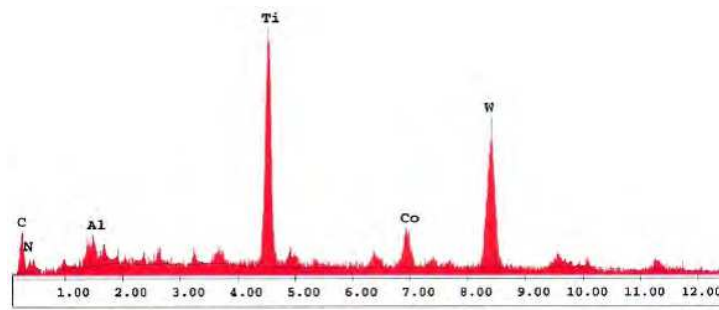
Fig. 10. EDAX Section of worn tool, showing adherent workpiece material on the cutting edge after drilling Ti-6Al-4V for 2 minutes at 45 m/min and 0.06 mm/rev (Rahim & Sharif, 2009)

Furthermore, diffusion wear is associated with the chemical affinity between the tool and workpiece materials under high temperature and pressure during machining of titanium alloys (Hartung and Kramer, 1982; Kramer, 1987). An intimate contact between the tool-workpiece interface at temperature above 800° C provides an ideal environment for diffusion of tool material across the tool-workpiece interface. The EDAX analysis (Fig. 10) confirmed that tool elements (C, Co and W) had diffused into the interface between tool-

workpiece during drilling Ti-6Al-4V (Rahim & Sharif, 2009). Diffusion wear is significant at the tool-workpiece interface, especially at high cutting temperature. Due to high chemical reactivity of titanium alloys, carbon reacts readily with titanium. Therefore, the formation of titanium carbide occurred at the interface between the tool and work material.

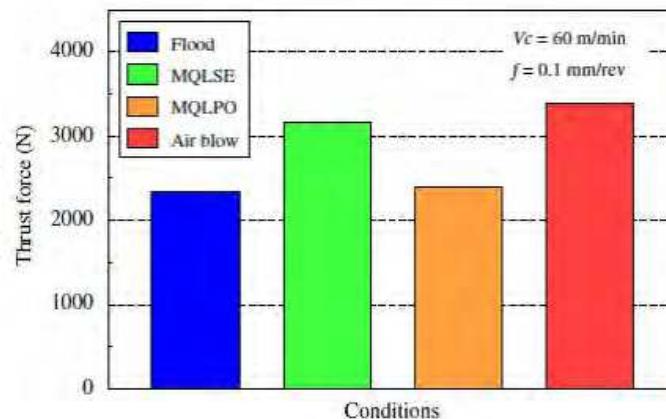
Fig. 11. Thrust force when high speed drilling of Ti-6Al-4V under various coolant-lubricant conditions (Rahim & Sasahara, 2011)

Comparison of thrust force against the coolant-lubricant conditions at cutting speed of 60 m/min and feed rate of 0.1 mm/rev is presented in Fig. 11 (Rahim & Sasahara, 2011). It was found that the air blow condition produced the highest thrust force in comparison to the other coolant-lubricant conditions. In contrast, the MQLPO (palm oil using MQL condition) and flood conditions exhibited comparable and the lowest thrust force among the other conditions tested. As expected, the flood condition demonstrated the lowest torque among the other conditions tested as shown in Fig.12. Through the comparison, it was found that air blow did not reduce the drilling torque as much as the other coolant-lubricant conditions. They concluded that the highest value of thrust force and torque for the air blow condition could be attributed to higher amount of friction between tool-chip interface, hence, more heat is generated during the drilling process. Furthermore, Lopez and co-

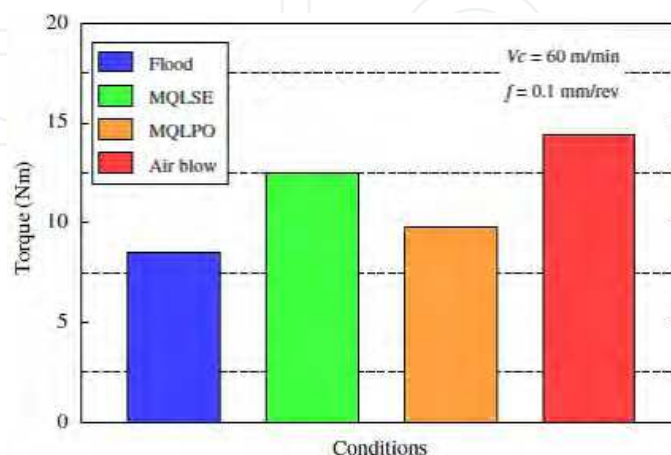
Fig. 12. Torque when high speed drilling of Ti-6Al-4V under various coolant-lubricant conditions (Rahim & Sasahara, 2011)

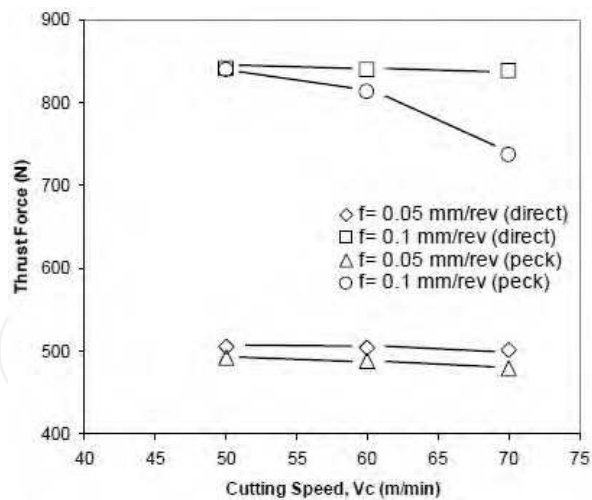
Fig. 13. Comparison of thrust force when drilling Ti-6Al-4V using cemented carbide tool under flood coolant condition (Rahim et al., 2008)

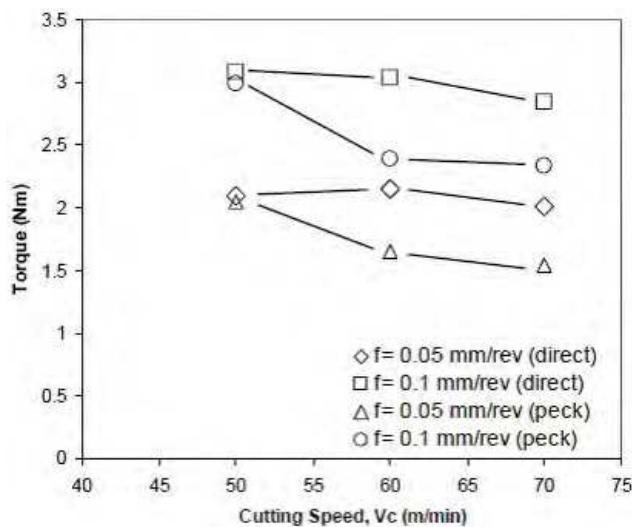
Fig. 14. Comparison of torque when drilling Ti-6Al-4V using cemented carbide tool under flood coolant condition (Rahim et al., 2008)

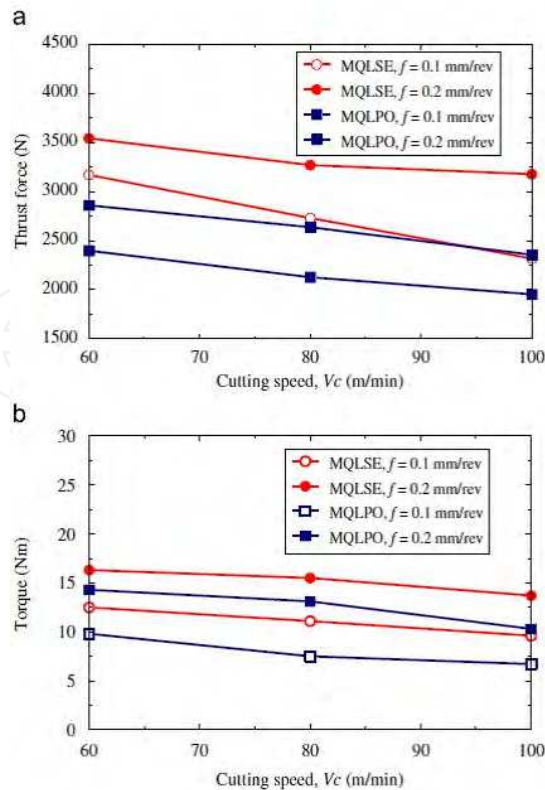
Fig. 15. (a) Thrust force and (b) torque for MQLSE and MQLPO under various cutting speed and feed rate (Rahim & Sasahara, 2011)

Some researchers have tested several techniques in drilling of titanium alloys. A step feed drilling or intermittently decelerated feed drilling and vibratory drilling were conducted by Sakurai co-workers (Sakurai et al., 1992; Sakurai et al., 1996) to examine the cutting force and cutting characteristic of TiN coated cobalt HSS and oxide treatment nitridized cobalt HSS when drilling Ti-6Al-4V. Results of their study showed that step feed drilling contributed a lower thrust force and torque as compared to continuous conventional drilling. In addition, the thrust force and torque on TiN drills are lower than oxide treatment nitridized drills in both conventional and step feed drilling. As reported by Okamura and co-workers (Okamura et al., 2006), the non-vibration drilling shows a tremendous reduction on thrust force. However, the value tends to decrease once the vibration exceeded 20 kHz. It is believed that the natural frequency of measurement systems does not exceed the vibrating frequency. In another work by Rahim and co-workers (Rahim et al., 2008) showed that pecking drilling method significantly reduces the thrust force and torque.

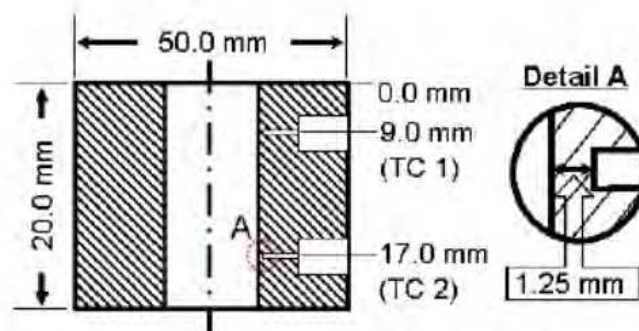
Fig. 16. Thermocouple locations (Rahim & Sasahara, 2010a)

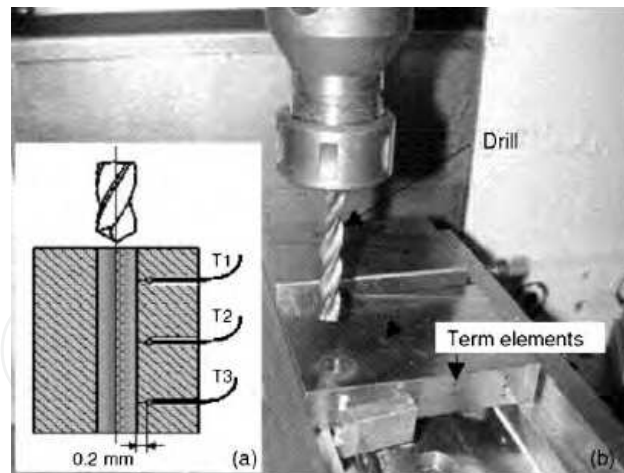
Fig. 17. System for measurement of the temperature in the workpiece (Zeilmann & Weingaertner, 2006)

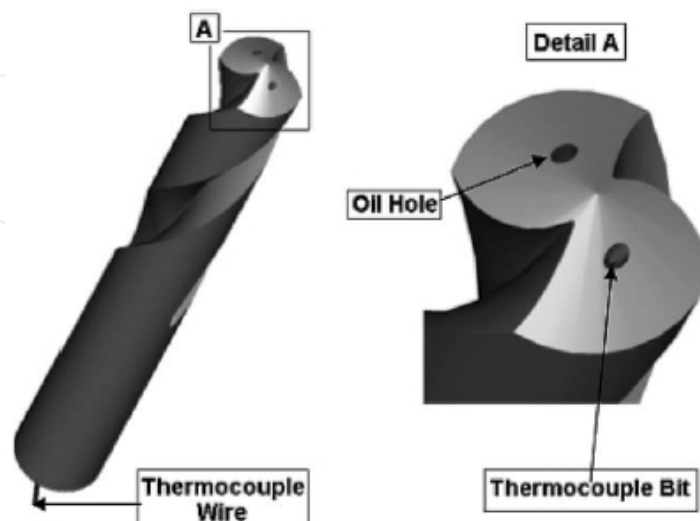
Fig. 18. The thermocouple was inserted through the oil hole of internal coolant carbide drill (Ozcelik & Bagci, 2006)

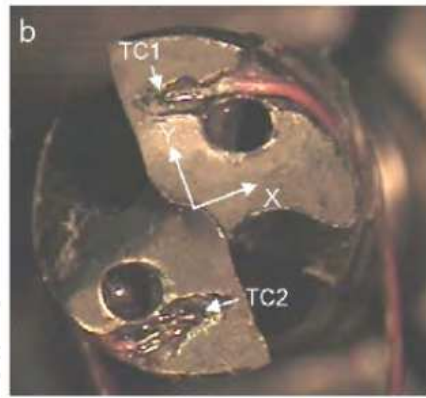
Fig. 19. Top view and coordinates of thermocouple tips on drill flank face (Li & Shih, 2007)

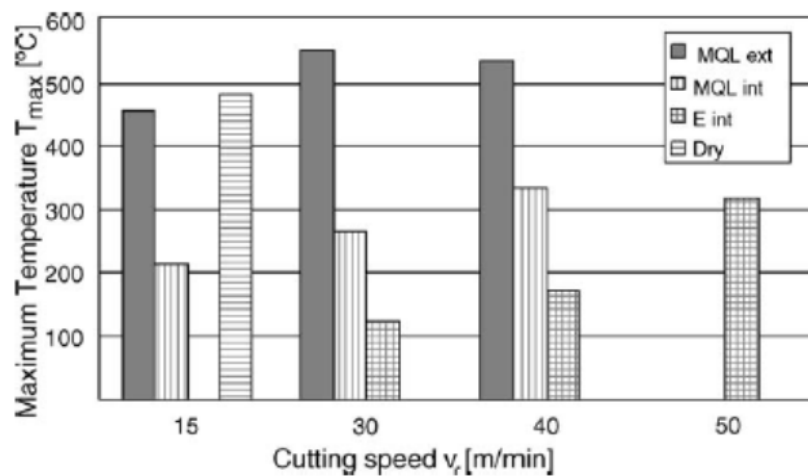
Fig. 20. Maximum temperature in the piece for different cutting fluids conditions when drilling Ti-6Al-4V using grade K10 cemented carbide tool (Zeilmann & Weingartner, 2006)

The application of different cooling methods provides a variation in temperature results. For example, the maximum temperatures recorded for drilling with abundant emulsion through the interior of the tool stayed in the range of 22–32% of the values obtained with the application of MQL with an external nozzle as shown in Fig. 20 (Zeilmann & Weingaertner, 2006). Comparing drilling with MQL applied with an external nozzle and dry drilling, the values obtained for the second condition were approximately 6% superior, ranging from 455 to 482 °C. Furthermore, flood and MQL conditions recorded a low workpiece temperature in comparison to the air blow condition as shown in Fig. 21 (Rahim & Sasahara, 2011).

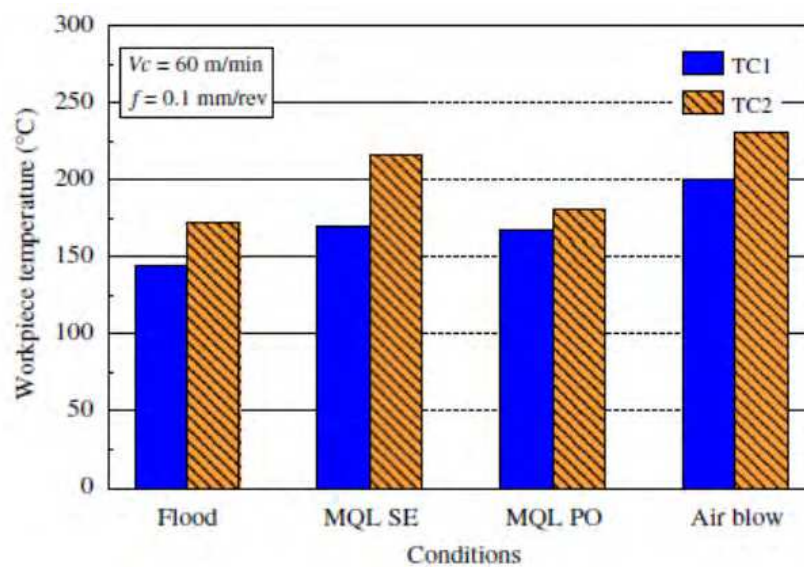
Fig. 21. Maximum workpiece temperature in high speed drilling of Ti-6Al-4V under various coolant-lubricant conditions (Rahim & Sasahara, 2011)

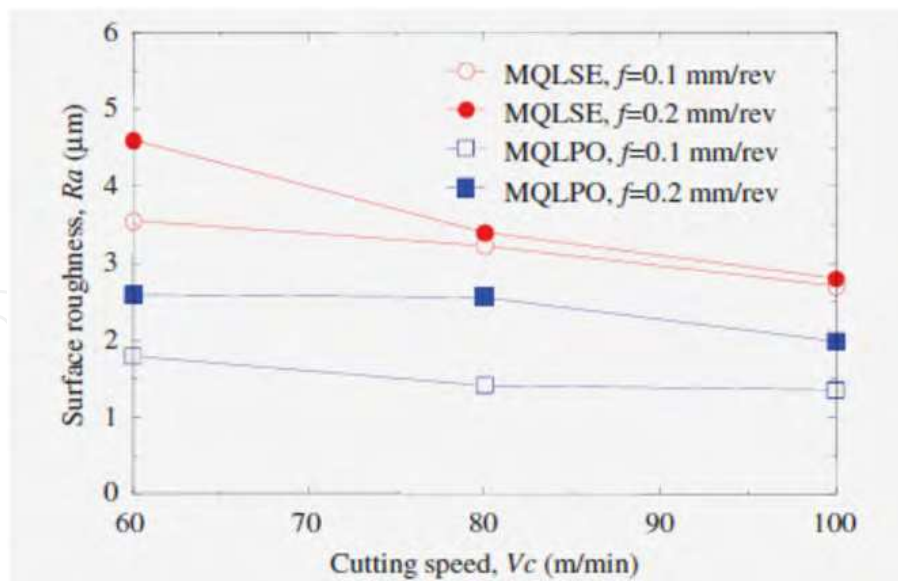
Fig. 22. Comparison of surface roughness level obtained when drilling Ti-6Al-4V using TiAlN coated carbide tool under MQLSE and MQLPO (Rahim & Sasahara, 2010b)

Previous study showed that surface roughness value is lower at high cutting speed when drilling Ti-6Al-4V using carbide drills (Sharif & Rahim, 2007). During machining at high cutting speed, the cutting temperature increases due the small contact length between tool-workpiece interfaces. This could be due to the decrease in the value of coefficient of friction, which results in low friction at the tool-workpiece interface. These factors could contribute to the improvement in surface roughness values as shown in Fig. 22 (Rahim & Sasahara, 2010b). In addition, as the cutting speed increases, more heat is generated thus softening the workpiece material, which in turn improves the surface roughness. However, a low cutting speed may lead to the formation of built-up edge and hence deteriorates the machined surface. Investigation revealed that at high feed rate the surface roughness is poor, probably due to the distinct feed marks produced at high feed rate (Rahim & Sasahara, 2010)

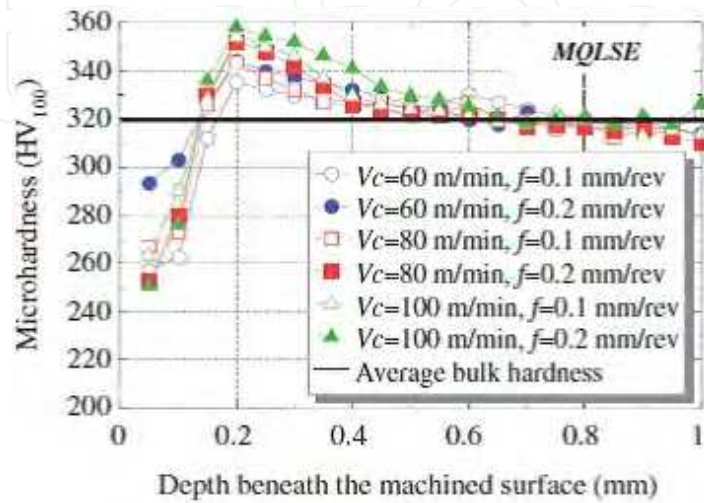
Fig. 23. Sub-surface hardness variations after drilling Ti-6Al-4V using MQLSE (Rahim & Sasahara, 2010b)

Fig. 23 shows that the microhardness of the sub-surface at 0.025 mm underneath the machined surface was below the average base material hardness. This indicates that the machined surface experienced thermal softening effect or over aging due to the localized heating during the drilling process (Rahim & Sasahara, 2010b). Turning test of titanium alloys by Haron and Jawaid (Haron & Jawaid, 2005) and Ginting and Nouari (Ginting & Nouari, 2009) have also indicated significant drop of microhardness value near the surface of machined layer. They pointed out that the existence of high cutting temperature and high cutting pressure produced noticeable softening in the surface region.

Fig. 23 also shows that there is hardening layer below the softened layer whose hardness depends on the cutting parameters (i.e cutting speed, feed rate, depth of cut) as well as mechanical and thermal interaction. It was generally observed in the work hardening region that the microhardness increases with increase in cutting speed and feed rate. An increase in microhardness of the surface layer, as a result of high feed rate could be associated by the high rubbing load between the tool and the machined surface and the consequent work hardening effect.

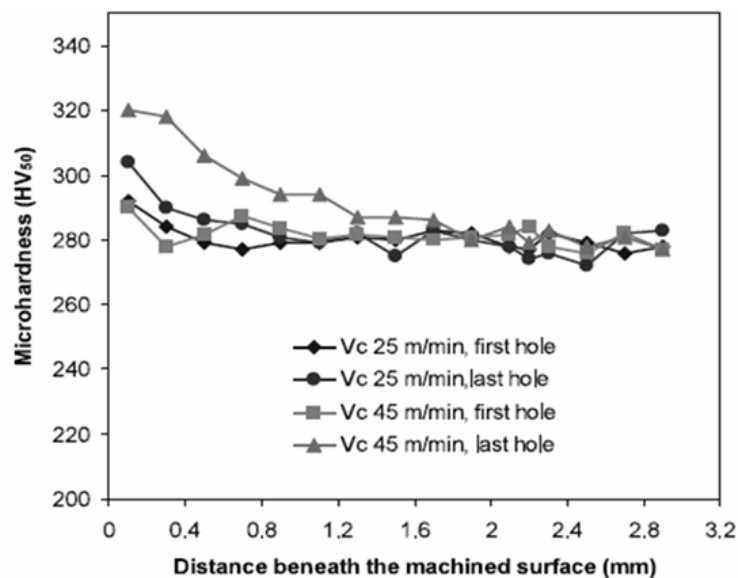
Fig. 24. Microhardness variation beneath the surface produced when drilling Ti-5Al-4V-Mo/Fe (Rahim & Sharif, 2006)

In another work by Rahim and Sharif (Rahim & Sharif, 2006), it was reported that the hardness value underneath the drilled surface was higher than the average hardness of the bulk material when drilling Ti-5Al-4V-Mo/Fe (Fig. 24). Meanwhile, a significant changed of microhardness values were also observed underneath the machined surface. It was due to the transformation of beta phase to alpha phase during drilling (Cantero et al., 2005).

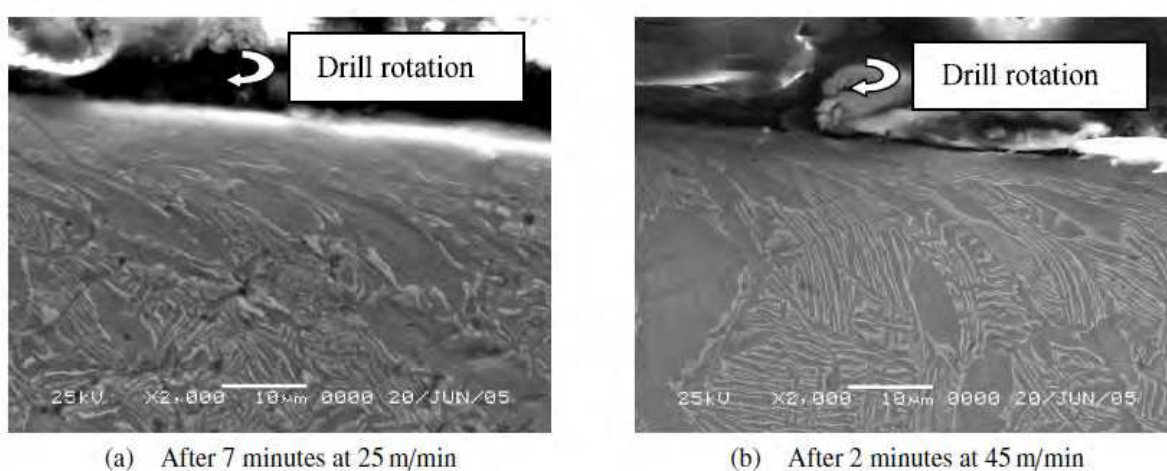
Fig. 25. Magnified view of the machined sub-surface when drilling Ti-5Al-4V-Mo/Fe (Rahim & Sharif, 2006)

Fig. 25 shows an evidence of sub-surface plastic deformation when drilling Ti-5Al-4V-Mo/Fe (Rahim & Sharif, 2006). In this figure, the deformation is found to be severe after prolonged drilling. In this case, no white layer especially on the top of the machined surface is observed. The authors stated that high cutting force and temperature are the dominant factors which lead to the severe plastic deformation. Cantero and co-workers (Cantero et al., 2005) also found the same phenomenon and they concluded that the plastic deformations during machining are caused by mechanical forces from the cutting tool acting upon the work-piece. Additional deformation can occur as a consequence of temperature gradients due to localized heating of the machined surface area.
