Resonance in Electrical Power Systems of Petrochemical Plants

Job García and Gabriel García
Instituto de Investigaciones Eléctricas
Mexico

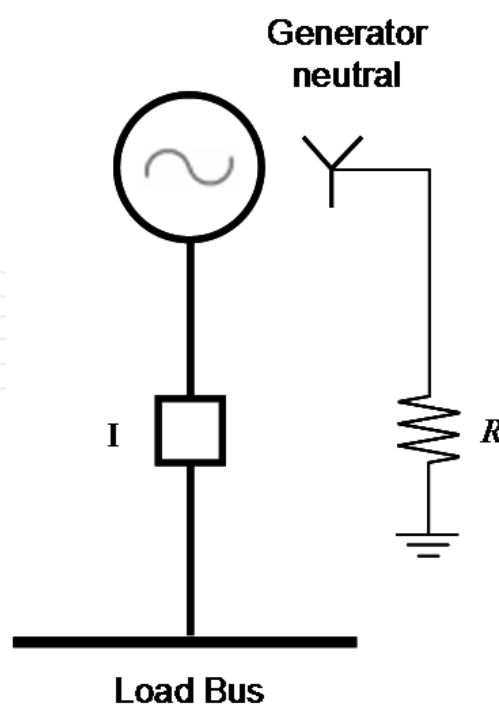
Fig. 2.1.1. Resistance with grounding.

In large systems where we have a high capital investment in equipment or losses which have a significant economic impact, we use the low impedance grounding [Manning, 1964; Shipp & Angelini, 1991]. In this scheme, a resistor is connected, normally a value that allows only a ground fault current of 200 to 800 A, through the neutral grounding system, see Fig. 2.1.1. As the grounding impedance is a resistance, any transient overvoltage is quickly damped and the overvoltage does not stay for a long time [Shipp & Angelini, 1991].

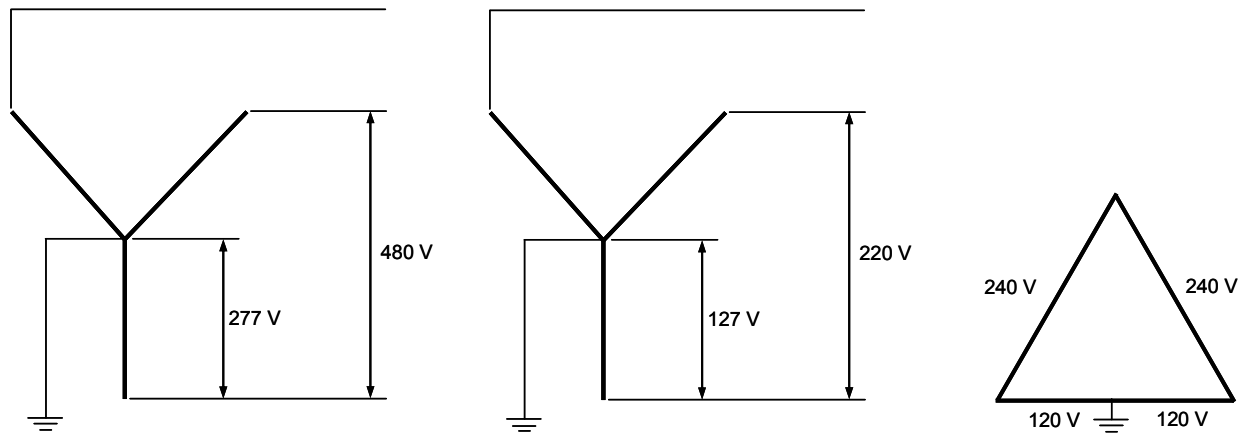
Fig. 2.2.1. Neutral solidly grounding.

Solidly grounding systems are the most commonly used. These schemes can be used in systems operating with a single phase loads, tending to a safe operation, see Fig. 2.2.1. If the system is not solidly grounded, the neutral system remains floating to ground, and remains as function of the load line to neutral and exposed to unbalanced voltages and instability [Shipp & Angelini, 1991].

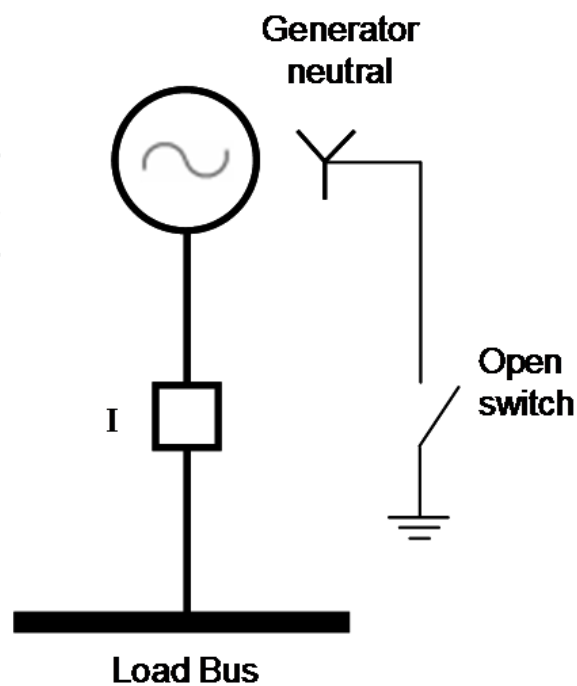
Fig. 2.3.1. Ungrounded neutral.

A floating system is used in those systems where service continuity is the main concern, see Fig. 2.3.1. The perception is that the floating systems provide greater continuity on the service. This is based on an argument that the ground fault current is smaller and therefore, the heating produced by the presence of such failure is negligible [Shipp & Angelini, 1991]. That way, the line to ground faults can remain on the system until it's convenient to remove them. This idea has some validity only if snapshots or "solids" failures are considered. However, in practice, most faults begin as ground faults by arcs of low energy. When starting a ground fault arc, we can have the following problems:

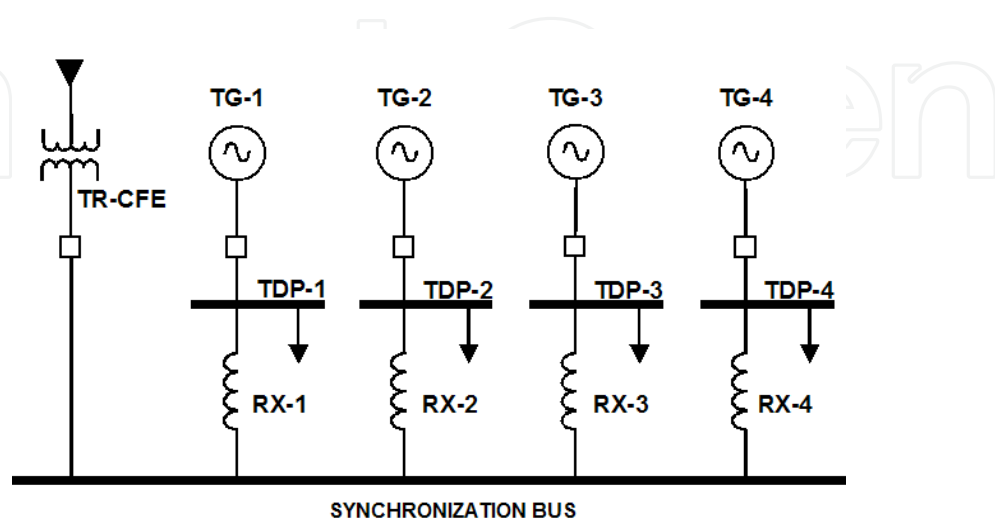
Fig. 3.1.1. Typical generation scheme of a petrochemical plant.

It is extremely necessary to maintain the electrical power supply of petrochemical power plants; therefore most of them have their own electrical energy generation. In some petrochemical plants there is a common practice to associate an electrical generator with a load connected directly to the electrical generator terminals. Most of the plants use 30 MW generators at 13.8 kV with a load on the order of 15 to 20 MW associated to their terminals. The generators are interconnected through a synchronizing bus with short circuit current limiting reactors as shown in Fig. 3.1.1. The use of these limiting reactors is associated with voltage regulation problems and with the necessity to overexcite the generators, causing problems with generator stator core. However, the use of this scheme maintains the continuity of energy supply to the load sustained through the public network when generators are out of service.

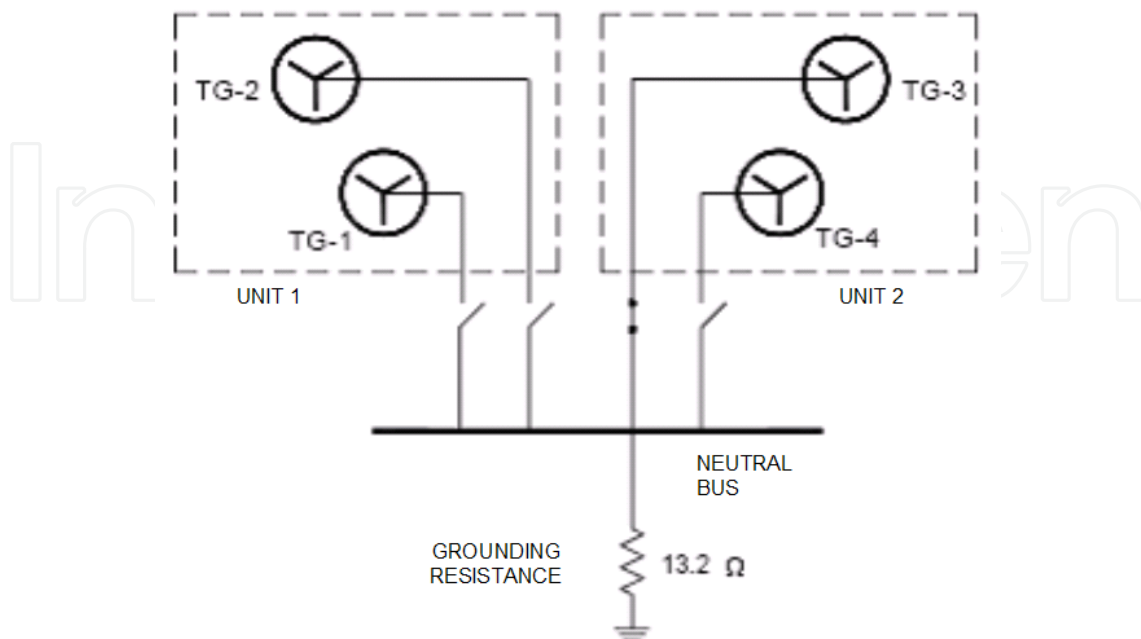
Fig. 3.2.1. Actual generator neutral grounding scheme.

The neutral grounding method used in a petrochemical plant is shown in Fig. 3.2.1. The system has two power units, the first unit consists in two generators of 32 MVA (TG-1 and TG-2) and the second one with 2 generators of 40 MVA (TG-3 and TG-4). The four neutral points are connected to a neutral bus through an interrupter. The neutral bus has a low resistance bank connected to ground. Therefore, only one generator is connected to ground.

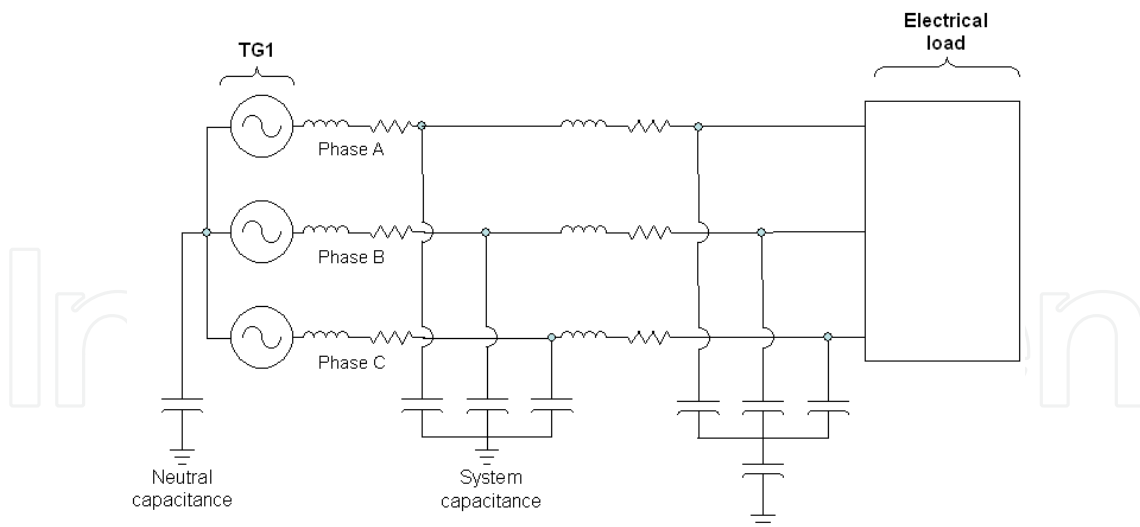
Fig. 3.3.1. Diagram of one generator neutral grounding.

Considering an ungrounded generator, that feeds an electrical load, as shown in Fig. 3.3.1. The generator model is represented by a source and an inductance in series. The cable and the load inductance are illustrated too. Also it represents the cables capacitance, the capacitors banks and the surge arresters.

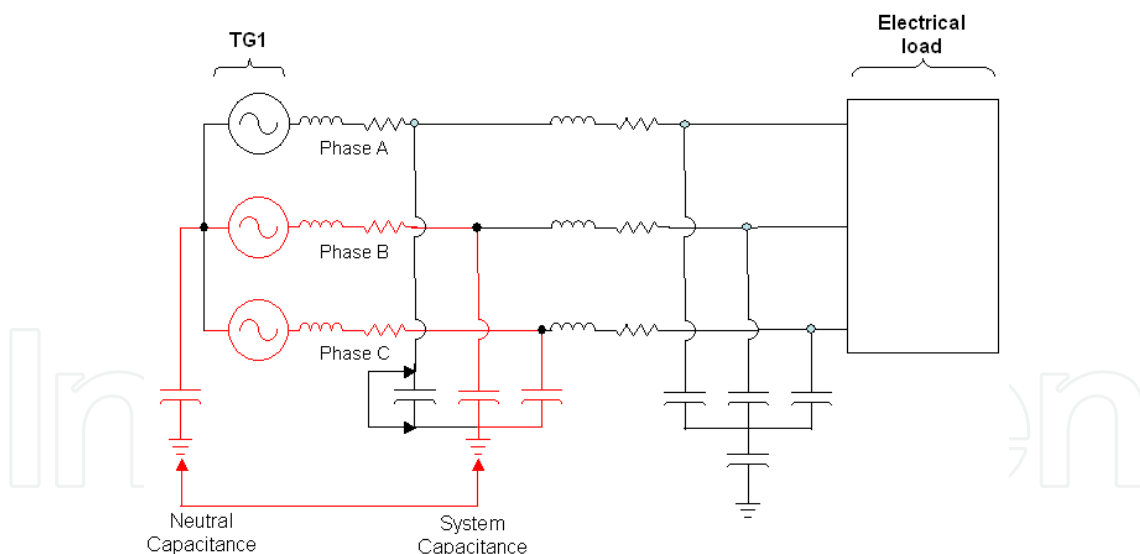
Fig. 3.3.2. Fault in phase A and current return path.

The system has a steady performance. The load is feeding by the generator; the neutral current is almost zero. The generator is grounded by its own capacitance. There is not current through the neutral generator and there is a third harmonic voltage of 1 kV peak to peak approximated. When a ground fault occurs in the system, a return current through the generator capacitance and a voltage appears through the neutral, which affects the voltage applied in the un-faulted phases, as shown in Fig. 3.3.2.

During the ground fault short circuit, the un-faulted phases have a distorted waveform. With this distorted wave, the generator supplies the demanded electrical energy in conjunction with the electrical public network. At this moment, the question is if all network with capacitance and inductance distributed values of all component, are in resonance or it is represented in somewhere of the circuit where it has appropriate tuned values. Founded evidences in some faults, demonstrate that resonance is located specifically and the damage takes place in the nearby equipments to the overvoltage site. The ground fault occurs in a different phase from that had failed previously. In practice, the second fault could occur at a different site where it occurred at the first time, the crucial condition is that the inductance and capacitance are synchronized and forming a series resonant circuit as shown in Fig. 3.3.2.

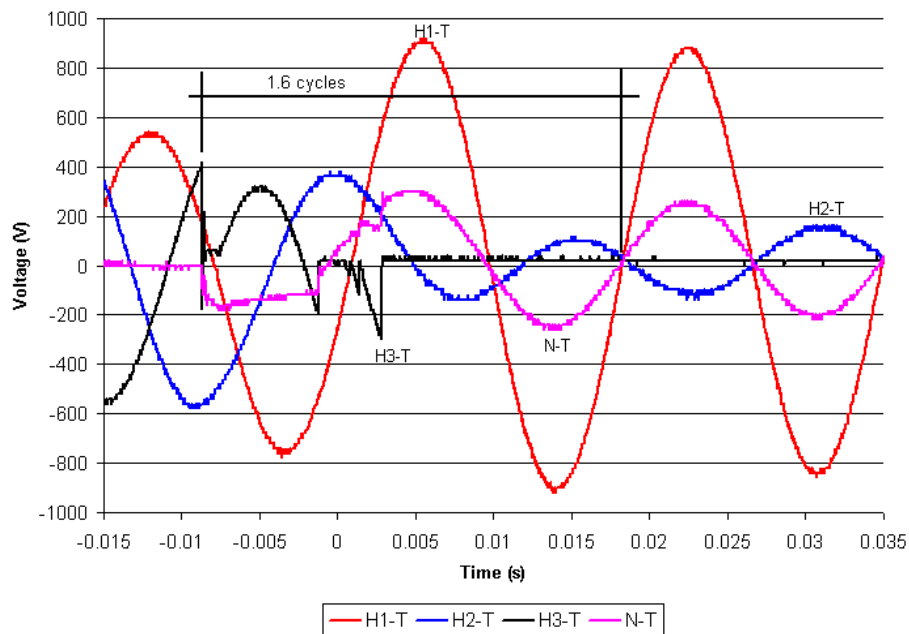
Fig. 3.3.3. Voltage increase in the no fault phase A into an ungrounded circuit.

When a current is injected through the neutral capacitance, the neutral potential increases, in such a way that ground potential of the phases change to voltage between phases due to neutral shift. Although it is negative, this situation is considered in the electrical systems designs. For example, power cables are designed with 173% of insulated level. As shown in Fig. 3.3.3, an increase in the magnitude for the next phase in sequence to the ground fault phase is observed.

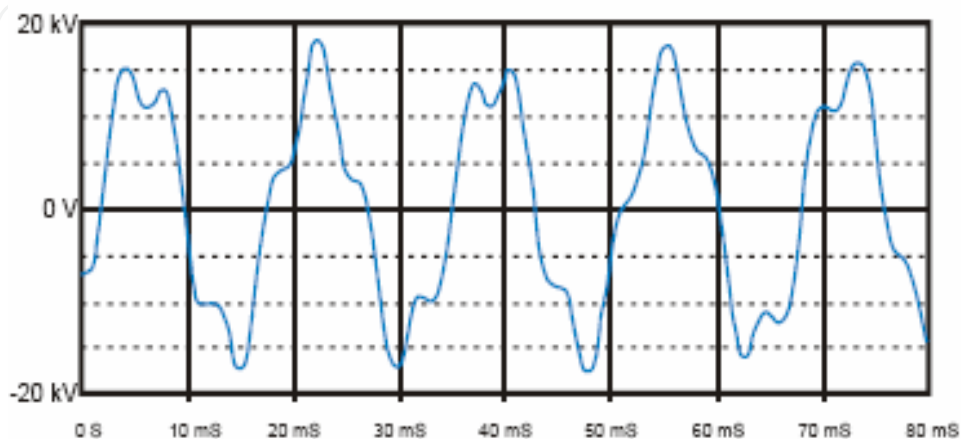
Fig. 3.3.4. Waveform of phase neutral voltage generated during a short circuit.

This voltage increase is not a problem for electrical equipments due to it is considered in design. The problem turns pessimistic due to short circuit current of ground fault phase to neutral, affecting the waveform of un-faulted phases, which stay with a no sinusoidal waveform. As a result of the interaction between fault phase and the others phases, it is obtained a waveform, as shown in Fig. 3.3.4.

During a short circuit the phase-neutral voltage is affected, and it is attributable to harmonics components, whose frequency depends on the generator inductance and capacitance equivalent values, furthermore, the equipments and accessories that are connected with the generator to a distribution switchboard. If a Fourier transform is applied to the voltage waveform illustrated in Fig. 3.3.4, it is possible to find the frequency of harmonic components. Fig. 3.3.5 exposes the Fourier analysis of generator phase-neutral voltage.

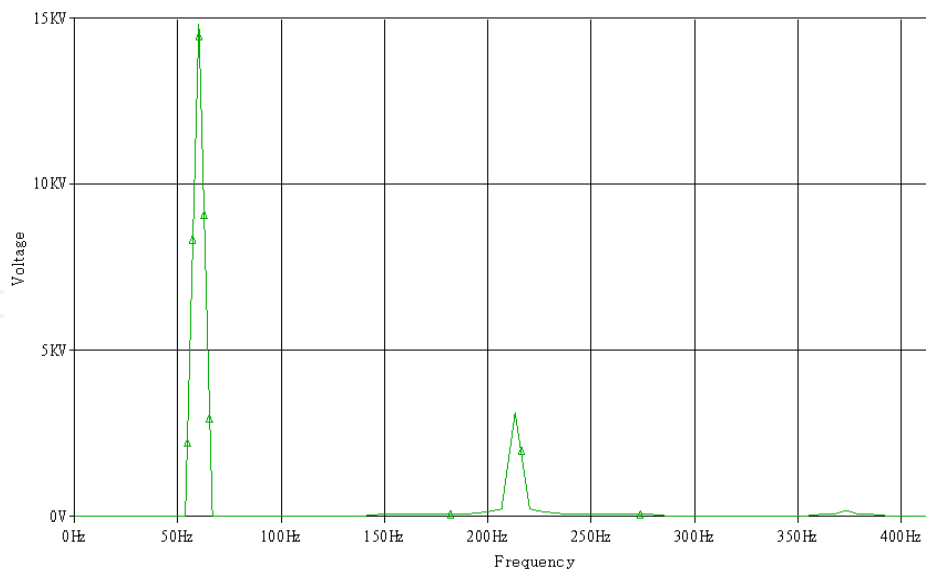
Fig. 3.3.5. Frequency spectrum of the voltage waveform illustrated in Fig 3.3.4.

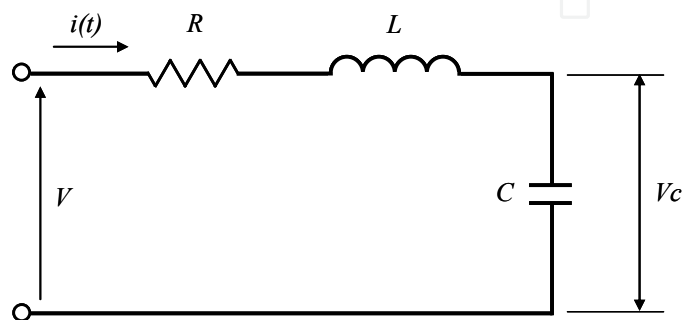
Fig. 3.4.1. Series RLC circuit.

In a series RLC circuit as shown in Fig. 3.4.1, the current $i(t)$ is given by equation (1).

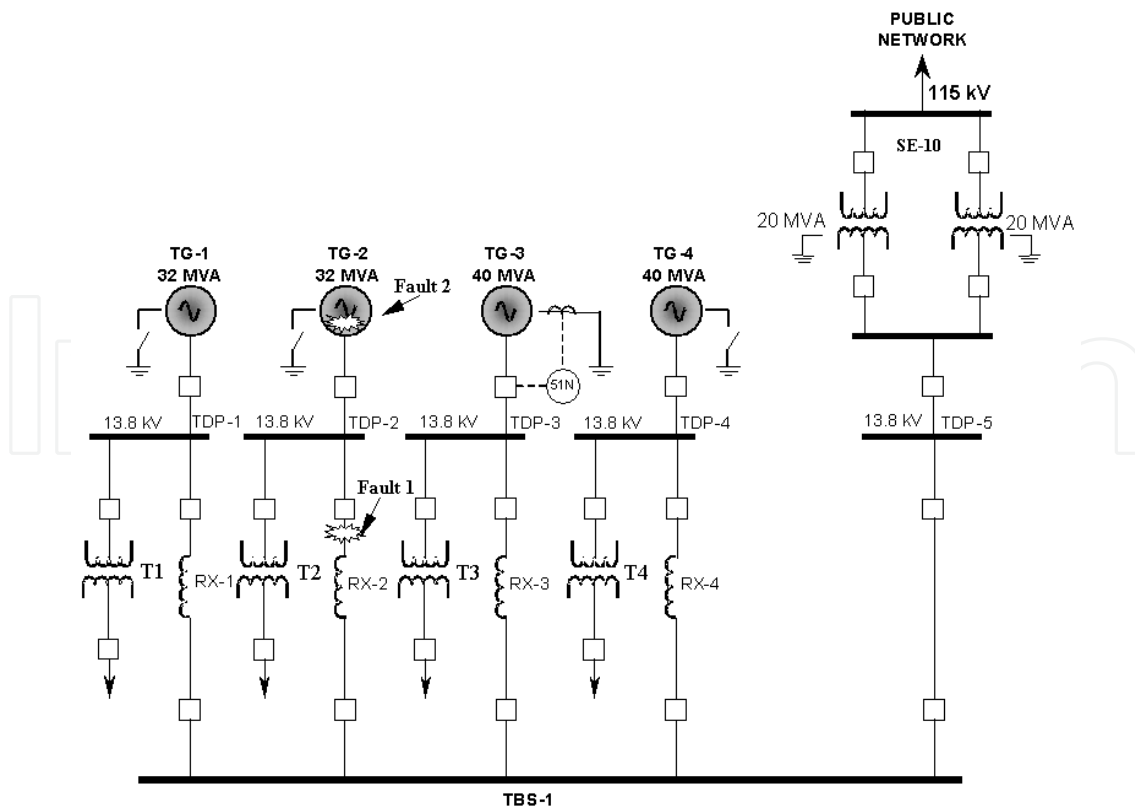
Fig. 3.5.1.1. Localization of faulted cable in the power electrical system.

The fault began with ground fault in the TDP-2 - RX-2 feeder (cable), see Fig. 3.5.1.1, when the ground fault occurred in this feeder, the negative sequence current circulated through the TG-3 neutral and TR-CFE transformer, condition that triggered the generator ground protection. After the trip from TG-3 also triggered transformer protection, therefore the power electrical system was temporarily ungrounded. Subsequently, TG-2 differential protection was operated. This protection operated because there was a ground fault in a coil of R phase into the TG-2 generator. Based on the system conditions at the time of TG-2 fault occurred, and the position of poles damaged, it is considered that this fault was caused, by the series resonance phenomena as a result of ungrounded system.

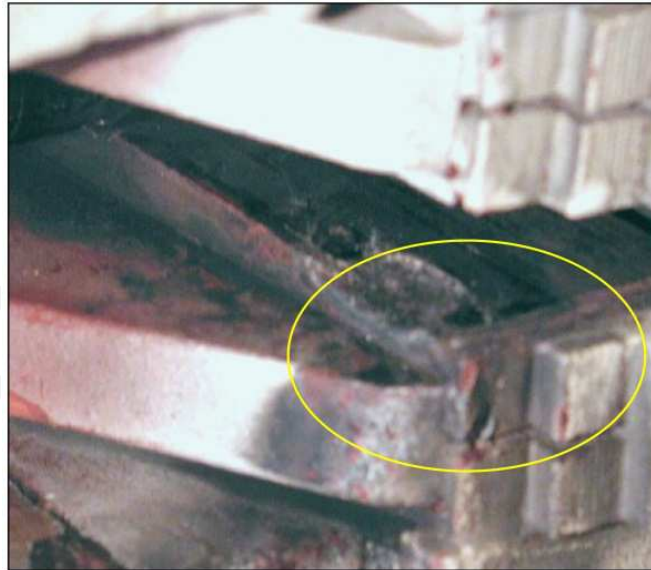
Fig. 3.5.1.2. Damages evidences in the stator core laminations of TG-2.

The generator core damage by electro-erosion, produce by arc flash, is shown in Fig. 3.5.1.2. The arc flash must begin by a magnitude voltage that broke the dielectric distance. For that distance, it is estimated an overvoltage that exceeding 100 kV.

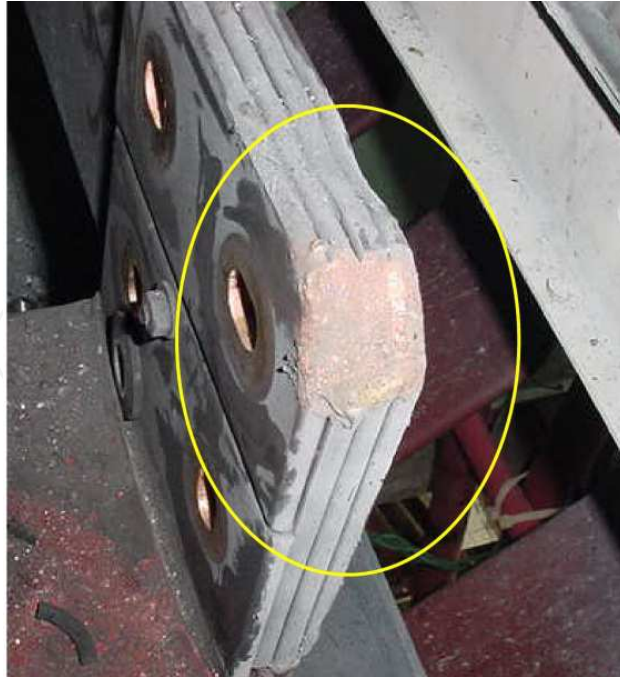
Fig. 3.5.2.1. Electroerosion damages by repetitive or intermittent ground fault arc flash.

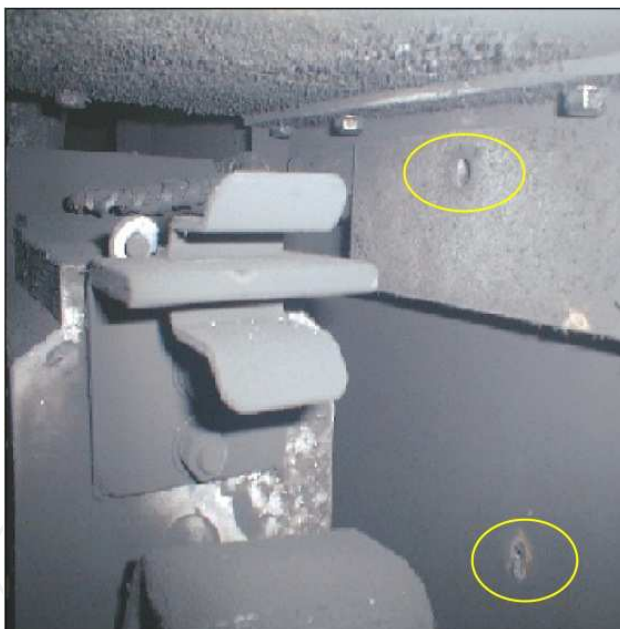
Fig. 3.5.2.2. Arc flash evidences between CT's and metallic walls.

Another switchboard fault was presented in this plant. The evidence showed that there was an arc flash between CT’s connection bars to the switchboard wall. A few minutes before the fault occurred in the 115 kV transmission line in the public network which was feeding the load plant, then it was produced an overvoltage in the 13.8 kV network of the plant. Due to the principal transformer is connected through a reactor to the synchronizing bus; the transient was spread to the feeder circuits connected to the bus. Due to the disturber in the 115 kV line service, the interrupter was operated. Immediately after, the load segregation system was operated.

The voltage regulator of the TG-4 generator tried to absorb the load, however, the generator left of operation by overexcitation protection. The TG-1 and TG-2 generators continued operating and feeding the not segregated load. Fig. 3.5.2.2 shows the evidence of arc flash between CT’s connection bars and the switchboard wall.

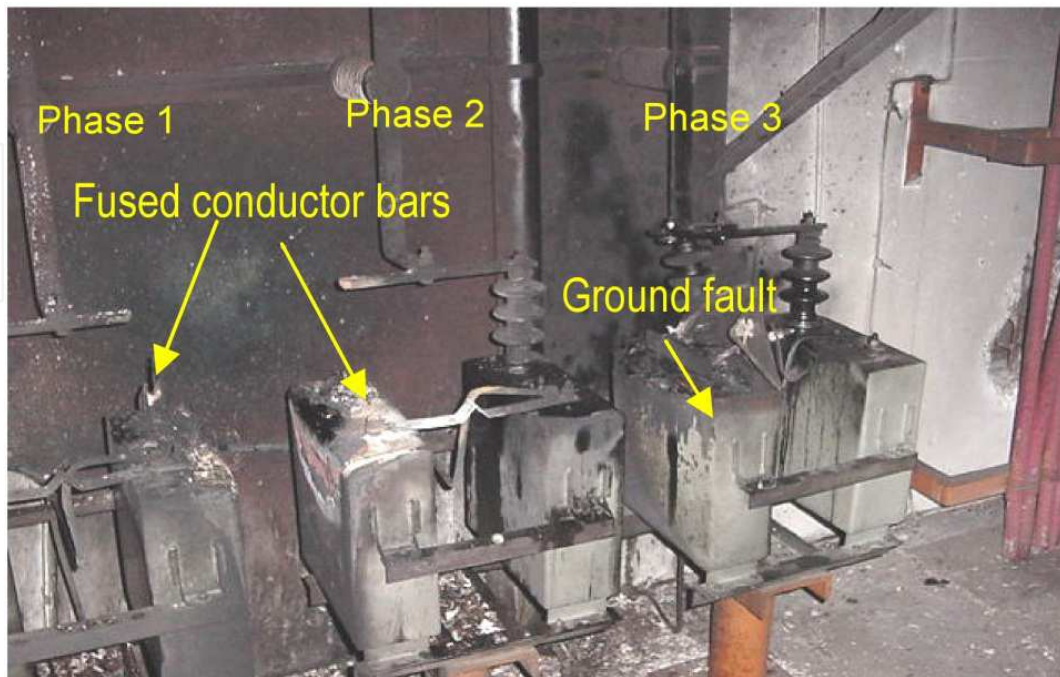
Fig. 3.5.3.1. Capacitor and capacitor bars connections damages.

In the cases above mentioned there was not an evidence of previous fault. In this case, the first fault occurred in a 13.8 kV cable feeder connected to TDP-1 switchboard about 200 meters away from where, 15 seconds after, occurred the second one. The second fault occurs in the called "cell fundamentals" where de protection and measure device's are located. The evidence shows that the generator surge protection capacitors were severely damaged, the connection bars were fused and the two potential open delta connecting

transformers, showed on their surfaces, a evidence of three-phase short circuit (see Fig. 3.5.3.1).

The fault began in a phase 2 feeder as a ground fault, it had produced an overvoltage in phase 3 with sufficient magnitude to cause the capacitor ground fault. The ground reference during the fault was in TG-3 generator; the current must be circulated through the ground resistance in TG-3. The fault performance was apparently like there was not a ground reference; the zero sequence current did not found ground return, it produced overvoltage in the not fault phases. This fact caused the generator operated like an ungrounded system.

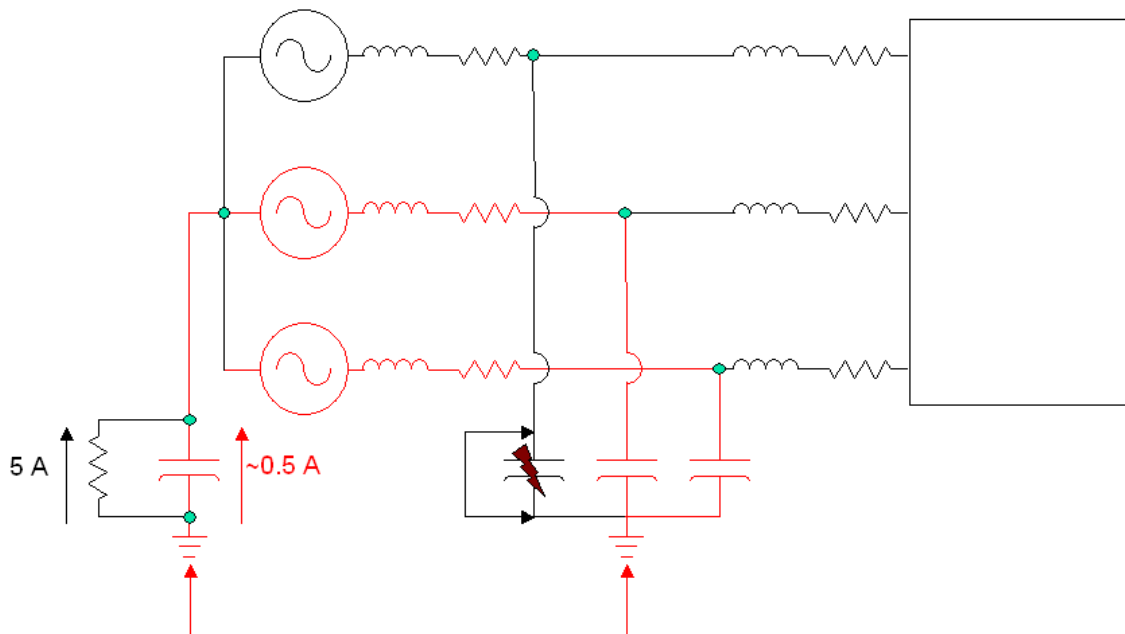
Fig. 3.6.1. High resistance grounded scheme to avoid resonance overvoltages.

It has been observed trough the years, that in some instances, when there is a ground fault in the 13.8 kV system, the generator that has a reference to ground sees the failure and the protection system takes it out of service. In this conditions, the electrical power system remains without a ground reference without being able to release the failure. The short circuit currents is limited by the capacitance of the generator, that is in the order of 0.5 A. The injected failure current trough the neutral produces a non sinusoidal voltage in the generator output. This voltage excites the failed system and a series resonant circuit can be excited. In this conditions a very dangerous overvoltages are generated. It practice, it has been observed arc flashover between electrodes that are 15 cm apart; and then the overvoltages are estimated in the order of 10 to 12 p.u. So, in order to avoid resonance overvoltages is necessary to have grounded systems to keep and intentional reference to ground. Fig. 3.6.1 shows a high resistance grounded system. When a ground fault occurs the short circuit magnitude is given by the high resistance value, in this diagram is 5 A. Simulations showed there are not maximums overvoltages more than 1.73 p.u. Finally, Fig. 3.6.2 shows a high resistance transformer installed in a petrochemical plant.

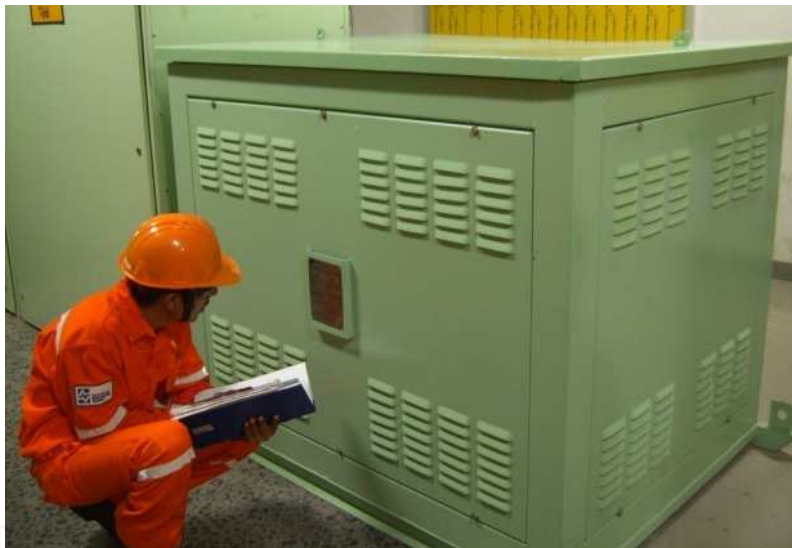
Fig. 3.6.2. High resistance transformer installed in a petrochemical plant.

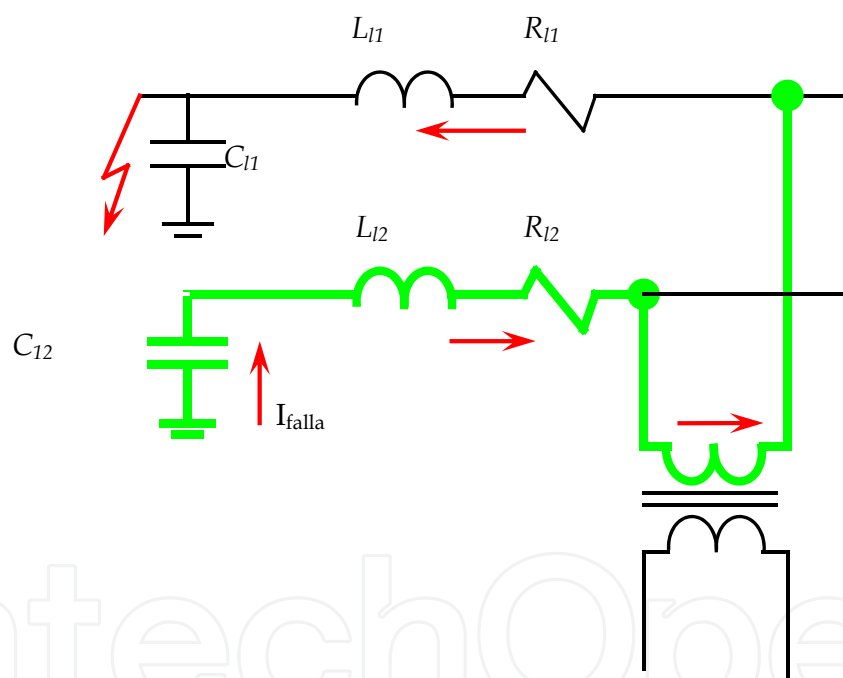
Fig. 4.2.1. Diagram of a PT in open delta connection.

The Fig. 4.2.1 shows that when a ground fault occurs, at the end of one of the feeders there is an RLC circuit formed by the resistor (R_{11} and R_{12}), inductance (L_{11} and L_{12}) and capacitance (C_{12}) of the feeders. Under fault conditions the current flows through these elements, this stream may contain a component of a frequency (1 to 10 kHz) that could generate a series resonant circuit.

The typical primary winding inductance of a PT is into the order of 28.5 H at 60 Hz, if the power cable would have a length of 1 m, this would present a capacitance of 1 nF. Therefore, in order to present the series resonance phenomenon requires a 990.8 Hz frequency. On the other hand, in the industrial petrochemical plants surges were detected in 5 to 7 kHz. These surges may be caused by maneuvers or system failure, see Fig. 4.2.2. Therefore, it is concluded that the open delta connection of PT's makes possible the resonance effect.

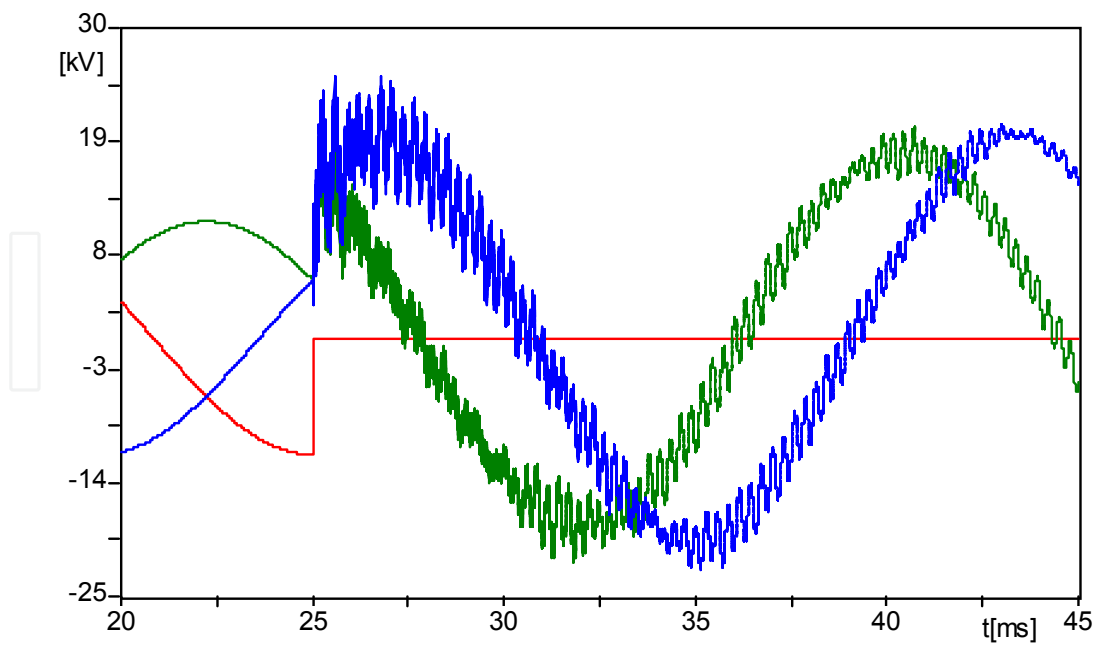
Fig. 4.2.2. Overvoltages registered in an industrial system due to maneuvers in the system itself.

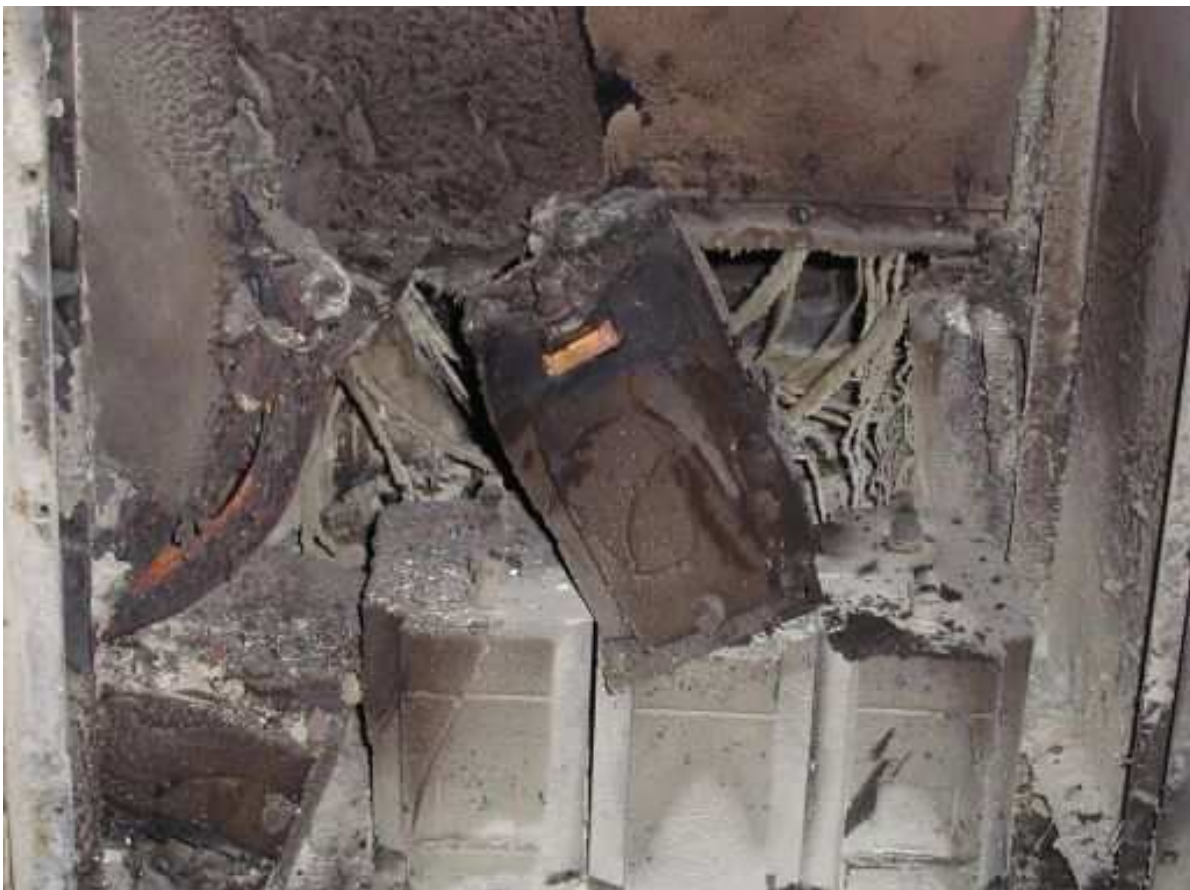
Fig. 4.3.1. Damage to the PT and panel where PT was connected.

Consider the following case, there was a failure of one of the PT's installed on the 13.8 kV level. The PT was located into a medium voltage switchgear connected to the output of a generator in an industrial petrochemical plant in Mexico. PT failure completely destroyed the switchgear that contained the PT, causing in turn the shot of the generators connected to the system and total loss of electrical power plant. As a result, the industrial petrochemical plant was out of operation for several hours, causing significant economic losses. Fig. 4.3.1 shows the damage to the PT, and Fig. 4.3.2, the damage on the switchgear.

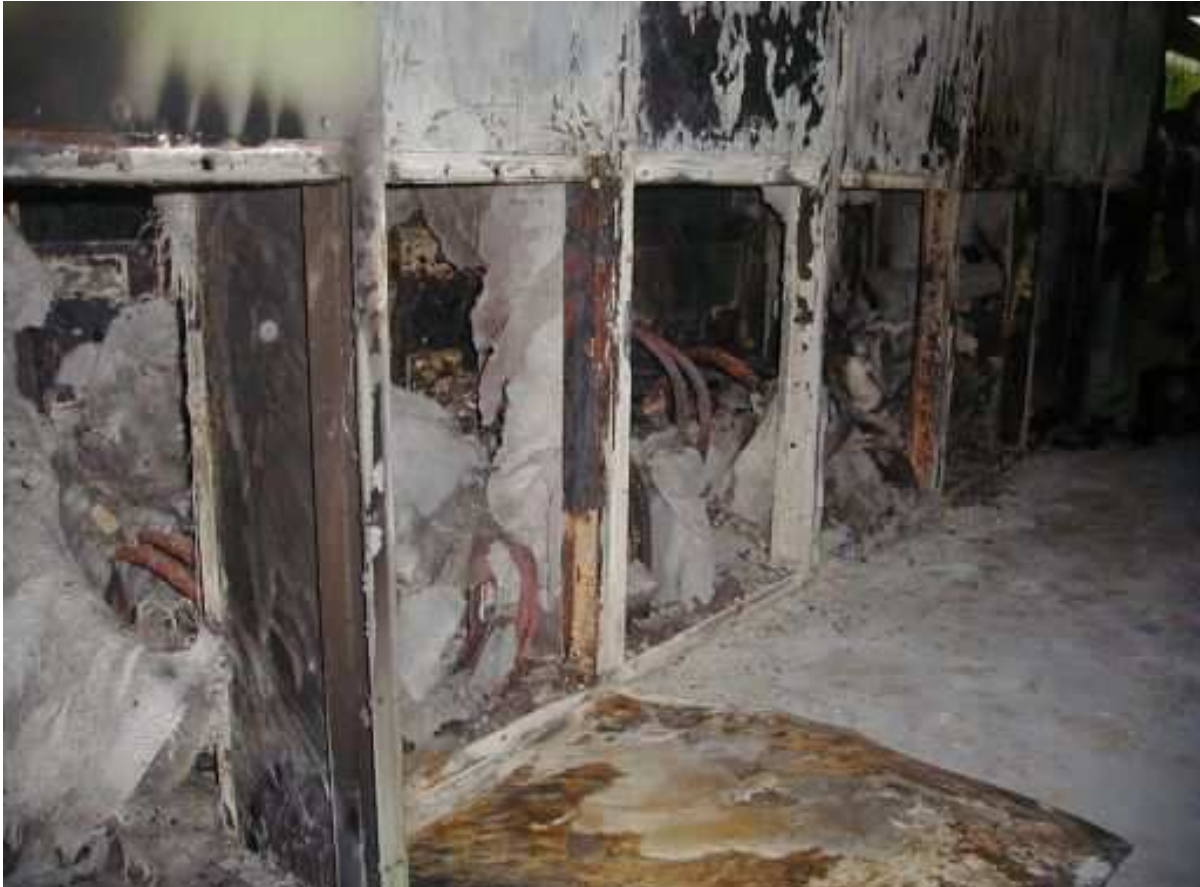
Fig. 4.3.2. Damage to the switchgear where the TP was connected.

The switchgear where PT was connected was of kind of metal-enclosed and was composed of 11 panels of 13.8 kV with a current capacity of 2,000 A. Nine of the panels were vacuum switches with their auxiliary equipment. One of the panels was used exclusively for measurement. The remaining panels, was empty because it could not be restored after the failure of one of the PT's occurred three years ago. One of the feeders of the switchgear was connected to one of the generators of the plant.

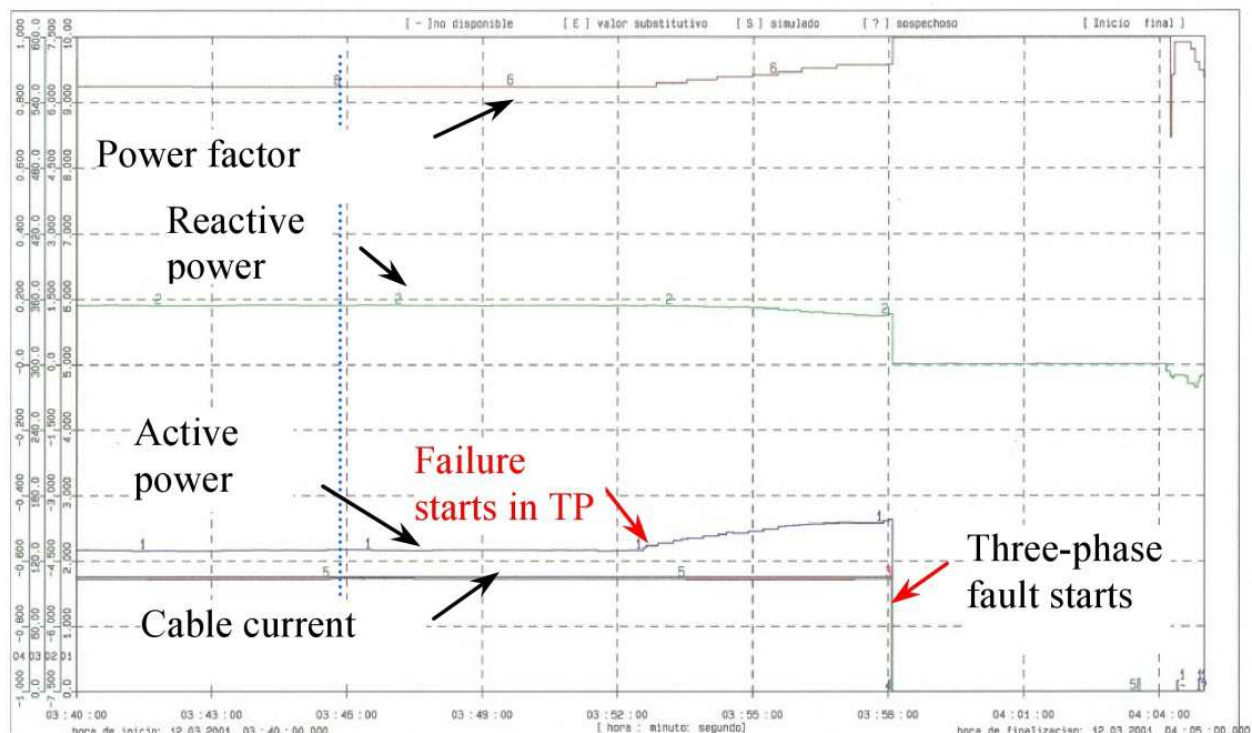
Fig. 4.3.1.1. Signals recorded of the feeder in the switchgear where the PT was installed.

The industrial petrochemical plant where the TP failure occurred has a monitoring and recording system for events and variables. Fig. 4.3.1.1 shows the data of voltage, current and power recorded 20 minutes before the failure occurred.

According to the records of power, there is an increase of active power on the order of 25% between 3:52:30 and 3:58.00. The PT had a two sections winding, each of 55 layers. Before the fault, the voltage was increased from 14.1 kV to 17.6 kV (25%). According to the transformer design, this means that one of the sections is affected at a rate of 12 seconds per layer. The initial conversion ratio was 120 and changed to 150 prior to the occurrence of the fault. That is, the transformer explosion happened after that was damaged 25% of the

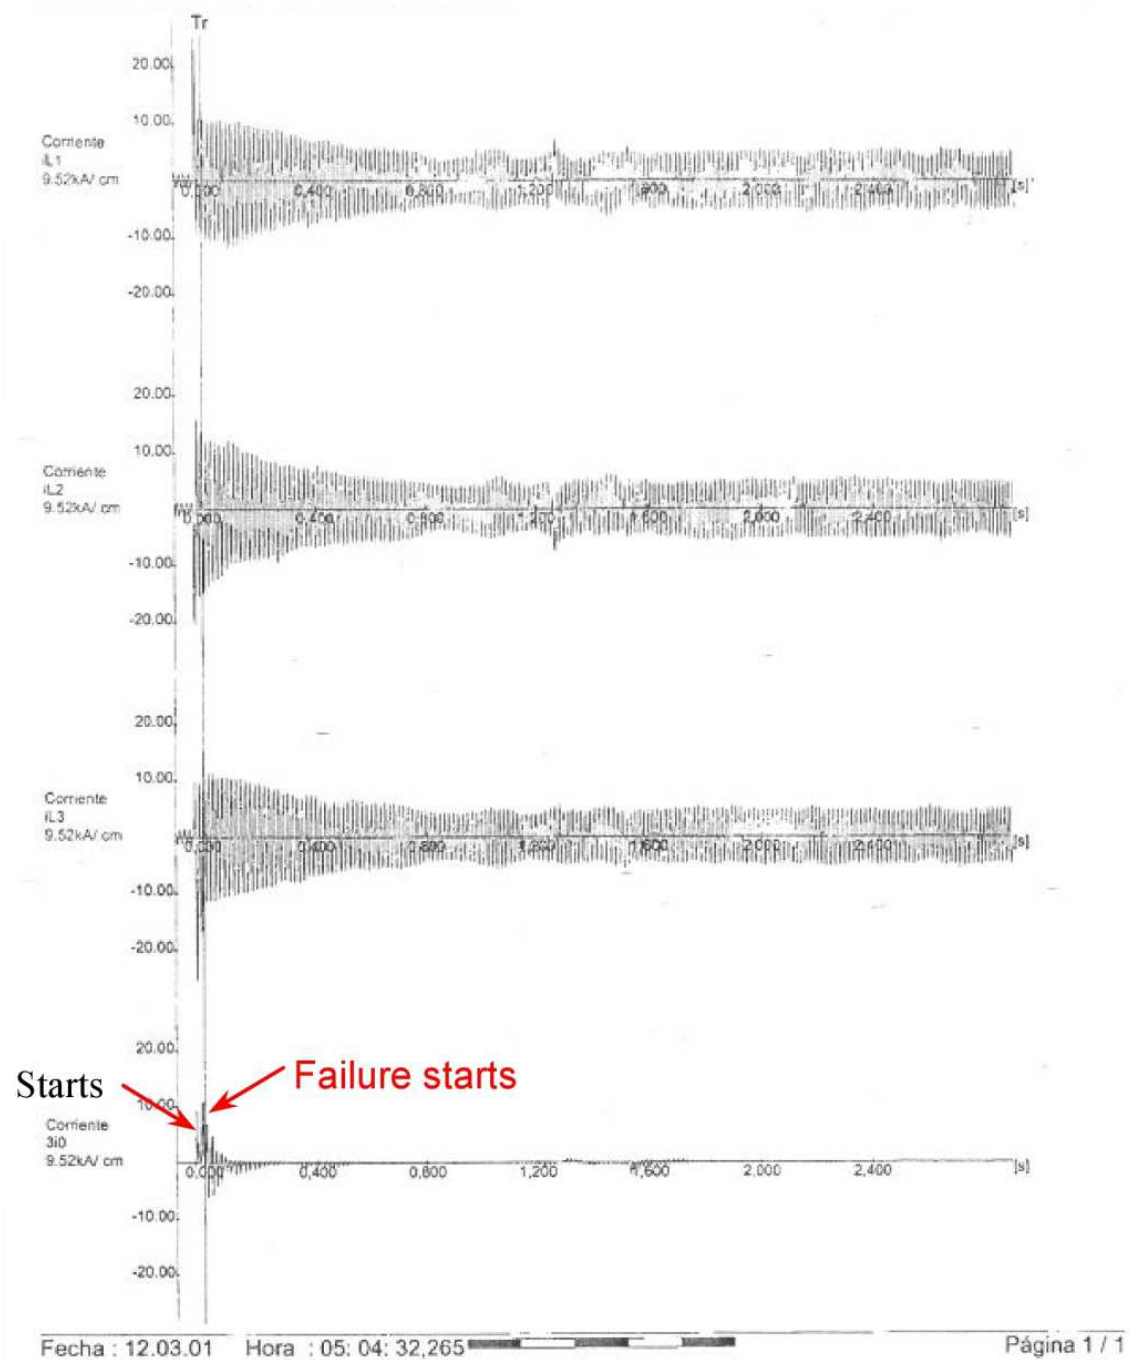
Fig. 4.3.1.2. Current signals recorded in the generator during the fault of the switchgear.

The system logs indicate that the failure of PT began 5'30" before the three-phase fault occurred on the switchgear, see Fig. 4.3.1.2.

Due to the open delta connection of PT's, it follows that the switchgear fire was started by the failure phase (between phases 2 and 3) of PT. According to the records of the fault currents, it is estimated that this event had duration of about 2 cycles (see Fig. 25). As shown in the figure, because the fault is a fault-phase, unbalanced residual current is generated through the common point of the current transformers. From the oscillograms it is concluded that the evolution of biphasic failure to three-phase fault was about 30 to 40 ms.

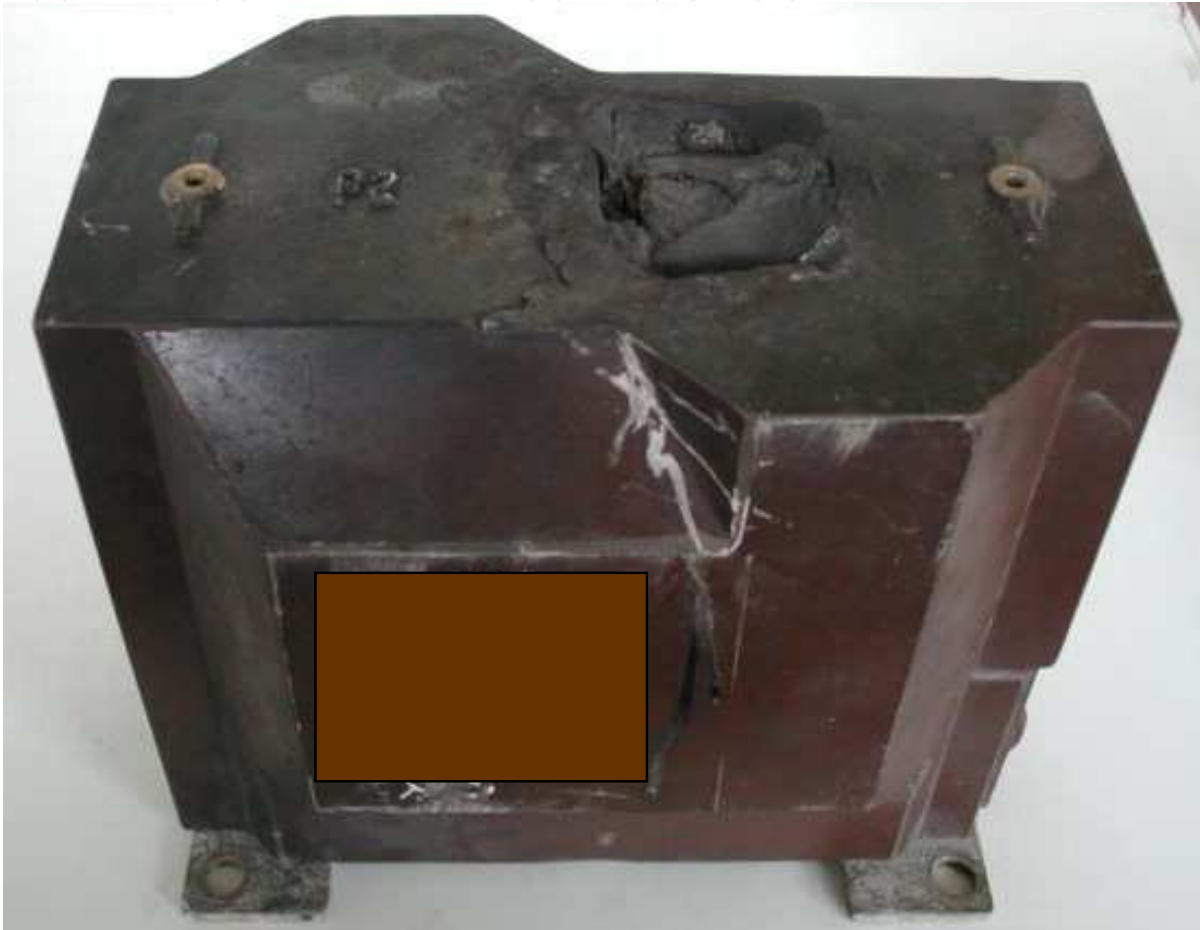
Fig. 4.3.2.1. Potential transformer that caused the failure in switchgear.

The failure of a PT can be started as a short circuit between turns or between rounds in the section of the primary winding of the transformer (see Fig. 4.3.2.1). The fault between turns can be maintained for a period of 5 to 10 minutes, until the pressure built up by the

An inspection at the failed PT indicated some manufacturing defects. Due to the arrangement used for the construction of the windings do not have adequate penetration of the resin between layers. This produces cavities between layers and therefore high levels of partial discharges.

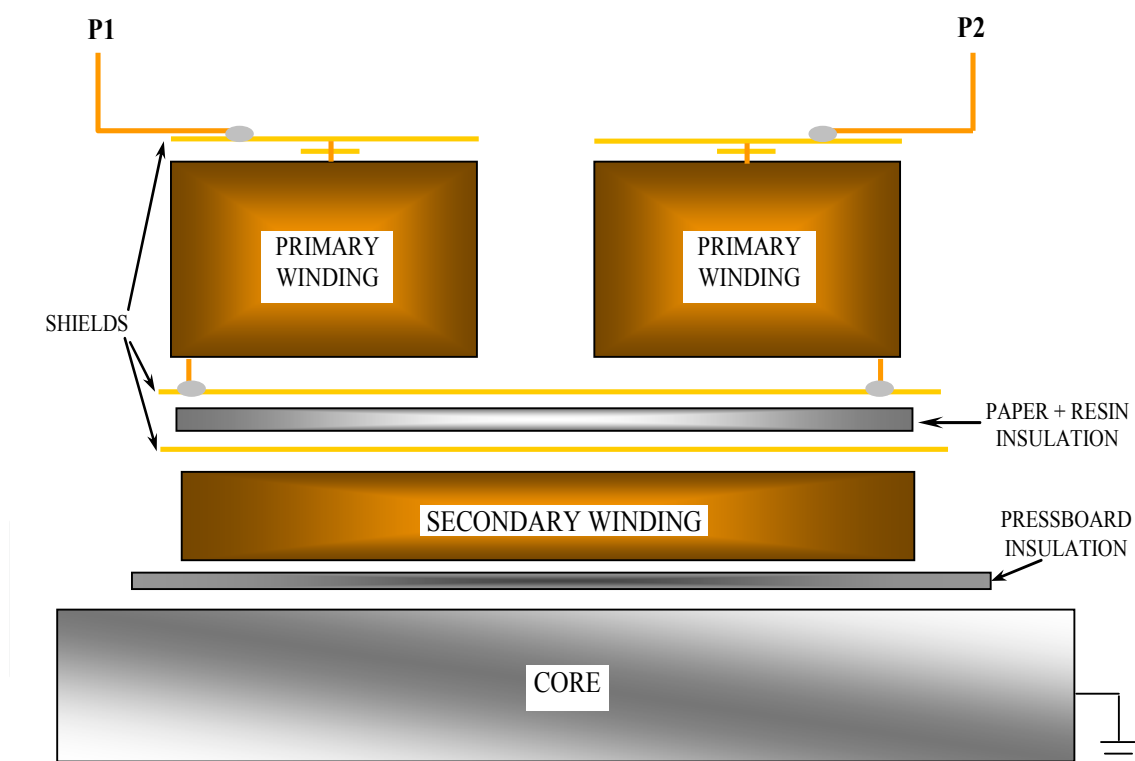
Fig. 4.3.2.2. Schematic design of PT.

The arrangement of the windings of the PT is shown in Fig. 4.3.2.2. Each different sections of the primary winding is made of 31 AWG wire, whose capacity for maximum current is 0.160 A, with a resistance of $435 \Omega / \text{km}$. Each section consists of 55 layers and 200 turns per layer so that it has an electrical gradient of about 130 V per layer. Between each layer exists one or two layers of insulating paper impregnated with varnish. It has 3 metal screens (brass) placed in different areas, which are not only used to obtain a uniform distribution of the electric field inside the PT, but also serve as a connection between the different windings.

It was detected a manufacturing defect in the high voltage windings of PT. In the section that connects the terminal P2, shows a surplus of winding and insulating material in a way peak. That is, the coil is not parallel to the core, which causes the protruding part of the coil winding.
