Resonance in Electrical Power Systems of Petrochemical Plants

Job García and Gabriel García
Instituto de Investigaciones Eléctricas
Mexico

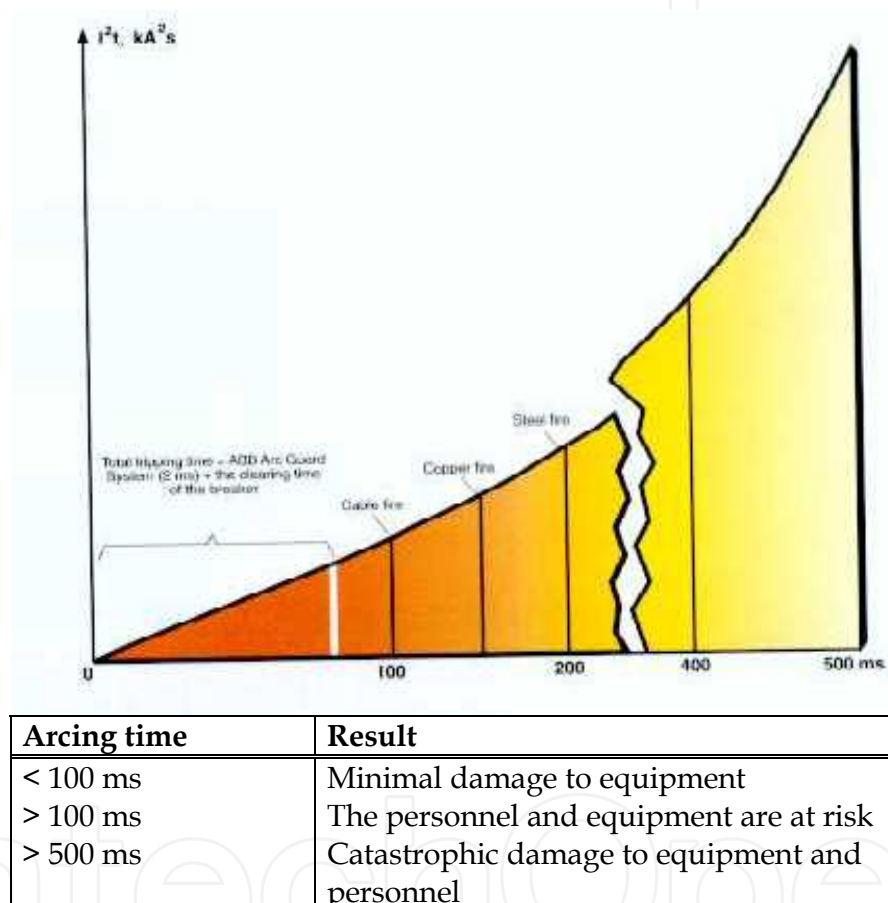
Fig. 4.3.3.1. Graph damage caused by an arc of power versus time.

Fig. 4.3.3.1 shows the relationship between arc duration and damage in different materials of the switchgear. This figure shows that from the 500 ms the damage caused by the arc can be considered catastrophic.

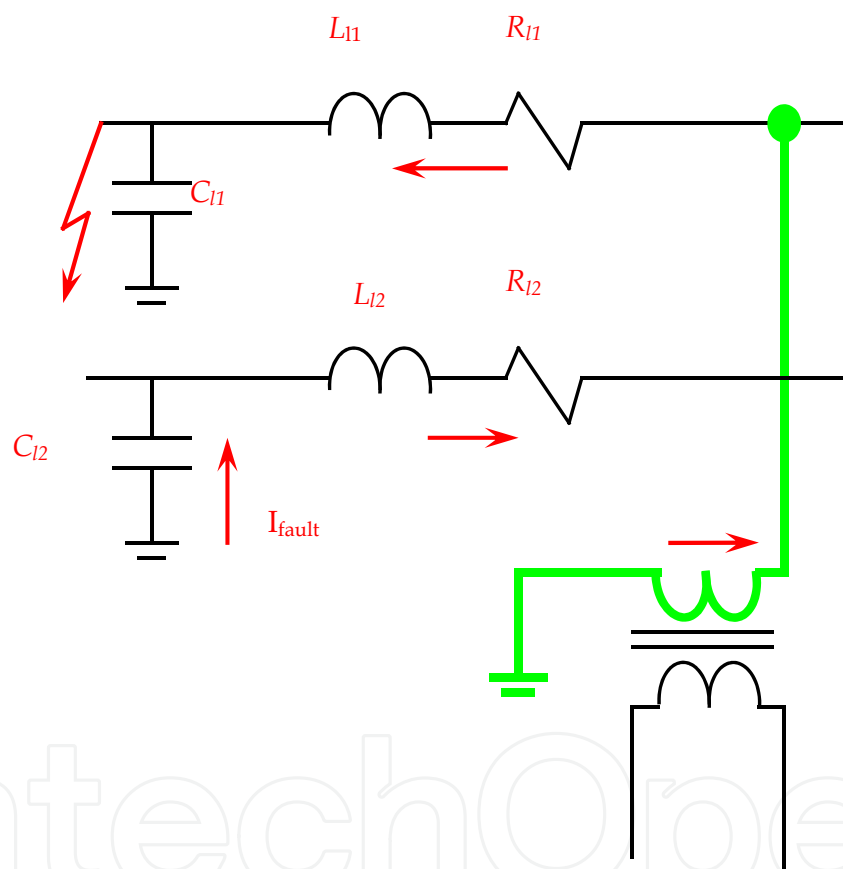
Fig. 4.4.1.1. Circuit connecting a grounded wye PT.

When a failure occurs in the grounded wye connection of PT's, the fuse will act protecting the PT. It is necessary to prevent failures that may arise between phases to prevent arcing that could ignite the switchgear. It is necessary to install non-flammable separators between the panels of the switchgears to prevent fires from spreading to other panels.

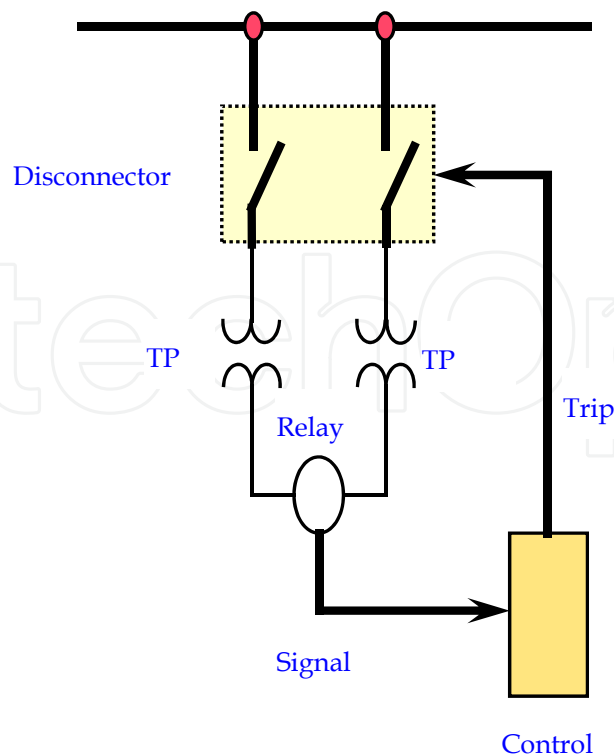
Fig. 4.4.2.1. Connection of disconnector link under load conditions in open delta PT's winding ircuit connecting a grounded wye PT.

Another way to avoid damage in switchgears due to faulty PT's is installing disconnects under load conditions in each of the phases of the open delta, see Fig. 4.4.2.1. Since the failure process is slow it can be detected through a relay to operate as a differential voltage and sent a signal to open a disconnect. This change is easy to implement in new switchgears and requires a specific analysis for each switchgear due to the fault currents that may arise in each.
