Advanced Applications in the Field of Structural Control and Health Monitoring After the 2009 L'Aquila Earthquake

Vincenzo Gattulli

1. Introduction

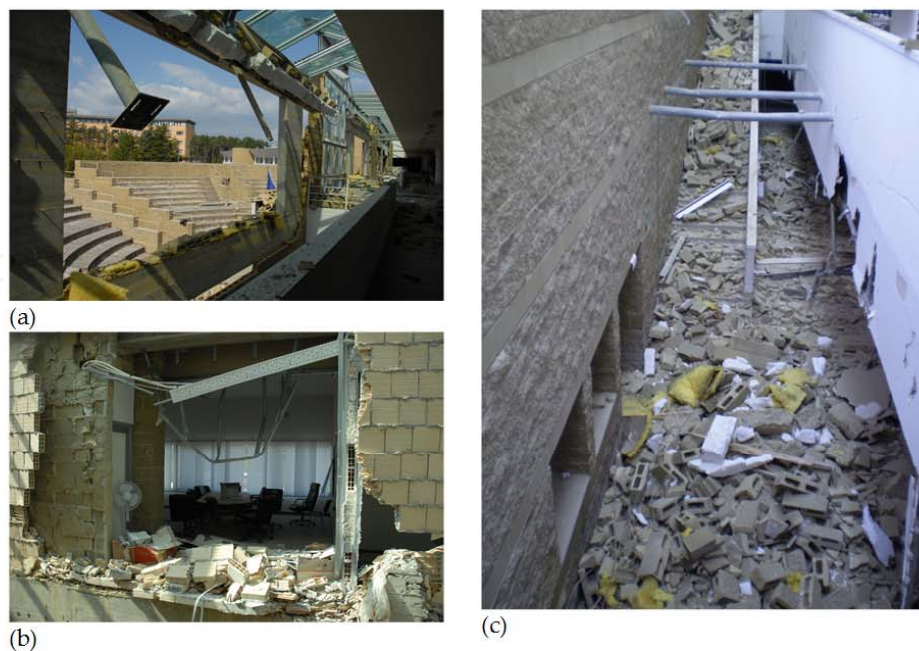
Figure 3. Damages caused by 2009 earthquake to the Edifice A: a) internal view of the main facade, b) internal partitioning walls c) heavy bricks fallen down inside the building from the facade.

The most evident damages in the Edifice A of Engineering Faculty were found to be localized in the main facade, which has lost large portions of the veneer masonry, made of heavy split-face bricks (Figure 3), laying bare the underlying reinforced concrete structure, remained practically undamaged. All the results collected during the early inspections confirmed that the structure underwent an excessive displacement and acceleration level, surely incompatible with the resistance of many non-structural elements. The massive inward cascade of heavy bricks and sharp glass, fallen down from the facade and the wall of the internal stairs, has realized an unpleasant dangerous scenario [1,4].

Horizontal steel tubes, functioning as interconnecting rods at different floor levels, ensured the coupling between the two substructures (Figure 3c). The bolted anchorages at the rod ends were probably under-dimensioned for the exceptional seismic action, since many of them

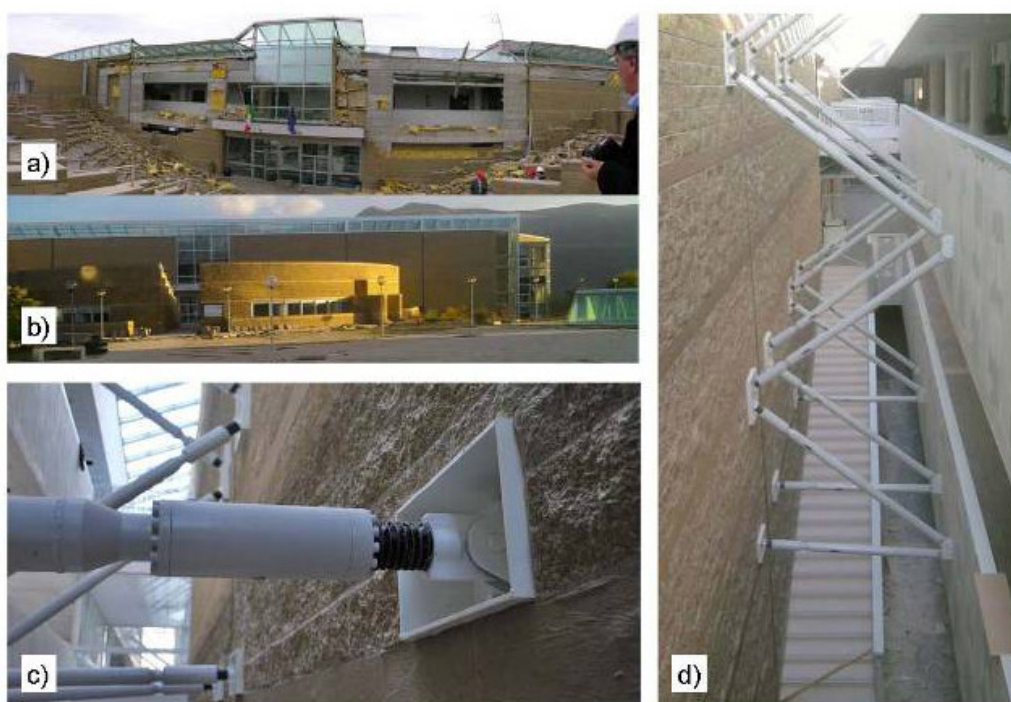
Figure 9. Reconstruction at Edifice A: a) damage scenario involving the facade, b) reconstruction of the facade, c) close view of the installed device, d) dissipative truss structures.

Figure 9 summarizes some relevant information such as: the large damage scenario appearing in the morning of April 7, 2009 immediately after the earthquake at the main facade of the Edifice A (Figure 9a); the facade completely rebuilt in a picture taken during the reconstruction (September 2011); of the same period two pictures presenting a close view of a DV1 horizontal device in the P1 zone (Figure 9c) and the four alignments of the dissipative trusses that following the perspective belongs the first one to the substructure A3 followed by two alignments in the P1 zone and completed by the last alignment which is the first one for the sub-structure A4 (Figure 9d). It can be noticed that in the last alignment due to the presence to the light stairs coming from the under floor the horizontal device is missed, this occurrence justifies the even total number of installed devices.
