Power Transformer Diagnostics Based on Acoustic Emission Method

Wojciech Sikorski and Krzysztof Walczak

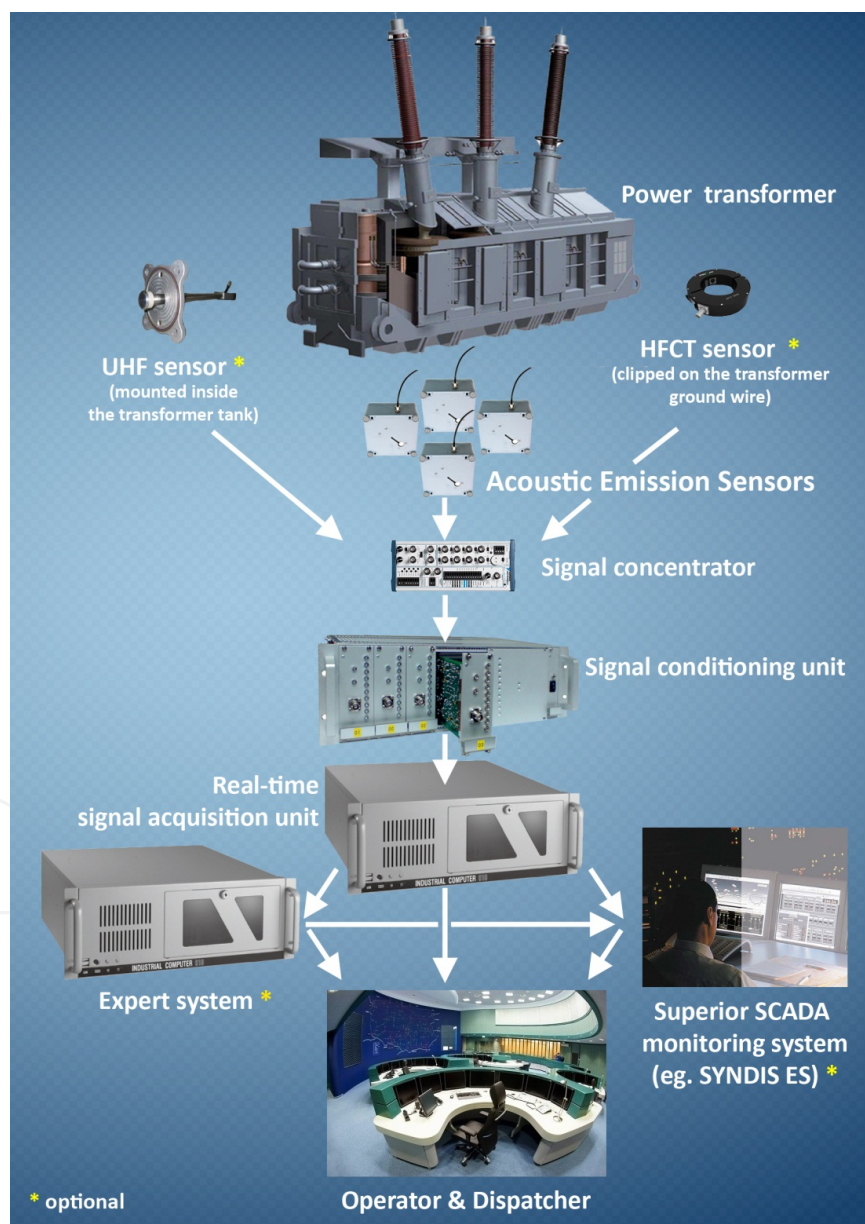
Figure 1. Schematic diagram of developed partial discharge on-line monitoring system

The schematic diagram of developed partial discharge on-line monitoring system, which was in detail described in (Sikorski & Walczak, 2010), was presented in figure 1.

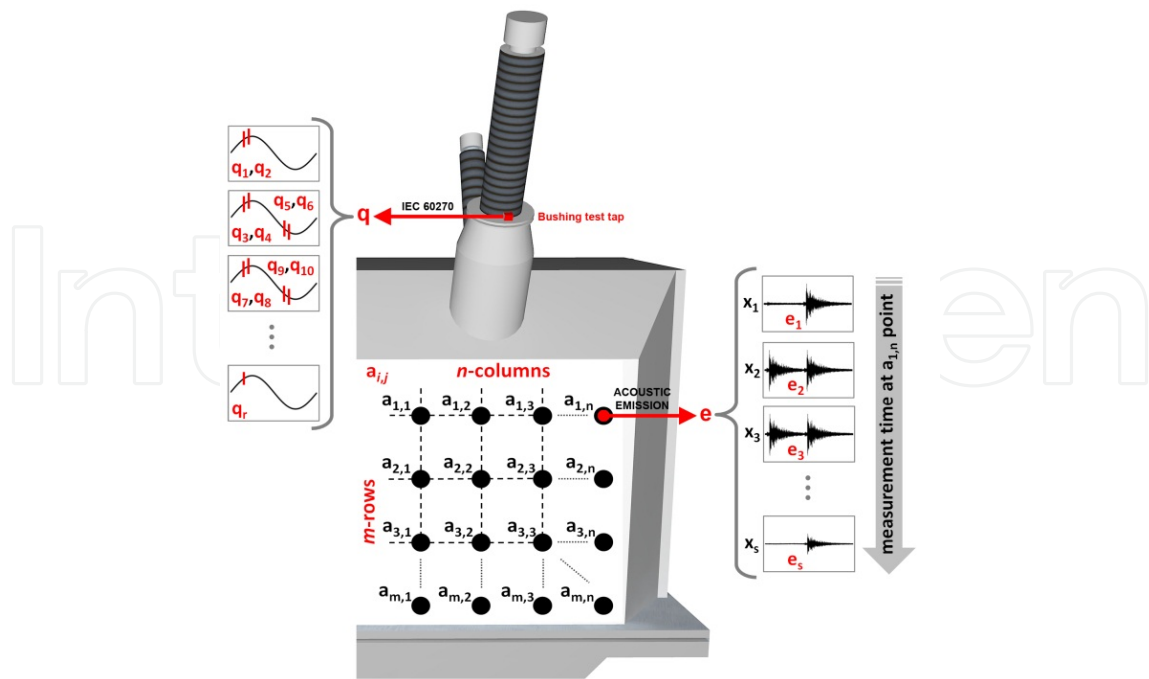
Figure 2. Schematic diagram of AAT measurement procedure

Step 2. On the transformer tank mark a grid of the measurement points, consisting of m -rows and n -columns (see Figure 2).

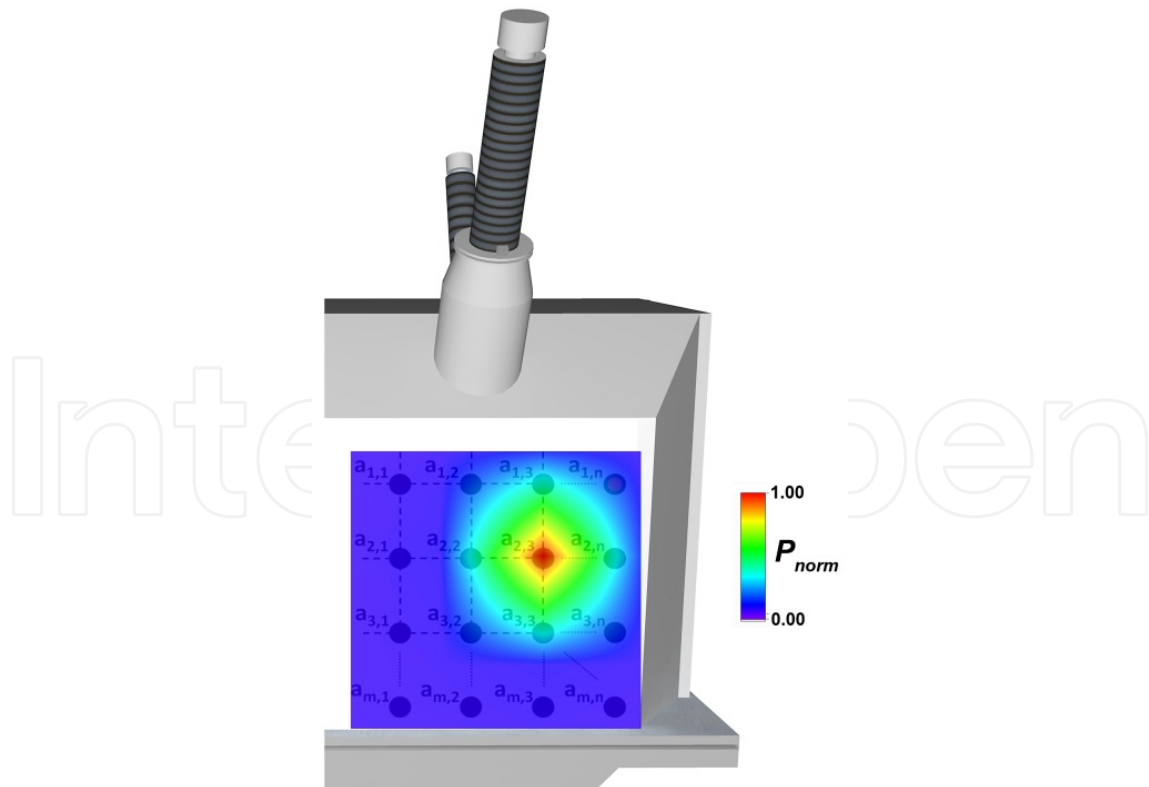
Figure 3. Two-dimensional visualization (*Acoustic Emission Map*) of PD-source location results in advanced auscultatory technique (AAT).

Because the *Acoustic Emission Map* shows the result of PD source location on the 2D plane (see Fig. 3), it is recommended, if possible, to perform the additional measurements with the TDOA triangulation technique, by placing the AE sensors on the tank wall close to the area of highest p values localized with AAT.

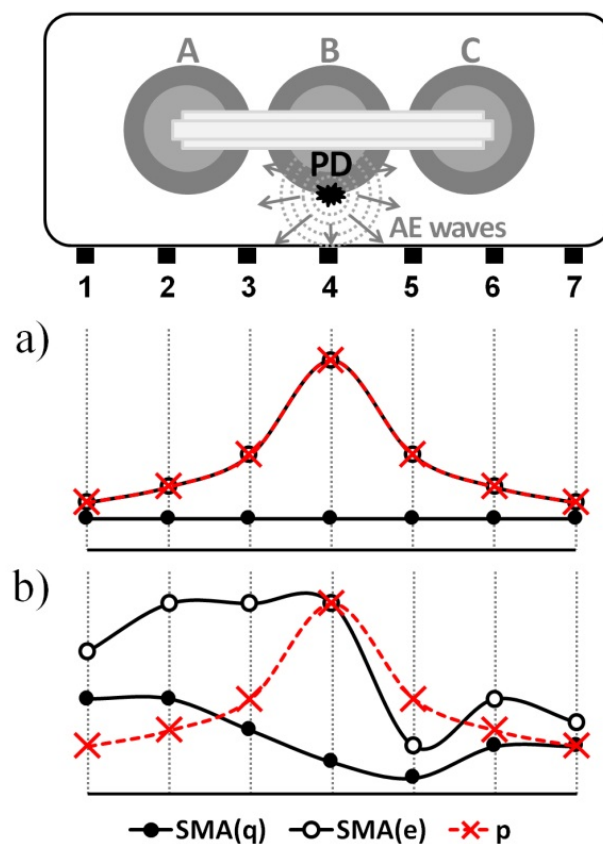
Figure 4. The diagram illustrating the result of PD location employing the parameter SMA(e) (standard auscultatory technique) and parameter p (advanced auscultatory technique) in case when the apparent charge of partial discharges is: a) stable, and b) varying in time during the measurement.

The most important modification, comparing to the SAT method, is application of the parameter p which, to a very significant degree, minimizes the negative influence of the temporal changes of PD energy on the defect location results. This positive feature is illustrated by a simulation shown in figure 4. For simplification, it was assumed that the defect is present in the 'B' phase of the transformer, and the AE pulses were registered only in 7 measuring points. In the first case, it was assumed that the partial discharges are stable and their energy does not change in time for the duration of the measurements. Of course, with such an idealistic and almost unrealistic assumption, both techniques achieve identical and correct result of the defect location (Fig. 4a). As for the second analysed case, when energy of PD varies (fluctuate) during the acoustic emission signals' measurements, only the AAT technique allows to obtain the proper location of the defect (Fig. 4b).

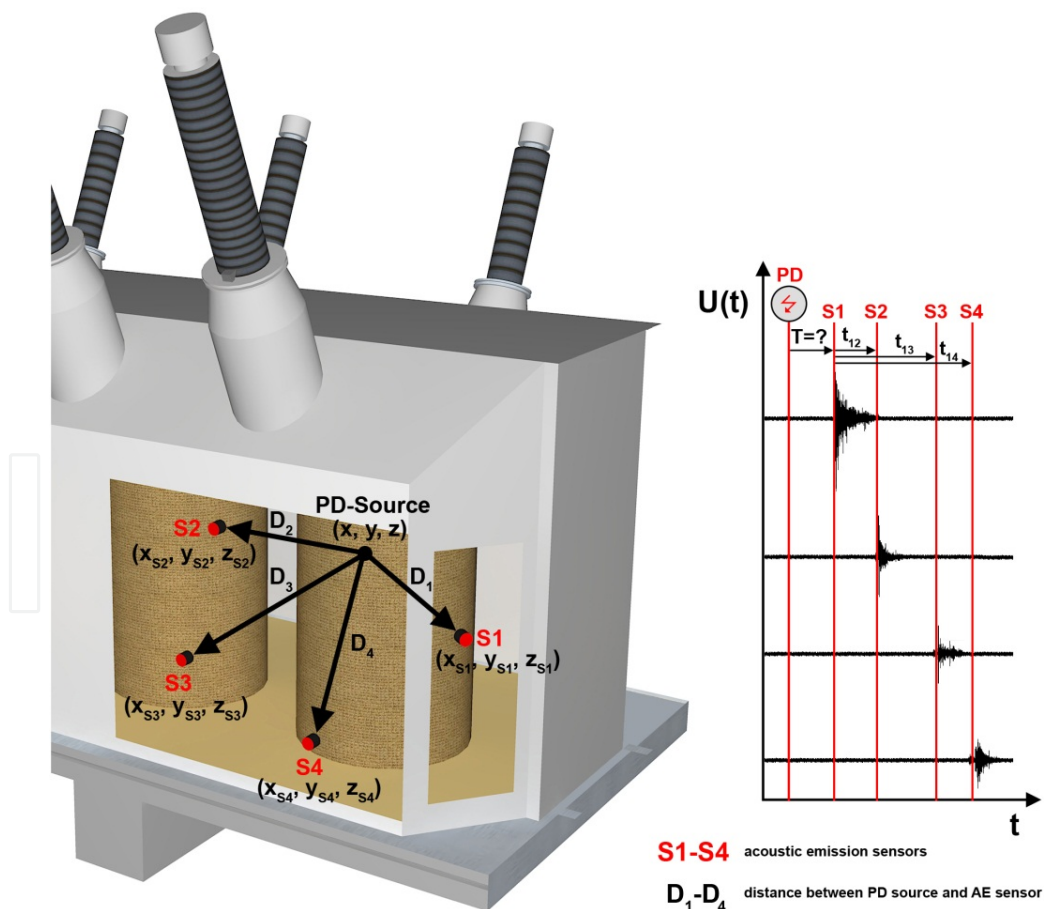
Figure 5. Schematic diagram of Time Difference of Arrival (TDOA) technique for partial discharge location in power transformer

The PD source location based on TDOA technique is usually applied during on-site diagnostic tests of large power transformers. At least four AE sensors are used for spatial location of a defect $PD(x, y, z)$ in transformer tank. The sensors theoretically are fixed in different distances from the PD source (Fig. 5). The position of the defect is estimated basing on measured time difference of arrival of acoustic signals. In order to find the coordinates of defect one should solve the following nonlinear system of equations:

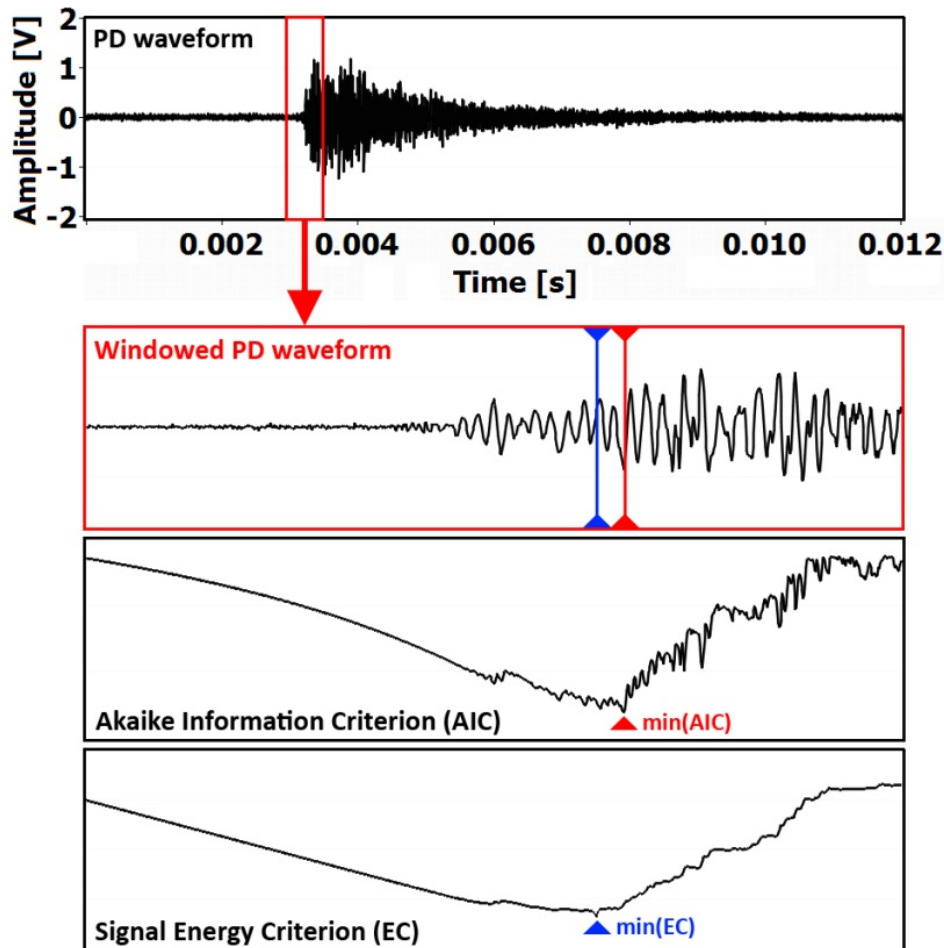
Figure 6. Exemplary estimation of the time-of-arrival of partial discharge pulse based on AIC and energy criterion

The figure 6 presents the example of the time-of-arrival estimation of partial discharge pulse based on AIC and energy criterion.

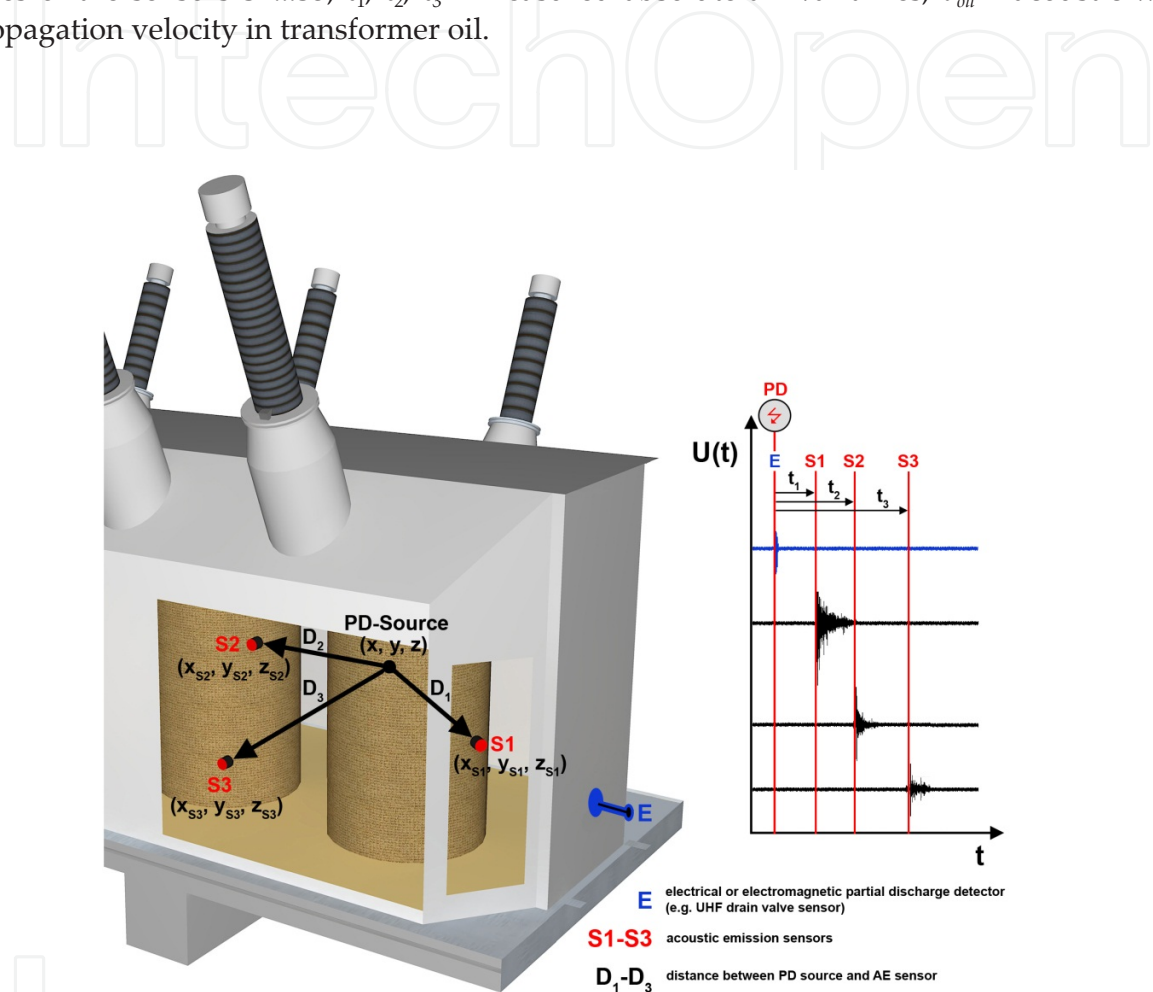
Figure 7. Schematic diagram of Time Difference of Arrival (TDOA) technique with electrical/electromagnetic triggering for partial discharge location in power transformer

The application of triggering with an electrical (IEC-60270 detector, only in laboratory conditions) or an electromagnetic (RFCT or UHF sensors, both in laboratory and on-site conditions) partial discharge signal is another variant of defects location technique (Fig. 7). The main advantages of simultaneous use of electrical/electromagnetic triggering and acoustic emission method are: (i) obtaining information on time of partial discharge initiation and (ii) reduction in the number of AE sensors required for measurement procedure (three are sufficient). In order to locate PD-source the following system of equations should be solved:

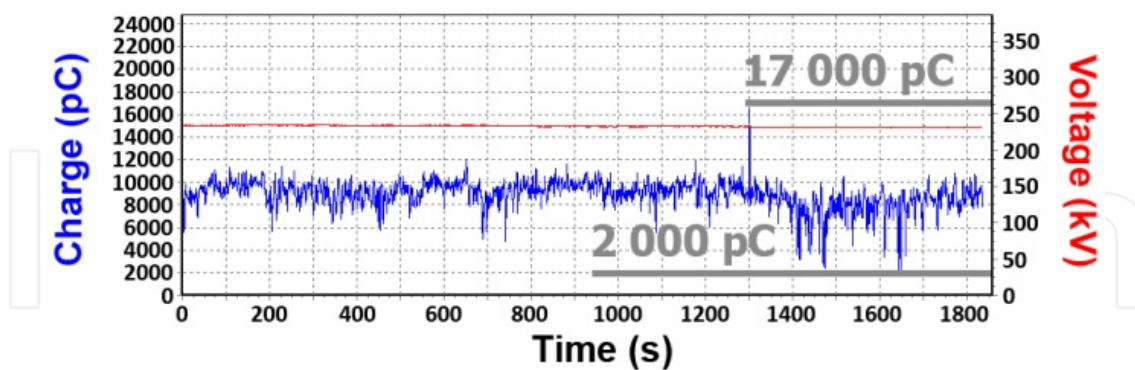
Figure 8. The results of PD apparent charge measurement in phase *HV 2* of investigated transformer.

The result of the PD measurements carried out with conventional electrical method revealed the presence of strong discharges in phase *HV 2* (Table 2). The maximum value of apparent charge reached 17 nC (Fig. 8), however the range of a phase angle, in which the discharges appeared, was mainly from 30° to 90°. In other phases of 220 kV side (*HV 1* and *HV 3*) the PD pulses were also recorded, but their apparent charge value did not exceed 10-11 nC. The range of phase angle was identical as in *HV 2* phase. On the basis of the obtained results it was concluded that the signals observed in phases *HV 1* and *HV 3* were the same as those coming from the *HV 2*, but attenuated, indicating their origin as *HV 2*. In the case of 110 kV side, only the low-energy signals were registered with the apparent charge up to 1 nC, and in *LV 2* phase only.

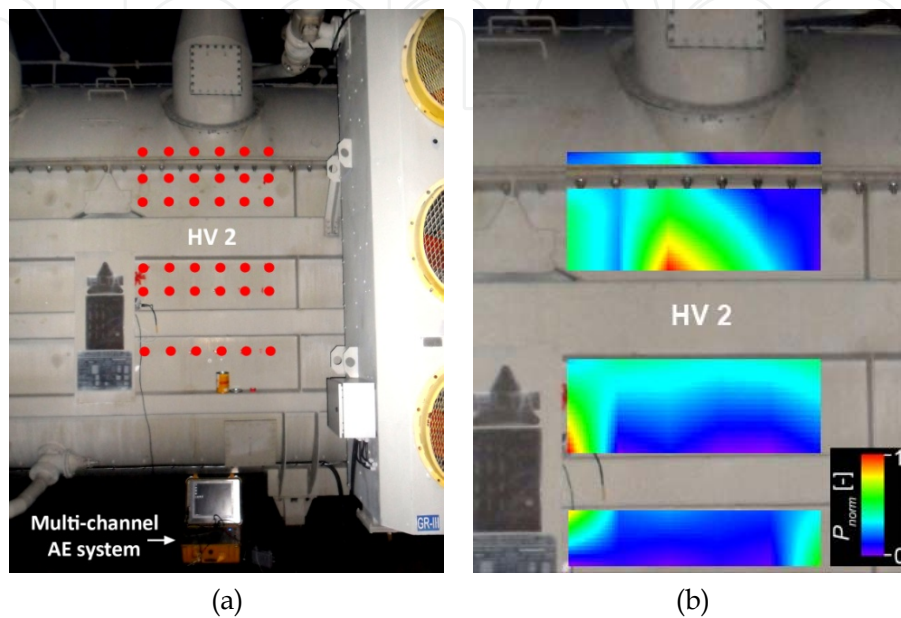
Figure 9. The measurement grid (36 points) used for PD source location with advanced auscultatory technique (a) and the result of PD source location presented as an *Acoustic Emission Map* applied in the picture of the HV 2 phase of the investigated power transformer (b).

In case of the AAT, in the first step, the measurement points on the surface of transformer tank were chosen and marked. These points formed a measurement grid. In order to increase the reliability of measurements, and simplify the interpretation of the obtained results, the fragments of tank walls with higher thickness were omitted (e.g. corrugated walls and welds). The measurement grid consisted of 36 points, as it is shown in figure 9a.

On the basis of the results obtained with the use of AAT, the *Acoustic Emission Map* was prepared and superimposed on a photograph of the transformer tank. The analysis of the *Acoustic Emission Map* image showed that in the HV phase 2 two sources of partial discharges were present (Fig. 9b).

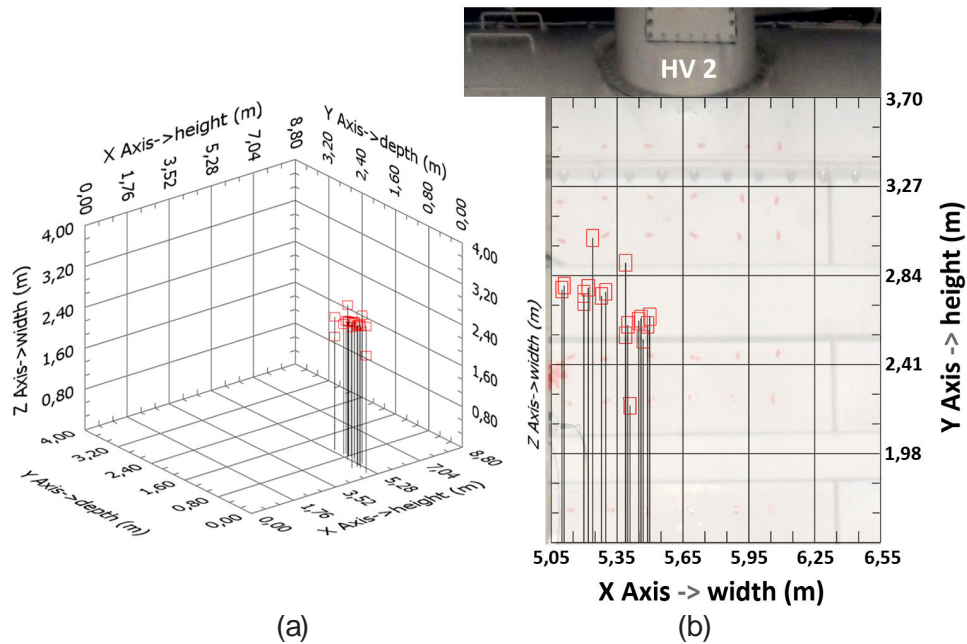
Figure 10. The result of the PD source location obtained with the use of triangulation method presented in the XYZ coordinates system (the XZ plane illustrates the wall of tank from the HV side) (a) and projection of calculated PD coordinates (XYZ) to the XZ plane (b).

The analysis of the results of PD source location, obtained with the triangulation method showed that both sources of discharges were placed near the symmetry axis of the phase HV 2 bushing and the transformer tank (Fig. 10a and 10b). On the basis of the investigation results, a hypothesis was assumed that partial discharges were generated inside the insulation of the winding leads or in the support beam that is close to the transformer tank.

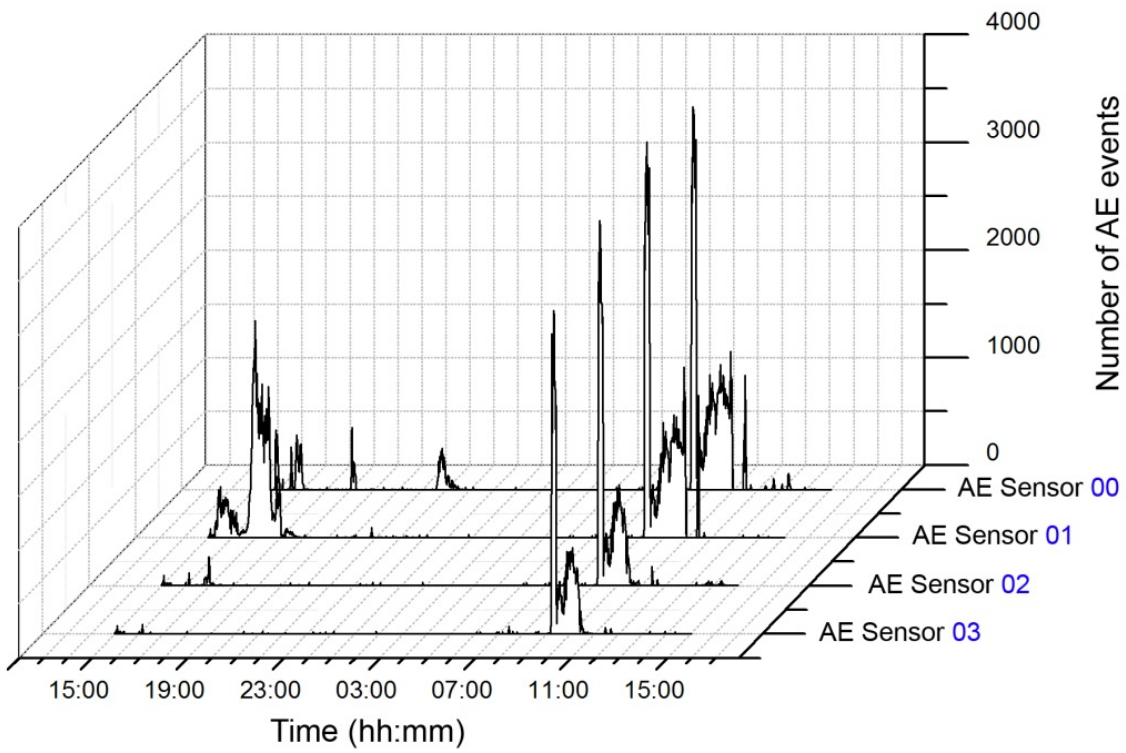
Figure 11. The number of AE events registered during daily monitoring of 160 MVA transformer

The same was also the average amplitude of the signal recorded by each sensor (Fig. 12). However, when looking at the distribution of number of AE events, it can be noted that daily activity profiles of the partial discharges recorded by pairs of sensor (00&01 and 02&03) were similar. This fact suggests the existence of two defects, which was already mentioned after the analysis of the location results with the use of *Advanced Auscultatory Technique* (see Fig. 9b).

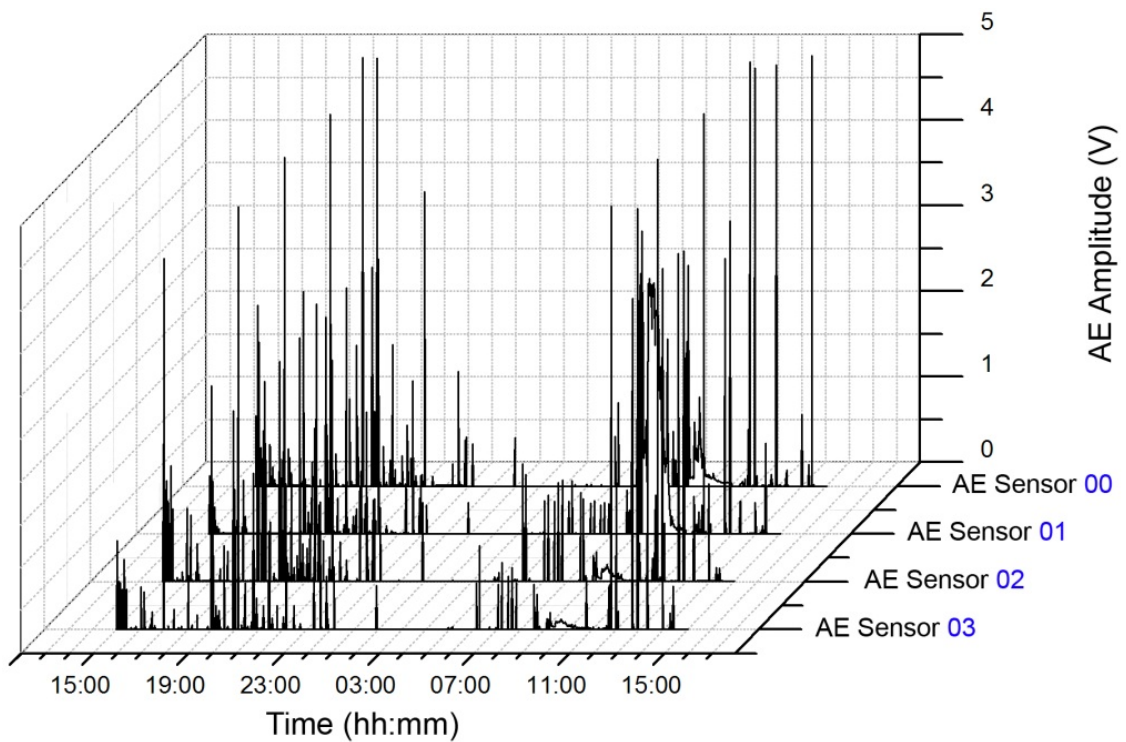
Figure 12. Amplitude of AE events registered during the daily monitoring of 160 MVA transformer.

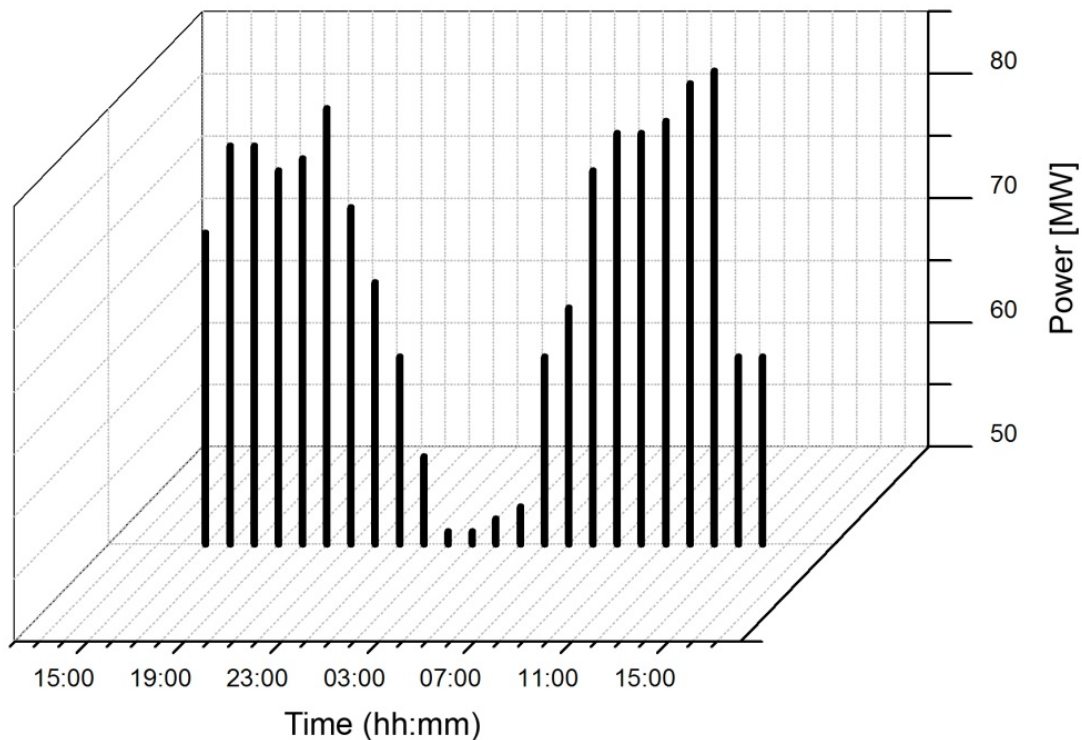
Figure 13. The value of daily load of the monitored transformer, registered in SYNDIS ES system

Further interesting conclusions arise when comparing both the number of events and the average amplitude of the acoustic signal with daily load of the unit (Fig. 13). One can observe that the increase in the load is associated with increase of intensity and amplitude of partial discharges. Load peaks, occurring at 21:00 and 12:00, are accompanied by the largest PD intensity and highest average amplitude of registered acoustic signals. Probably, the temperature increased closed to defect, which was a consequence of the growth in the value of the current, causing intensification of the partial discharge phenomenon. Analysis of the impact of voltage changes caused by tap changes of the autotransformer, did not show any significant correlation with respect to the recorded acoustic signal (voltage change were small indeed).

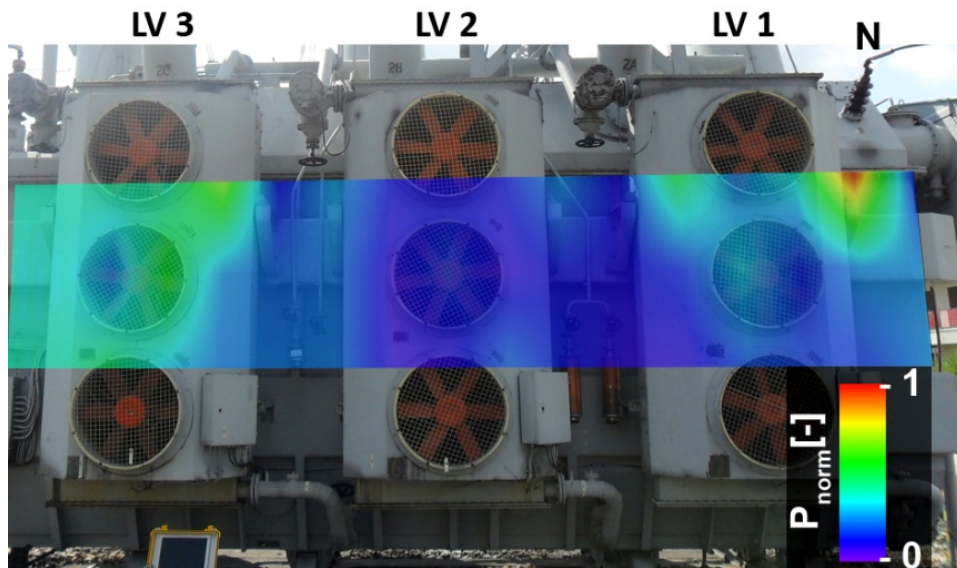
Figure 14. Results of PD source location (*Acoustic Emission Map*) obtained using advanced auscultatory technique (AAT) on low voltage side of the 250 MVA transformer

During the tests, several areas were located on tank in which recorded acoustic emission pulses were characterized by high amplitude. In the case of the lower voltage side (110 kV), repeatable pulses with the largest amplitude were recorded close to neutral point bushing (*N*). In addition, on the same side, sporadically occurring high amplitude PD pulses localized in phase *LV 1* and *LV 3* were recorded. During the measurements, any discharge pulses in phase *LV 2* were not registered (Fig. 14). In the case of the high voltage side (400 kV) sporadically occurring partial discharge pulses were also recorded, however, they were characterized by much smaller amplitude than it was in the case of the low voltage side.

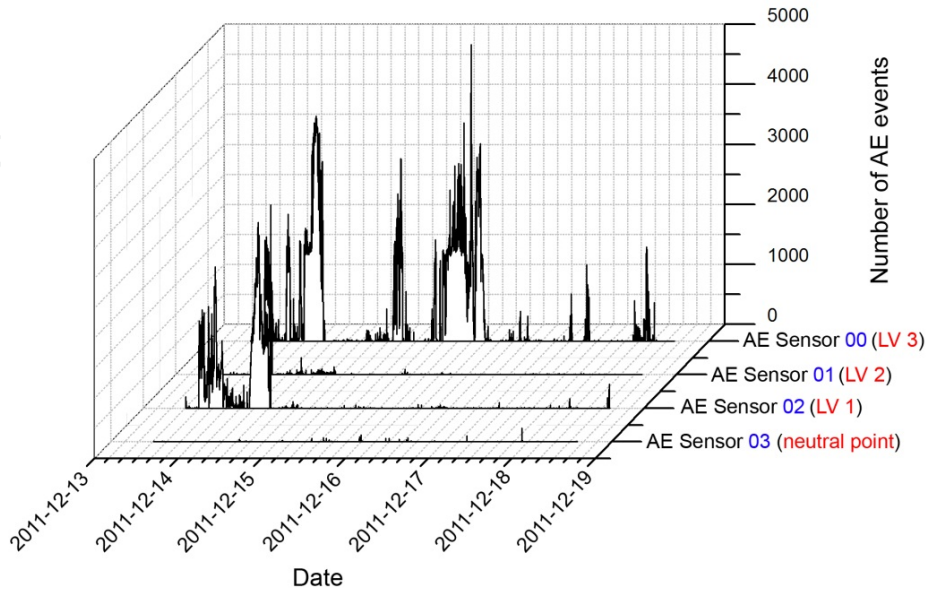
Figure 15. The number of EA events registered during the weekly monitoring of tested 250 MVA transformer

summarized in figure 15. In turn, on figure 16 the values of the oil temperature in top layer and voltages of monitored transformer registered in SYNDIS ES system were presented.

Analysis of the characteristics showing the number of AE events recorded by the monitoring system confirmed the presence of partial discharges in phase *LV 1* and *LV 3* and the absence or presence of a few discharges in phase *LV 2* and close to neutral point bushing (Fig. 15). Monitoring showed that pulses with the highest intensity and energy are generated in phase C. The recorded PD pulses were unstable, and their ignition took place only in periods of voltage growth (Fig. 16). Moreover, it was noted that the moment of PD ignition correlates with temperature minima of top layer of oil, which may have a relationship with some dynamic changes in moisture at the interface of oil-paper insulation, described for example in (Borsi & Schroder, 1994; Buerschaper et al., 2003; Sokolov et al., 1999).

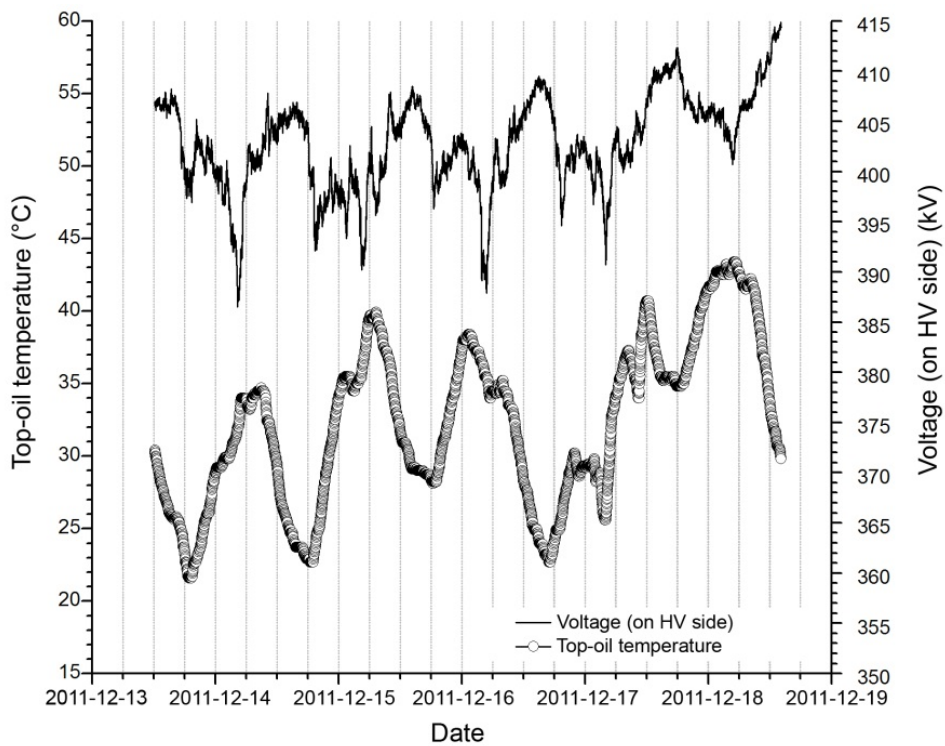
Figure 16. The value of the top layer of the oil temperature and voltages of the monitored 250 MVA transformer registered in SYNDIS ES system

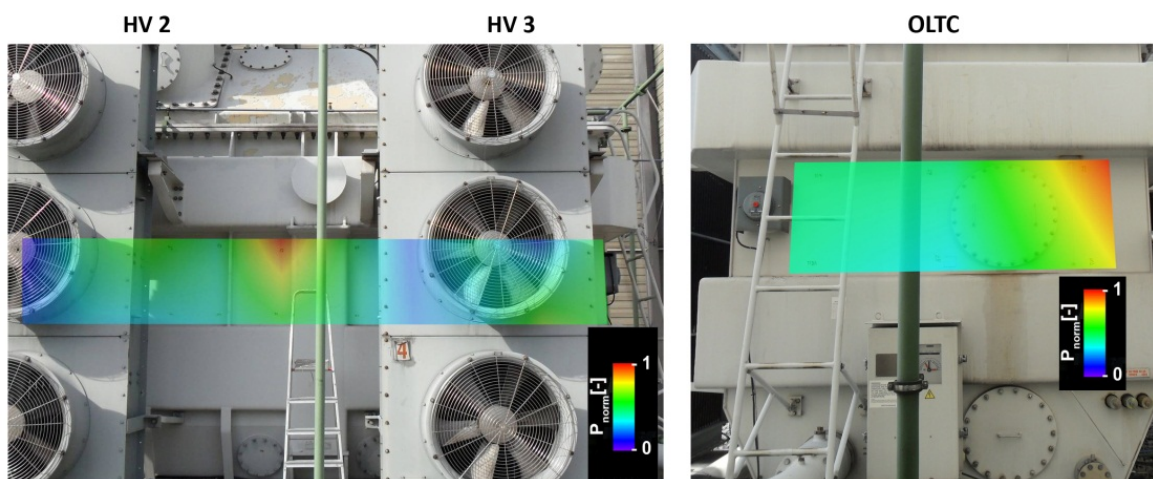
Figure 17. Results of PD source location (*Acoustic Emission Maps*) obtained using advanced auscultatory technique (AAT) on HV and OLTC side of the 330 MVA transformer

In this case the choice of the research object, on which continuous monitoring was tested, did not result from bad condition of the transformer. The primary purpose was integration of the PD monitoring system with the superior system (SYNDIS ES) and evaluation of opportunities for their cooperation. However, as in other cases, place of sensors location were selected basing on previously carried out detection and PD sources location using *Advanced Auscultatory Technique* (Fig. 17).

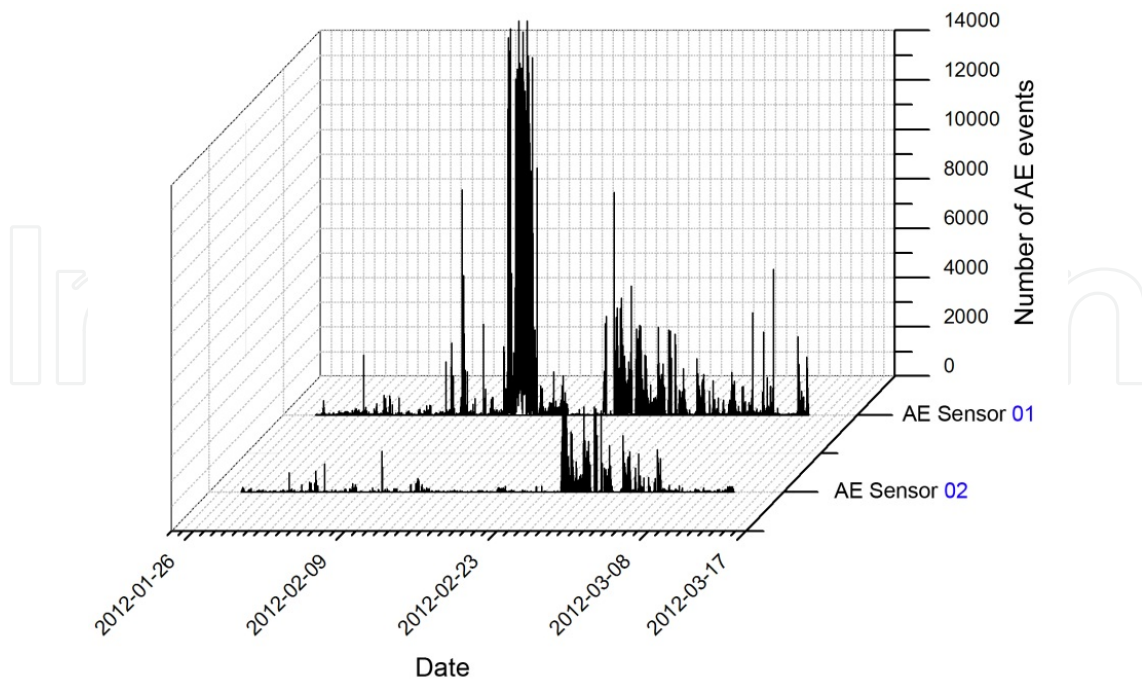
Figure 18. The number of AE events registered on 330 MVA transformer, where the long-term test of partial discharge monitoring system was carried out.

For example, figure 18 shows the number of PD pulses registered by two sensors with numbers '01' and '02', installed respectively in phase *HV 1* and *HV 2*. As one can observe, partial discharges were transient, but comparison with other parameters, such as temperature and voltage (Fig. 19), allows to detect a correlation. As it was described in the previous case, the moment of PD initiation and growth of its intensity were connected not only with an increase in voltage, but at the same time, with relatively low value of oil temperature (20-30°C). Particularly high partial discharge activity has been reported in cases, in which the period of oil cooling and at the same time the growth of voltage lasted at least several hours. In the phase *HV 1* (sensor '01') this situation took place from 25 until 27 February, and in phase *HV 2* (sensor '02') between 12 and 13 day of the same month.

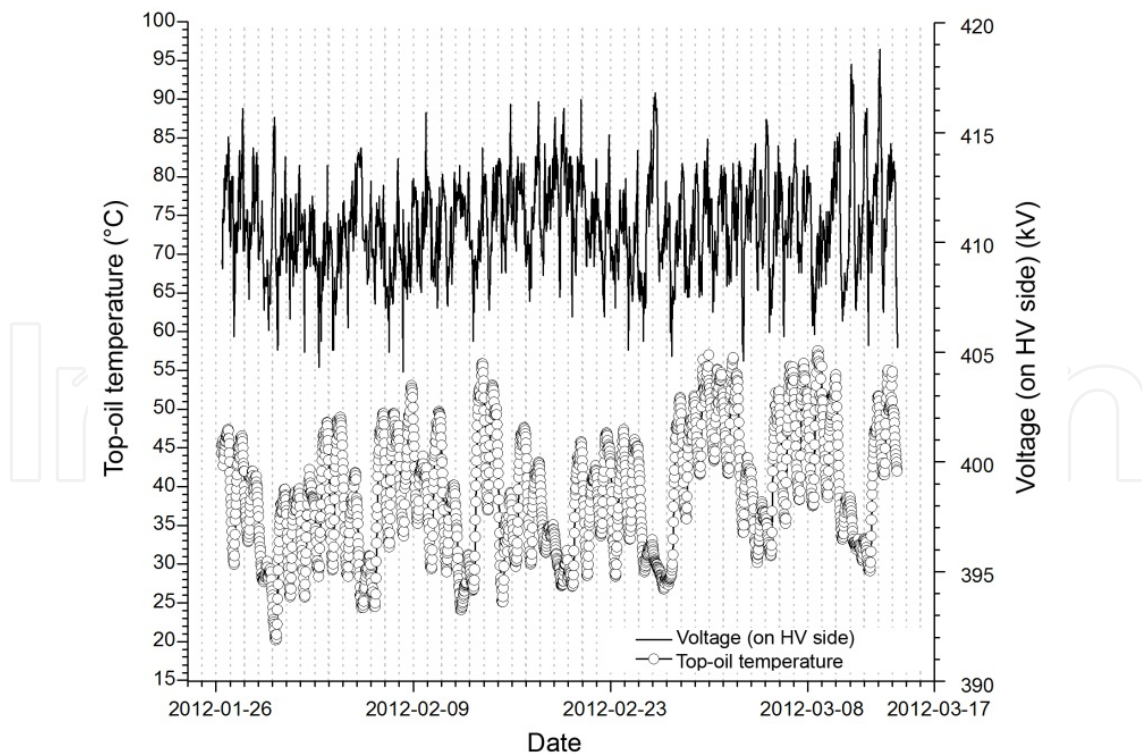
Figure 19. The oil temperature at top layer and values of voltages of the monitored 330 MVA transformer registered in SYNDIS ES system
