New Scuffing Test Methods for the Determination of the Scuffing Resistance of Coated Gears

Remigiusz Michalczewski, Marek Kalbarczyk,
Michał Michalak, Witold Piekoszewski,
Marian Szczerek, Waldemar Tuszynski and
Jan Wulczynski

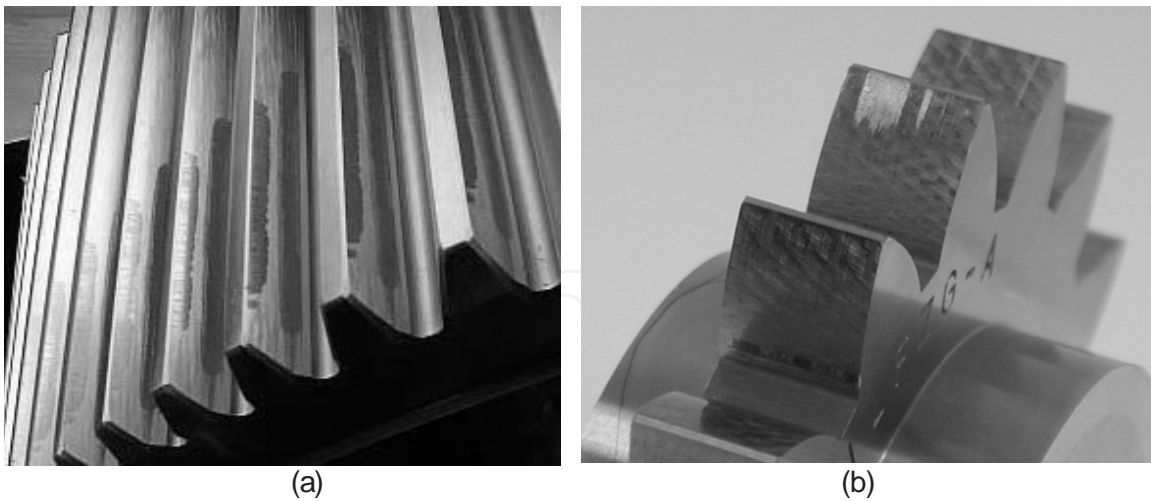
Figure 1. Photographs of failures of the gear teeth flanks due to scuffing: a) “non-symmetric” scuffing observed in gear service, resulting from the incorrect distribution of load along the tooth [3], b) scuffing on the flank of the test gear due to poor extreme-pressure (EP) properties of the tested gear oil during the gear scuffing experiments performed by the authors

Failures of the gear teeth flanks due to scuffing are shown in Figure 1.

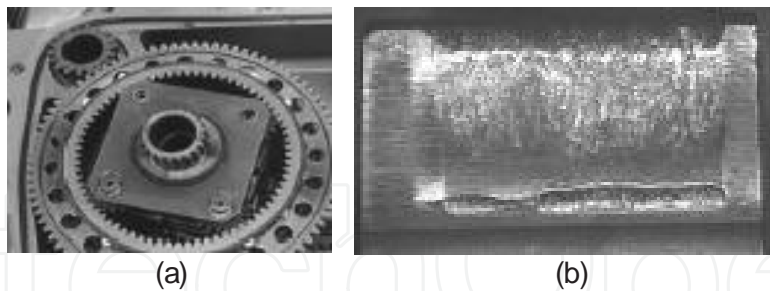
Figure 2. Photographs of the components of the rudder speed brake power drive unit of a space shuttle: a) pinion and ring gear of the power drive unit, b) damaged pinion tooth [4]

Another example of scuffing of gears concerns the rudder speed brake power drive unit of a space shuttle, observed during its inspection after grounding [4]. Figure 2 a) shows the pinion and ring gear of the power drive unit of the space shuttle. Figure 2 b) presents the pinion tooth with wear at the tip and scuffing on dedendum. It was postulated that early shutdown of one of three hydraulic motors driving the gearbox could cause scuffing - in a differential gearbox, early shutdown of one motor could cause the overloading with potential for scuffing.

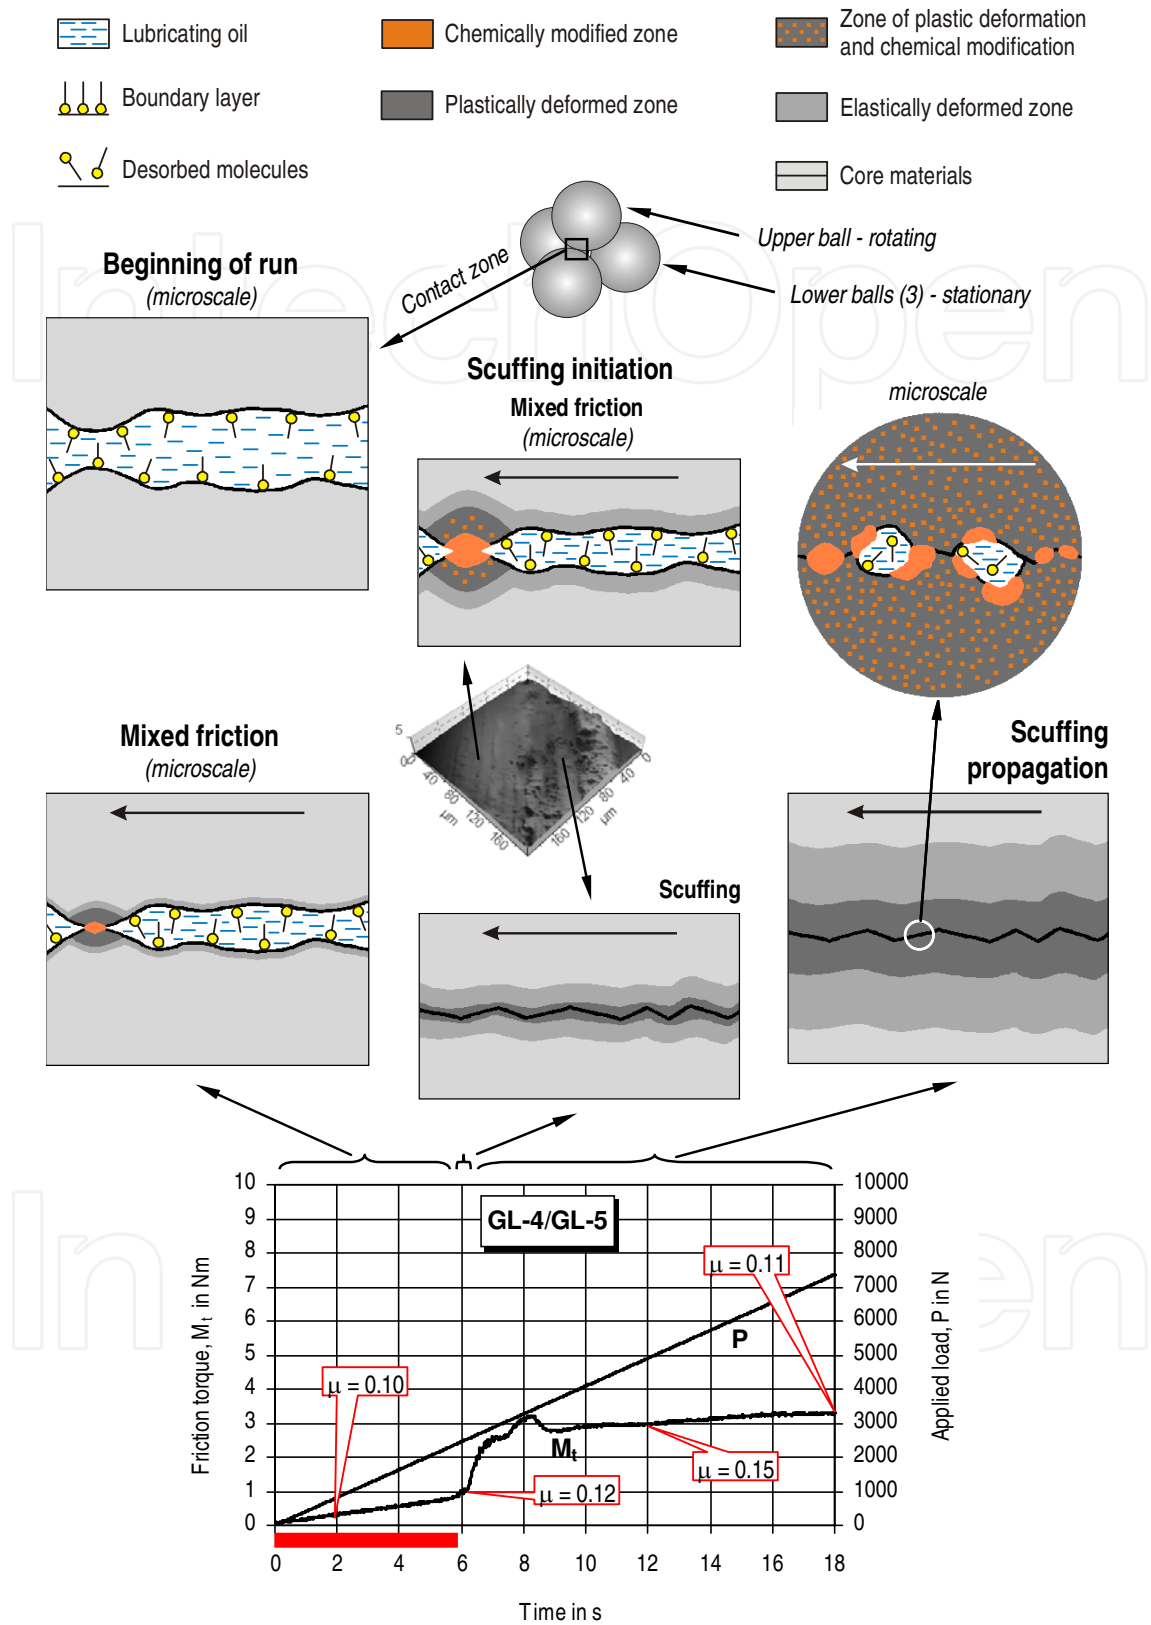
Figure 3. Models of scuffing in different phases for the automotive gear oils of the API GL-4 and GL-5 performance levels

To better understand scuffing, Figure 3 presents the interpretative models of the phenomena in different phases of this process, caused by the continuously increasing load. The models

In the models, three characteristic zones in the wear scar surface layer were identified: a chemically modified zone through the action of the lubricating additives and the steel surface, a zone of plastic deformation, and a zone of elastic deformation. All of these zones are described in the legend above the models in Figure 3.

At mixed friction, the micro-EHL films mainly carry the load and the mating surfaces are protected from direct contact by the boundary layer. But at some micro-zones, due to the failure of the micro-EHL film surface, asperities locally collide, which is illustrated in the model with the heading "Mixed friction" in Figure 3.

The scuffing initiation occurs at a load called the scuffing load, which is characteristic for each tested lubricating oil. At this load, the lubricating film collapses, the number of colliding surface asperities drastically increases, and the destruction changes its occurrence from the micro- to macro-scale and scuffing appears. Initially only part of the friction surface undergoes scuffing. It can be observed in the surface topography image of the border between the surface that did not exhibit very rough topography typical of scuffing (left side) and the surface destroyed by scuffing (right side) - Figure 3.

The upper model shows that the micro-scale phenomena in the zone intact by scuffing are similar to those described in the phase "Mixed friction" apart from the thickness of elastic and plastic deformations which increased due to rising load. Probably, in view of plastic deformation that causes surface defects, the reactive diffusion of "active" atoms from the EP lubricating additives (e.g. sulphur atoms) into the surface layer takes place and iron sulphides form, which is confirmed by other researchers, e.g. in the work [7]. The diffusively modified micro-zones inside the highest asperities are plastically deformed and are indicated in the respective model as orange spots - Figure 3.

This phase refers to the scuffing process, after its initiation. It is reflected by a sharp increase in the friction torque (M_i), accompanied by a high intensity of the lower test balls wear - Figure 4 a, b). This situation is illustrated in the models with the heading "Scuffing propagation" in Figure 3.

For the API GL-4 and GL-5 gear oils, the effective chemical modification of the surface mitigates the increase of the wear scar diameter - Figure 4 b, c) - in the phase of the SBL formation, accompanied by a mitigated rise in the friction torque and a decreasing friction coefficient (Figure 3).

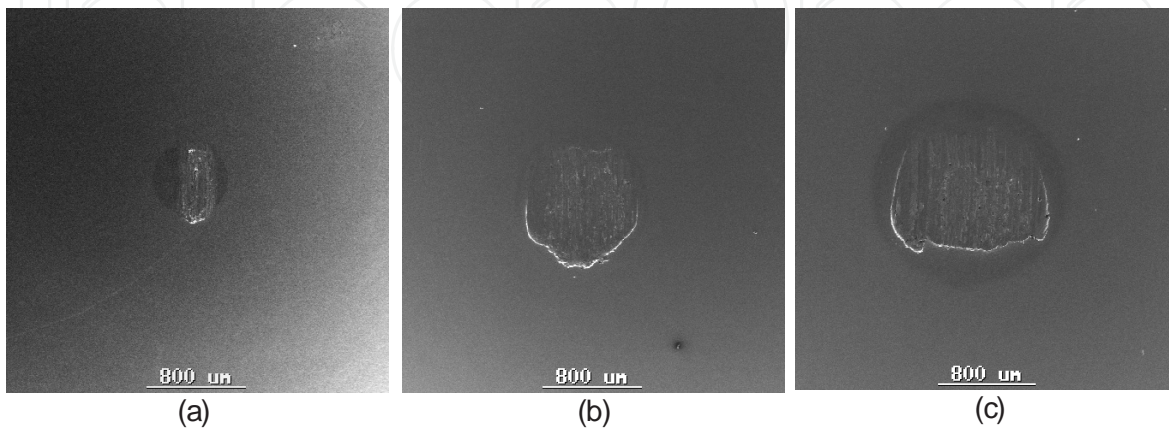
Figure 4. Development of the wear of the lower test balls due to scuffing: a) at scuffing initiation, b) at 12th seconds of the run (scuffing propagation), c) at the end of the run; images obtained at the same magnification

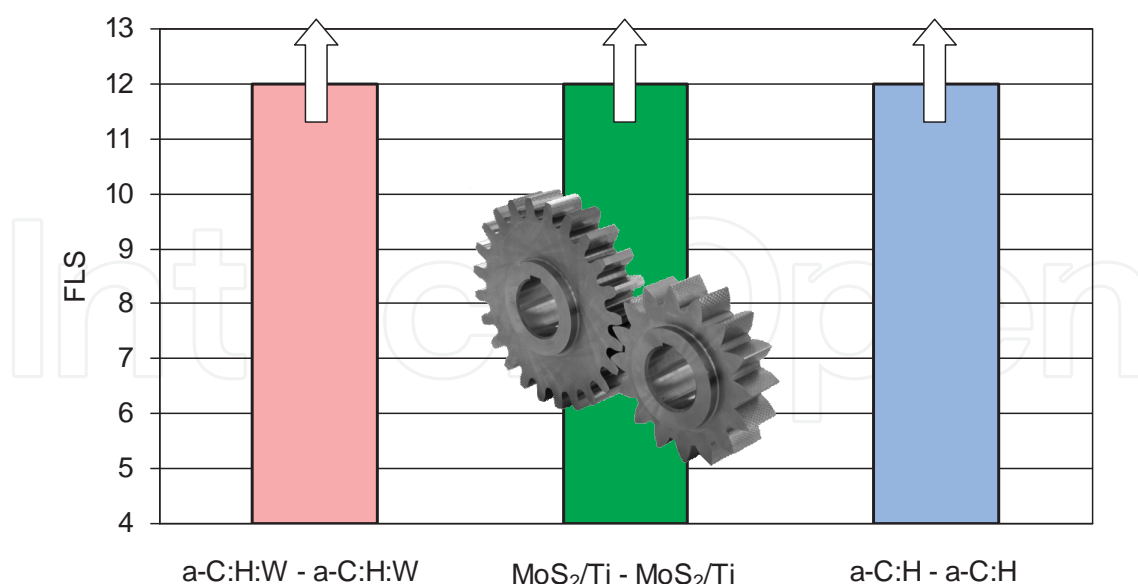
Figure 5. Failure load stages (FLS) obtained for the tested coatings (both gears coated) - FZG A/8.3/90 test method; data compiled from [23-25]

It is apparent from Figure 5 that the failure load stages (FLS), indicating the gear resistance to scuffing exceed the maximum number 12, so that it is impossible to differentiate between the coated gears using the FZG A/8.3/90 test method.

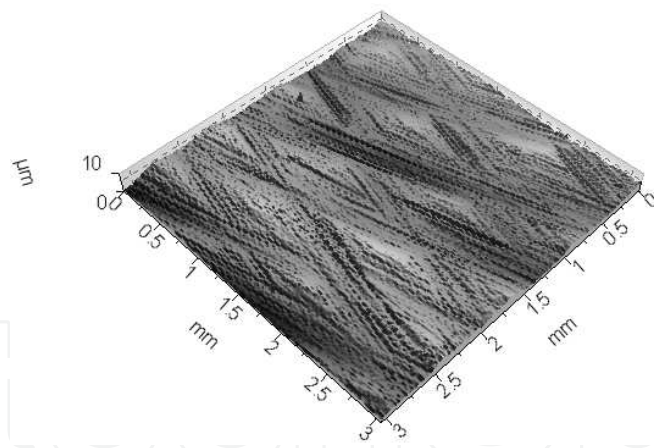
Figure 6. Original criss-cross-grinding pattern on the test gear teeth - stylus profilometry image

Polishing can be identified when the “mirror-like” surface on the tooth flank is observed with the disappearing criss-cross-grinding pattern shown in Figure 6.

Scoring marks run in the same direction as scratches. On the basis of CEC L-07-95 standard [26], it can be adopted that they occur singly or in zones as light, medium or deep grooves continuing towards the tip of the tooth and having a rougher appearance than the criss-cross-grinding pattern (Figure 6).

Scuffing marks occur as single, fine marks or strips, or areas covering a part or all of the flank width. According to CEC L-07-95 standard, they appear as dull areas with the roughness much greater than the original criss-cross-grinding pattern shown in Figure 6. In this case, the grinding pattern is no longer visible.

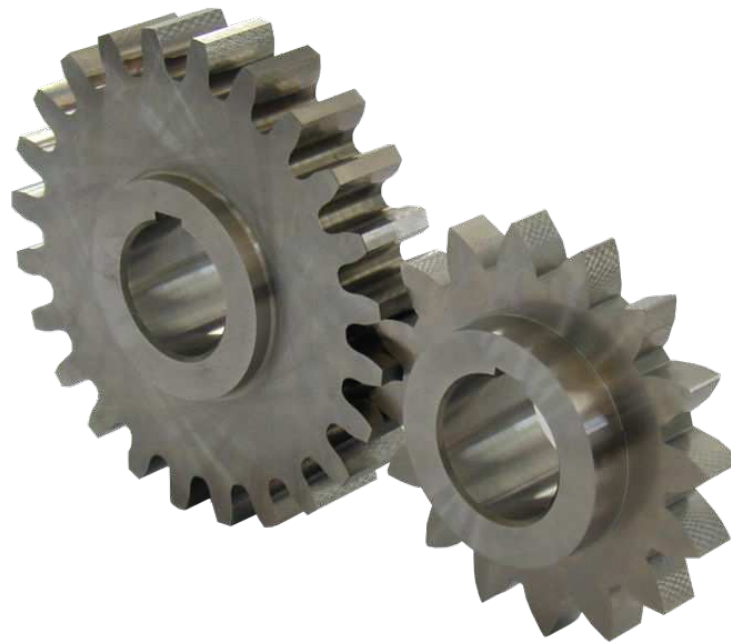
Figure 7. Photograph of the FZG A10 scuffing test gears

A photograph of the FZG A10 scuffing test gears employed in the tests according to the developed methods is shown in Figure 7.

The A10 test gears are made of 20MnCr5 steel. They are carburized, case hardened, tempered and Maag criss-cross ground. The surface hardness is HRC = 60 + 2 and the case hardness depth (CHD) is 0.6 to 0.9 mm (Eht). The effective face width of the pinion is 10 mm, and the wheel is 20 mm. The number of pinion teeth is 16, and wheel 24. The gears are identical to the ones used to perform tests according to the FZG A10/16.6R/90 and S-A10/16.6R/90 methods.

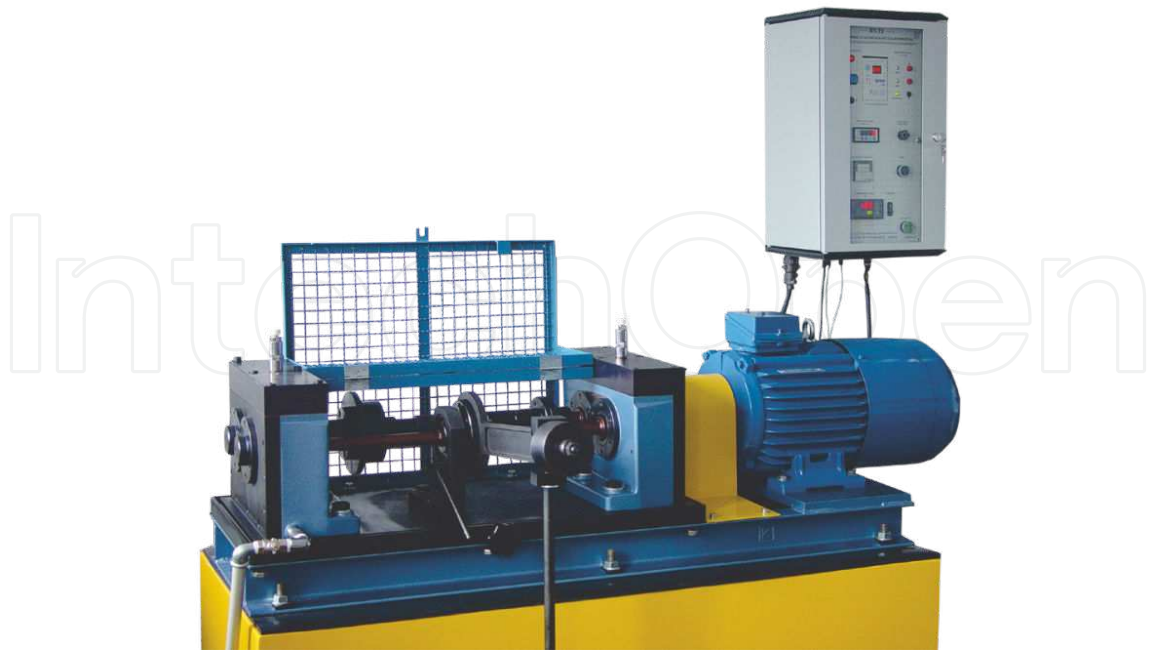
Figure 8. Photograph of the T-12U gear test rig

For the complex testing of gears, a back-to-back gear test rig, denoted as T-12U, was designed in the Tribology Department of ITeE-PIB in Radom. Its photograph is presented in Figure 8 and kinematic schemes are presented in Figure 9.

The T-12U test rig is equipped with a control-measuring system, which consists of measuring transducers (thermocouple, speed transducer) and the controller (Figure 8).

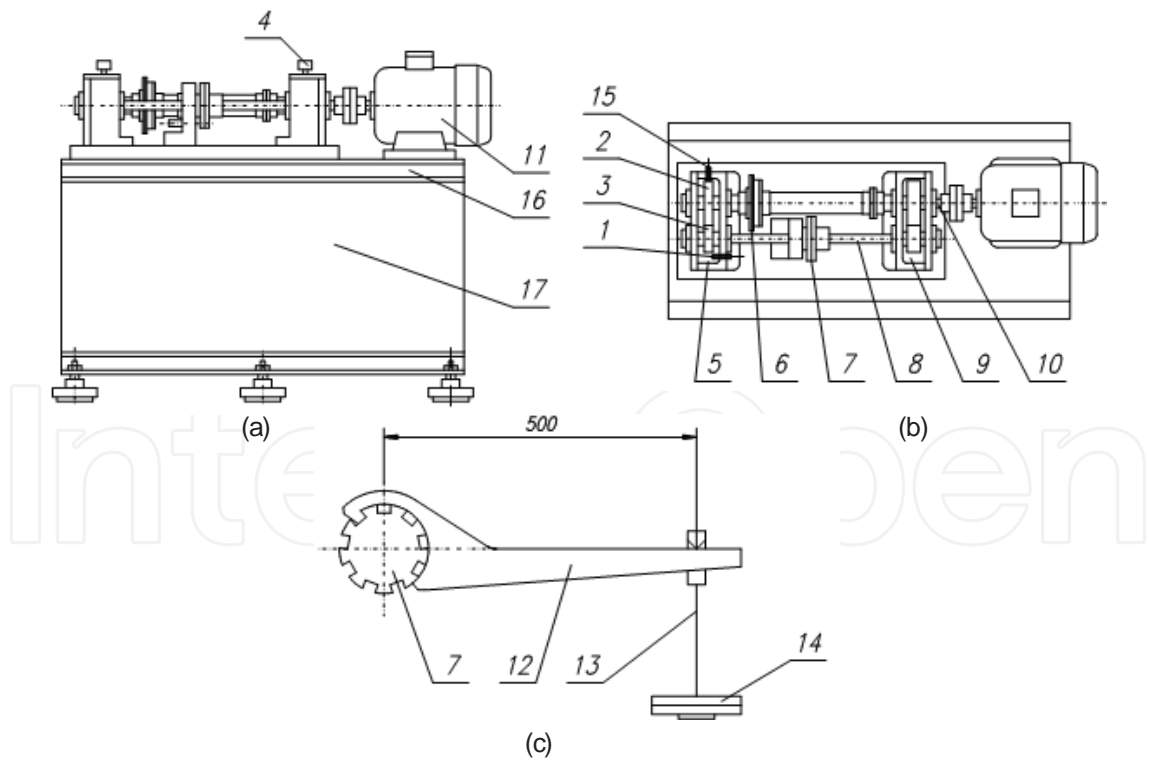
Figure 9. Kinematic schemes of the T-12U gear test rig: a) front view, b) top view, c) loading equipment; 1 - thermocouple, 2 - test wheel, 3 - test pinion, 4 - vent, 5 - test chamber, 6 - shafts torsion angle indicator, 7 - load clutch, 8 - front shaft, 9 - slave chamber, 10 - drive clutch, 11 - electric motor, 12 - loading lever, 13 - weight hanger, 14 - weights, 15 - heaters, 16 - frame, 17 - concrete base

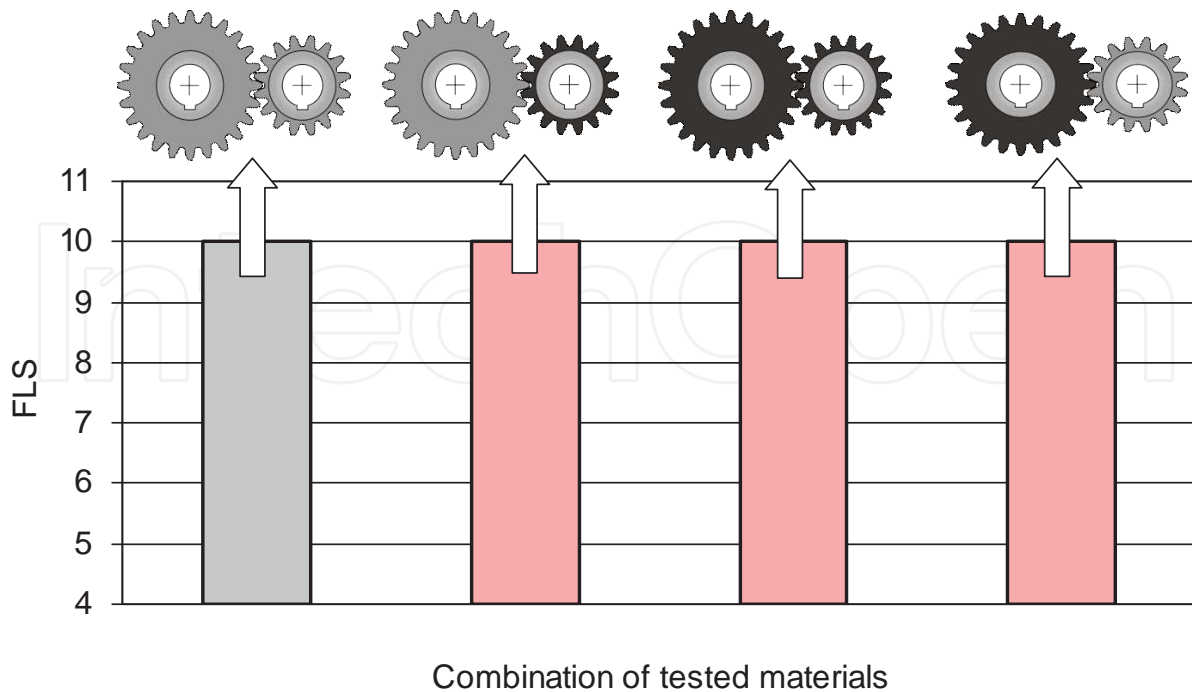
Figure 10. Failure load stages (FLS) obtained using the Gear Scuffing EP Test for Coatings for the tested material combinations with the a-C:H:W coating

Failure load stages (FLS) obtained for the tested material combinations with the a-C:H:W coating are presented in Figure 10. The coated gear is dark grey coloured, and the uncoated one is light grey.

Figure 10 shows that the Gear Scuffing EP Test for Coatings is unable to differentiate between the tested material combinations from the point of view of the main criterion - FLS. All the FLS values exceed the maximum load stage, i.e. 10th. Thus, the additional criteria of failure assessment, related to the wear of the pinion after runs at particular load stages, were taken into account - Table 3. The table presents the symbolic modes of the wear of the test pinion at particular load stages for the tested material combinations with the a-C:H:W coating, and the mode of wear that appeared most often on the pinion teeth was considered. Below are the symbols of the wear modes, the total area of failures on the pinion (A_p) are given. The used symbols of wear were presented earlier in Table 2.

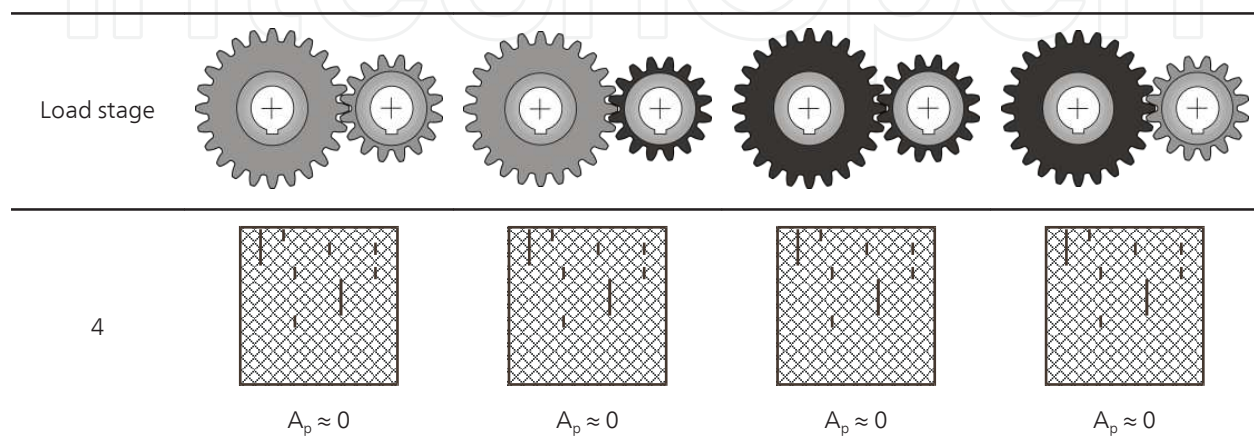
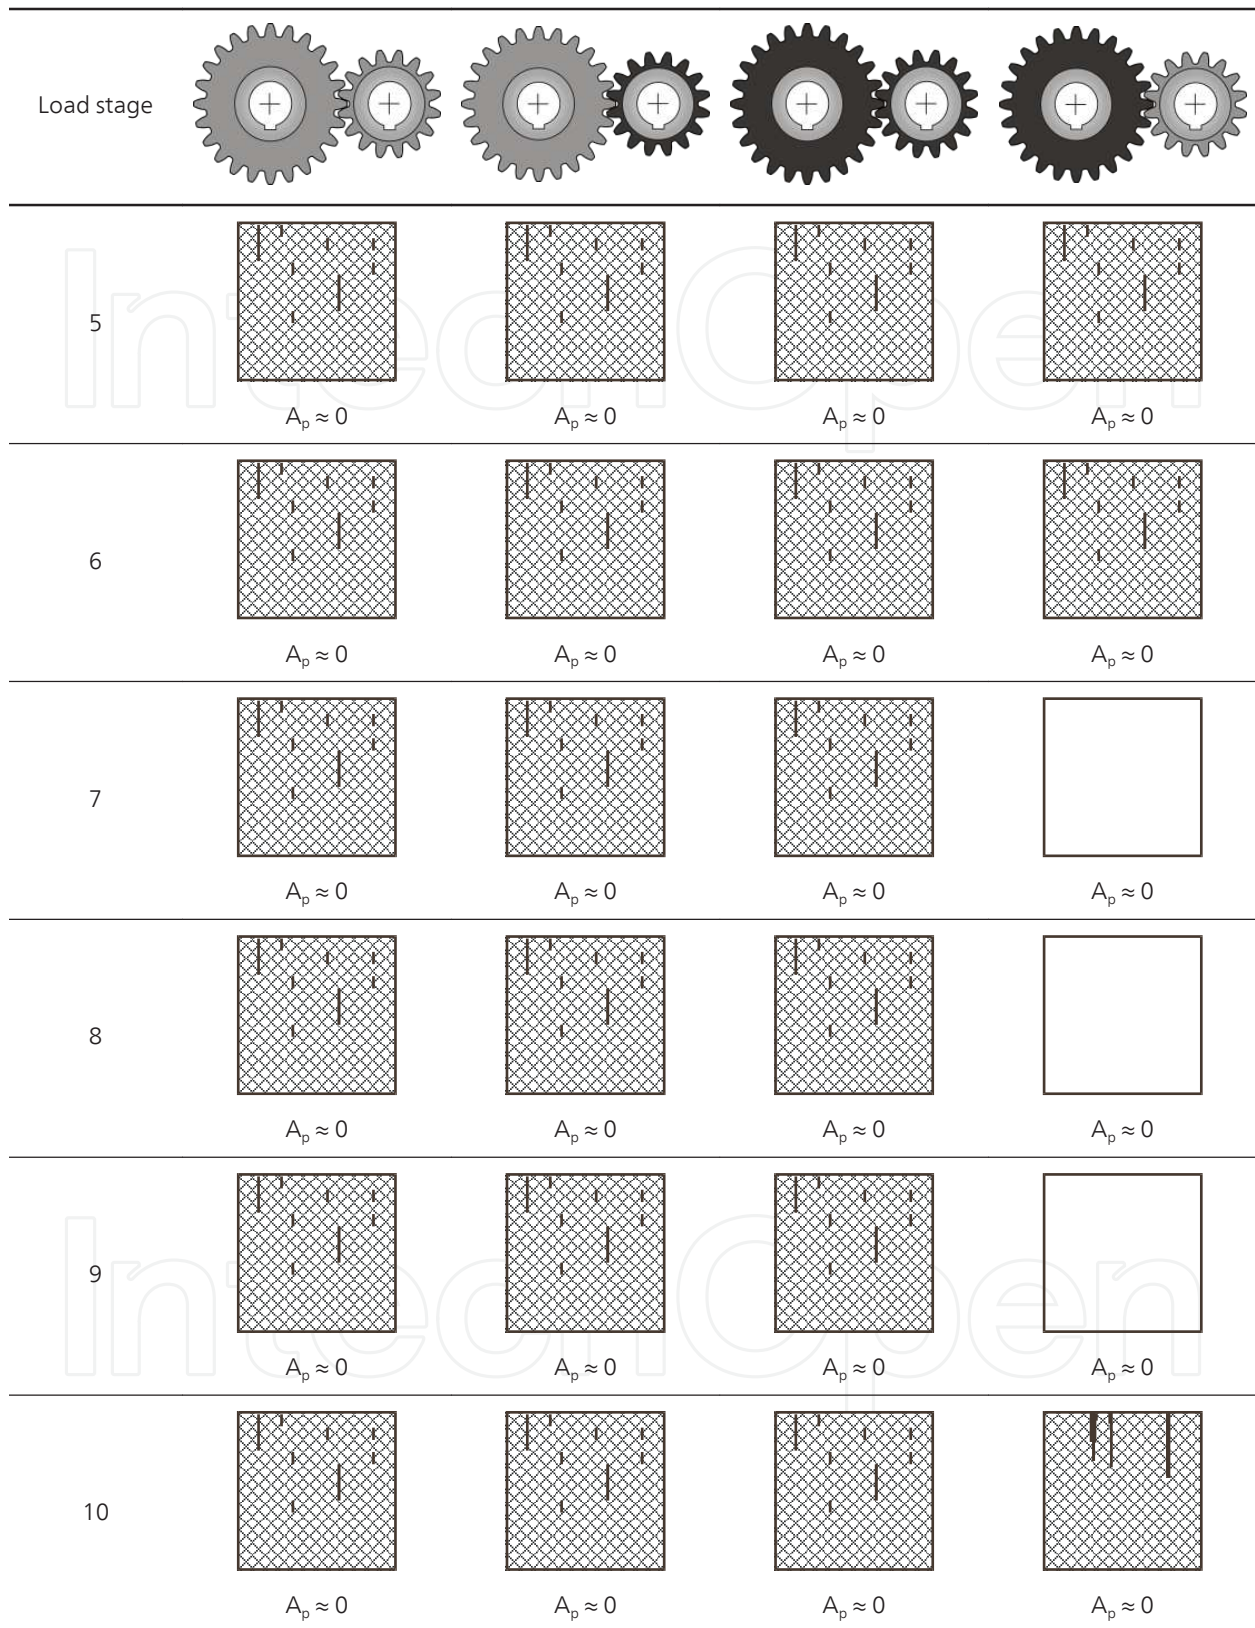
Table 3. Modes of the wear of the test pinion at particular load stages for the tested material combinations with the a-C:H:W coating, together with the total area of failures on the pinion (A_p); Gear Scuffing EP Test for Coatings

As can be observed in Table 3 for the tested material combinations, the three modes of wear that appear most often on the pinion teeth are scratches, polishing, and scoring. The uncoated pinion undergoes the process of polishing through the rubbing by the hard a-C:H:W coating deposited on the meshing wheel. Similar action was observed on the uncoated wheel meshing the coated pinion (results not shown here). The role of such polishing is to be explained in further experiments planned by the authors.

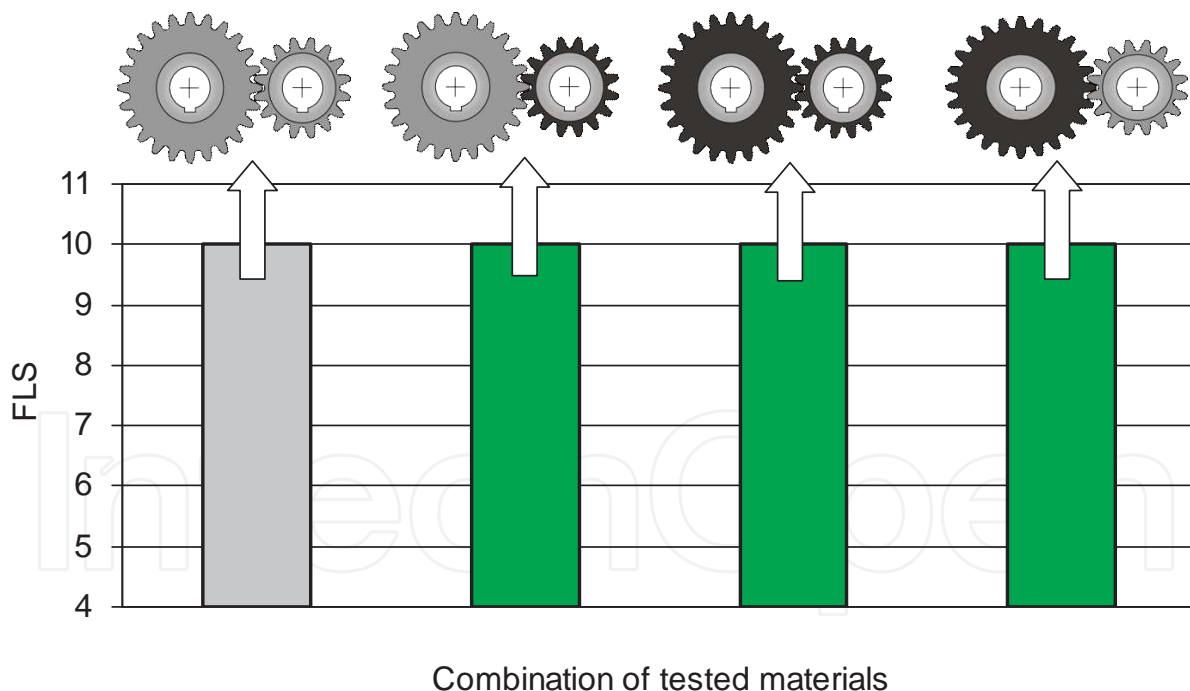
Figure 11. Failure load stages (FLS) obtained using the Gear Scuffing EP Test for Coatings for the tested material combinations with the MoS₂/Ti coating

Failure load stages (FLS) obtained for the tested material combinations with the MoS₂/Ti coating are presented in Figure 11. The coated gear is dark grey coloured, and the uncoated one is light grey.

Figure 11 shows that the Gear Scuffing EP Test for Coatings is unable to differentiate between the tested material combinations from the point of view of the main criterion - FLS. As in the case of testing the a-C:H:W coating, all the FLS values exceed the maximum load

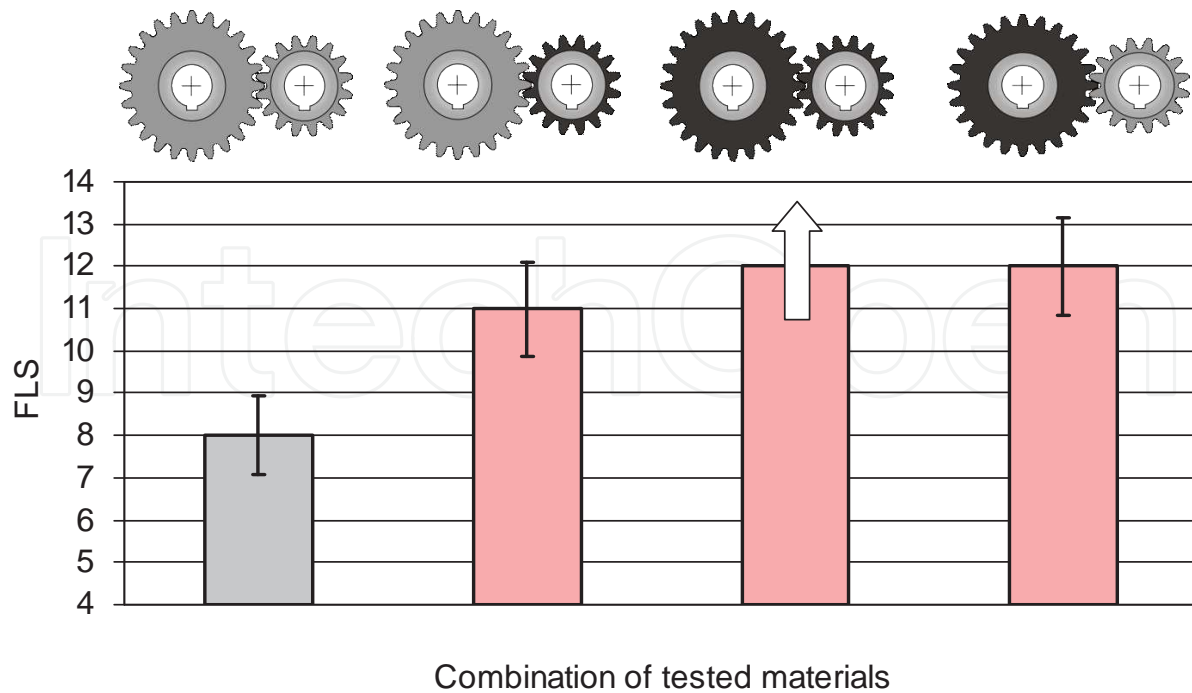
Figure 12. Failure load stages (FLS) obtained using the Gear Scuffing Shock Test for Coatings for the tested material combinations with the a-C:H:W coating

Failure load stages (FLS) obtained for the tested material combinations with the a-C:H:W coating are presented in Figure 12. The coated gear is dark grey coloured, and the uncoated one is light grey. The assessed uncertainties of measurement for each result obtained are also shown in the Figure.

Figure 12 shows that the Gear Scuffing Shock Test for Coatings makes it possible to differentiate between the tested material combinations. The best resistance to scuffing (highest FLS) is observed when both gears are coated.

Under “shock” conditions, when the pinion is uncoated and the wheel is coated with the a-C:H:W coating, the resistance to scuffing is slightly higher than in the case when the pinion is coated and the wheel is uncoated. Hypothetically, there is a transfer of graphite (solid lubricant) from the a-C:H:W coated gear to the teeth of the uncoated one, which is more effective for the wheel coated than in the opposite situation, because the area of the coated steel surface of the wheel (larger gear with 24 teeth) is greater than in the case the coating is deposited on the pinion (small gear having only 16 teeth). However, one must have in mind that the difference in the scuffing resistance of the two material combinations is not statistically significant, because the measurement uncertainties overlap each other.

In comparison to the case of the both gears uncoated, when the a-C:H:W coating is deposited on one or two gears, much higher resistance to scuffing is observed. This is a result of a high surface energy for metals (here for steel) promoting adhesive bonding in the steel-steel contact, and smaller affinity in the different materials than when both of them are identical (i.e. steel-steel), which protects the surface from adhesive bonding. Yet another phenomenon can be attributed to it. When one of the mating materials (coating) is much harder than the other one (steel), or when two very hard materials are in contact (coating-coating) there is a reduction in the tendency to adhesive bonding, hence scuffing.

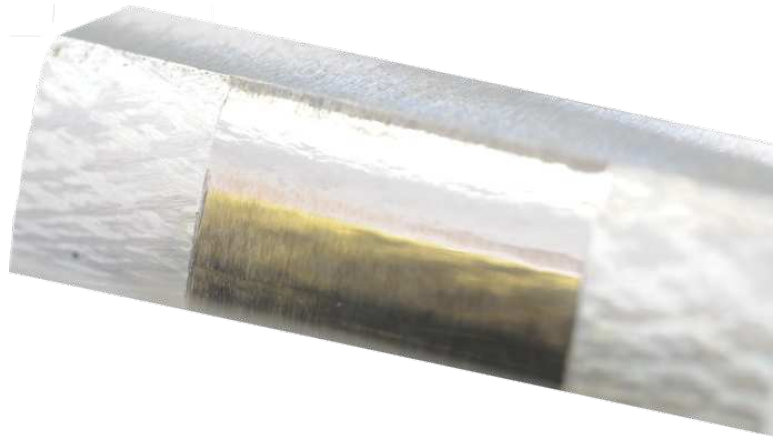
Figure 13. Photograph of the tooth flank of the uncoated wheel, polished by the a-C:H:W-coated pinion; Gear Scuffing Shock Test for Coatings

What was observed also during the Gear Scuffing EP Test for Coatings, and what seems to be typical of “the action” of the a-C:H:W coating, the uncoated gear undergoes the process of polishing or scoring through the rubbing by the hard coating deposited on the meshing gear. The polishing on the wheel teeth flanks can be seen in Figure 13.

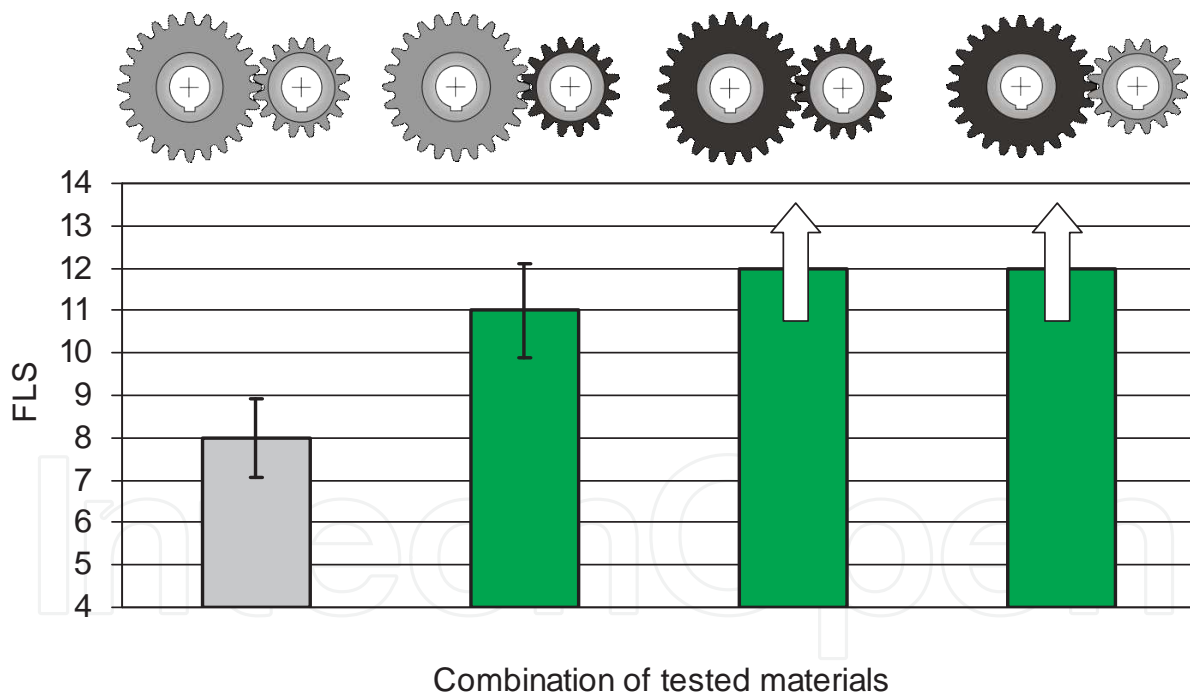
Figure 14. Failure load stages (FLS) obtained using the Gear Scuffing Shock Test for Coatings for the tested material combinations with the MoS₂/Ti coating

Failure load stages (FLS) obtained for the tested material combinations with the MoS₂/Ti coating are presented in Figure 14.

Figure 14 shows that the best resistance to scuffing (highest FLS) is observed when both gears are coated with the MoS₂/Ti coating, or when the uncoated pinion meshes the coated wheel.

As in the case of the a-C:H:W coating, when only the wheel is MoS₂/Ti-coated, under “shock” conditions the resistance to scuffing is higher than in the situation when only the pinion coated.

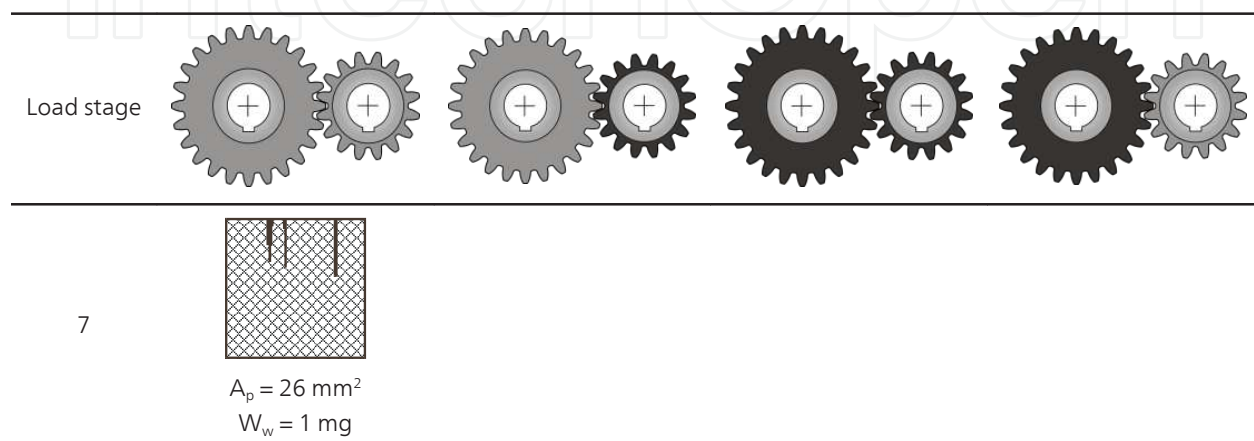
Table 6. Modes of wear of the test pinion at particular load stages for the tested material combinations with the MoS₂/Ti coating, together with the total area of failures on the pinion (A_p), and wear of wheel (W_w), obtained in the Gear Scuffing Shock Test for Coatings; red-shadowed cells - the failure load stage (FLS)

Table 6 presents the symbolic modes of wear of the test pinion at particular load stages for the tested material combinations with the MoS_2/Ti coating. As in the case of the a-C:H:W coating, the mode of wear that appeared most often on the pinion teeth was taken into account. The photographs of the most often appearing mode of wear of the pinion at the highest load stage are also shown in the table. Red-shadowed cells in the table denote the failure load stage (FLS). Below are given the symbols of the wear modes, the total area of failures on the pinion (A_p) and wear of wheel (W_w). The symbols of wear were presented earlier in Table 2.

As can be observed in Table 6 for the tested material combinations, the two modes of wear that appear most often on the pinion teeth are scuffing and scoring. When one or both gears are coated, only scoring predominates on the pinion teeth.
