# **Economic Feasibility Study of Canal Plastic Lining in the Aral Sea Basin**

Inna Rudenko, Sanaatbek Salaev,  
Sanjar Davletov and Ruzumboy Eshchanov

<http://dx.doi.org/10.5772/59101>

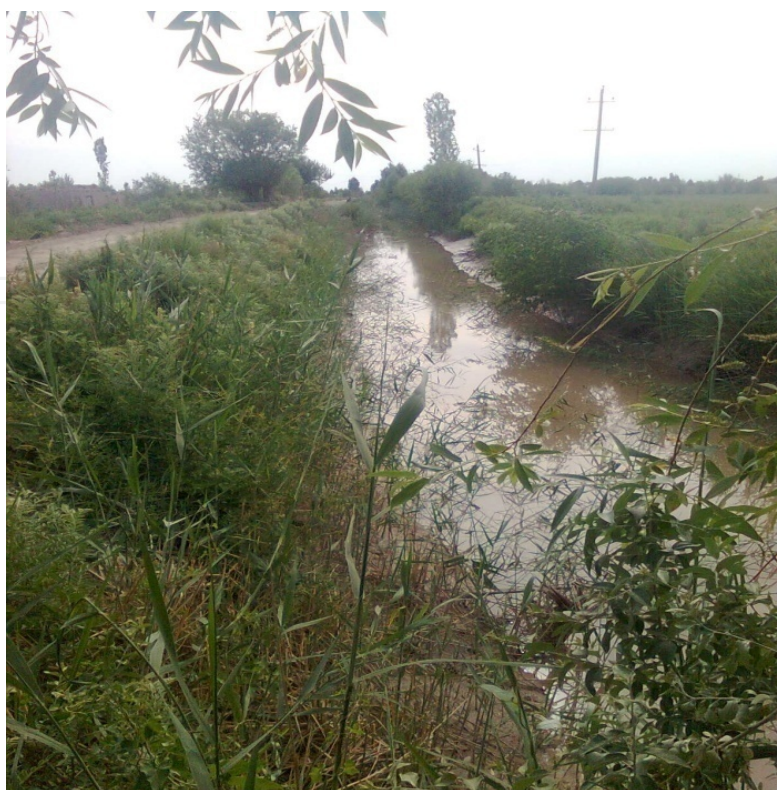
**Figure 1.** Appearance of the channel prior to plastic lining

The selected channel, 2.6 km long, provided irrigation water to 400 ha of farm land and had the discharge capacity of 1.5-2 m<sup>3</sup> per second. The average performance ratio hardly reached 0.49, meaning that 51% of water in the channel was lost due to seepage and infiltration.

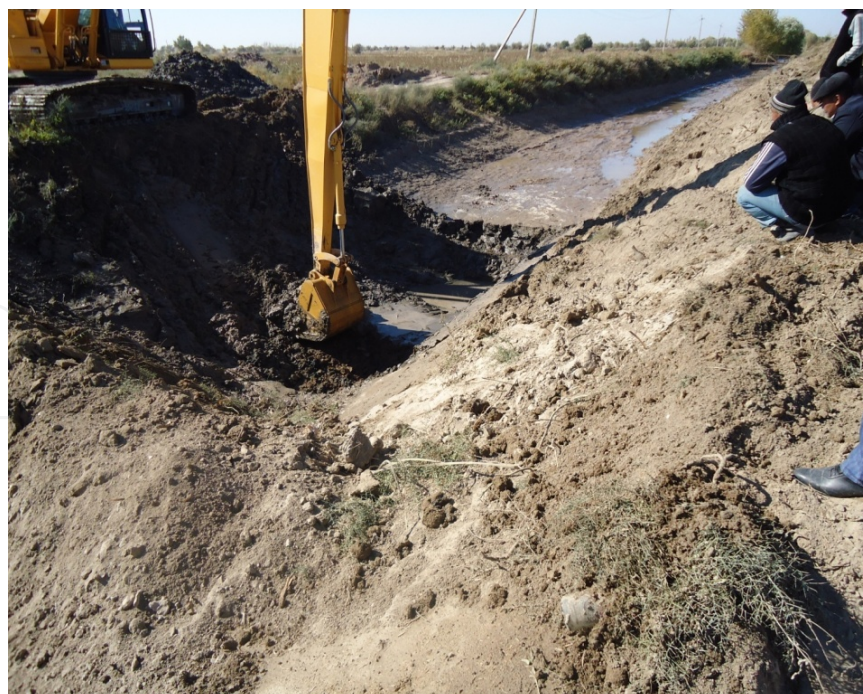
**Figure 2.** Cleaning the bottom and the banks of the channel

When applying the technology an area slightly larger than the banks and bottom of the canal was cleaned and excavated of soil. Prior to excavation works the channel was checked for elevation with the use of special leveling laser tools as to ensure gravity flow of water after plastic lining. Approximately 10 to 15 cm of sand was placed as a base on the cleaned bottom of the channel (refer to the photos). The plastic was laid on top of the sand. The plastic was then covered by up to 0.5 m layer of compacted soil to keep the plastic in place, and prevent exposure to the sun.

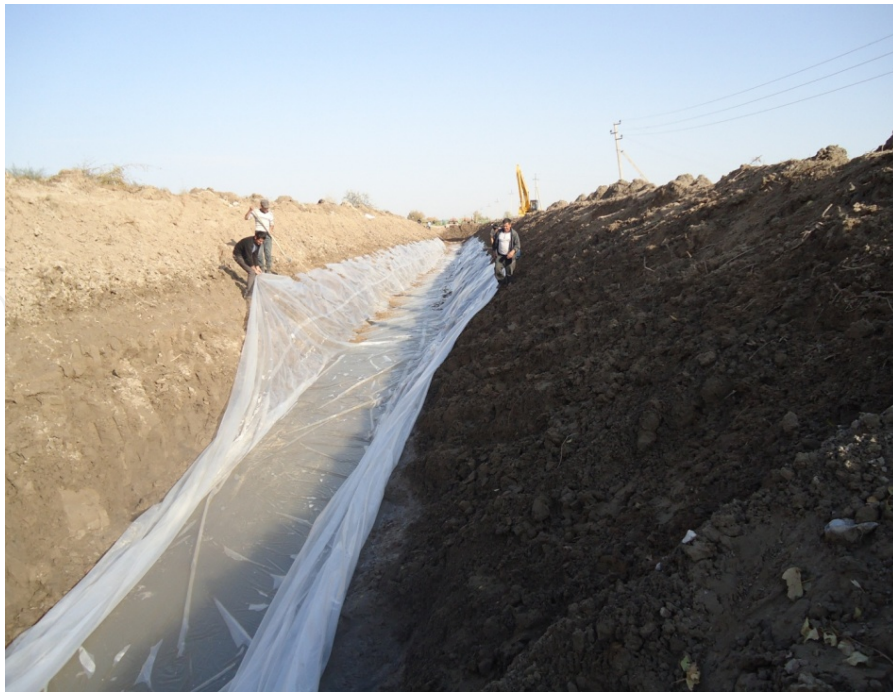
**Figure 3.** Lining of plastic

Specifications of the plastic liner included 100  $\mu\text{m}$  thickness, 7 m wide, and elasticity of 250%. Such plastic is locally available and is usually and widely used by the rural population to cover the temporary greenhouses for year round production of vegetables and green vegetables. The

plastic laid at the bottom of the channel can last up to 50 years given the proper coverage by compacted soil and non-exposure to the UV sun rays.

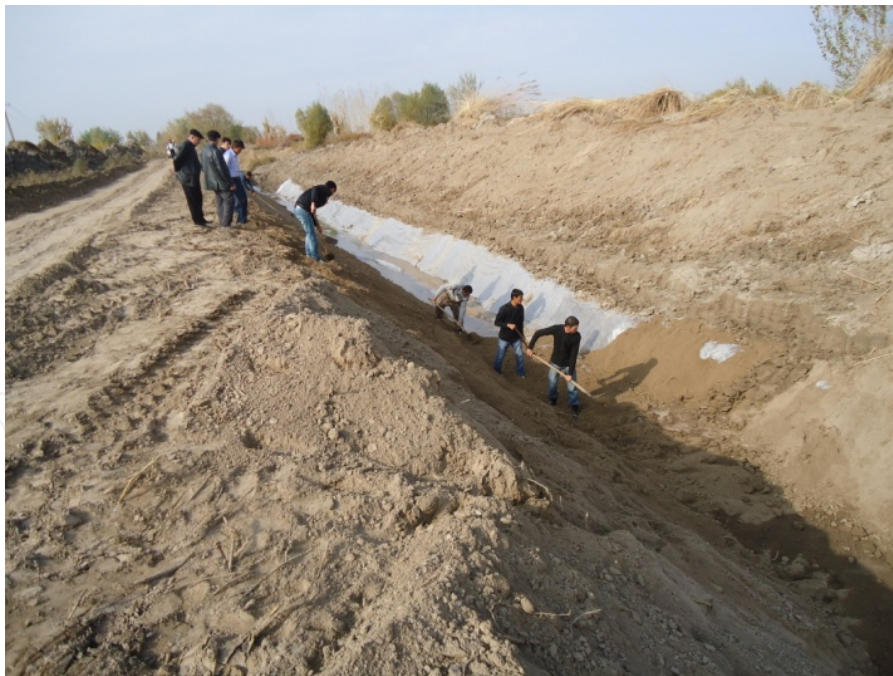
**Figure 4.** Covering of plastic with compacted soil

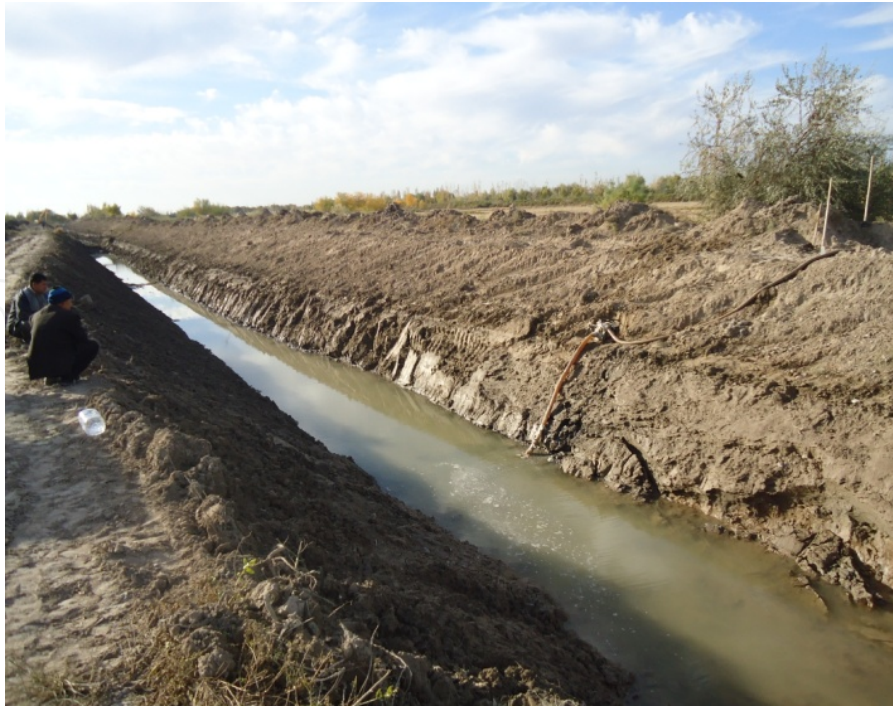
**Figure 5.** Gravity flow of water in the plastic lined channel

Another major achievement was the gravity flow of water in the lined channel due to leveling measures. Gravity flow allowed the farmers to stop using pumps for delivering water both to the tail end of the channel and to the fields with higher elevation levels compared to the channel. Thus, the farmers could save enormous financial resources for electricity or diesel, not talking about the benefits to the environment.
