Case Study: Detached House Designed by Following the Control System

Kazutoshi Fujihira

Abstract

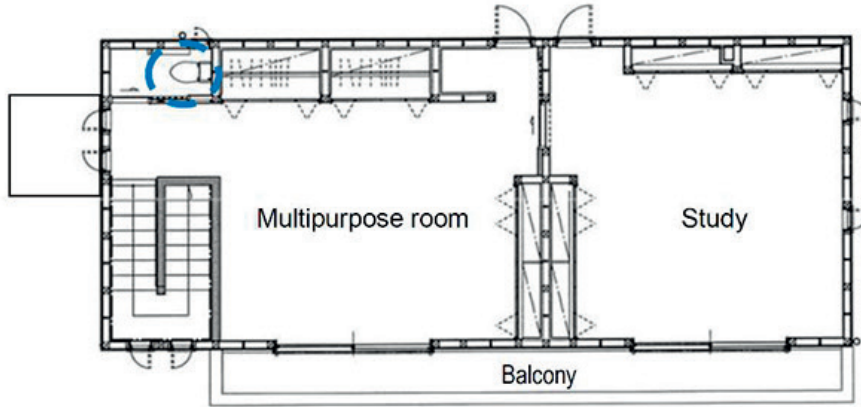
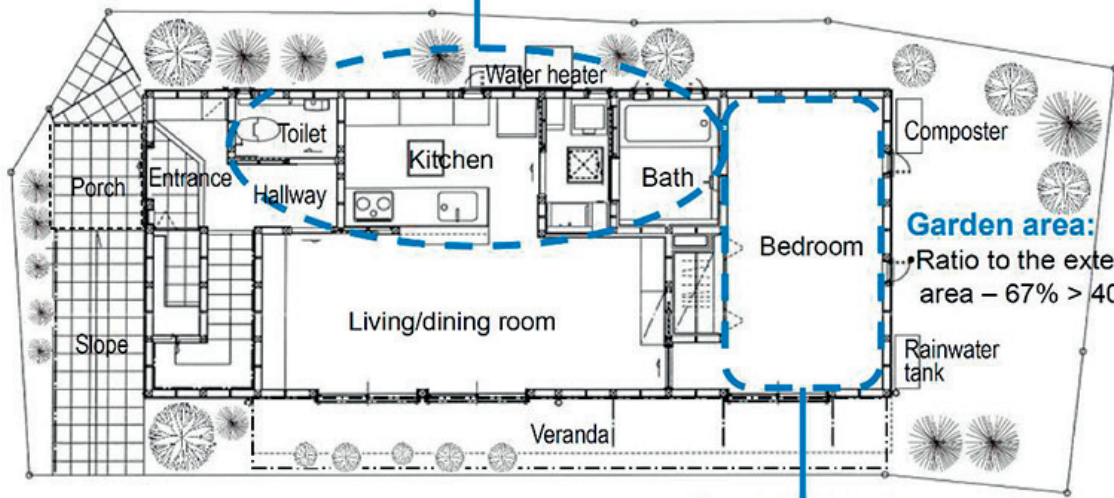
Figure 1. Site and floor plans.

- First floor area: 61.48 m²
- Second floor area: 61.48 m²
- Total floor area: 122.96 m²

- Total floor area – 122.96 m² > 75 m² [OK]
- Proviso: Each floor area (excluding stairs) > 40 m² [OK]

Position and area of windows:

- Natural ventilation – CASBEE Q_H1 1.2.1: Level 5 [OK]
- Ratio of the total daylighting window areas to the floor area in each living space – 25-31% > 20% [OK]

Areas relating to water use and hot-water supply:

- Areas in the home – Placing them closer [OK]

Garden area:

- Ratio to the exterior area – 67% > 40%

Specified bedroom:

- Routes to toilet & bath area, dining room, kitchen, and entrance - Accessible without steps [OK]
- Internal floor space - 12.6 m₂ > 9 m₂ [OK]

First, **Figure 1** demonstrates the site plan and floor plans in which the descriptions of five spatial elements are included.

The total floor area of this detached house is 122.96 m²; both the areas of the house’s first and second floor (excluding stairs) exceed 40 m². These figures sufficiently satisfy the desired value, which has led to the LQH certification.

In this house, their bedroom and other essential areas for daily life, namely toilet, bath, dining room, kitchen and entrance, all have been placed on the first floor [1]. This floor planning enables them to have easy access to such areas without any steps [1].

Meanwhile, the “internal floor space” of this specified bedroom is 12.6 m², which has fulfilled the desired value, 9 m² or more.

We have located windows so as to allow breezes in and heat out. As shown in **Figure 1** and **Table 1**, all of the four living spaces, namely living/dining room & kitchen, bedroom, multipurpose room, and study, have windows which face two or three directions. This arrangement of the windows meets the desired value, “Level 5” of the CASBEE’s relevant item. In

In order to take sufficient daylight in, we have secured larger window areas, especially on the southern side of each living space. As demonstrated in **Figure 1** and **Table 1**, the ratios of the window area to the floor area in the four living spaces range between 25 and 31%. These values have substantially satisfied the desired value, 20% or more.

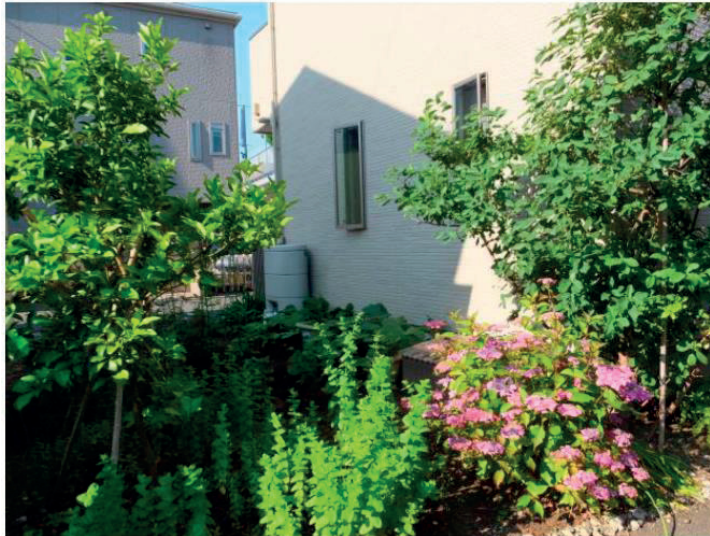
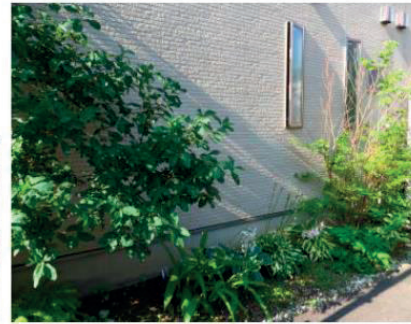
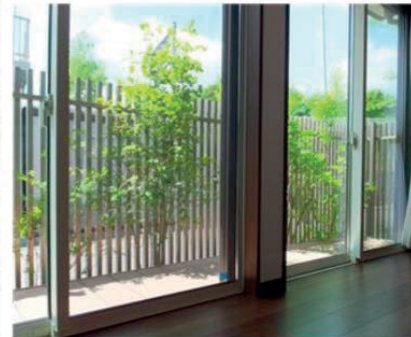
Figure 2. Plants in the garden area.

Eastern area:
Vegetable garden surrounded by various kinds of plants

Northern area

Southern area:
Plants in front of the veranda

In this building site, the “garden area” surrounds the areas of the house, veranda, approach to the entrance, and subsidiary equipment such as the rainwater tank, as demonstrated in **Figures 1** and **2**. The garden area and the total exterior area are 45.9 and 68.7 m², respectively. Therefore, the “ratio of the garden area to the total exterior area” is 67%, which satisfies its desired value, 40% or more. In the garden area of this home, various kinds of trees, shrubs, and herbs have been planted. Moreover, in a part of the garden area near the rainwater tank and composter, several kinds of vegetables are cultivated every year.

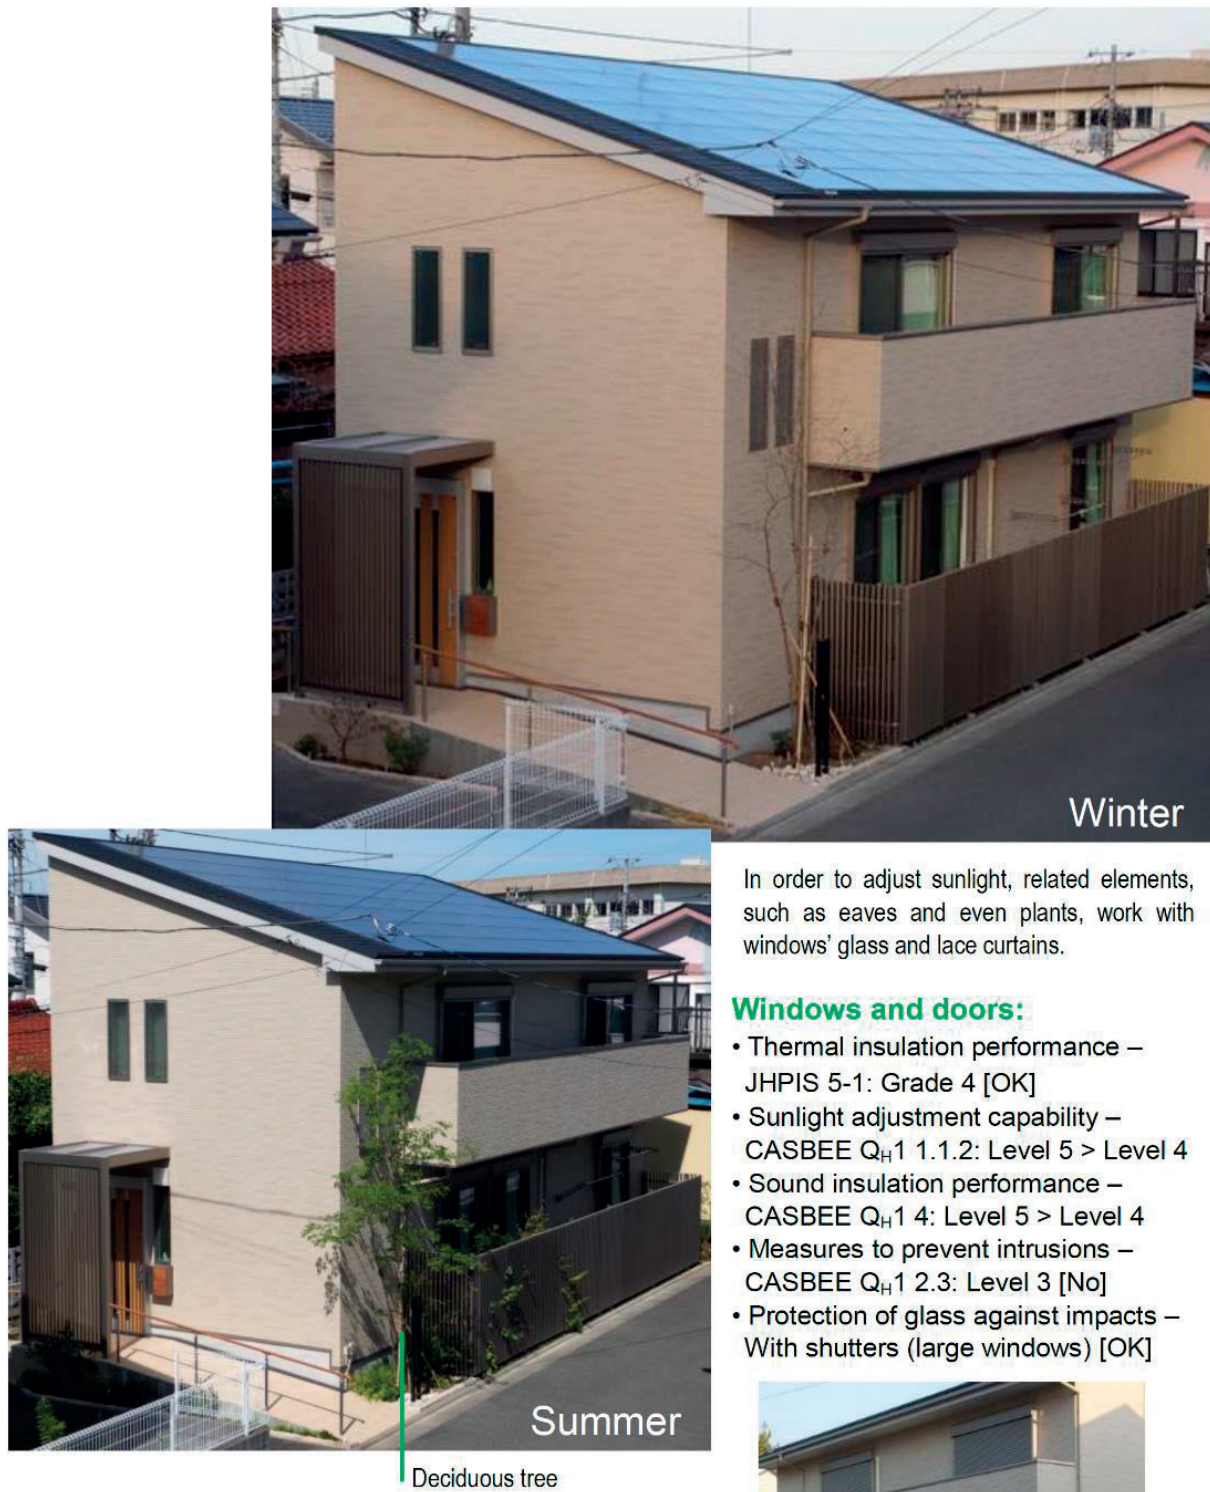
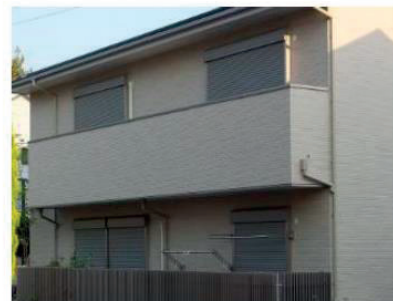
Figure 3. External appearance.

In order to adjust sunlight, related elements, such as eaves and even plants, work with windows' glass and lace curtains.

Windows and doors:

- Thermal insulation performance – JHPIS 5-1: Grade 4 [OK]
- Sunlight adjustment capability – CASBEE Q_H1 1.1.2: Level 5 > Level 4
- Sound insulation performance – CASBEE Q_H1 4: Level 5 > Level 4
- Measures to prevent intrusions – CASBEE Q_H1 2.3: Level 3 [No]
- Protection of glass against impacts – With shutters (large windows) [OK]

Exterior (outer wall, roof, etc.):

- Fire resistance (outer wall) – JHPIS 2-6: Grade 3 [OK]
- Shape & color – Consideration for the landscape [OK]
- Durability – CASBEE Q_H2 1.2 & 1.3: Level 4 [OK]
- Materials – CASBEE LR_H2 1.3: Level 1 [No]

Figure 3 shows external appearance, including panoramic views in winter and summer, with the descriptions of two material elements: “exterior” and “windows and doors.”

As demonstrated in the bottom right-hand photo of **Figure 3**, “shutters” have been installed on the large windows which face south. The installment of these shutters have been aimed at protecting the glass against impacts, including fire, hurricane, and flying objects [1]. This installment can also reduce the risk of being damaged by the adverse impacts of climate change, such as typhoons [1], which are projected to increasingly become more severe.

As demonstrated in **Figure 3**, the greater part of the single-pitch roof is covered with solar panels. The total power generation capacity of the 49 solar panels amounts to 11.4 kW. In the 1 year immediately after moving-in, this solar system generated the electricity of 15,911 kWh [1]. In the same period, the energy consumed in this house has been 3085 kWh [1]. Thus, as shown in **Figure 4**, the energy self-sufficiency reached a surprising 516%, which substantially exceeded the desired value, 100% [1].

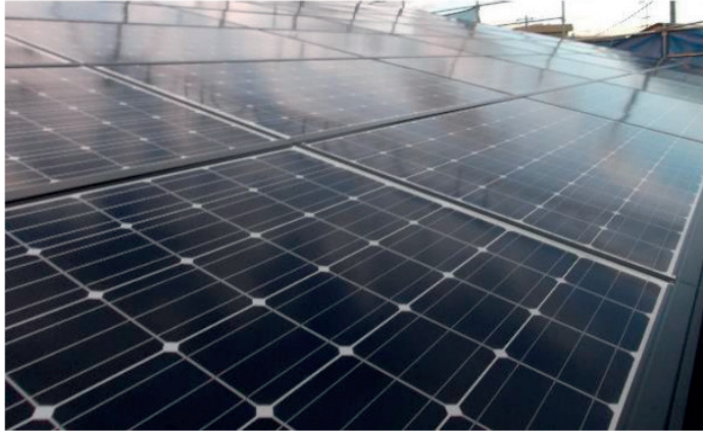
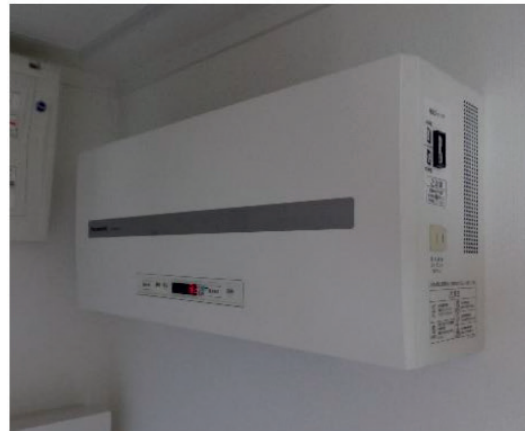
Figure 4. Equipment for harnessing natural energy.

Equipment for harnessing natural energy:

- Harnessed natural energy – 516% of the total energy usage > 100%

Solar panels:

The solar-generated electricity is preferentially used in this household. The surplus electricity is transmitted to the power grid.

Power conditioner:

In an emergency, the grid-connected system can be switched to the self-supported operation, so as to provide emergency household electricity.

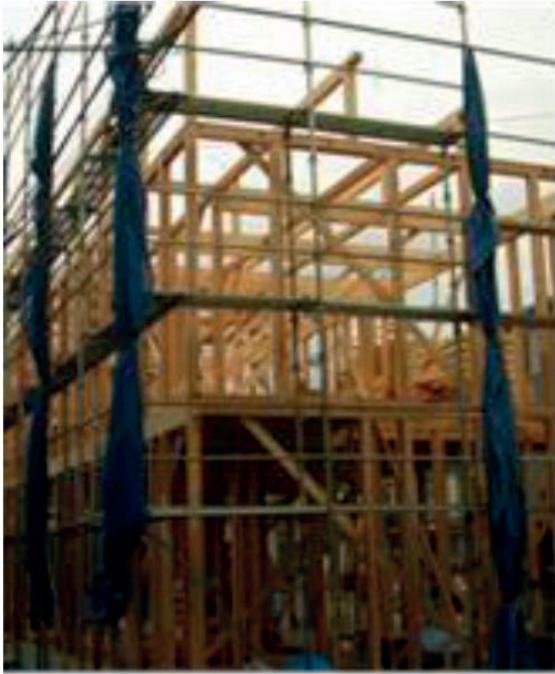
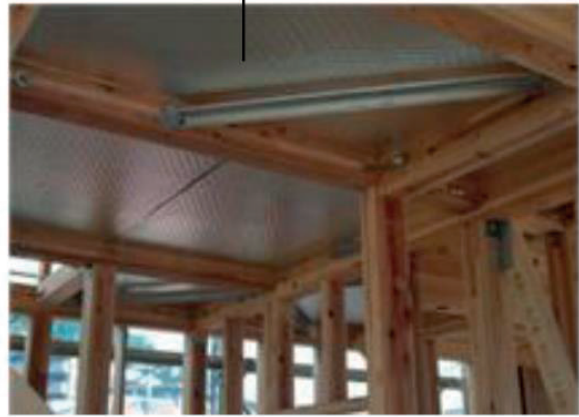
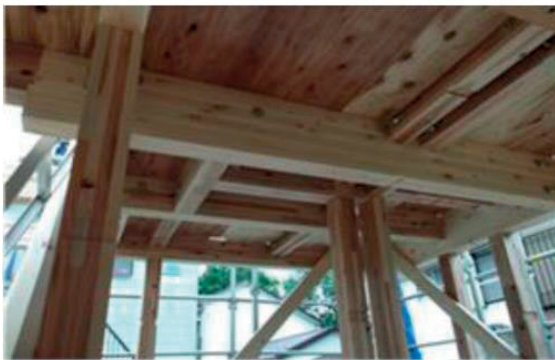
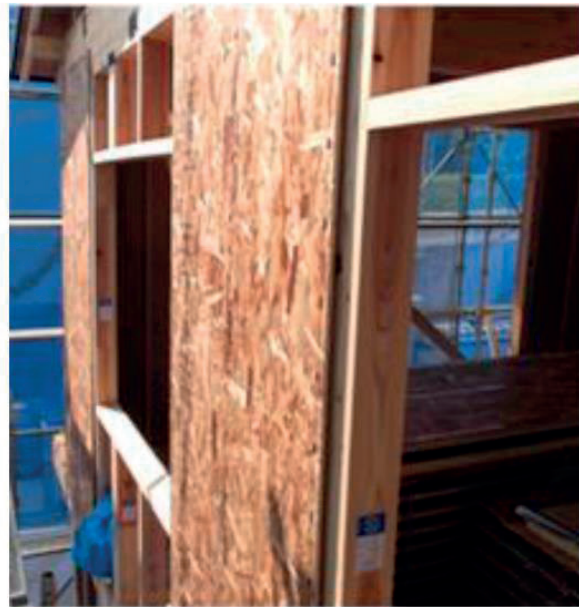
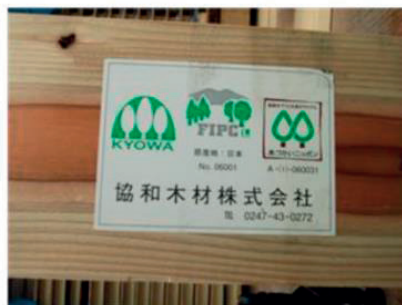
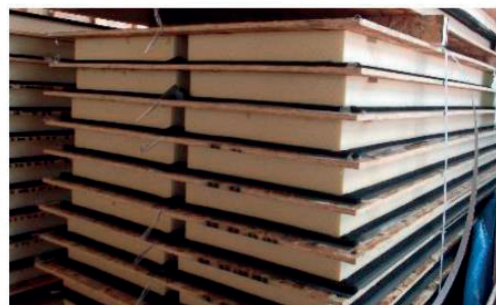
Figure 5. Framework and thermal insulation.

Framework:

- Resistance to earthquakes – JHPIS 1-1: Grade 3 > Grade 2
- Durability – JHPIS 3-1: Grade 3 [OK]
- Materials – CASBEE LR_H 2 1.1 Level 5 > Level 4

Thermal insulation:

- Thermal insulation performance – JHPIS 5.1: Grade 4 [OK]

Ceiling insulation:

Boards of rigid polyurethane foam with foil facing

The label shows the legality and sustainability of the wood.

Well-insulated airtight wall panels backed with boards of rigid polyurethane foam

This home has been designed so that the “resistance to earthquakes” of the framework meets “Grade 3” in the Seismic resistance grades of JHPIS (Figure 5), which surpasses the required level, Grade 2. “Grade 3,” the highest grade, means that the building can withstand 1.5 times the strength of an earthquake stipulated in the Building Standards Act of Japan, as an earthquake that occurs very rarely, that is, once every several 100 years [5].

Rigid polyurethane foam and extruded polystyrene form are used as thermal insulation materials of this home. Boards of rigid polyurethane foam, one of the most efficient high performance insulation material with minimal occupation of space [9, 10], are placed in the walls facing outside as well as on the ceiling of the second floor (Figure 5, right). Boards of extruded

polystyrene foam, features of which includes greater insulating power and higher resistance to compression and moisture [9, 10], are installed on the base and earth slab concrete.

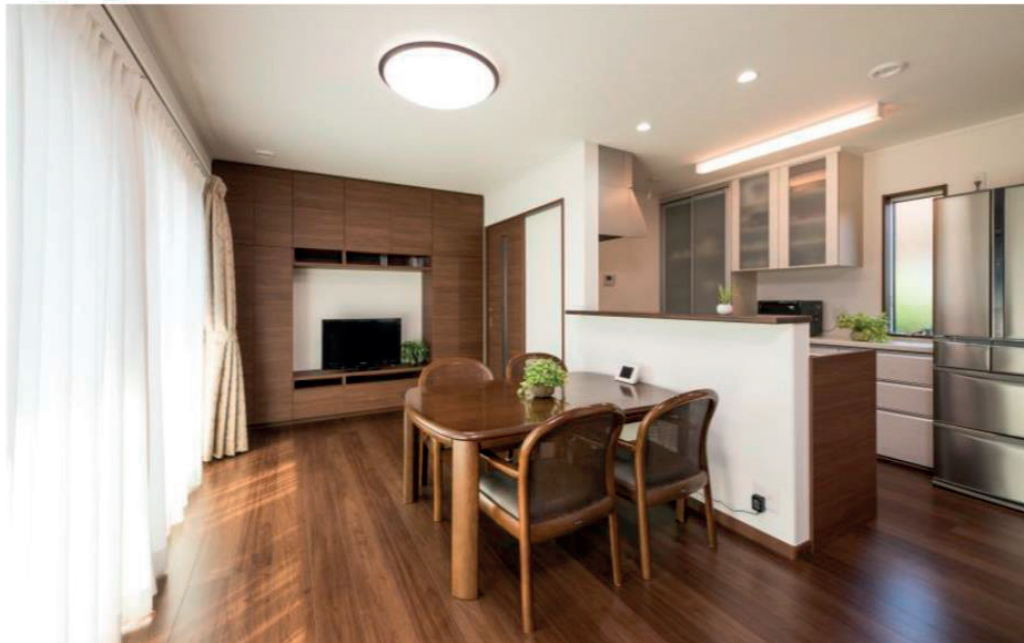
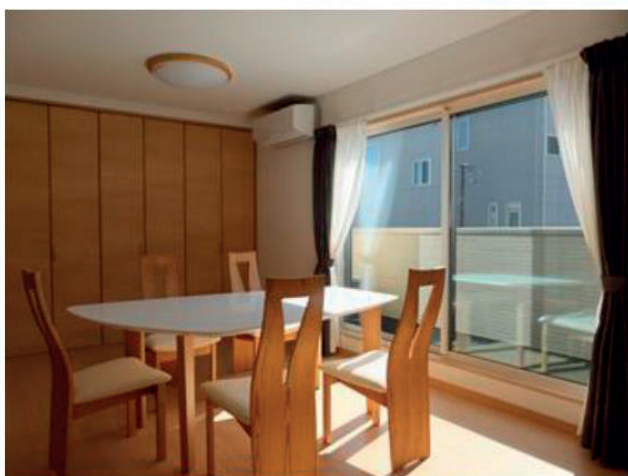
Figure 6. Interior, appliances, and lighting fixtures.

Lighting fixtures: • Type of light – LED [OK]

Living/dining room and kitchen

Multipurpose room

Appliances:

- Energy-saving standard achievement rate –
[Refrigerator] Five stars [OK]
[Television] Five stars [OK]
[Air conditioner] Four stars [OK]

Interior:

- Measures against formaldehyde –
JHPIS 6.1: Grade 3 [OK]
- Materials – CASBEE LR_H2 1.4: Level 3 [No]

Figure 6 illustrates three material elements, namely "interior," "appliances," and "lighting fixtures".

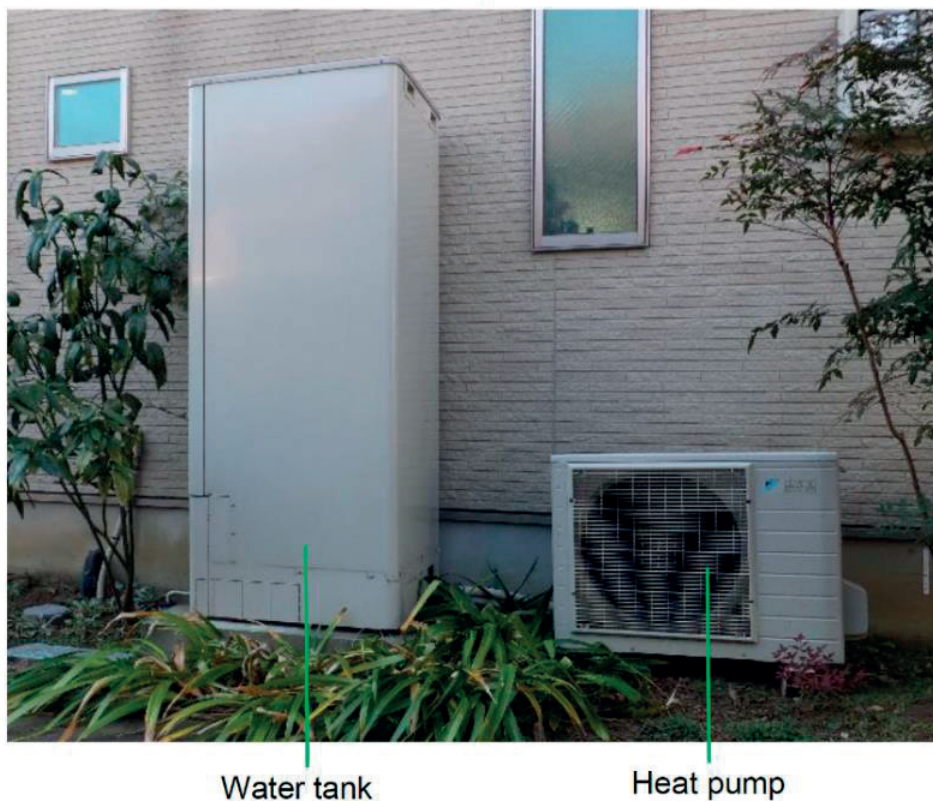
Figure 7. Water heater.

Water heater:

- Type of water heater – Electric heat-pump water heater
= CASBEE LR_H1 2.2.1: Level 5 [OK]

We have selected an “electric heat pump water heater” as hot water supply equipment. Heat pump water heaters take the heat from surrounding air and transfer it to water in an enclosed

The utilization of an electric heat pump water heater meets the desired value, “Level 5” in the assessment levels of the CASBEE’s relevant item. In addition, the heat pump water heater used in this home (**Figure 7**) can produce three times as much heat energy as consumed electric energy.

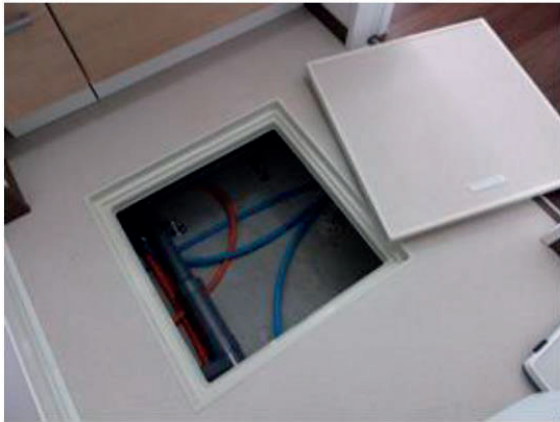
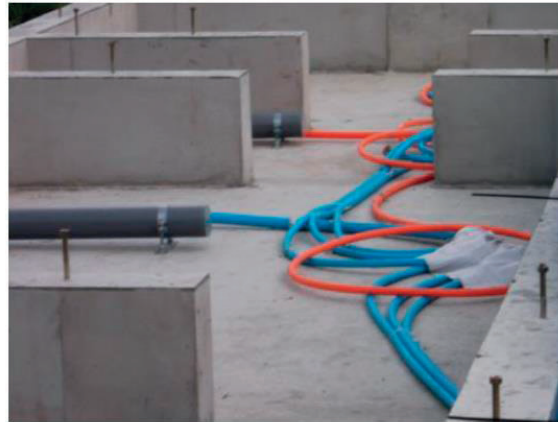
Figure 8. Piping.

Piping:

- Measures for maintenance – JHPIS 4.1: Grade 3 [OK]
- Method of water and hot-water piping – Header and pipe-in-pipe system [OK]

Underfloor inspection opening

Header and pipe-in-pipe system:
Water pipes (blue) and hot-water pipes (orange)

been becoming widespread in Japan, due to its several advantages, including easy maintenance, easy piping work, and energy efficiency. Consequently, we have naturally adopted this piping method and achieved the desired value (Figure 8, right).

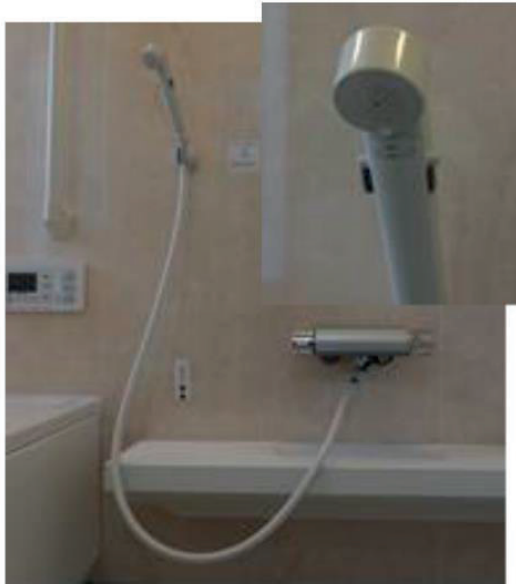
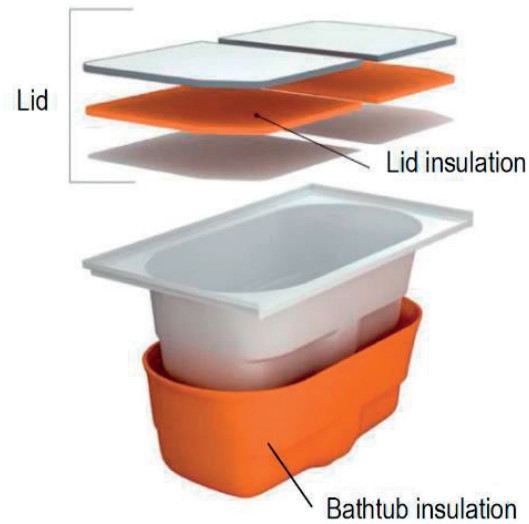
Figure 9. Water-using equipment and bathtub [14].

Water-using equipment:

- Water-saving functions – CASBEE LR_H1 3.1: Level 5 [OK]

Bathtub:

- Heat insulation – Insulated [OK]

Structure of the insulated bathtub

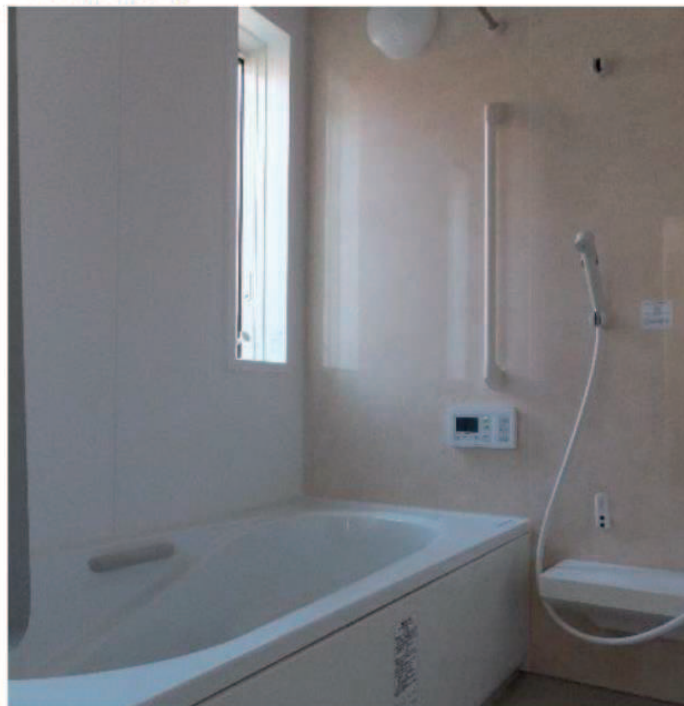
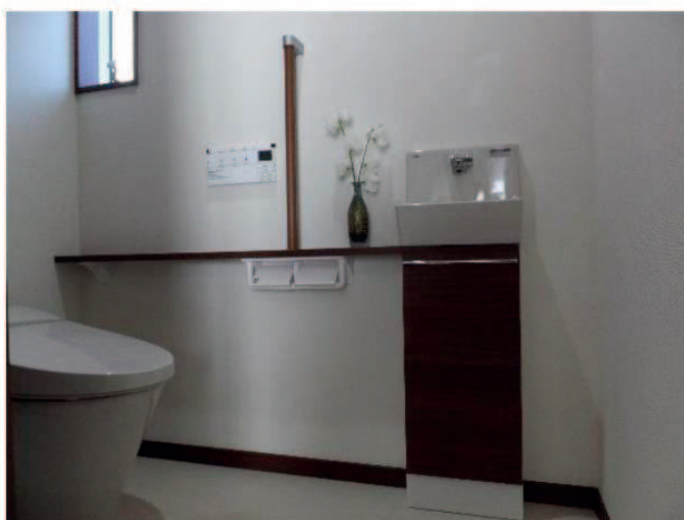
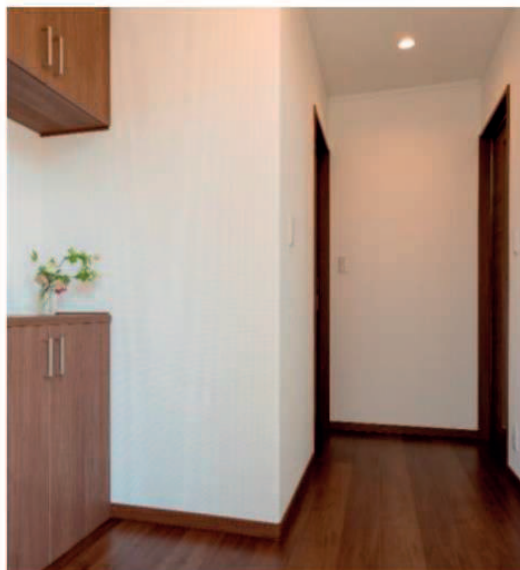
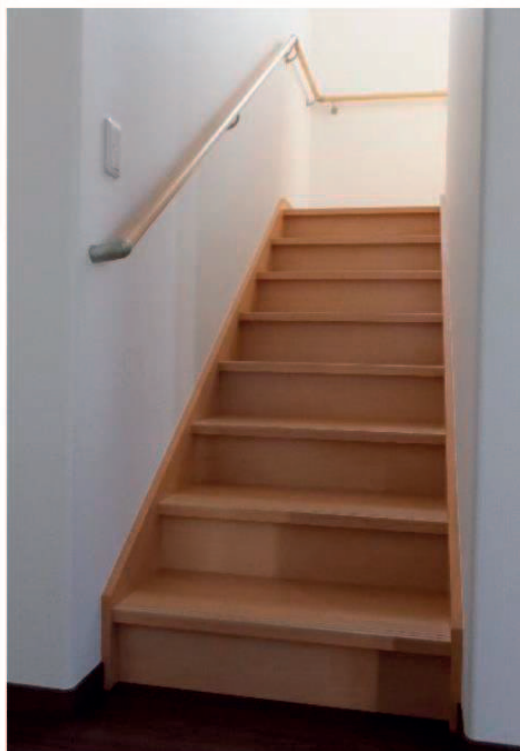
Bathroom:

- Width – 160 cm > 130 cm [OK]
- Floor space – 3.2 m² > 2 m² [OK]
- Handrail helps users go in out of the bathtub – Installed [OK]

Toilet:

- Length – 169 cm > 130 cm [OK]
- Spacing from the front rim of the toilet bowl to the wall – 98 cm > 50 cm [OK]
- Handrails help users sit and stand – Installed [OK]

Hallway:

- Width – 104 cm > 78 cm [OK]

Stairs:

- Grade of steepness:
 - Rise/Run – 18/25 < 22/21 [OK]
 - (Rise * 2 + run) – 610 mm < 650 mm [OK]
 - Run – 250 mm > 195 mm [OK]
- Handrail – Installed [OK]

Figure 10 illustrates four spatial elements, namely “bathroom,” “toilet,” “hallway,” and “stairs.”

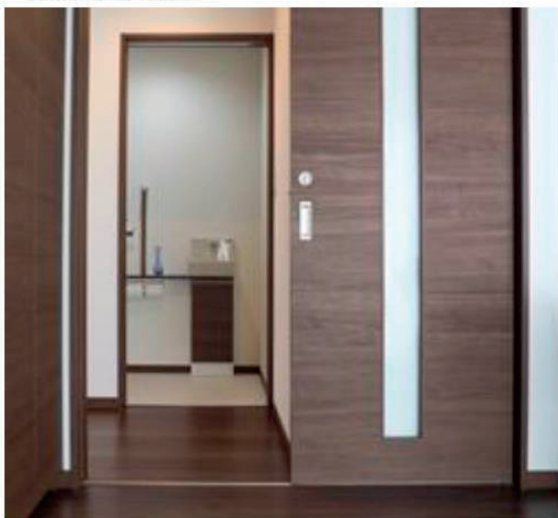
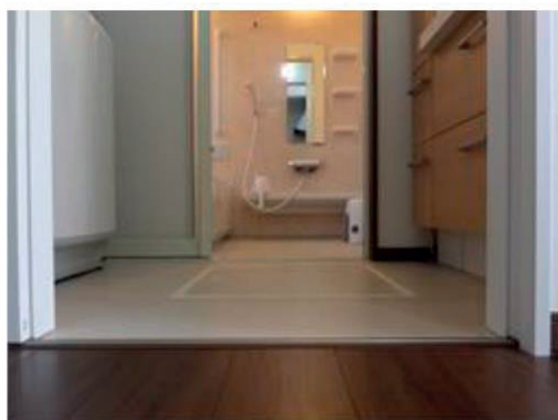
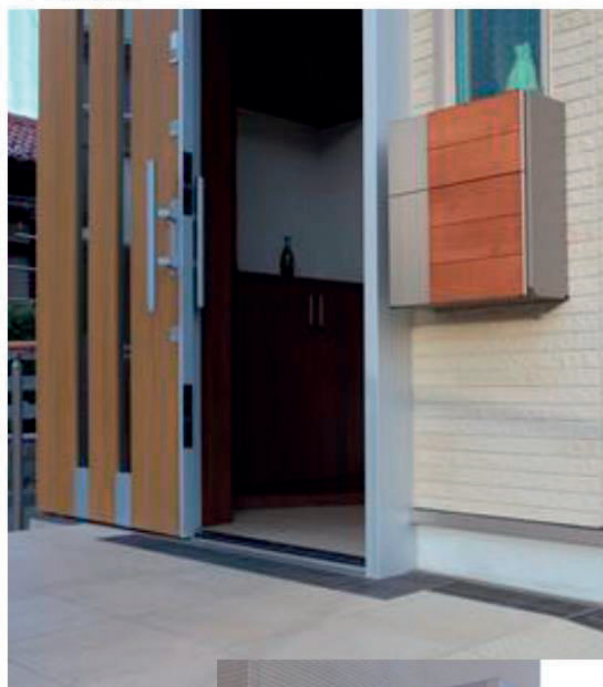
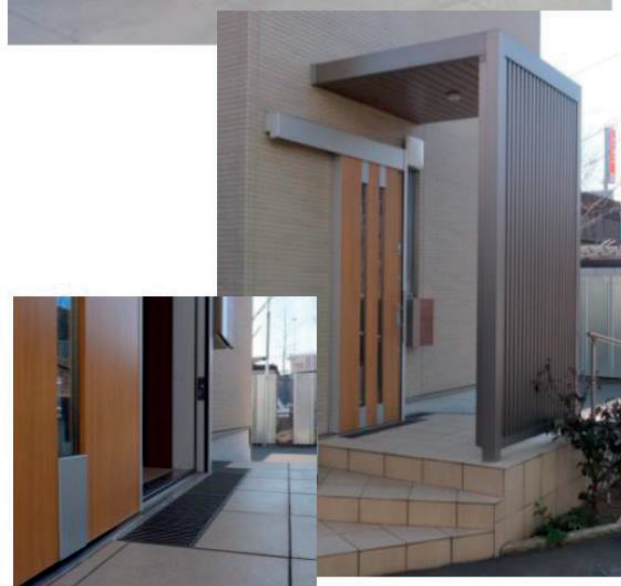
Figure 11. Doorways.

- Differences in level – No differences [OK]
- Width (except bath) – 75 cm [OK],
Width (bath) – 67cm > 60 cm [OK]

LDK and toilet

Washing room and bath

Entrance

At the entrance door, “no difference in level” requires appropriate protection from the rain and storm. In this case, a grated drain and a relatively large roof over the porch limit the quantity of water in the area adjoining the sliding door.

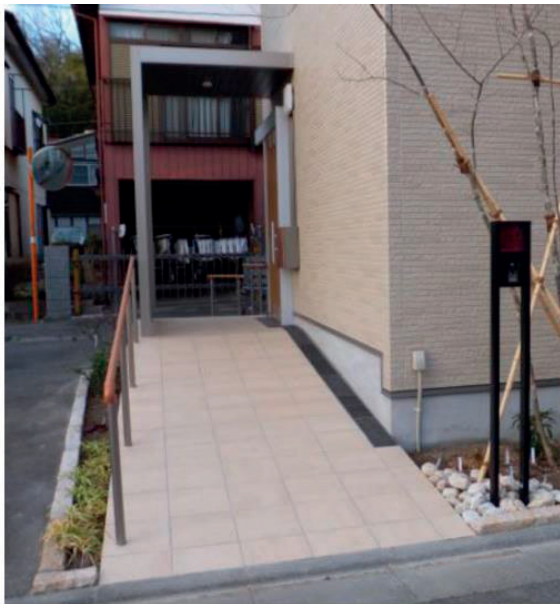
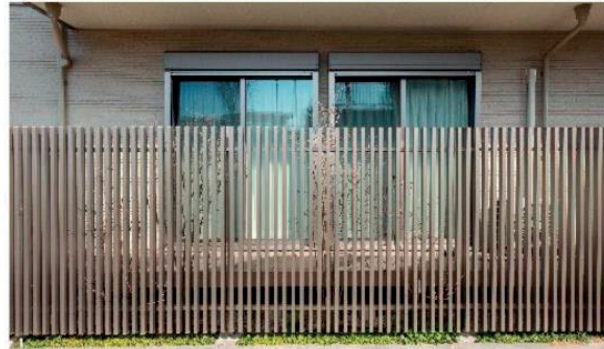
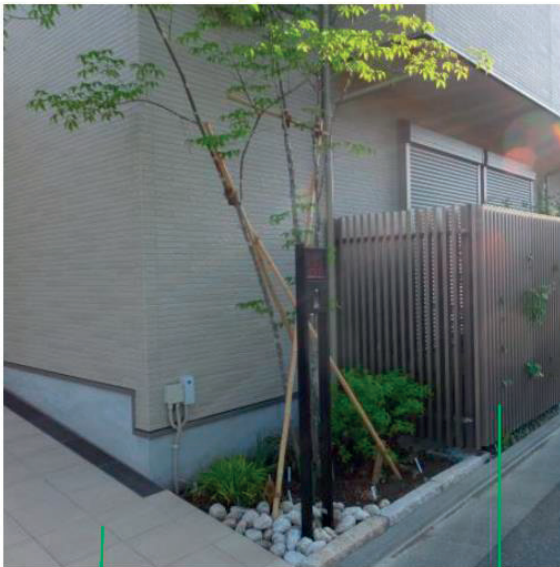
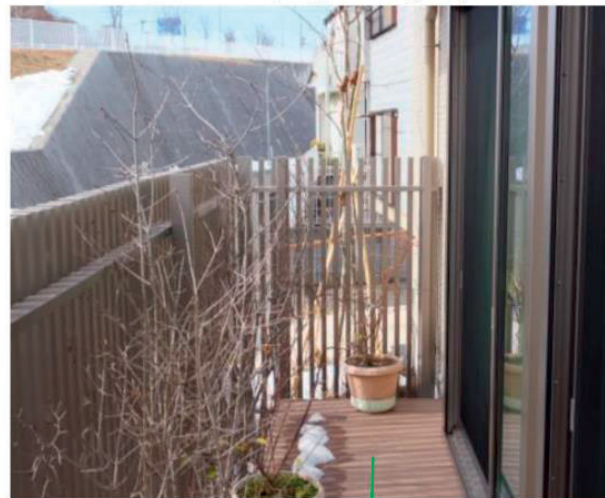
Main access route to the entrance:

- Surface – Level or sloping [OK]
- Width – 140cm > 90cm [OK]

Slope:

- Grade of steepness – $1/9 < 1/8$ [OK]
- Handrail – Installed [OK]

Outdoor facilities (Fence):

- Form – Not blocking sightlines [OK]

Floor tile – recycled product

Fence – recyclable product

Veranda deck – recycled product

“Appearance” of outdoor facilities, including color and shape, requires “consideration for the landscape.” The color of the fence and the porch’s roof and screen, which is called “shining gray,” is the same as that of the house’s window frames and shutters. The tiles of the approach floor have a similar color to that on the outer walls, namely light beige. We expect that the above color coordination creates sense of unity between the house and outdoor facilities and moreover brings stability to the landscape.

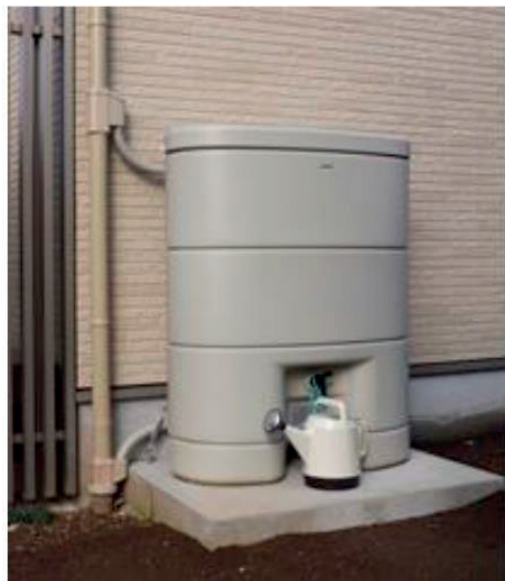
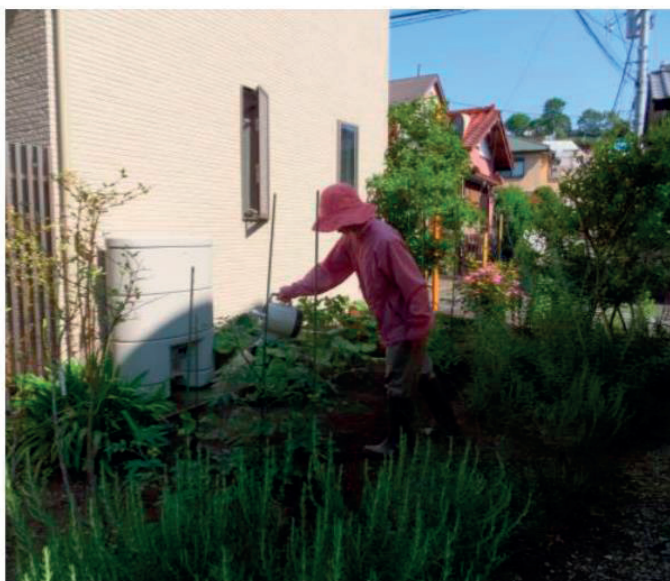
Figure 13. Equipment for rainwater use.

Equipment for rainwater use:

- Rainwater equipment – CASBEE LR_H1 3.2: Level 4 [OK]

200-liter rainwater tank

Watering the garden by using the rainwater
