EQ-grid: A Multiaxial Seismic Retrofitting System for Masonry Buildings

Stefania Rizzo and Lothar Stempniewski

Abstract

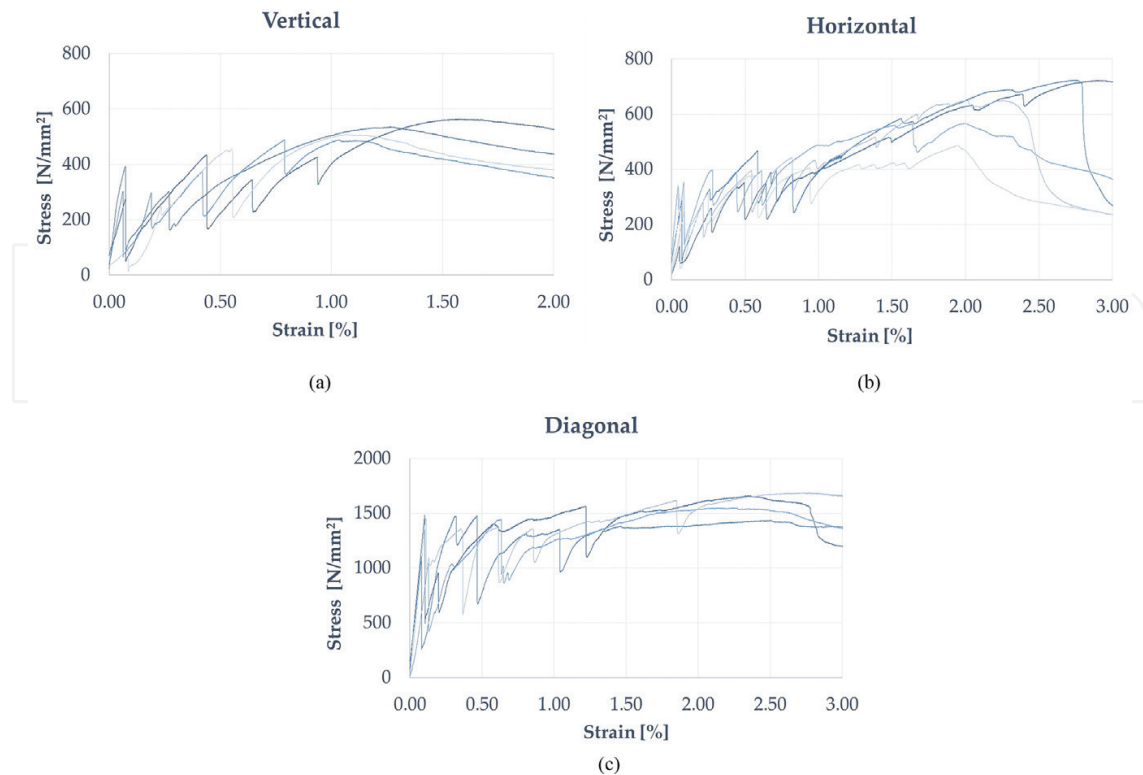
Figure 4. Results of the tensile tests on the EQ-grid composite specimens: (a) stress–strain curves in the vertical direction; (b) strain curves in the horizontal direction; and (c) stress–strain curves in the diagonal direction.

where F is the measured tensile force and A_{eq} is the equivalent cross-sectional area. Moreover, it is easy to recognize the uncracked phase in each curve of **Figure 4**, in which the tensile behaviour of the system is mainly governed by the mechanical properties of the matrix. The stress in the matrix at the first cracking load can be so evaluated as:

After reaching the tensile strength of the matrix, cracks develop and the load is gradually transferred to the textile. Furthermore, the cracking and cracked stages cannot be clearly identified in all the response curves. The average number of cracks in the vertical direction is 2.75 and the distance between these is about 12.8 cm. In the horizontal direction, four cracks with an average distance of 8.2 cm approximately formed, while three cracks with an average distance of 13.6 cm formed in the diagonal direction. The higher number of cracks in the horizontal direction is due to the better bond between fibres and matrix [3]. In fact, the AR glass fibres in this direction cannot be uniformly bundled by the production process. However, this manufacturing inaccuracy has a positive impact on the system's load bearing capacity. The mortar can better encapsulate the individual horizontal fibres and provides increased force against the sliding of the fibres from the matrix. This improved bond in the horizontal direction is also confirmed by the fact that in two samples some fibres have broken after reaching the maximum tensile force. This is also easily recognizable in **Figure 4b**, in which two curves show a strength drop after the peak stress.

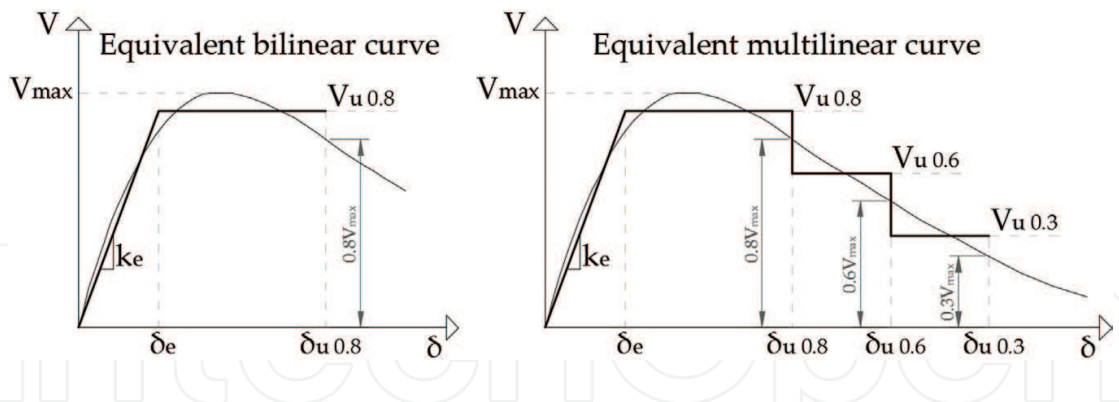
Figure 7. Cyclic envelope and the equivalent curves.

The in-plane response of unstrengthened masonry walls subjected to cyclic lateral shear tests is generally interpreted idealizing the cyclic envelope of the hysteresis loops with a bilinear force-displacement curve [10] (**Figure 7**).

Moreover, in order to define the inclination of the elastic line of the equivalent curves, the secant stiffness k_e (Figure 7) is determined. This is calculated between zero and the 70% of the maximum shear force V_{max} , since the walls are generally not cracked in this range of values and the behaviour can be approximated linear elastic. The ultimate displacement $\delta_{u,0.8}$ is identified on the envelope curve at a residual lateral strength equal to 80% of the maximum force ($0.8 V_{max}$ in the Figure 7). Ensuring that the dissipated energy of the experimental and the equivalent curve remains the same, the ultimate shear force $V_{u,0.8}$ (Eq. (6)) is calculated through the equivalence of the areas below the cyclic envelope $A_{env.}$ (Eq. (4)) and below the bilinear curve $A_{bil.}$ (Eq. (5)) [10].

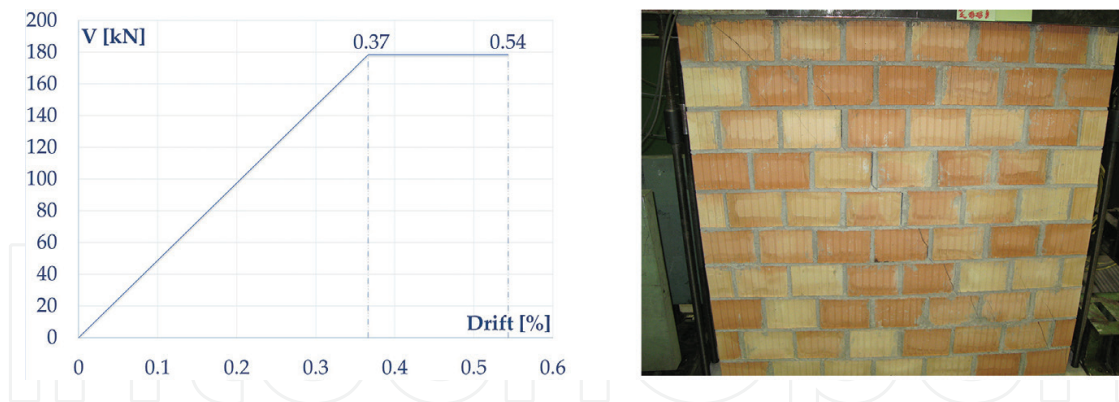
Figure 9. HC_UN: unstrengthened hollow clay masonry wall. Cracking pattern at $d_{u,0.8} = 0.54\%$ and equivalent bilinear curve.

The type of failure that has occurred in all the walls in hollow brick is the diagonal shear cracking, since all the specimens are squat with a slenderness ratio $h/b = 1$. The unstrengthened wall showed a very brittle behaviour after the attainment of the maximum force with cracks mainly through the bricks (**Figure 9**). In fact, after the peak, the hysteresis curve is characterized by a sudden strength degradation with residual force value of about 26 kN in the last displacement cycle. The equivalent bilinear curve is represented in **Figure 9**, in which the drift values $d_e = 0.37\%$ and $d_{u\,0.8} = 0.54\%$ are achieved. It is worth pointing out that this latter is higher than the ultimate interstorey drift adopted from the Eurocode 8 for

the life safety in case of in-plane shear failure (0.4%) [12]. Furthermore, the crack pattern at the drift 0.54% is also shown in **Figure 9**, in which it is easy to recognize the diagonal cracks mainly through the bricks, and the specimen can be considered in this case slightly damaged (grade 2).

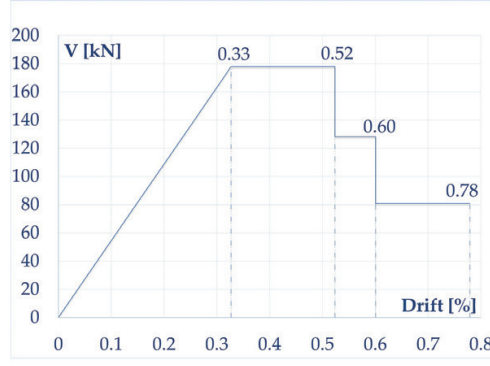
Figure 10. HC_S1: hollow clay brick masonry wall strengthened on one side. Cracking pattern and equivalent multilinear curve.

The wall reinforced on one side (**Figure 10**) has shown a similar behaviour in terms of maximum lateral force but the post-peak residual strength and displacement capacity are higher than the ones of the unreinforced wall. This is due to the greater post-peak dissipation of energy of the strengthened specimen, since no delamination occurred and the adhesion of the mortar matrix to the masonry substrate revealed to be very strong. This is also confirmed by the cracking pattern. In fact, the reinforced sample is not cracked (grade 1) at the ultimate drift $d_{u,0.8} = 0.52\%$ (**Figure 10**) while the unstrengthened wall was already damaged (grade 2) at practically the same level of drift ($d_{u,0.8} = 0.54\%$ for this latter). Only in correspondence with the drift of 0.60% a slight cracking occurred (grade 2) and finally at $d_{u,0.3} = 0.78\%$ the wall was moderately damaged with cracks mainly through the bricks and spalling of the brick at the centre of the wall (**Figure 10**).

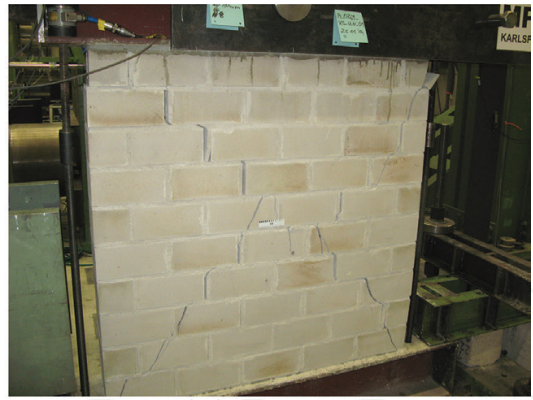
Figure 12. CS_UN: calcium-silicate brick masonry wall unstrengthened. Cracking pattern at 0.51% drift and equivalent bilinear curve.

As already mentioned for the hollow brick samples, also the calcium-silicate walls failed with diagonal cracks from corner to corner, since the specimens have all the same dimensions ($125 \times 125 \times 24$ cm with the slenderness ratio $h/b = 1$) and the vertical applied load is the same. The unreinforced wall collapsed by shear cracking with the development of diagonal cracks through the mortar joints and inclined cracks in the units at the centre and the compressed toes of the wall (**Figure 12**). The cracking began at the attainment of the maximum force, after that a sudden strength degradation occurred. The equivalent bilinear curve is shown in **Figure 12** in which the drift values $d_e = 0.29\%$ and $d_{u,0.8} = 0.51\%$ are reached. As for the specimen in hollow brick, also in this case the ultimate drift $d_{u,0.8}$ is higher than the one adopted from the Eurocode 8 [12]. The cracking pattern of the sample at the drift 0.51% is also shown in **Figure 12**, in which it is easy to recognize that the wall is moderately damaged (grade 3).

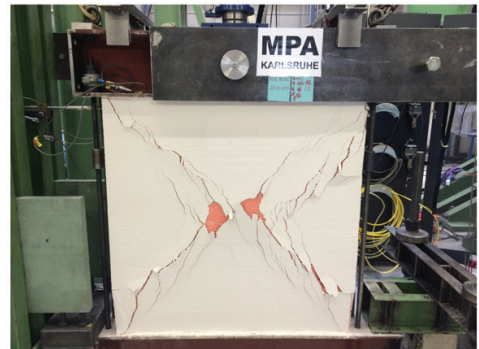
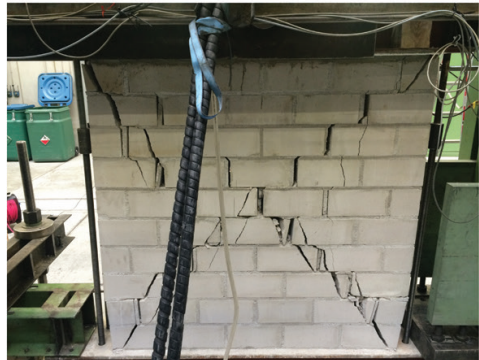
Figure 13. CS_S1: calcium-silicate brick masonry wall strengthened on one side. Cracking pattern and equivalent multilinear curve.

The specimen reinforced on one side (**Figure 13**) attained a greater value of maximum force and has shown a higher displacement capacity compared to the unreinforced sample. In fact, the ultimate shear $V_{u,0.8}$ and drift $d_{u,0.8}$ increase respectively by 44 and 21%. This is due to the presence of the EQ-grid system, which brings a structural improvement to the panel. In fact, more the mechanical characteristics of the masonry are poor, greater will be the effect of the reinforcement system. According to the Eurocode 6 and the German national annex [13], the calcium-silicate walls have a characteristic compressive strength f_k equal to 3.70 N/mm^2 and the E-Modulus of about 3500 N/mm^2 . On the other hand, the walls in hollow brick have better mechanical properties with the compressive strength f_k of 8.00 N/mm^2 and the E-Modulus of 7700 N/mm^2 . This is also confirmed by the fact that, despite the same geometry and the same
