# The Comparison of Cutting Tools for High Speed Machining of Ti-6Al-4V ELI Alloy (Grade 23)

Chakradhar Bandapalli, Bharatkumar Mohanbhai Sutaria and Dhananjay Vishnu Prasad Bhatt

#### **Abstract**

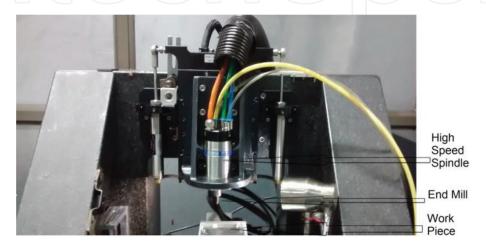
**Figure 1.**High speed micromachine.

Standardised experimental tests are carried out on high-speed micromachine setup as shown in **Figure 1**. The work material considered was Ti-6Al-4V ELI titanium alloy (Grade 23) of dimensions  $60 \times 40 \times 4$  mm as shown in **Figure 2**. Chemical composition and properties of the work material are shown in **Tables 1** and **2**. Experimental tests conducted are shown in **Table 3**. Two flute uncoated tungsten

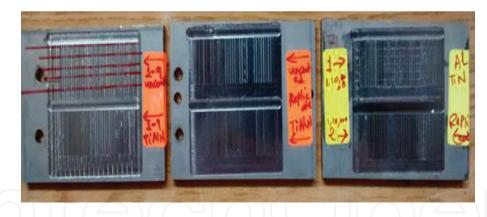
Figure 2.
Ti-6Al-4V ELI titanium alloy (Grade 23).

Properties	Metric
Tensile strength	860 MPa
Yield strength	790 MPa
Poisson's ratio	0.342
Elastic modulus	113.8 GPa
Shear modulus	44.0 GPa
Elongation at break	15%
Hardness Rockwell	35
Density	4.43 g/cm <sup>3</sup>
Melting point	1604–1660°C

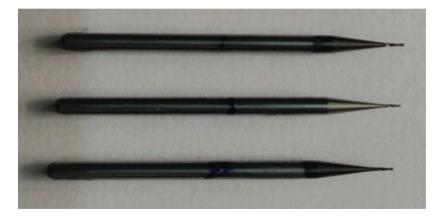
Figure 3.
Micro-end mills.

carbide end mills and physical vapour deposition-coated TiAlN and AlTiN tungsten carbide end mills of diameter 500  $\mu m$  supplied by IND-SPHINX Axis tools were used in this work as shown in **Figure 3**. The total length of each machined slot was 12 mm. Tool over hang length considered was 18 mm. The width of cut is 500  $\mu m$  as the process is slot milling operation. Cutting edge radius of tool identified is 2.71  $\mu m$  through SEM. Coating of the material as specified by the IND-SPHINX Axis tools is

$2-6~\mu m$ . Rake angle of the tool is +5°. Static run-out of the tool was measured as 3  $\mu m$ . No structural vibrations were observed under considered machining conditions. Chip thickness observed is about 3  $\mu m$ . Machining time was 10–12 s for 30,000 rpm, 6–8 s for 70,000 rpm and 3–5 s for 110,000 rpm.

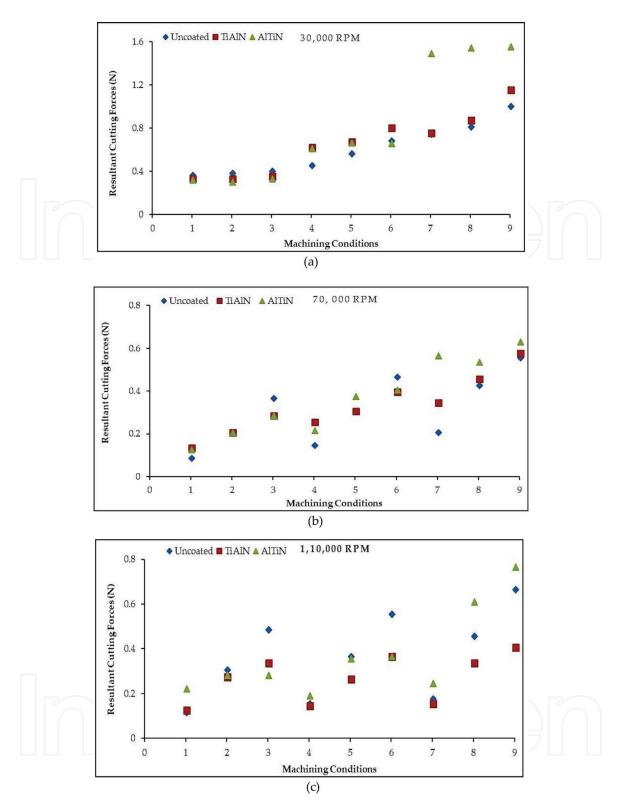
**Figure 4.** Comparison of (a) uncoated, (b) coated TiAlN and (c) AlTiN WC tools for resultant cutting force (N) at independent spindle speed (rpm), feed ( $\mu$ m/tooth), depth of cut (mm).

At 30,000 rpm, if depth of cut and feed is varied, then resultant cutting force increased by 63% as shown in **Figure 4(a)**. At 70,000 rpm, if depth of cut and feed is varied, then resultant cutting force increased by 87% as shown in **Figure 4(b)**. At 110,000 rpm, if depth of cut and feed is varied, then resultant cutting force increases by 83% as shown in **Figure 4(c)**.

At 30,000 rpm, if depth of cut and feed is varied, then resultant cutting force increases by 81.7% as shown in **Figure 4(a)**. At 70,000 rpm, if depth of cut and feed is varied, then resultant cutting force increases by 85.14% as shown in **Figure 4(b)**. At 110,000 rpm, if depth of cut and feed is varied, then resultant cutting force increases by 78% as shown in **Figure 4(c)**.

At 30,000 rpm, if depth of cut and feed is varied, then resultant cutting force increases by 82.6% as shown in **Figure 4(a)**. At 70,000 rpm, if depth of cut and feed is varied, then resultant cutting force increases by 87% as shown in **Figure 4(b)**. At 110,000 rpm, if depth of cut and feed is varied, then resultant cutting force increases by 85% as shown in **Figure 4(c)**.

From the experimentation, it is observed that the resultant cutting force increase might be due to the increment in feed rate and depth of cut, leading to more chip formation, high contact between tool and chip, high-temperature formation by shearing and ploughing action reducing the yield strength of work material. It was observed that when spindle speed is increased, while the depth of cut and feed rate is kept at low, then cutting force generated was less. When depth of cut and feed rates are reduced, the chip load encountered in the process becomes the same order of magnitude as the grain size of many alloys. The cutting-edge radius of the end mill is comparable in size to the chip thickness. As a result, no chip is formed when the chip thickness is below the minimum chip thickness and instead part of the work material plastically deforms under the edge of the tool and the rest elastically recovers. This change in the chip formation process, known as minimum chip thickness effect and the associated material elastic recovery cases, increased cutting forces and surface roughness. Observed irregularity on the machined surface due to the plastic side flow and burr formation seem to suggest that the tool workpiece interaction is more likely to be elastic-plastic in nature. Due to the increment in feed rate, depth of cut and cutting speed, the tool wear and cutting-edge distortion took place that leads to more cutting force requirement to remove the material. At 30,000 rpm, uncoated tools performed better than both the coated tools. Uncoated tools produced less cutting force compared to coated tools because of tools stability and resistance to wear. At 70,000 rpm, 0.02 and 0.06 mm depth of cut with feed 2–8 μm/tooth, the uncoated tool required more cutting force to remove the material rather than both the coated tools. At 70,000 rpm, 0.1 mm depth of cut with feed 2–8 μm/tooth, the uncoated tool is found to generate less cutting force than both the coated tools. At 110,000 rpm, coated TiAlN tools are better performed than coated AlTiN and uncoated tools, which is due to increase in cutting temperature in the shear zone, thus reducing the yield strength of the workpiece material, chip thickness and tool-chip contact length. If coated TiAlN and coated AlTiN tools are compared, then performance of TiAlN tools is better. Depending on the particular parameters during machining processes, uneven phenomenon (sudden tool or spindle vibration, sudden workpiece movement) occurs, leading to increase of cutting forces. SEM and EDS analyses are performed to identify the wear and its formation mechanism on two flutes of each tool, that is, uncoated and PVD-coated AlTiN, TiAlN tungsten carbide end mills as shown in Figures 5 and 6. Tool wear on particular end mill is observed using SEM after machining nine slots for each set of spindle speed as shown in Figures 7-12. Tool wears measured on each cutting flute in two series of experiments have been considered and average values are reported as shown in Figure 13. Coated TiAlN tool wear was high at spindle speed

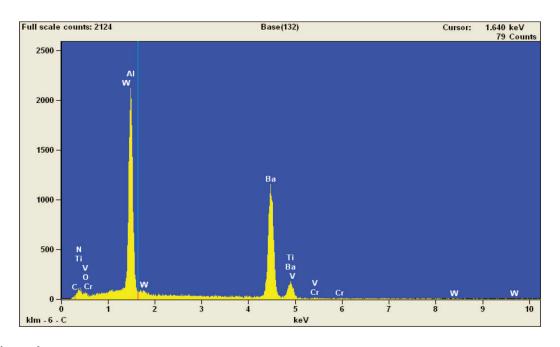
**Figure 6.** *EDS spectrogram.*

Adhesive, diffusion, abrasive and oxidation wear were the major means on the flank face. The elements observed on the cutting tool edge and workpiece indicate the diffusion process has taken place. From the EDS and SEM analyses, the existence of workpiece material constituents V, Al and Ti on the rake face wear land with built-up layer of cutting edge indicates diffusion might take place. Increasing cutting speed leads to the decrease in presence of V and Al at the tool cutting tool tip and it might be imaginable that Ti only sticks to the cutting tool edge. It has therefore been considered reasonable to suggest that the built-up layer was started through the sticking of Ti by different bonding actions, that is, directly proportional with temperature. Under very high speed cutting conditions, tool life depends directly on the formation of crater wear. Thin titanium oxide layer formation was observed on cutting edge of both the tools. In high-speed cutting conditions, cratering becomes so severe that the tool edge is weakened and eventually fracture which has been observed for the AlTiN and TiAlN tools at 110,000 rpm spindle speed, 0.1 mm depth of cut and 8  $\mu$ m/tooth feed rate. At higher and lower

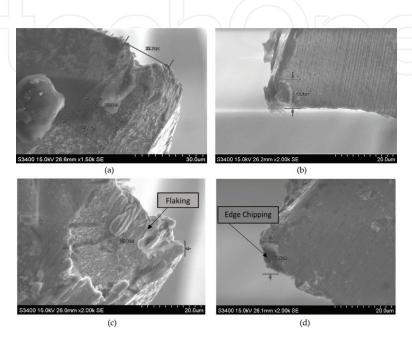
Figure 7.
(a–d) Tool wear observation for uncoated tools.

30,000 rpm machining conditions than uncoated and coated AlTiN tools. Uncoated tools produced less wear than both the coated tools at spindle speed 70,000 rpm machining conditions. Coated TiAlN tools produced less wear than AlTiN-coated and uncoated tools at spindle speed 110,000 rpm machining conditions. Tool wear is increased for all the tools when the feed rate and depth of cut for the considered spindle speed is increased. Adhesive wear, edge chipping, flaking, coating delamination and measured tool wear that were observed under SEM at different machining conditions are shown in **Figures 7–12**.

SEM examination of the leading cutting edge for coated and uncoated tools indicates plastic deformation, adhesion wear, chipping and flaking as shown in **Figures 7–12**. In addition, coating delamination at the tool cutting edge and significant changes in the tool shape was observed under the SEM. Tool material reacts with titanium alloy by means of high chemical reaction, forming adhesive wear. During the tool-workpiece interaction, adhesive layers of tool material will break down that progresses to adhesion wear. The intimate contact between the tool and

subjected to thermal and mechanical loads and could not be able to resist the wear during the interrupted cutting in the end milling process. The chip shape, segmented or continuous, decides the cutting temperature formation inciting to thermoplastic shear localization at the contact length, resulting in the diffusion process. The chip constituents and the rate of diffusion are controlled by cutting temperature. In the machining of titanium alloys, the machining parameters, particularly, cutting speed, influence the cutting temperature origination at the tool edge for initiating the diffusion process. The earlier researchers verified that cutting speeds generate high cutting temperature, a short contact length, a low shear angle and a high cutting pressure. Chip segmentation and tribological parameters—the physical medium—may be causing the coating delamination for both the coated tools while machining the titanium alloy. Since the thermal conductivities of the coating constituents are different, the heat flux q flows through the coating layer and penetrates the tool substrate. The reason behind the diffusion process at the tool substrate surface might be due to chemically instable Co binder elements. Adhesive surface between the coating layer and tool substrate surface was completely eliminated gradually by diffusion process as depicted in Figures 7–12 and confirmed through EDS analysis.

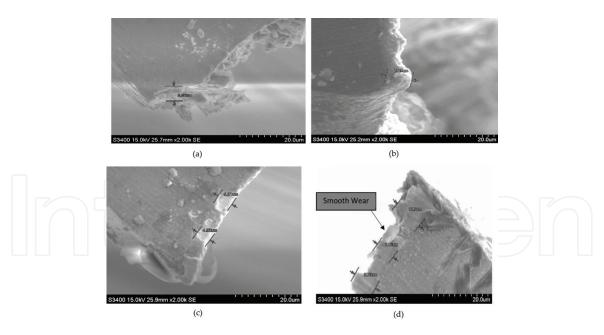
**Figure 8.**Coated TiAlN tool wear at (a and b) 30,000 rpm and (c and d) 70,000 rpm.

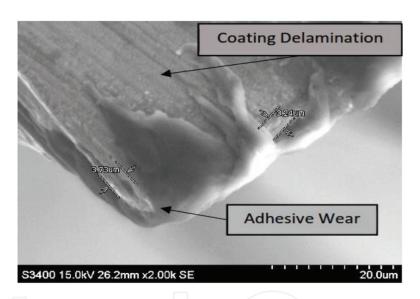
Figure 9. Coated TiAlN tool wear at 110,000 rpm.

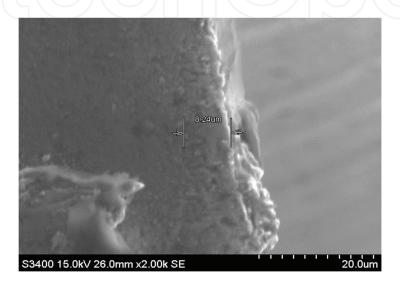
**Figure 10.**Coated AlTiN tool wear at 30,000 rpm.

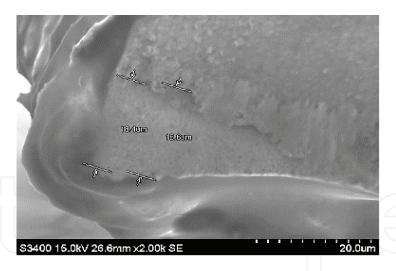
**Figure 11.**Coated AlTiN tool wear at 70,000 rpm.

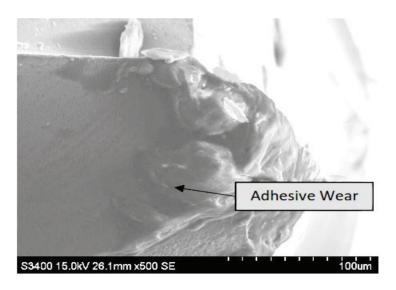
**Figure 12.**Coated AlTiN tool wear at 110,000 rpm.

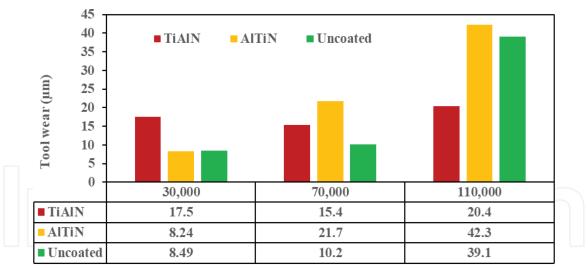
**Figure 13.**Tool wear versus different machining conditions.
