# Combining Unmanned Aircraft Systems and Image Processing for Wastewater Treatment Plant Asset Inspection

Jorge Sancho Martínez, Yadira Bajón Fernández, Paul Leinster and Mónica Rivas Casado \*

School of Water, Energy and Environment, Cranfield University, College Road, Cranfield, Bedfordshire MK430 AL, UK; jorgesanchomartinez7@gmail.com (J.S.M.); y.bajonfernandez@cranfield.ac.uk (Y.B.F.); Paul.Leinster@cranfield.ac.uk (P.L.)

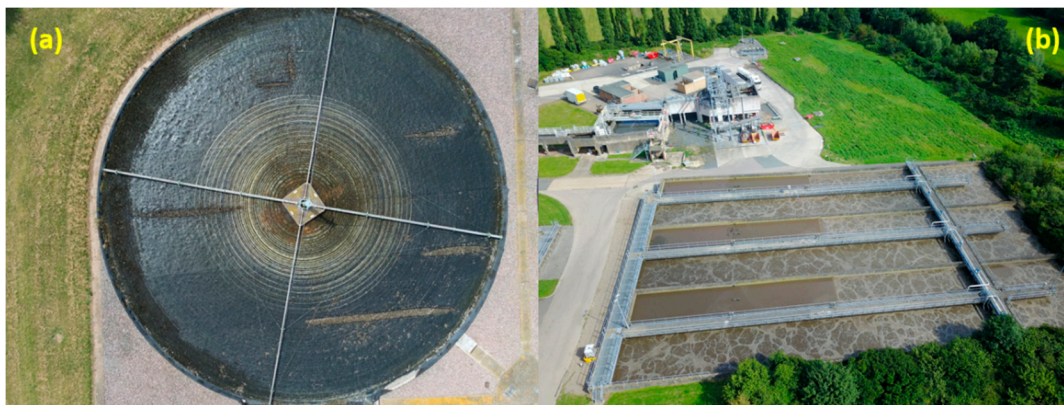
**Figure 1.** (a) Example of trickling filter and (b) example of activated sludge within two independent wastewater treatment plants.

TFs and ASs (Figure 1) are the most common biological processes in WWTPs in England [7]. TFs deal with organics and nitrogen in the wastewater [8], whereas AS also treat the organics and nitrogen, but can also be easily adapted to treat phosphorous [9]. TFs are most likely to be installed in small and remotely located WWTPs which operators visit but are not based at permanently. Remote WWTPs are considered to be those with a capacity below 10,000 p.e [10]. In UK, approximately 54% (986) of the WWTPs have a lower capacity than this [11]. AS consists of aerated tanks containing suspended biomass followed by settling tanks to allow for the separation of the biological flocs from the treated water. It requires a high level of maintenance [9], as any changes in pollutant levels in the wastewater require a manual adjustment to key parameters, such as the Sludge Retention Time, Return Activated Sludge rates, and the Oxygen Supply Rate. The use of AS is not feasible for small plants and remote sites, because it requires a high level of operator oversight [9].

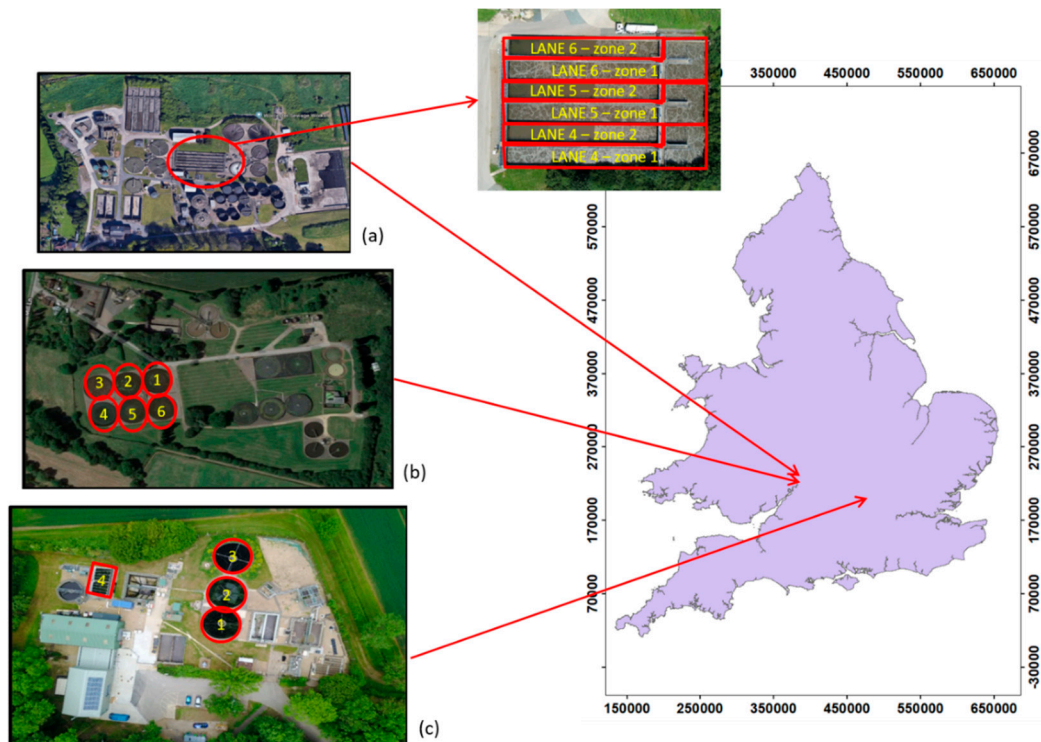
**Figure 2.** Wastewater treatment plants (WWTPs) selected for the development of the combined unmanned aircraft systems—image processing framework for the automated inspection of assets. The imagery corresponds to the following sites: (a) Worcester; (b) Malvern; and, (c) Cranfield University. Contains Ordnance Survey data © Crown copyright and database right 2020.

A total of three WWTP study sites (Figure 2) located in Cranfield University (Cranfield, England), Worcester (Worcestershire, England), and Malvern (Worcestershire, England) were selected based on their capacity (i.e., size) and treatment type (TF/AS). The site at Cranfield is located 80 km north-west from London, one kilometer North of Cranfield University. The WWTP serves the university's facilities, as well as the student (4500) and staff (1500). There are three TFs at this facility. The three TFs are 5.4 m long and they have a diameter of 12.3 m. They have a total of 10 orifices per arm, with the diameter of each orifice being 24 mm [25]. The area covered by each TF is 475 m<sup>2</sup>. A total of 675 m<sup>3</sup> of wastewater per day is treated and discharged into the Chicheley Brook, which flows into the River Great Ouse, an Environment Agency Freshwater Fish Protected Area [26]. Within this site, the treatment train comprises an inlet screen, balance tank, a lamella clarifier, a primary TF, then a second lamella clarifier and TF, and to a final TF before the discharge of the effluent to the Chicheley Brook.

The site at Malvern has a capacity for 36,000 p.e. and it is approximately 23 km south-west from Worcester, discharging its effluent to Pool brook. The site treats a total of 4500 m<sup>3</sup> of wastewater per day, where two-thirds is treated by six TFs of 32 m diameter, whilst the other third is processed by an

additional five TFs of 30 m diameter. The 32 m diameter TFs cover a total area of 735.4 m<sup>2</sup> each and have arms of 15.3 m length each with a total of 31 orifices per arm and an orifice diameter of 42 mm. The 30 m diameter TFs cover an area of 642.4 m<sup>2</sup> each and they have rotating arms of 14.3 m length, with 29 orifices per arm of 37 mm each in diameter. The treatment train consists of inlet screening, and grit removal, followed by a sedimentation tank and distribution to the TFs. The effluent is then treated in a humus tank to clarify it before discharge.

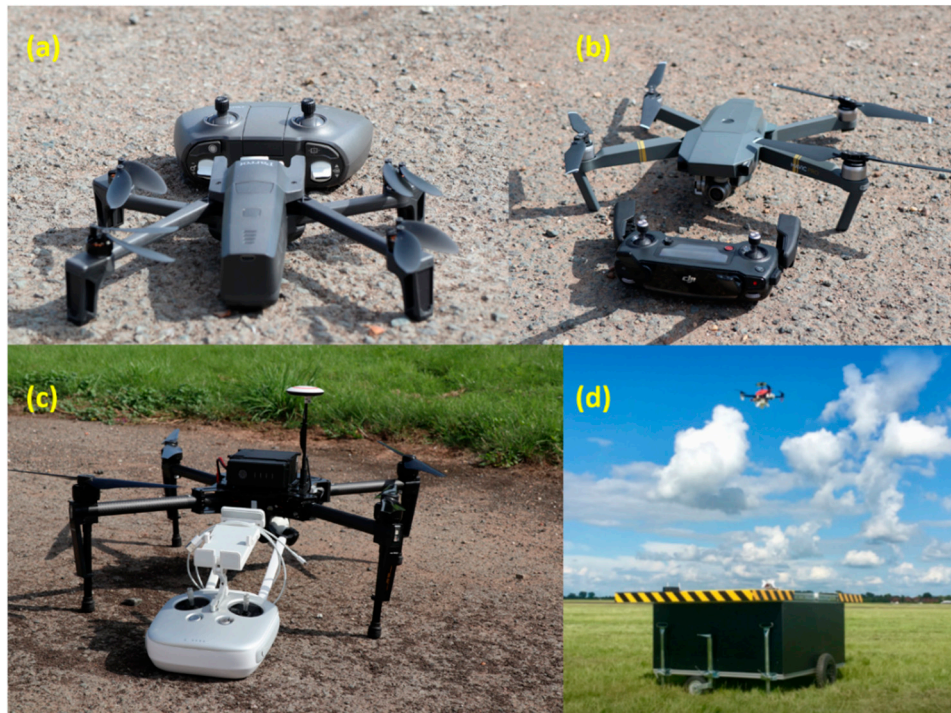
**Figure 3.** Unmanned aircraft systems compared for image quality acquisition at the Cranfield WWTP study site. (a) Parrot Anafi (Parrot, France); (b) DJI Mavic 2 Pro (DJI Technology Co, China); and (c) DJI Matrice 100 (DJI Technology Co, China). (d) Autonomous docking station (Herotech8, UK).

Three different quadcopters were used for image acquisition during an initial pilot study that was carried out at Cranfield WWTP (Figure 3): the Parrot Anafi (Parrot, France), the DJI MAVIC 2 Pro (DJI Technology Co, China), and the DJI Matrice 100 (DJI Technology Co, China) (Figure 3). The Parrot Anafi (Parrot, France) is one of the smallest (0.17 m × 0.24 m × 0.06 m) and lightest (0.32 kg) UASs currently available in the market. The platform has a 4K and 21 megapixel (35 mm focal length, 1/2.4" CMOS sensor) camera with High Dynamic Range (HDR) video and digital zoom capabilities. The camera can tilt up and down through 180 degrees. The Parrot Anafi has a high-density Li-Po battery that provides 25 min flight time and a GPS and GLONASS geo-positioning system that enables the smart return to home and accuracy of ±0.5 m in the vertical and ±1.5 m in the horizontal axes. The UAS legs contain a dual-band antenna to optimize the video transmission up to 4 km. It is able to operate in wind speeds up to 50 km h<sup>-1</sup> and speed of up to 55 km h<sup>-1</sup> in the sport mode. The DJI Mavic 2 Pro (DJI Technology Co, China) with a dimension of 0.32 m × 0.24 m × 0.08 m, weighs 0.90 kg. The platform has omnidirectional obstacle sensing and a 20 megapixel (28 mm focal length, 1" CMOS sensor) Hasselblad L1D-20c camera that can be tilted up and down through 180 degrees. The Li-Po 4S battery provides up to 31 min of flight time. The DJI Mavic 2 Pro is equipped with the same GPS as the Parrot Anafi. The UAS legs contain a dual-band antenna for optimizing the video transmission up to

The Herotech8 (Herotech8, UK) UAS docking station (Figure 3) was used to autonomously deploy the UASs. The docking station enables autonomous take-off, landing, flight plan implementation, and image capture at selected waypoints. The docking station is  $1.6 \text{ m} \times 1.6 \text{ m} \times 1.1 \text{ m}$ , weighs 80 kgs,

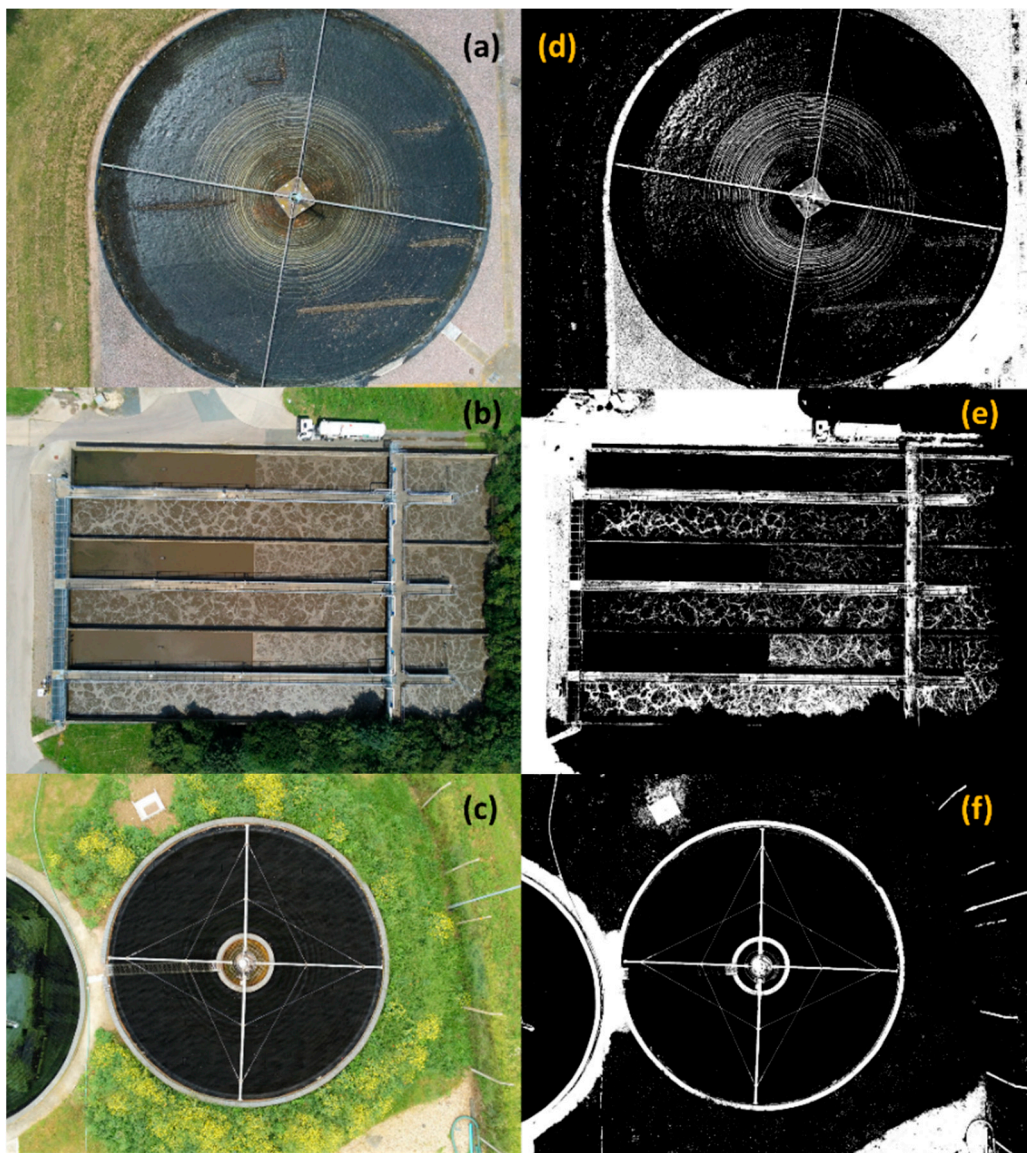
**Figure 4.** Examples of identification of asset failure. (a–c) Red, Green, and Blue (RGB) images taken with the Parrot Anafi (Parrot, France) Unmanned Aircraft Systems representing “working” conditions (a) and “failure” conditions (b–c); (d–f) white and black transformation of the RGB image. The white pixel to total pixel ratio is 7.85% for (d), 10.76% for (e), and 3.23% for (f).

The variation in the TF ratios of white pixels over total number of pixels differed, depending on the site and TF inspected, with values that range from 1.3% to 2.7% for Cranfield and 8.6% to 7.7% for Worcester. Figure 4 shows typical values and image outcomes obtained for the TFs and ASs algorithms. The threshold values for the classification of an asset as failing or working correctly are not reported, due the confidentiality aspects of the research carried out.
