Experimental study on fallout behaviour of tempered glass façades with different frame insulation conditions in an enclosure fire

Wang, Y, Sun, J, He, L, Wang, Q & Rush, D 2018, 'Experimental study on fallout behaviour of tempered glass façades with different frame insulation conditions in an enclosure fire', *Proceedings of the Combustion Institute*. <https://doi.org/10.1016/j.proci.2018.07.111>

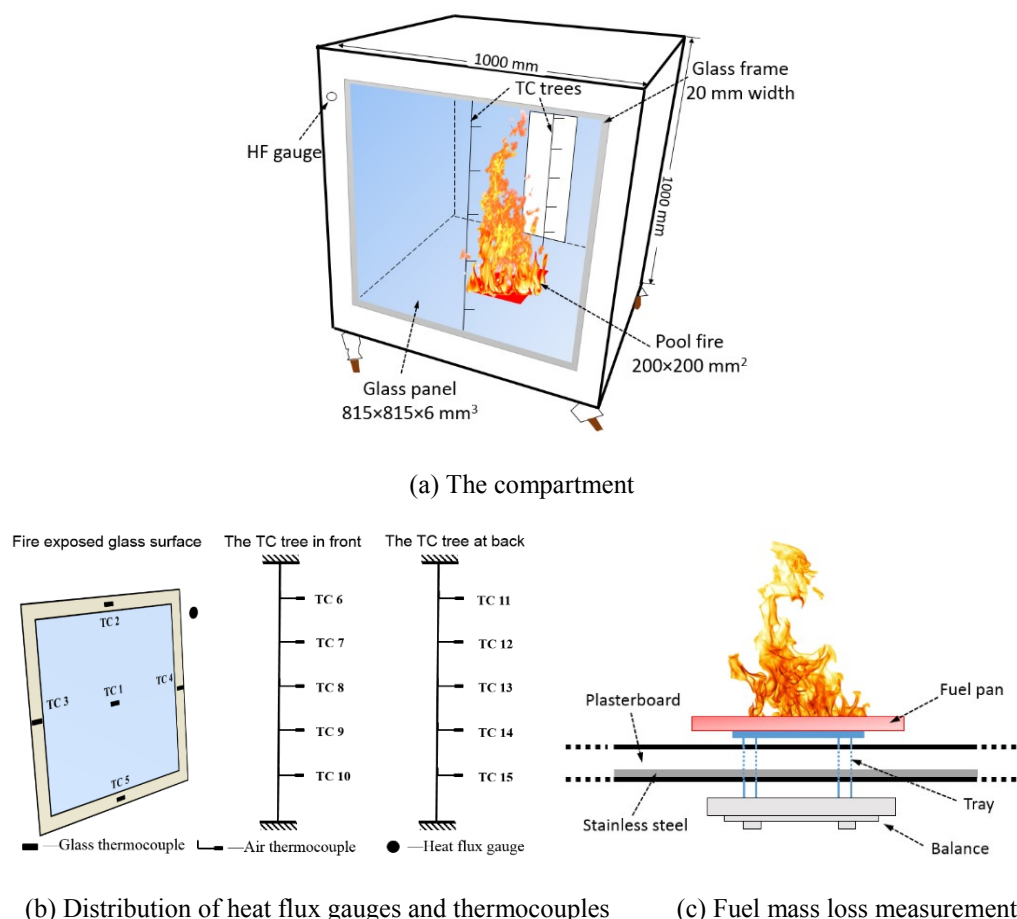
Fig. 1. The schematic of compartment used for the experimental tests.

Fig. 1. The schematic of compartment used for the experimental tests. (a) The compartment; (b) Distribution of heat flux gauges and thermocouples; (c) Fuel mass loss measurement.

A compartment with an external dimension of $1000 \times 1000 \times 1000 \text{ mm}^3$ was built to resemble the fire conditions in glass façade furnished buildings, as shown in Fig. 1(a). In the compartment model, one face of the wall is totally glass and its opposite side is a door which is to resemble the office in the high-rise buildings. The walls of this enclosure were constructed of 5 mm stainless steel lined with 20 mm-thick plasterboards. To the authors' knowledge and survey, an estimated range of glass façade panel dimension is from $300 \times 300 \text{ mm}^2$ to $6000 \times 6000 \text{ mm}^2$, tempered glass panels of $815 \times 815 \text{ mm}^2$, 6 mm thick, were installed into the front wall in the present work. The glass frame was made of 1 mm thick stainless steel and capable of installing glass panels with different thicknesses. Stainless steel was selected due to its relatively stable behavior in fire compare with other frame materials, such as aluminium extrusion, timber or plastic. In each test, the pressure from frame to the glass in the thickness direction was controlled by four screws. Since the maximum expansion, less than 1 mm, is smaller than the normal gap of several mm between the frame and the glass panel [4, 19], no in-plane restraint from the frame existed in the experiments, thus simulating realistic conditions as closely as possible. In addition, a ventilation opening of $200 \times 1000 \text{ mm}^2$ was incorporated into the back wall of the compartment and a pool fire with a dimension of $200 \times 200 \text{ mm}^2$ was positioned at the center of the compartment. The opening factor of the compartment was 0.033 and is representative of an office the

The measurement systems included the sheet and sheathed thermocouples (TCs), heat flux (HF) gauge, mass loss balance, digital camera and data acquisition. The sheet thermocouples were attached to the glass panes to detect the surface temperature via their high heat-conducting sheets, which is made of aluminium alloy with a high heat conductivity of $226 \text{ W/m}\cdot\text{K}$. The dimension of sheets is approximately $25 \times 15 \text{ mm}^2$, thus it can increase the contact areas between detected objects and a temperature-sensing element. Two TC trees, 30 mm away respectively from the glass wall and back wall, were positioned at the center line of the compartment, as shown in Fig. 1(a). In each tree, five

sheathed thermocouples were fixed equidistantly (158 mm) to measure the gas temperature. Meanwhile, five sheet thermocouples were employed to record the glass surface temperatures at the fire side: four TCs were attached in covered areas and only one at the center of the fire-exposed surface. It should be noted that both sheathed and sheet TCs were K-Type thermocouples with a measurement range of 0-1200 °C and sensitivity of 41 mV/°C. The uncertainty of TCs was estimated at 10-20% [20].

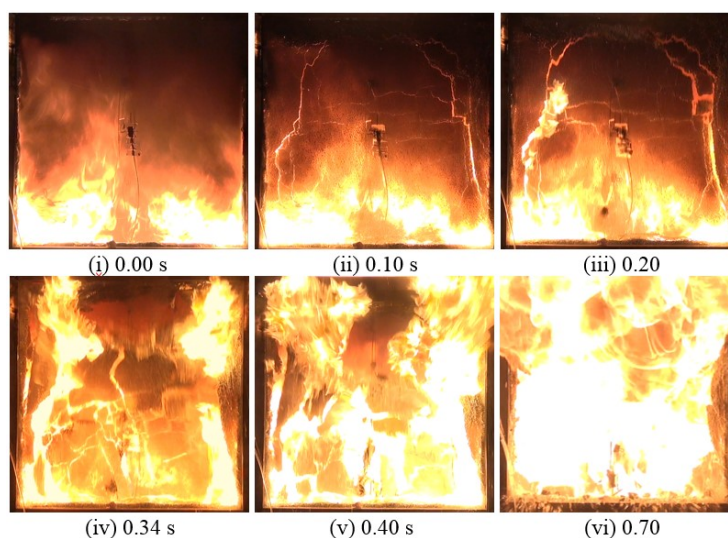
(a) Breakage and fall out

Fig. 2. The process of glass fallout and flame spread in Test 3.

Fig. 2. The process of glass fallout and flame spread in Test 3. (a) Breakage and fall out; (b) Side view of window-ejected flame (glass located at left side)

Fallout of the tempered glass, if critical breakage conditions were satisfied and cracks initiated, occurred very quickly. As an example, the failure of Test 3 is shown in Fig. 2(a). The process only took 0.70 seconds from the crack initiation to complete fallout. It appears that two primary cracks initiated from the top edge of the glass panel and dominated the first 0.2 seconds of breaking. Once the glass had started to fall out, the fallout of the glass allowed a portion of the ejected fuel vapours to ignite outside the compartment. Meanwhile, the whole glass panel broke into a large number of small pieces and started to fall out. This phenomenon occurred in other tests as well. The crack initiation and

propagation process at the very beginning were similar to that of float glass, however, more “islands” could be formed in tempered glazing which renders it much easier to fall out.

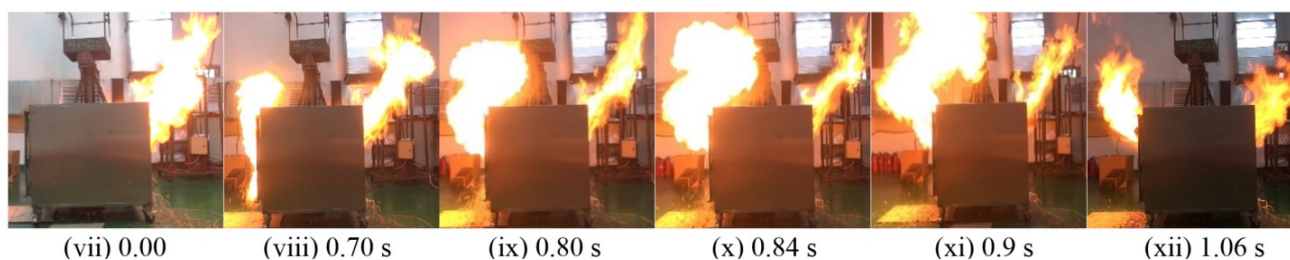
(b) Side view of window-ejected flame (glass located at left side)

Fig. 2(b) demonstrates the ejected flames after the glass completely fell out. The glass fallout affects the ventilation to the compartment which in turn affects the fire dynamics both to the interior and exterior of the compartment. At the front side, the flame with large momentum spread quickly in both horizontal and vertical directions, with the largest visible flame height of 2.1 m above the glass top edge and the largest horizontal distance of 0.7 m from the glass surface. A scale ruler software was used to measure the visible flame dimension in video and pictures using the compartment size as a reference. In the other tests, the ejected flame heights were all above 2.0 m. After 0.36 s, the burning went back to the new stable status again. The ventilation-controlled fire in the fully developed stage switches to a fuel-controlled fire due to glass fallout. Because of the significant effect of glass fallout, we can define the compartment fire development as pre-fallout and post-fallout stages. The effect of ventilation changes on the critical fallout parameters is discussed in the following section.

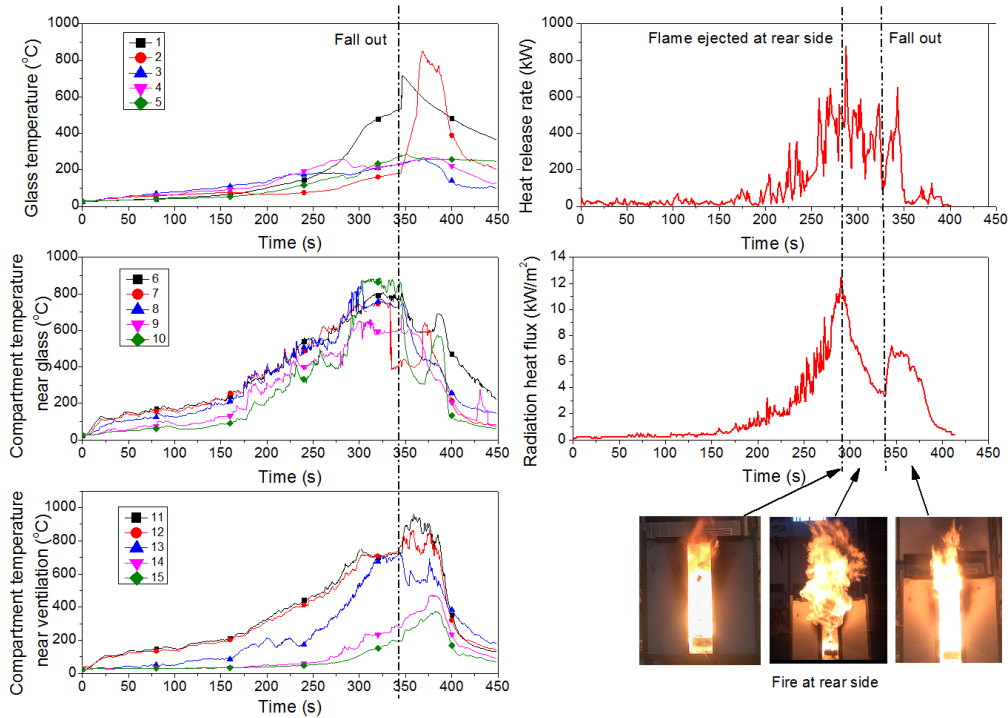
Fig. 3. The temporal evolution of the parameters in Test 3.

convection, conduction in the remaining tests) were recorded and compared. The parameters in Test 3 are shown in Fig. 3. According to HRR variance, the flashover occurred at around 250 s. From T_{11} - T_{15} , the height of neutral plane decreased gradually until the glass fallout, which can be explained simply but the ideal gas equation: the gas density decreased with the increase of temperature. In addition, the following equation can directly estimate the phenomenon [25]:

where h_N and H_o are the neutral plane height and vent height; T_g and ρ_g are enclosure gas temperature and density; ρ_a is the density of air outside the room. Moreover, the exposed glass surface temperature measured by TC1 started to increase much faster than the temperatures in covered areas at around 250 s and the glass fell out at 343 s. At the post-fallout stage, it was found that the T_6 - T_{10} were cooled down rapidly from 800 °C to 400 °C. Meanwhile, the T_{13} declined markedly, which indicates the neutral plane moved higher relative to the floor. The similar phenomena occurred in the other tests.

In HRR curve, it indicates a spike just after the flame ejection (291 s) occurs and is also volatile up until about 350 s. However, it did not change the HRR greatly which stabilized between 400-600 kW. With consideration of the noise in the compartment, this HRR is reasonable. Meanwhile, the incident radiation heat flux (front side) decreased by 60%, and then slightly increased due to the glass fallout. This change in heat flux suggests that the flame radiation, rather than the smoke radiation, dominated the imposed radiation received by the glass panel.

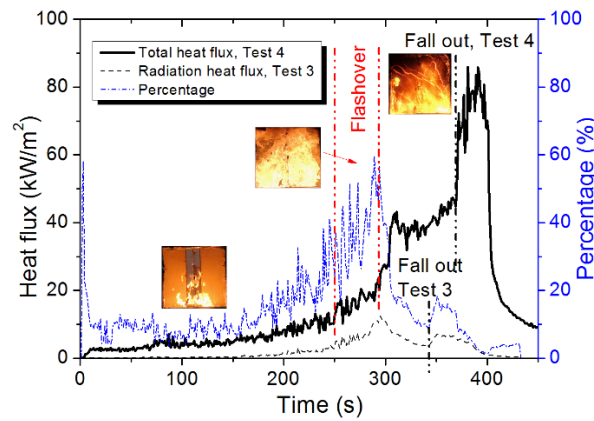
Fig. 4. The comparison of total heat flux and radiation heat flux.

The experimental conditions are assumed identical, and the comparison of imposed total and radiation heat fluxes is illustrated in Fig. 4. It was established that convective heat transfer usually accounts for more than 80% of the glass heating, except during the flashover phase where it is approximately 60%. The convective heat transfer is shown to be the primary heat exchange mechanism between the glass panel and the enclosure fire. This is markedly different from the glass heating in

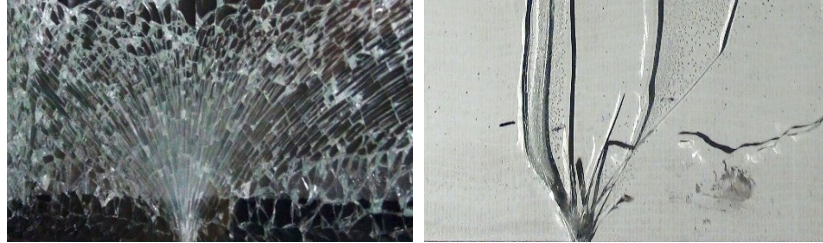
(a) Crack initiation in Test 2.

(b) Crack initiation in float glass.

Fig. 5. Post cracks of tempered and float glass panels after heating.

The fan-shaped cracking pattern at the edge of the tempered glass panel, as shown in Fig. 5(a), exists, similar to that which would be found in float glass (Fig. 5(b)). This implies overloading/overstressing of edge defects in both float and tempered glass can cause failure. The “primary” cracks in tempered glass ran at a very high speed before the whole glass panel disintegrates due to the release of the pre-stress energy [27]. To catch the “primary” cracks, one additional laminated tempered glass panel was tested under the identical condition Fig. 5(c). A scanning electron microscope was used to photograph the glass surface near the panel edge, as shown in Fig. 5(d). The evident crack path and numerous tiny flaws observed confirm that the dominant failure cause of tempered glass in fire is related to the tensile stress concentration near the flaws or defects at the glass panel edges.

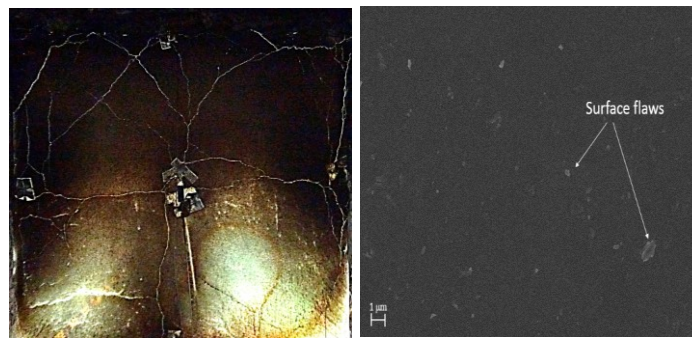
(c) Crack path in laminated tempered glazing (d) The distribution of tiny flaws on the glass surface

Fig. 5. Post cracks of tempered and float glass panels after heating. (a) Crack initiation in Test 2; (b) Crack initiation in float glass; (c) Crack path in laminated tempered glazing; (d) The distribution of tiny flaws on the glass surface.
