Fire performance of closed-cell charring insulation materials in plasterboard insulation assemblies

FIRE PERFORMANCE OF CLOSED-CELL CHARRING INSULATION MATERIALS IN PLASTERBOARD-INSULATION ASSEMBLIES

Juan P. Hidalgo*^{1,2}, José L. Torero², and Stephen Welch¹

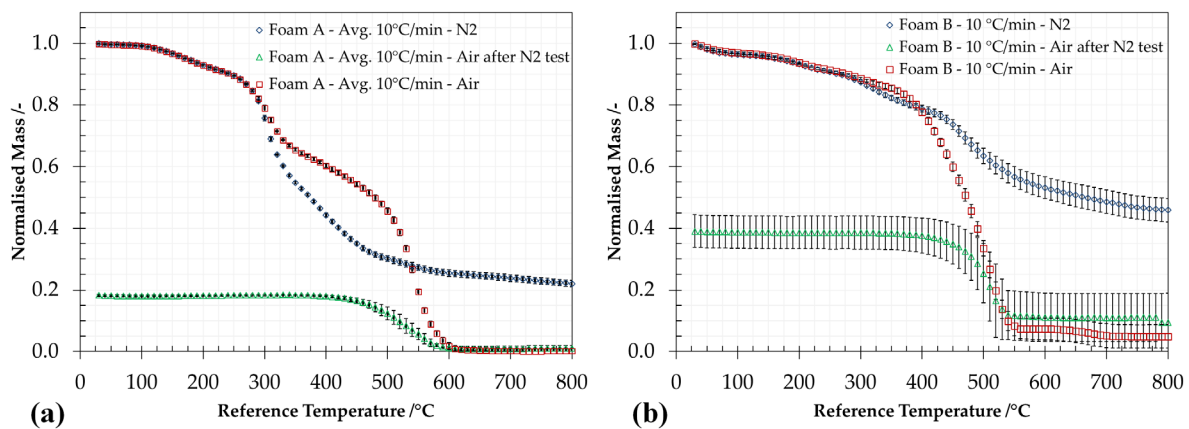
Figure 1. Thermogravimetric data from (a) foam A and (b) foam B materials in nitrogen and air, with a heating rate of $10\text{ }^{\circ}\text{C}\cdot\text{min}^{-1}$. Error bars represent deviation from the average value for duplicates. Blue diamonds: test in nitrogen. Green triangles: Residue of test in nitrogen tested in air. Red squares: test in air.

Characteristic TGA results for the specific polyisocyanurate and phenolic foams studied herein with a heating rate of $10\text{ }^{\circ}\text{C}\cdot\text{min}^{-1}$ in different atmospheres (nitrogen, air, and the residue obtained in nitrogen exposed to air) are presented in Figure 1. In inert atmospheres, the polyisocyanurate foam (foam A) is shown to leave a residue of $(22 \pm 1)\%$ from its original mass at 800°C , while the residue of the phenolic foam (foam B) is $(45 \pm 4)\%$ (refer to the blue diamond series in Figure 1a/b). This indicates that overall, in non-oxidative conditions, a larger mass is pyrolysed from the foam A than the foam B; therefore, a larger release of flammable gases is to be expected for the foam A under these conditions. The temperature at which the main release of pyrolysis gases is obtained corresponds to approximately $275 - 350^{\circ}\text{C}$ for foam A and $400 - 475^{\circ}\text{C}$ for foam B. The residue from both foams obtained in the absence of oxygen (blue diamond series) proceeds to oxidise between $450 - 550^{\circ}\text{C}$ when exposed to air (green triangle series in Figure 1). If the foam samples are directly exposed to air (refer to the red square series in Figure 1), the thermal degradation of foam A proceeds as two main well-differentiated reactions of a first pyrolysis and a posterior oxidation, while the main pyrolysis and oxidation reactions from foam B seem to overlap. The latter sequence of reactions is, however, not expected to occur in real end-use conditions, as the insulation is often covered by a lining or thermal barrier, and the presence of air at the surface of the foam is expected to be rather limited.

Then, from a pyrolysis release (flaming) point of view, foam B apparently shows a less hazardous behaviour, with generally higher pyrolysis temperatures and larger char residue. However, in the presence of oxygen, foam B presents a worse behaviour as the pyrolysis and oxidation reactions are in the same temperature domain, as shown in the differential thermogravimetric (DTG) curves presented in Figure 2. This performance, which was further discussed elsewhere¹⁴, indicates that the char from foam A is expected to play a more effective role than the char from foam B protecting the virgin material.

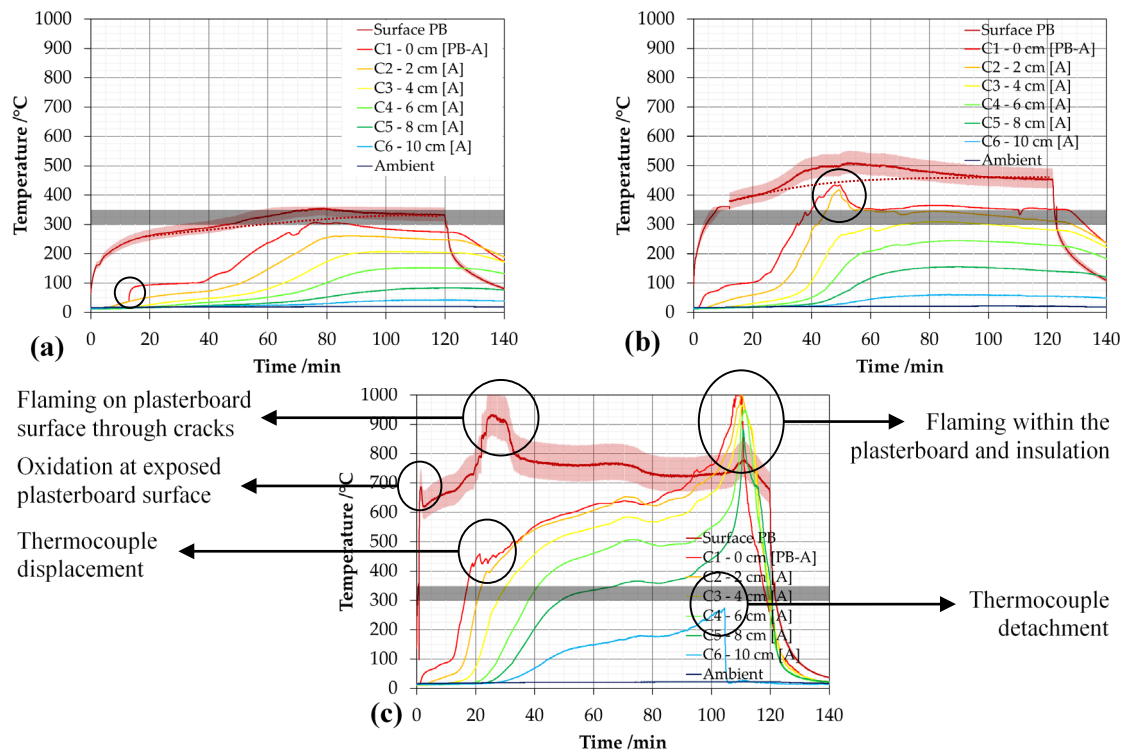
Figure 5. Time-history of temperatures within the 'plasterboard – foam A' assembly tested under external heat fluxes of (a) 15, (b) 25, and (c) 65 kW·m⁻². Shading in the surface temperature indicates the sensitivity of its quantification in relation to an emissivity within $\varepsilon = 0.9 \pm 0.1$. Horizontal shading represents the presumed/nominal pyrolysis domain.

The time-history of temperatures for 'plasterboard – foam A' assemblies under external heat fluxes of 15, 25 and 65 kW·m⁻² is shown in Figure 5. These temperature measurements correspond to the centre position, as it represents the region where more uniformity in the external heat flux is obtained. The temperature range indicating the main pyrolysis domain for foam A is included in the charts as a horizontal shading region between 300°C and 350°C. A series of patterns can be observed in these temperature profiles:

- The surface temperature of the plasterboard does not evolve as would be expected from an inert behaviour, with a change in the curvature as shown in Figure 5a/b, where an inert dotted baseline is projected. The observed increase in the surface temperature is due to (1) the oxidation of the back-face render of the plasterboard and (2) the flaming at the surface of the plasterboard from pyrolysis gases escaping through cracks in the plasterboard.

- A peak on the surface temperature is observed for the experiment at 65 kW·m⁻² after one to two minutes of the test (Figure 5c), with a peak temperature in the range 650 – 750°C. These results are consistent with the visual observations that verified the oxidation of the front face render (paper) of the plasterboard.

Figure 5a shows a case study where the surface of the insulation board marginally achieves the critical temperature of 300°C for foam A. Indeed, the plasterboard surface achieves a temperature of approximately 330°C during the steady-state. An irregularity is observed at the interface thermocouple (C1) at 15 min, indicating a bad positioning of the thermocouple which was later corrected. Some small cracks were observed on the surface of the plasterboard after 70 min of the test, as well as some expansion of the insulation board after 72 min, which seemed to push the plasterboard out. Some vapours were observed after 75 min of the test, coinciding with the time when the interface reached temperatures near the critical temperature. However, it was visually assessed that the release of volatiles was minor.

Figure 5b shows a case study where the surface of the insulation board achieves the critical temperature after 35 min of the test. Consistently, the release of vapours from the edges of the plasterboard was observed from 36 min to approximately 50 min. Some cracks were observed in the plasterboard with the release of grey-black smoke, leaving a pattern of soot deposition on the plasterboard surface. Additionally, the sample was found to expand 10 mm at the centre from the back of the frame, which was identified by the significant movement of the interface and C2 thermocouples, observed at 49 min. Eventually, as noted in Figure 5b, a thermal equilibrium was obtained from 60 min.

Figure 5c shows a case study where surface oxidation consumed the plasterboard's exterior render after 1 min of the test. A significant amount of vapours, probably mainly moisture, were released from the plasterboard during the first 5 min of the test. The release of volatiles through the plasterboard-frame edges was observed after 17 min, which is consistent with the interface achieving the critical temperature of 300°C at 16 min. After 20 min, flaming was observed from the cracks of the plasterboard surface, which was verified by the significant increase of surface temperature (above 900°C) recorded by the thermal camera between 21 and 33 min. The thermocouple measurement at the interface shows a drop just after 20 min, suggesting the expansion of the insulation board, which is confirmed by the 40 mm movement of the back face of the board from its original position, and the gap between the

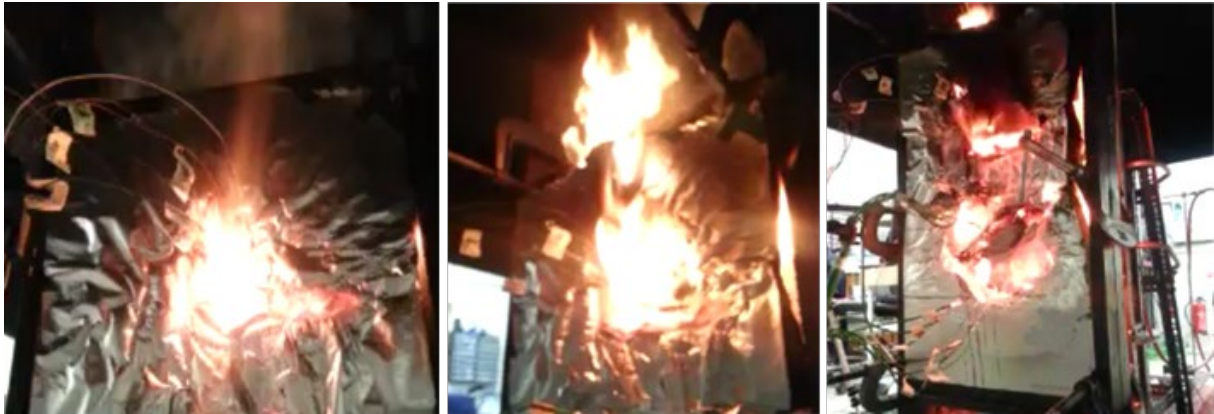
Figure 6. Evolution of the back face of the foam A board tested at $65 \text{ kW}\cdot\text{m}^{-2}$ at 100-110 min, with smouldering/flaming breaking through.

plasterboard and the surface of the insulation. An approximately steady state is observed in the temperatures between 40 and 80 min, at which point a sudden temperature increase is observed for all the thermocouples in the core of the insulation. Dark smoke was observed, suggesting that this enhanced temperature increase was due to smouldering of the char within the frame. After 95 min, flaming was observed between the edge of the insulation and the top of the frame. The flames finally broke through the insulation board, and flaming was observed at the back face of the board and top, as shown in Figure 6. These events are represented by the accelerated increase of temperature shown in Figure 5c from 100 min until 110 min. Large pieces of char remained from the board, and they continued to glow (smoulder) after the end of the experiments.

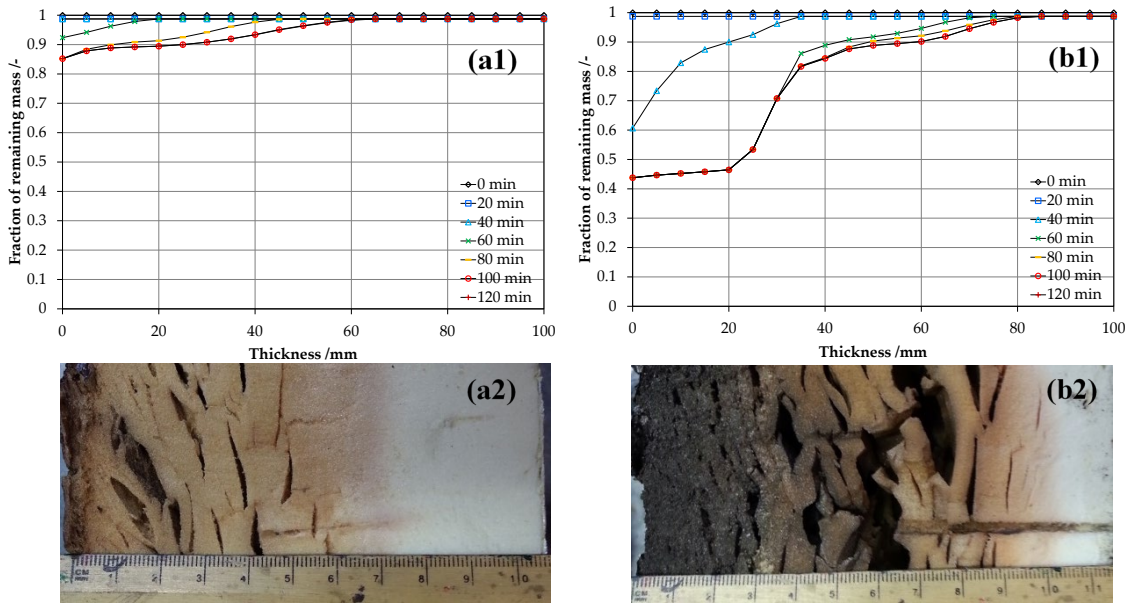
Figure 9. Estimated fraction of remaining mass of foam A under external heat fluxes of (a1) $15 \text{ kW}\cdot\text{m}^{-2}$ and (b1) $65 \text{ kW}\cdot\text{m}^{-2}$ and their residue at the end of the test (a2 and b2).

The temporal evolution of the fraction of remaining mass from the experiments at $15 \text{ kW}\cdot\text{m}^{-2}$ and $25 \text{ kW}\cdot\text{m}^{-2}$ is presented in Figure 9, together with sections from the core of the insulation samples, which indicates the degree of thermal degradation by the insulation discolouration. The section of the sample tested at $15 \text{ kW}\cdot\text{m}^{-2}$ shows significant cracking and a related thickness expansion of up to 10 mm, while the section tested at $25 \text{ kW}\cdot\text{m}^{-2}$ presents more severe cracks and a final total thickness of approximately 120 mm.

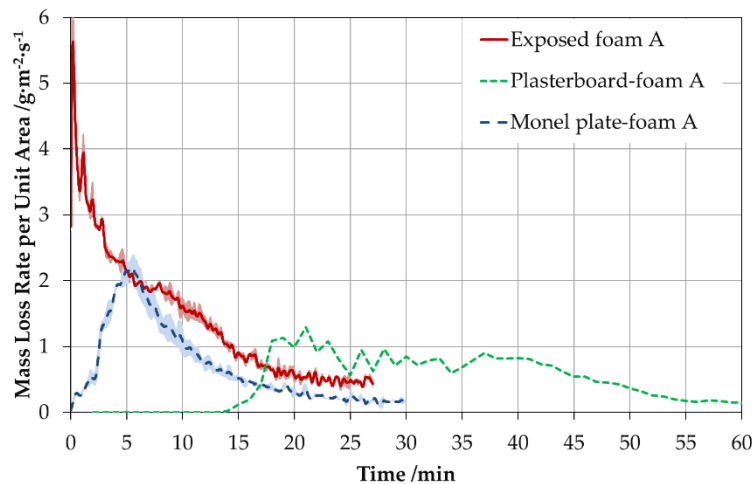
Figure 12. Mass loss rate per unit area for exposed foam A (red solid line)¹², a monel plate-foam A sample (blue dashed line)²² and plasterboard-foam A (green dashed line) from the present work when exposed to 65 kW·m⁻².

Figure 12 shows that when exposed, the foam proceeds to pyrolyse instantly after the heat exposure onset, which is as expected, due to the low thermal inertia of the material. When protected by a thermally thin element of significant thermal mass (6 mm Monel 400 plate), the pyrolysis onset is not significantly reduced; however, the time to reach a peak MLR is delayed. For the case studied herein (plasterboard – foam A), the effect the plasterboard has on delaying the pyrolysis onset is clear, amounting to approximately 15 min from the heat exposure onset.

Another interesting aspect to consider is the reduction in MLR experienced by different protections. It is expected that if the protection is a thermally thin element of low thermal mass, the time to reach a peak MLR would be much faster as shown by Hidalgo *et al.*¹⁸ and Crewe *et al.*³⁰. In the case of a thermally thick protection such as the plasterboard, it is clearly shown that the peak MLR is below the limit of 2 g·m⁻²·s⁻¹. At this rate, it is unlikely that self-sustained burning would occur; however, flaming may be achieved under particular conditions as observed in these experiments.
