Procedia CIRP 59 (2017) 139 - 143

The 5th International Conference on Through-life Engineering Services (TESConf 2016)

Tensile Response of Adhesively Bonded Composite-to-composite Singlelap Joints in the Presence of Bond Deficiency

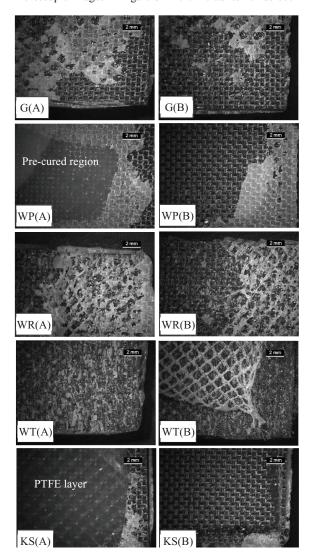
All joints were observed to fail at the bond interface. The images from each adherend contact faces (A and B) of the bond of one representative joint from each category (except KD) are shown in Figure 3. Bright and dark regions represent the adhesive and the surface of the composite respectively. The images for the bonds incorporating PTFE film (KS and KD) were very similar and only images for the KS joint are presented. Any cohesive failure behavior of the adhesive was minor, with most joints exhibiting adhesive failure at the adherend/film adhesive interface. This was evident from the microscopic images in Figure 3 where the adhesive has been

Figure 3. Microscopic images of the bonded joints after failure

observed bonded on one adherend only and peeled from the other. The only exception was the bonded joint cured in a time shorter than the others (WT), where a combination of interface and cohesive failure was observed. This is expected as in a shorter curing time, the bulk of the epoxy adhesive has not reached to its ultimate strength, and tends to deform with greater ductility and lower strength. The observed sudden drop in load level occurring at the ultimate failure point is also an indication of the dominant interfacial failure.

The adhesive films contain carrier cloth which, based on our observations, did not fail (see e.g. WT(B) in Figure 3), and thus is believed to be directing damage toward the interface. The bond thickness was relatively low (0.25mm) compared to the Standard [10] recommendation (0.76mm). This difference should reduce the joint eccentricity but the reduced thickness is expected to experience higher peel strain from geometry effects.

The images, figure 3, are consistent with the failure load results, figure 2. The pre-cured bond (WP) and the kissing bonds with PTFE films (KS) failed approximately at a same load and their failure mechanism appears to be similar, Figure 3. It should be noted that due to the unsymmetric bond area in the WP and KS categories, unsymmetric secondary bending is introduced, i.e. the composite adherend at the weak bond side undergoes higher bending strain.

Also of interest is the bond cured by rapid heating (WR). As seen, the morphology of the failure surface is different from the others. It has been observed that higher ramp rate could cause increased voids and increased variation in degree of cure due to temperature gradients throughout the bonded joint [14]. This significantly affects the bond and structural integrity. This category with the one with reduced curing time (WT) has both shown the lowest failure loads in Figure 2.

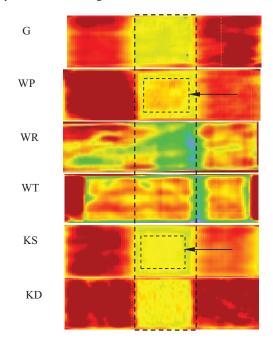
The C-scanned images of the joints' overlap region is shown in Figure 4, carried out using the parameters given in section 2.3 (the outer dashed line represents the overlap bonded region for all joints). Note that the C-scan images represents attenuation of a probe signal through the two composite adherends and the adhesive (bond). However as the significant difference is expected to arise from the adhesive (bond), and not in the adherends, the difference seen in the colour contours is referred to as defects. Taking the good bond with green/yellow contours as the reference for a bond with no defect, apparent differences observed for the rest of the joints are a sign of bond deficiencies. The WR and WT joints have also shown a clear mismatch and difference in the whole overlap region of the bond, compared to the image of the good bonded joint. This is in agreement with the results in Figure 2 where WR and WT had the most significant drop in failure load compared to the good bond. Clearly for the joint with reduced cure time, the C-scan is able to qualitatively capture the significant mismatch in the adhesion and bulk properties of the pre-maturely cured bond. Moreover, the main outcome from the figure is that the ultrasound technique clearly highlights the bond deterioration at the centre of the overlap region for WP (pre-cured bond) and KS (single-PTFE bond). This central region captured by NDI, shown by the arrows in the figure, represents the 20mm×20mm disband intentionally introduced at the centre of the overlap for WP and KS joints. Surprisingly, the disbond region is not observed for the KD joint which has

Figure 4. C-scan images of the bonded joints before test (outer dashed line represents the overlap bonded region of the joints (25mm×25mm) while inner dashed lines with arrows represents 20mm×20mm disbond at the centre of the overlap for WP and KS joints)

two PTFEs at either side of the bond. Understanding this requires further investigation.

The current research provided a comparative study of adhesively bonded joints with bond deterioration. A number of techniques were used to introduce 'defects' to the central bond area of the composite-to-composite single-lap joints. Three main curing strategies were selected to prepare such 'defects'. It was found that a bonded joint with any defect, non-standard cure or contaminant, has a reduced strength. The 'kissing bond' defect was found to cause the lowest 'stregth reduction' (categories WP and KS with stregth reduction of 33% and 40%). Rapid cure was found to cause a 50% reduction in failure load. The effect of curing time was also quantified, and found that, in terms of a curing parameter, it has the most significant effect on the bond mechanical response, also observed using NDI. The NDI ultrasound technique was also capable of capturing the 20mm×20mm central disbond region of the bond for WP and KS joints.
