Icelandic Concrete Surfaces: Guðjón Samúelsson's *Steining* (1930–50)

Sofia Nannini

Politecnico di Torino, Italy

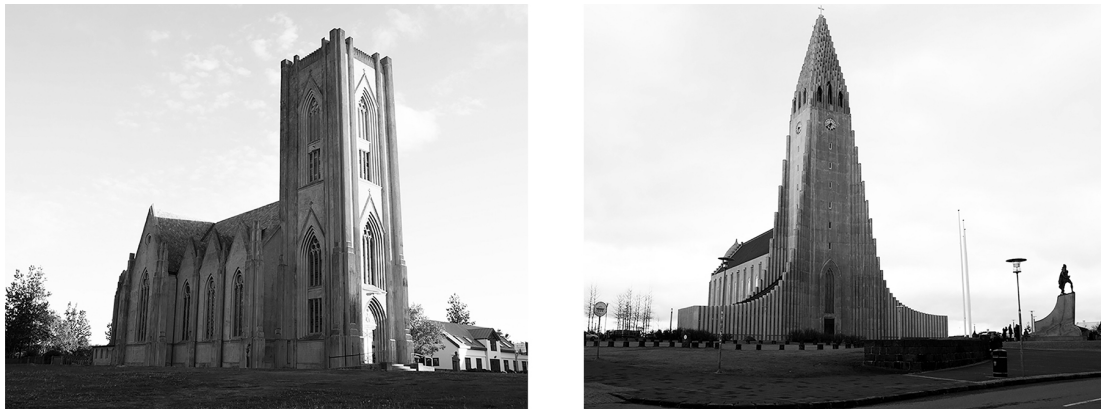
Figure 2. Left, Landakotskirkja (1925–29); right, Hallgrímskirkja (1937–86). Reykjavík. Photos by Sofía Nannini.

Many examples of what was defined as *stuðlabergstill* – translated to ‘basaltic style’ – can still be found in Reykjavík. Among them are the Catholic church *Landakotskirkja* and the Lutheran church *Hallgrímskirkja*, together with the National Theatre [*Þjóðleikhúsið*] and the main building of the University of Iceland [*Háskóli Íslands*]. (Figs 2–3)

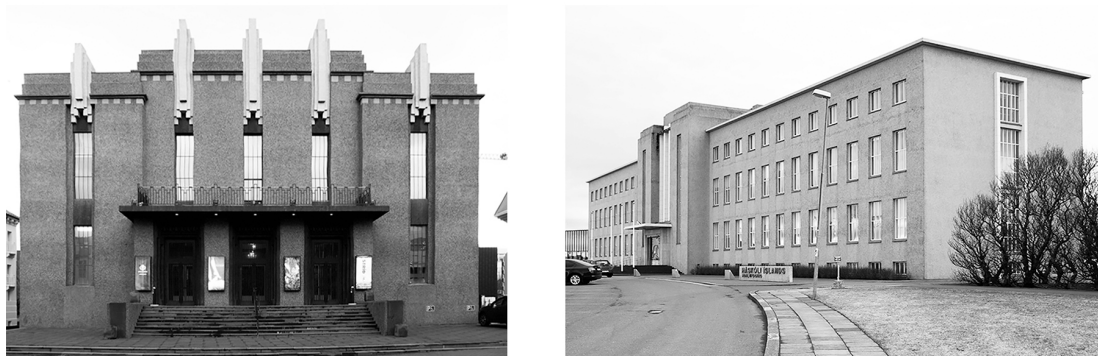
Figure 3. Left, the National Theatre (1928–50); right, the main building of the University of Iceland (1934–40). Reykjavik. Photos by Sofia Nannini.

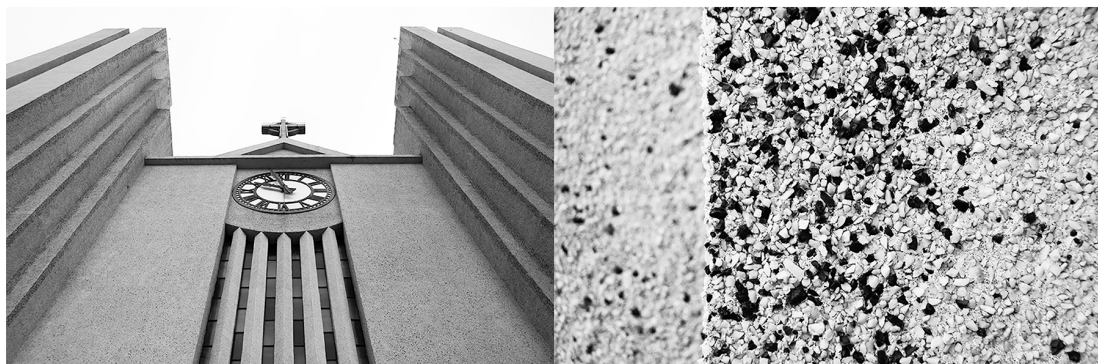
Figure 7. Steining on the church of Akureyri. Detail on the right. Photos by Sofia Nannini.

Quartz (*kvars*) was mined in the Mosfellsbær area, near Reykjavík. Its presence was discovered mostly in the vicinity of some gold mines which had been active since 1909 [31]. An interesting application of both obsidian and quartz can be seen on the façade of the church in Akureyri, northern Iceland, designed and built by Guðjón Samúelsson in 1934–40. Dark obsidian splinters were used to mark the edges of the structure, while pale quartz pieces covered the rest of the surface (Fig.7).

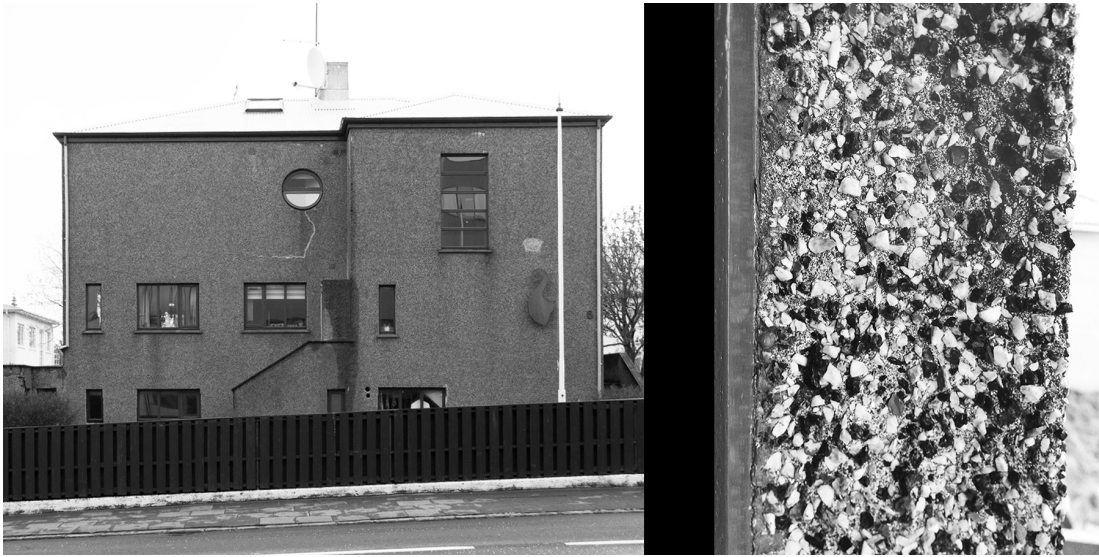
Figure 8. The villa in Eiríksgata 6, Reykjavik, designed by Guttormur Andrússon and commissioned by Trausti Ólafsson. Detail of Steining on the right. Photos by Sofia Nannini.

The most precious material to be found in the *Steining* render is ground Iceland spar (*silfurberg*), also known as Iceland crystal. This particular kind of calcite had been mined in Helgustaðir, eastern Iceland, since the mid-nineteenth century, and it had been pivotal in the development of modern studies on light polarisation [32]. Indeed, only the cheapest and most opaque fragments of Iceland spar were used for building purposes [33]. Today, a few buildings still boast the original *Steining* render and their first pebble mix. One of them is the modern villa commissioned by the chemist Trausti Ólafsson in 1934, whose *Steining*-rendered walls include Iceland spar, obsidian, and other volcanic rocks (Fig.8).

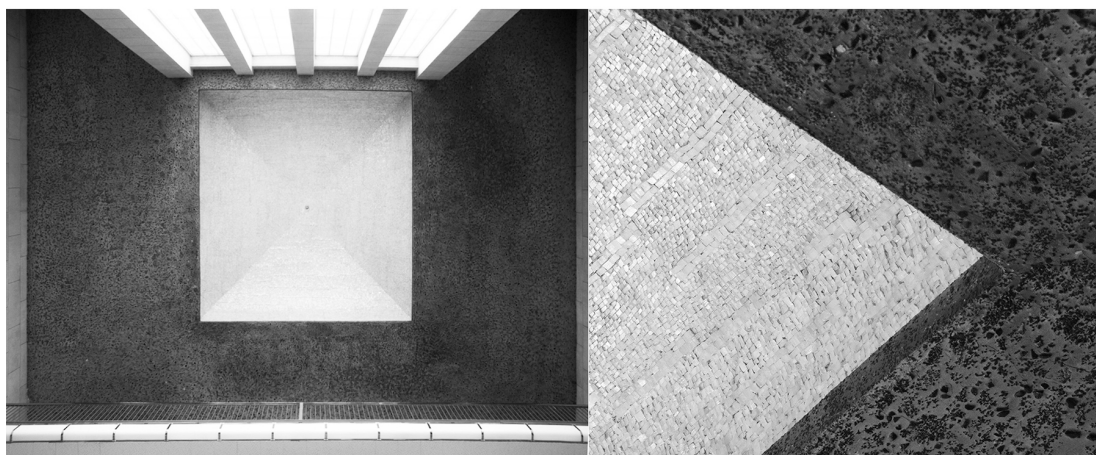
Figure 10. *Steining* on the ceiling of the main entrance of the University of Iceland. The central vault is rendered with calcite fragments, the surrounding portion with obsidian on a blue-cement field. Photos by Sofia Nannini.

The vestibule’s walls were covered with seashell-rendered slabs, and the ceiling coated with ground, shiny Iceland spar. The main doorway was rendered with a mixture of ground obsidian together with greenish rhyolite. The floor was covered with dolerite, whereas the main hall’s vestibule was clad with red rhyolite slabs. The altar of the University’s chapel was decorated with clear Iceland crystals. The whole outer façade was rendered with a quartz-based *Steining* blend, for which approximately 7 tons of quartz were imported [39] (Figs.9-10).
