Experimental Characterization of Piezoelectric Transducers for Automotive Composite Structural Health Monitoring

Massimiliana Carello, Alessandro Ferraris, Andrea Giancarlo Airale, Alessandro Messina, Lorenzo Sisca, Henrique de Carvalho Pinheiro, and Simone Reitano

Politecnico di Torino

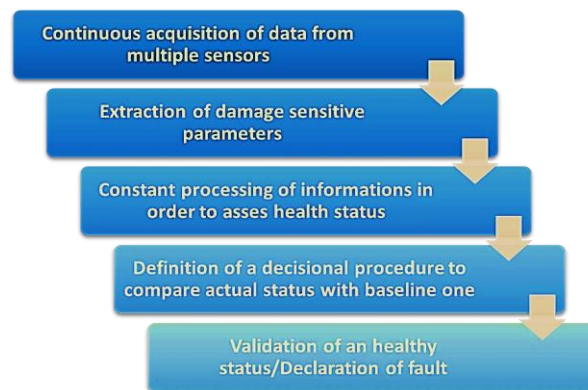
Figure 1: Schematic steps for a Structural Health Monitoring system.

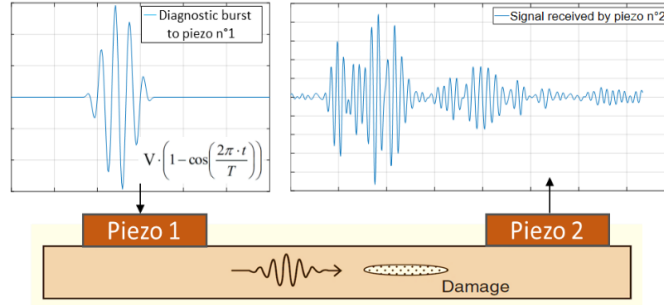
The NI-6259 Multifunction I/O Device is controlled by a computer interface built in MATLAB environment. For the excitation signal, a sinusoidal burst is selected as resulted from the trials on the signal shape supported by piezo transducers. An impulse shape is given by the function shown in the Figure 10.

Figure 10: Schematic representation of voltage signal given to piezo 1 and obtained by piezo 2 as function of the structure health status.

The frequency of the diagnostic burst is controlled, and it is imposed at 40, 50, 75, 100 kHz, in order to evaluate the system response at different frequencies. The amplitude of exciting voltage as output from the NI-6259 module remains constant at 3.5 V, without modification caused by Multiplexer. The received voltage signal from the piezo sensors has been recorded by the NI-6259 as input and transferred to the MATLAB algorithm, which performs the data processing.

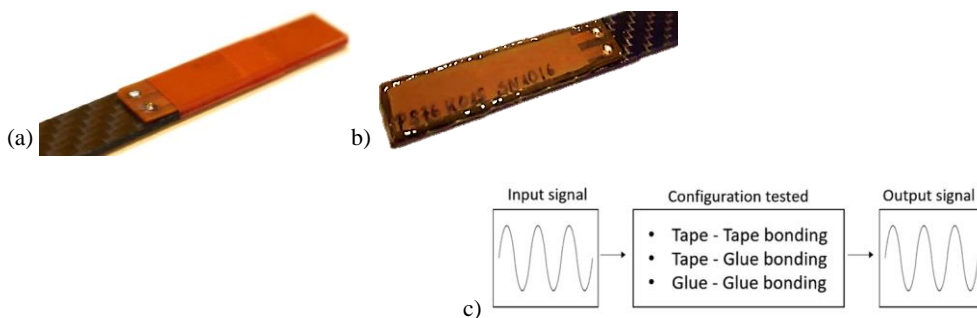
For the beam sample, two rectangular DuraAct P876-K015 have been coupled to the composite in order to evaluate the coupling influence to the signal transmission. Two different bonding techniques have been tested, as shown in Figure 14: a special flash tape and epoxy resin, as recommended by PI technical datasheet, Figure 13 (b) [21].

Figure 14: Bonding of rectangular piezo patch to the composite beam with special flash tape (a) and epoxy resin, as recommended by PI (b). Coupling effect study with different bonding configuration (c).

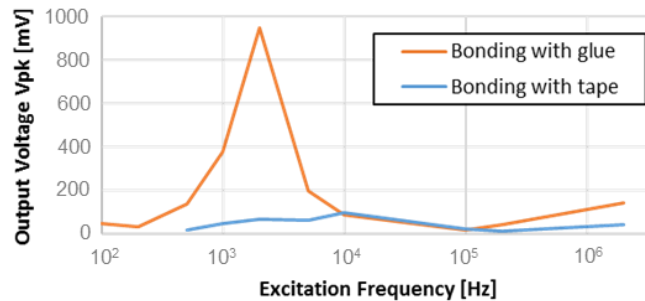
Figure 17 shows the behavior of piezo n°2 (tip) at different frequencies. The Output Voltage Amplitude reach the maximum value at 2 kHz for the glue-glue bonding onto the composite beam.

Figure 17: Output Voltage-Excitation vs. Frequency excitation for the glue-glue and tape-tape bonding of piezo n°2 (tip) onto the composite beam.

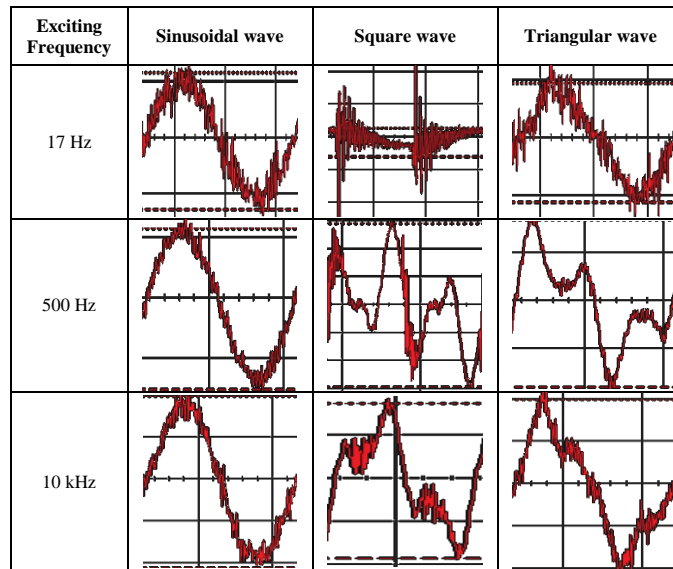
Table 6: Analysis of wave shape transmission from piezo actuator to piezo sensors.

When a sensor receives a signal transmitted by an actuator, some distortion with regard to the external input can be detected. For this reason, the distortion typology investigation has an important role in order to distinguish if it is caused by the natural propagation inside the material or if it is due to a failure in transmission. As a matter of fact, sinusoidal, square and triangular wave shapes have been sent to the piezo actuator with a constant amplitude of ± 12 V, in order to characterize the effective reproducibility of the wave shape. For each wave shape, different excitation frequencies have been imposed, in order to evaluate the transmission behavior (Table 6).

The sinusoidal wave is the only input shape that is perfectly transmitted and received at any frequencies. On the contrary, triangular wave is subjected to distortion at low frequencies and it becomes acceptable just at the higher ones, while the square wave is not received well neither at high nor at low excitation.

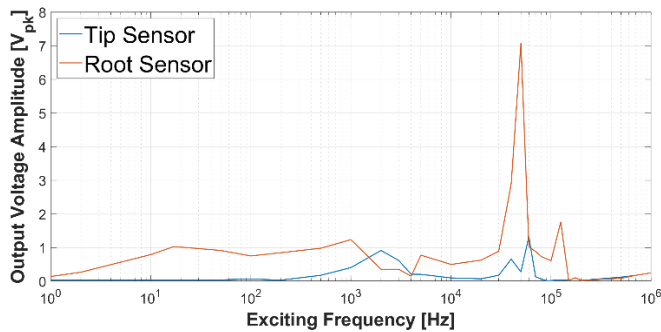
It is important to note that the Output Voltage values for the piezo sensor at the root are generally higher than the piezo sensor at the tip. This result is probably related to the energy dissipation at higher distances from the exciting place. In terms of acoustic propagation, if the frequencies increase, the waves travel far away from the source. Hence, the need to impose a high frequency for sending the input signal in a SHM system. An overview of sensed frequency is shown in **Errore. L'origine riferimento non è stata trovata.**, with the Output Voltage Amplitude for root and tip sensors.

Figure 21: Output Voltage Amplitude vs. Frequency for piezo sensors at root and tip in the range of frequency from 1 Hz to 1 MHz.

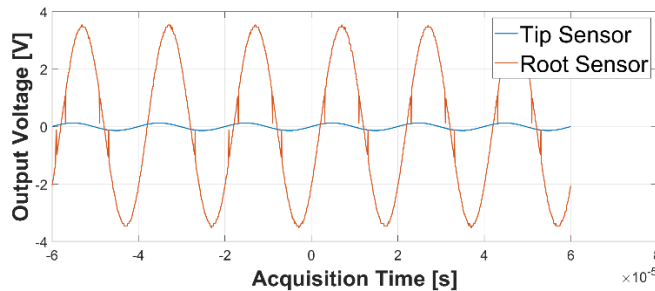
In conclusion, the best frequency for the strain signal transmission, in this experimental configuration, is 50 kHz. This value will be used for the validation of the SHM system. Figure 22 shows the response for root and tip sensors, at the chosen excitation frequency of 50 kHz.

Figure 22: Output Voltage vs. Time for the piezo sensors at root and tip at the exciting frequency of 50 kHz.

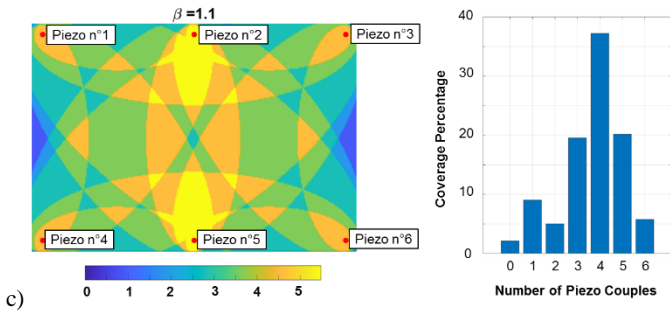
The area covered by each data transmission between two couples of transducers depends on the value of β . Three different configurations with β equal to 1.01, 1.05 and 1.1 are shown in Figure 25.

Figure 25: Covered area for the piezo couples at values of β equal to 1.01 (a), 1.05 (b) and 1.1 (c).

The increasing of the influence area for each couple generates a larger area covered by the damage inspection. On the other hand, the accuracy for damage localization decreases, because the damage index is spread on an area instead to be localized on a single point. The β value of 1.05 is the trade-off between accuracy and a large covered area, as reported in the literature [15].

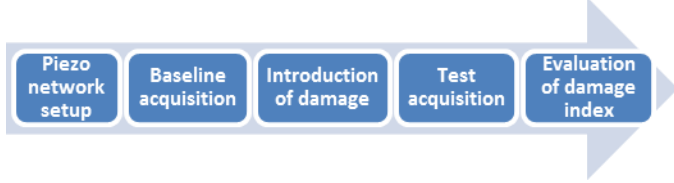
Firstly, a baseline acquisition for the healthy structure without any damage has been effectuated either for beam or for plate. After that, an external defect has been generated on the sample surface and a second data acquisition has been recorded. The defect presence that induces a distortion in the guided waves propagation, has been demonstrated, through the comparison between the two data sets. Figure 3131 shows a schematic representation of the steps required for experimental investigation for beam and plate.

Figure 31: Schematic representation of the experimental procedure.

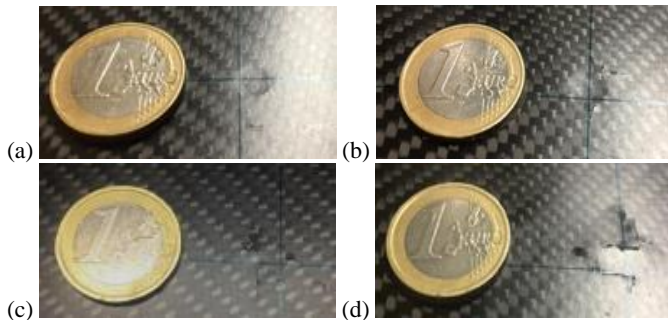
Figure 38: Visual inspection of the four stages on the composite beam.

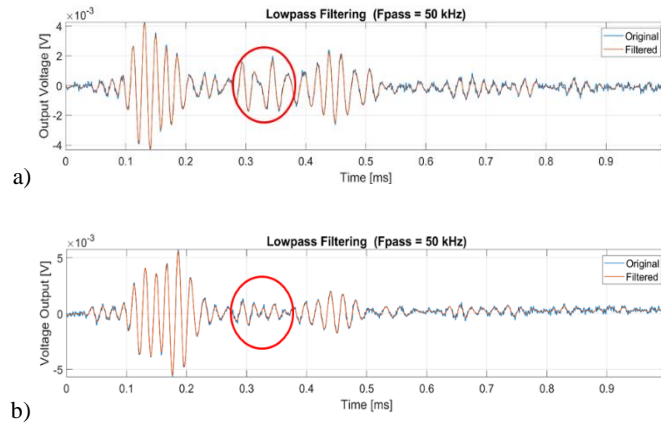
Despite the structural conditions are the same, different data sets have been acquired. Consequently, each configuration needs its proper baseline acquisition. Then, the comparison between reference and actual signals for each defect has been analyzed. The actuation signal is a sinusoidal burst. For the right excitation signal definition, the test frequency changed in the range 100 Hz to 125 kHz. For low frequency of 100 Hz, a low amplitude mechanical vibration is induced and the sinusoidal signal transmitted cannot be distinguished, as plotted in Figure 42.

Figure 41: Low-pass filter at exciting frequency applied to the baseline data sets for the appended (a) and clamped (b) configurations.

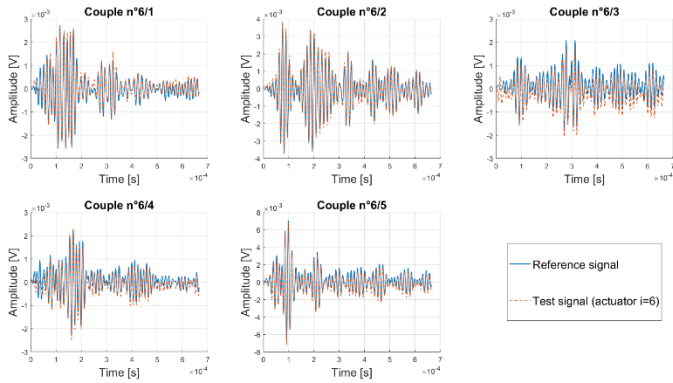
Only the data recorded at higher frequencies (50-125 kHz) have been considered for SHM purpose, in order to overcome the structure mechanical vibrations. An example of data set acquired for all piezo couples with the piezo actuator n°6 is reported in Figure 44.

Figure 44: Example of filtered data set acquired for all piezo couples with the piezo actuator n°6.
