**Operational Safety of Gravel Roads in Rural and Tribal
Communities: Vulnerability to Structural Failures and Geo-
Hazards**
FINAL PROJECT REPORT

**Department of Civil and Environmental Engineering
University of Idaho**

**Center for Safety Equity in Transportation (CSET)
USDOT Tier 1 University Transportation Center
University of Alaska Fairbanks
ELIF Suite 240, 1764 Tanana Drive
Fairbanks, AK 99775-5910**

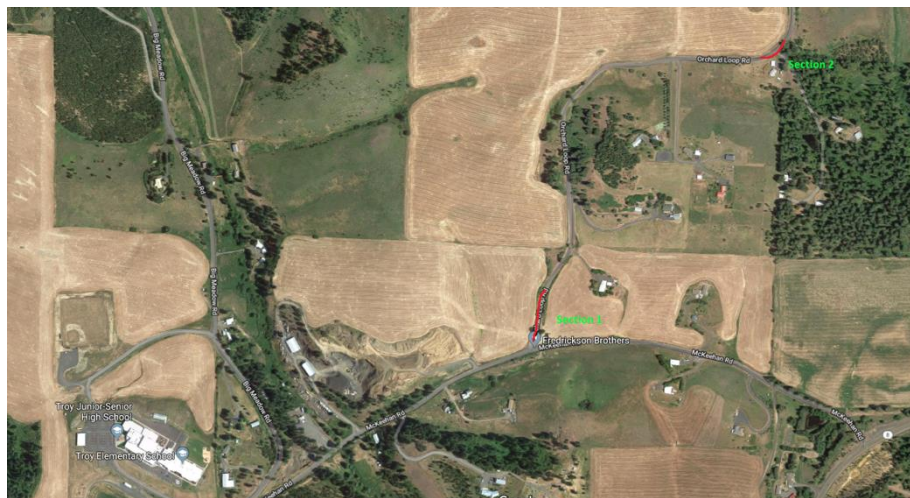
Figure 2.2 Gravel road (Troy, ID)

A field visit was conducted by the research team to two of the gravel roads in Troy, ID as shown in Figure 2.2. The roads were selected based on information in the database of gravel roads provided by Idaho Transportation Department. The ditch width, drainage slopes, and the shoulder width were measured by the team and the roads were found in reasonably good condition as shown in Figures 2.3 to 2.6.

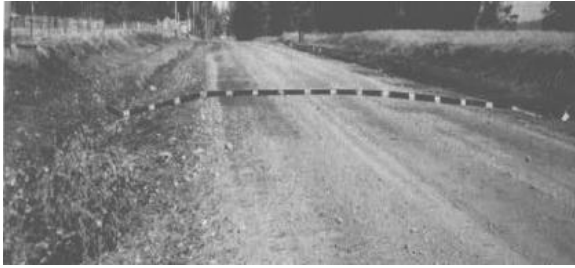
Where right of way is available, flatter slopes combine a safety feature with satisfactory drainage.

Figure 2.7 Acceptable levels of road characteristics in Idaho (ITD 2019)

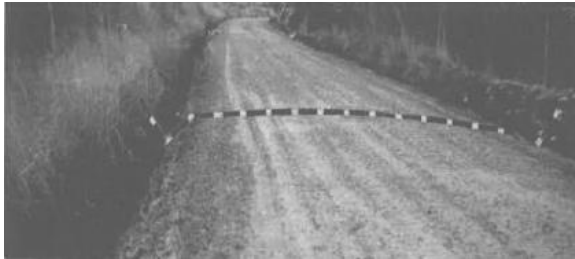
Restricted right of way may require steeper, less safe slopes to achieve proper drainage.

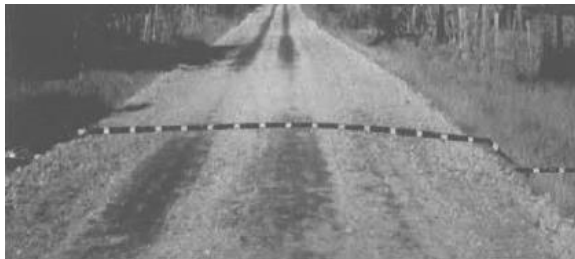
Flat sections in good gravel must be crowned to insure drainage to the outside.

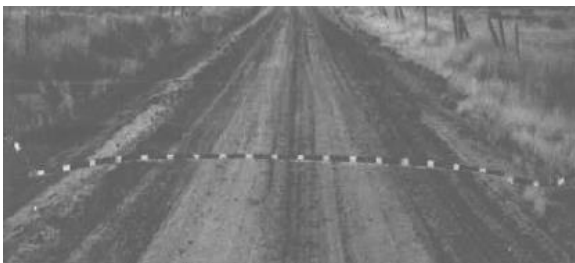
This profile depicts a road surface with a definite crown and minimal side-ditching. Drainage may be barely adequate.

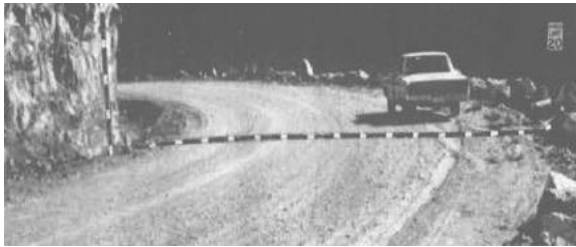
Entire traveled surface is sloped to a shallow ditch at the toe of the hill. In extremely difficult conditions involving essentially solid rock, ditching is not mandatory.

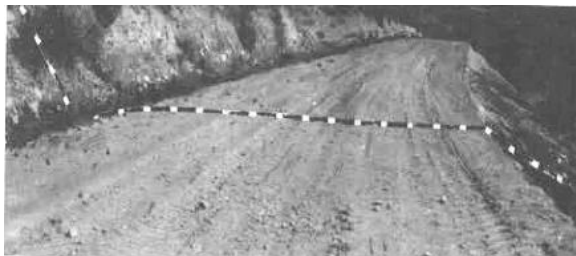
When material is non-erodible, or erosion is controlled, drainage can be accomplished by sloping away from the hillside. Consideration should be given to hazards in this type of drainage where surface may become slick.

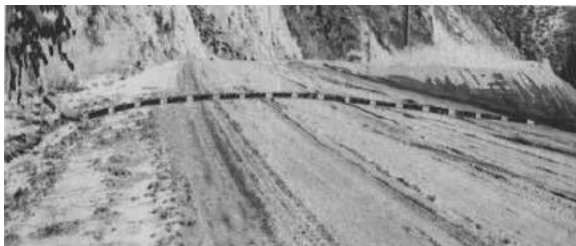
When erosion is controlled, a normal crown may be appropriate.

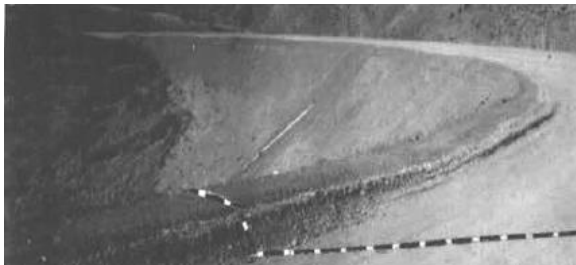
Protection against erosion in this fill section is provided by soil curbs and drain pipes.

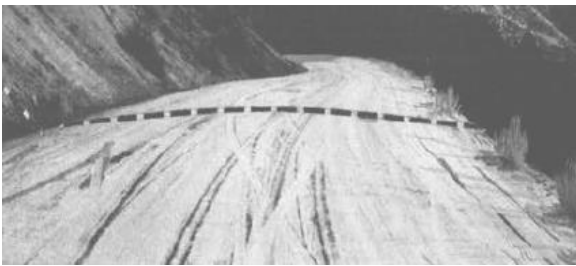
When erosion is controlled, a normal crown may be appropriate.

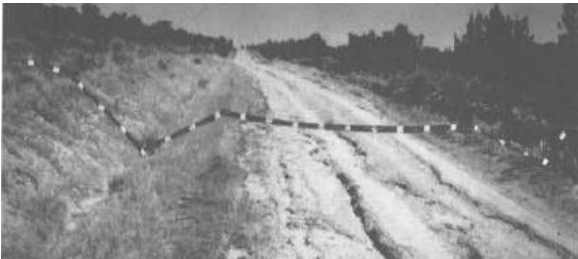
Concave surface prevents proper drainage. Limited corrective measures could change classification to acceptable.

Figure 2.8 Unacceptable levels of gravel road characteristics in Idaho

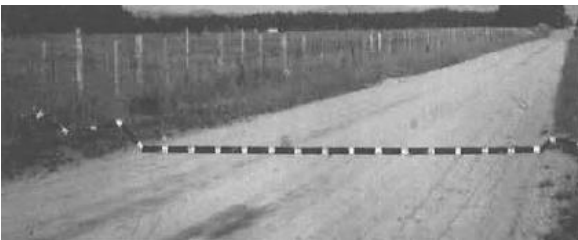
Inadequate maintenance has allowed drainage features to disappear. Side ditches, culverts and crowning are needed.

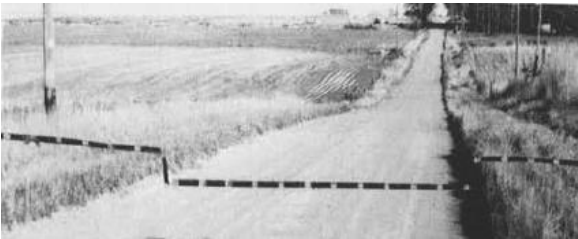
Repeated float-blade maintenance has created a virtual canal.

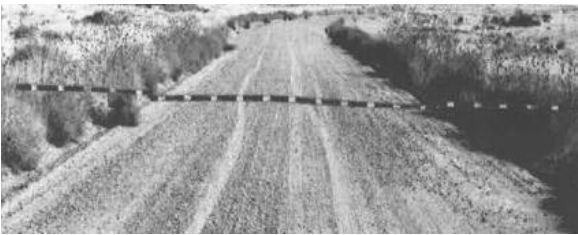
Flat sections in good gravel must be crowned for adequate drainage to the outside.

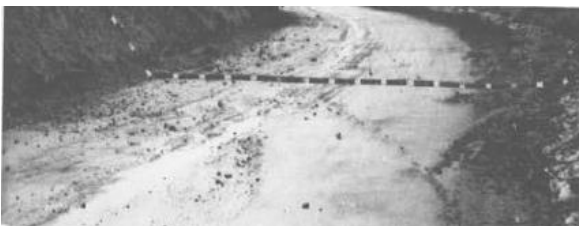
Hillside section in earth must have proper slope and ditch at the toe of the hill, or a normal crown when erosion is controlled to provide adequate drainage.

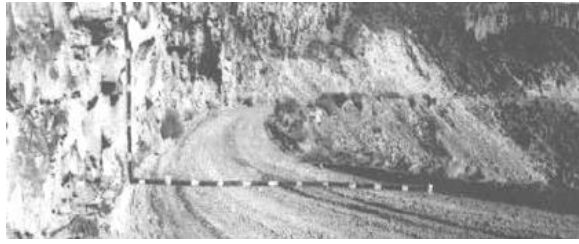
Hillside section in rock and gravel must have a proper slope either to the toe of the hill or to the outside, or, have a normal crown. If the slope is to the toe of the hill, ditching is necessary unless material is essentially solid rock. If the slope is to the outside, or a normal crown is used, ditching is required and erosion on the outside must be controlled.

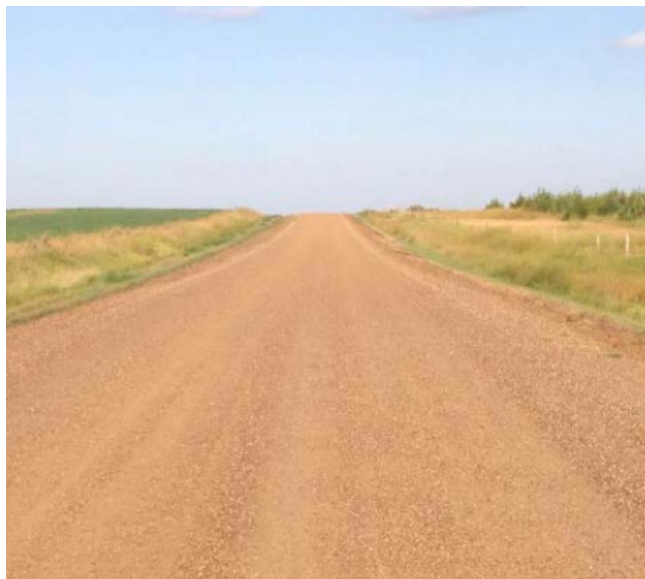
Figure 2.10 Gravel road with adequate crown.

Figure 2.10 shows a gravel road with good shape of the entire cross section. The road has a driving surface with adequate crown that slopes directly to the edge of the shoulder.

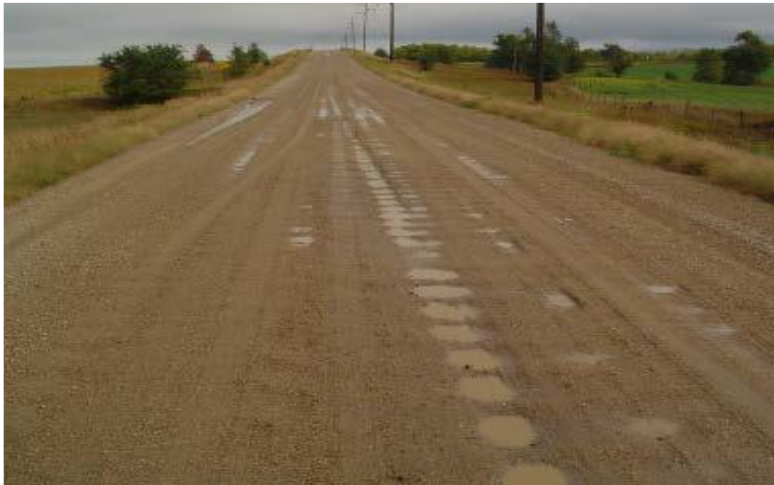
Figure 2.11 Gravel road with inadequate crown

Figure 2.11 shows a gravel road that lacks adequate crown. As a result, potholes and corrugation are forming because the lack of a crown prevents water from draining off the road surface.

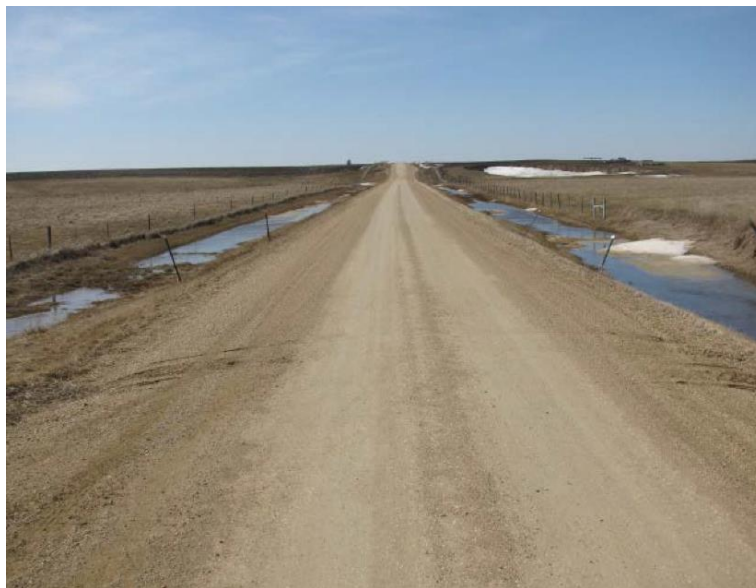
Figure 2.12 Gravel road with excessive crown.

Figure 2.12 shows a gravel road that is wide (25 feet surface width) with traffic predominately driving in the middle. The primary reason is excessive crown.

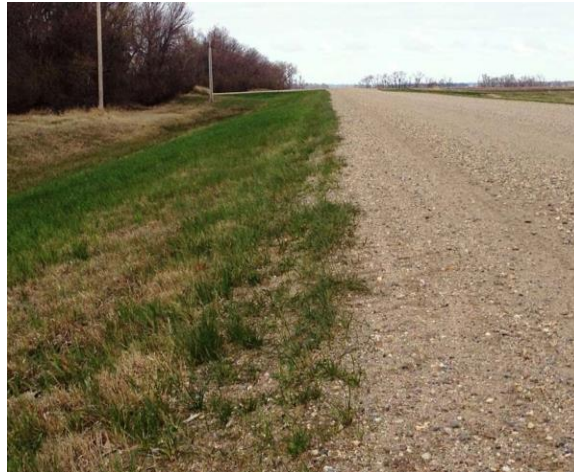
Figure 2.13 Example of good gravel shoulders.

edge support. Figure 2.13 shows one example of gravel shoulders that match the edge of the roadway very well and drain water to the ditch.
