Simulation of Slightly Degraded Reinforced Concrete Shaft Lining in Thick Topsoil

Haijian XIE, Henglin LV

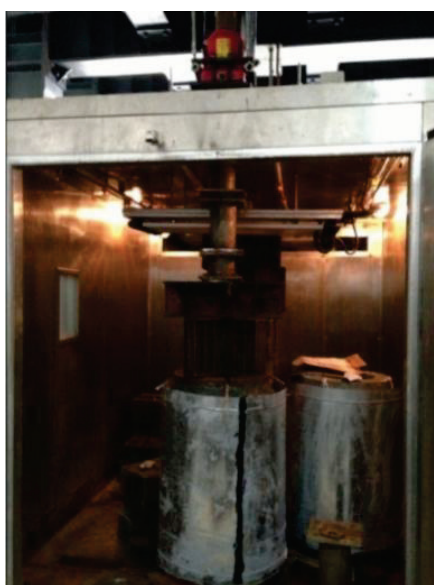
Figure 2 The simulation environment

The simulation environment is shown in Fig. 2.

Step 1. To simulate the horizontal pressure from soil and water, prestressed steel strands were adopted to apply circumferential load to the outer lining of model 1, model 2 and model 3.

Step 2. To simulate the top-down dead load of the shaft lining, vertical jacks were employed to apply vertical loads on inner and outer linings of model 3.

Step 3. To simulate the erosion of the inner lining under combined effects of gas, liquid, solid, temperature and humidity (Tab. 4), model 2 and model 3 were entirely placed in aphytotron. Model 1 (comparison object) was placed in natural environment.

Step 4. To simulate the erosion of the outer lining by corrosive media, the outer lining of model 2 and model 3 were surrounded by a ring of steel plates, and the gap between the outer lining and the steel plates was injected with corrosive solution (Tab. 4).

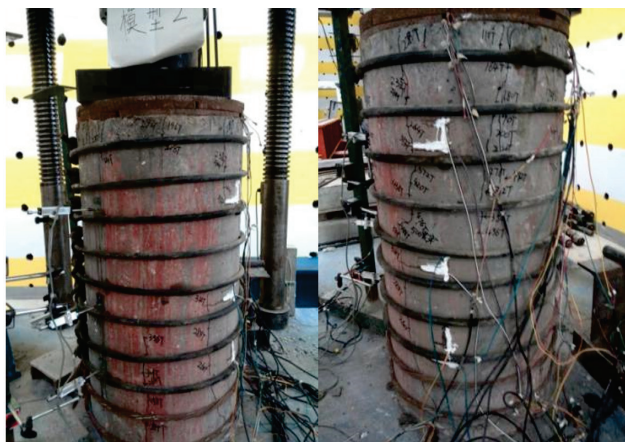
Figure 4 Crack propagation and failure of model 2

Before the simulation under vertical load, model 2 was applied a circumferential load and was placed in phytotron / soaking environment. The crack propagation and failure of this model are shown in Fig. 4.

The failure of this model also carries obvious features of brittle failure: the outer lining was penetrated by cracks, and the upper part was crushed. Cracking sounds were heard clearly from the concrete when the load reached the cracking

Under the initial load, several cracks (18 cm) were generated in the upper and lower parts of the outer lining, and distributed uniformly along the shaft circumference. Under further loading, cracking sounds were heard, and several cracks propagated towards the middle part. Once the load reached 85% of the ultimate load, cracking sounds were heard continuously from the inner lining, and penetrating cracks were observed on the outer lining. When the load reached the ultimate load, the upper part of the lining was crushed, showing a diagonal shear failure.

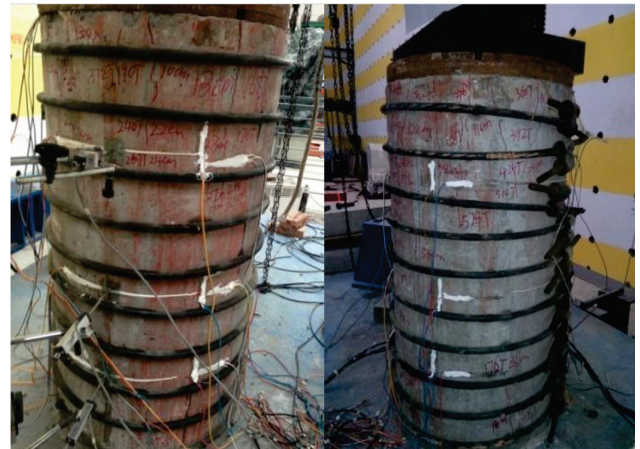
Figure 5 Crack propagation and failure of model 3

Before the simulation under vertical load, model 3 was applied a vertical load and a circumferential load, and was placed in phytotron / soaking environment. The crack propagation and failure of this model are shown in Fig. 5.

Like that of model 2, the failure of model 3 has obvious features of brittle failure: the outer lining was penetrated by cracks, and the upper part was crushed. Below is an analysis on the crack generation and propagation of the outer lining.

Under the initial load, several cracks appeared in the upper and lower parts of the outer lining. These cracks were longer than those of model 2 in the same period, and obey uniform distribution along the shaft circumference. Under further loading, more cracking sounds were heard, and several cracks propagated towards the middle part. Once the load reached 90% of the ultimate load, cracking sounds were heard continuously from the inner lining, and penetrating cracks were observed on the outer lining. When the load reached the ultimate load, the upper part of the lining was crushed, showing a diagonal shear failure.

- (1) The cracks first appeared on the top and bottom of the outer lining;
- (2) The diagonal cracks coalesced on the outer lining before the failure of the shaft lining.
- (3) The concrete of the inner lining was cracked, and the upper part of the shaft lining was crushed, showing a diagonal shear failure.
