Paper ID: 1421

Theme 3. Sustainability of grasslands- social and policy issues

Significance of grasses in establishment of ecological restoration in mined out degraded land in Jharia coalfield, Dhanbad

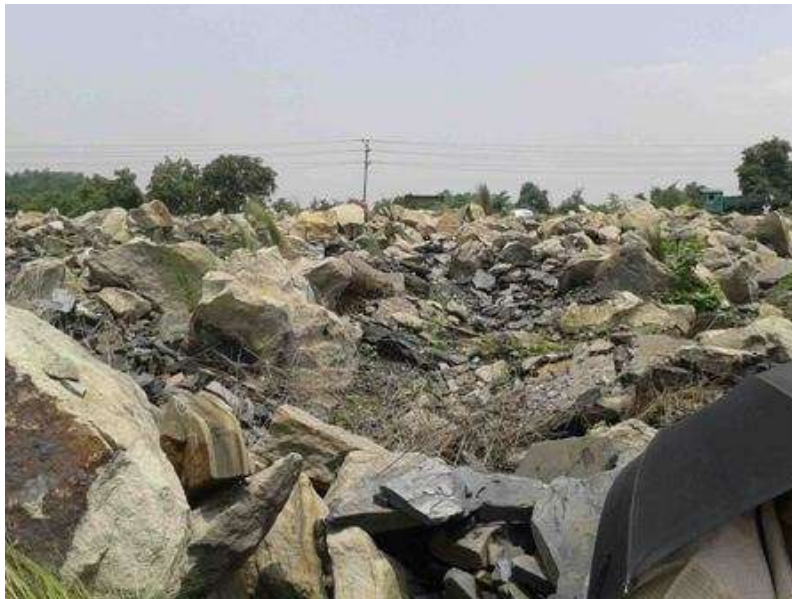
Plate 1- Mined out degraded land study site, Damoda (2011-12)

Both the study sites before the ecological restoration were completely devoid of grass cover. With the initiation of ecological restoration, seeds of various grass species were sown and have completely covered ground of the site with eradication of weeds from the sites. Grasses like *Pennisetum pedicellatum*, *Cenchrus setigerus*, *Cenchrus ciliaris* and, *Saccharum spontaneum* have grown up to the height of 4-6 feet. Degradation of the biomass is triggering the top soil generation at the sites. Plants litter and root exudates provide nutrient-cycling to soil. The shrubs and bushes like *Dodonaea* have shown significant results. With in short period of 3 years, growth of bamboos is tremendous and many bamboos have grown to the height of 15-20 feet and have started propagating. The trees of *Albizia* and *Ziziphus* have grown up to the height of 12-15 feet and girth of 3-4 inches. *Bauhinia purpurea* has also shown good results with average height of 9-10 feet and diameter of 1.5 inches. Besides successful growth of flora, fauna like chameleons, frogs, grass hoppers, lizards, snakes, butterflies, mouse, rabbits, sparrows, parrots, squirrels, caterpillars, earthworms, centipedes etc have also been seen at the site after successful restoration indicating the development of a self-sustaining ecosystem and food chain.

The success of both the study sites was exemplary and un-precedential. This was achieved in spite of demanding challenges from highly degraded coal mining areas. The challenges consisted of absence of soil cover where the terrain comprised of boulders; the mined out degraded lands were thickly invaded by the exotic weeds and their removal from these sites.

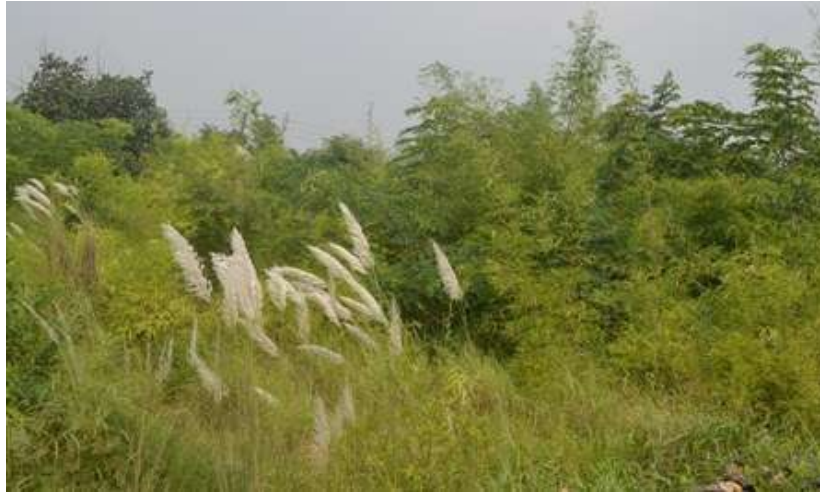
Plate 2- Grass cover establishment and ecologically restored study site, Damoda (2014-15)

The establishment of grass cover has helped in generation of large quantity of biomass and increase the nutrient availability in the mined out lands and establishment of the ecosystem. The wide spread network of the roots of the grasses has helped in stratum binding and stabilization of the slopes. Various living beings of the lower trophic levels of the ecosystem like butterflies, bees, arthropods, insects etc have developed their niche in the grasslands and attracting the other higher trophic level organisms. On some overburden dumps with mine fire, it has been observed that establishment of grass cover on these overburden dumps have reduced these fires and prevent the further expansion of the fires. Subsequent to the success of the study sites, BCCL has drawn up a plan for ecological restoration of about 226 ha mined out degraded land up to 2018-19. BCCL has already started ecological restoration work on 120 ha of land.
