**Citation:** Qian, K., Hu, H., Fu, F. ORCID: 0000-0002-9176-8159 and Deng, X. (2020). Dynamic Behavior of Precast Concrete Beam-Column Sub-Assemblages with High Performance Connections Subjected to Sudden Column Removal Scenario. In: Soules, J. G. (Ed.), Structures Congress 2020. (pp. 467-474). Virginia, USA: ASCE. ISBN 9780784482896

**Dynamic Behavior of Precast Concrete Beam-Column Sub-assemblages with  
High Performance Connections Subjected to Sudden Column Removal  
Scenario**

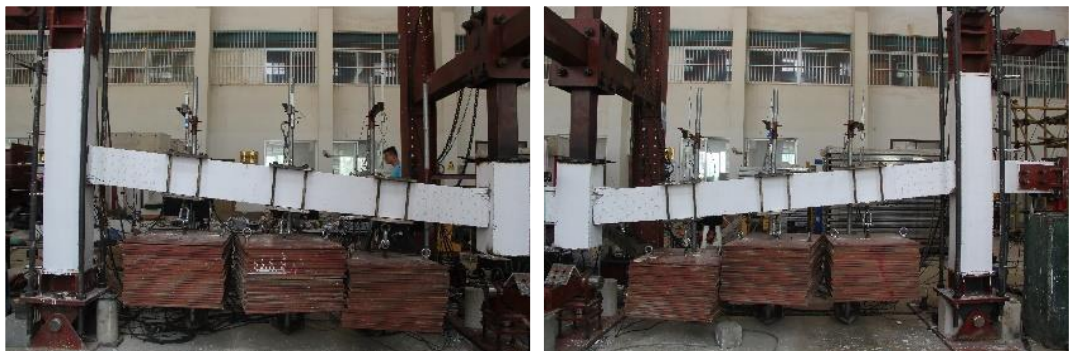
**Figure 6 Crack pattern and local damage of UPPC-DH (from the author)**

The crack pattern and local damage of UPPC-DL and UPPC-DH were illustrated in Figures 5 and 6, respectively. The differences caused by different axial compression ratio were mainly reflected in the crack pattern of the side columns. It could be found that the cracks observed in the side columns of UPPC-DH were much fewer than that in UPPC-DL. Moreover, the cracks formed in the interior column were milder than that in the exterior one for both specimens.
