**ARC2014-1087**

**Graphic Representation and Military  
Architecture: The Trace of the  
Fuenterrabía Fortifications in the  
Current City**

Fuenterrabía, one of the most outstanding strongholds of the Basque Country, has historically been a strategic checkpoint on the land crossing between France and the Iberian Peninsula. Due to its military interest, it was many times besieged between the sixteenth and nineteenth centuries for its possession and territorial control, main reason for the extraordinary importance of the development in its fortification system. Military engineers developed continuous fortification projects to adequately resist the advances in artillery and siege warfare tactics. This progress also affected the urban development, including the social and economic living standards of its inhabitants. This paper attempts to analyse the relationship between the evolution of the fortress and the urban development of Fuenterrabía through the recovery of the missing trace of its fortifications at its present location. By precise graphic overlays and research on the perfection of the outlines in historical drawing, the different traces of fortifications can be accurately

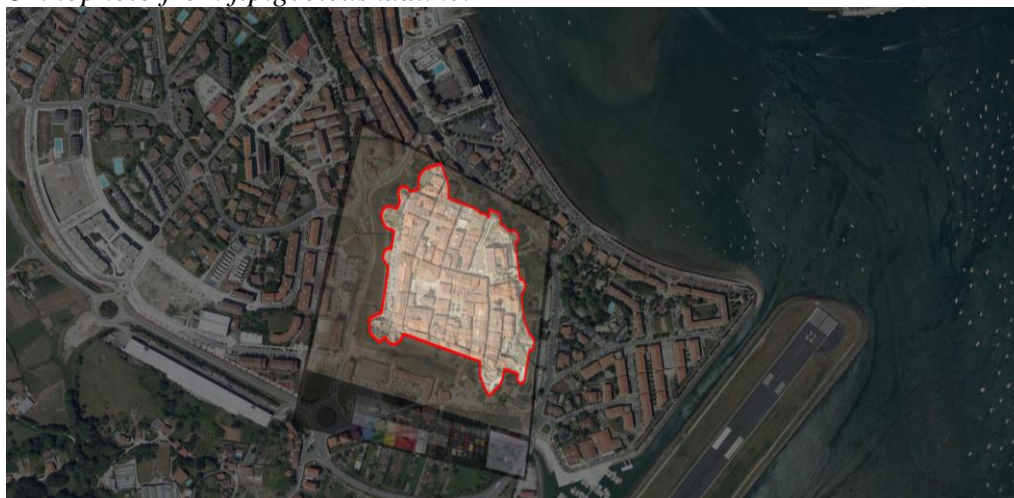
**Figure 1.** *Own Production: Overlay of AGS. M. P. y D. XIII-55 and Aerial Orthophoto from ftp.geo.euskadi.net*

As was the case with population centres in strategic locations, Fuenterrabía, in the Bidasoa mouth and French border, had medieval city walls dominated from the inside by a defensive tower since its original foundation. But it was after the annexation of Navarre to Castile, in the historical and cultural birth of modern states, when it experienced a boom of defensive buildings and got a new bastioned enclosure. The Catholic Kings built over the old defensive tower a castle, being later enlarged and restored by order of Charles V<sup>4</sup>. In 1476 and 1477 Fuenterrabía suffered two sieges by French troops during the campaigns of defence of the rights of Queen Isabella against Joanna *la Beltraneja*. From the second decade of the sixteenth century, the towers, battlements and walls were lowered to provide embanked masses of soil contained by masonry walls finished with meticulous ashlar. The first bastions were built. But the truth is that the real transformation came later, once the design of the modern bastion had matured. A modern defensive belt wrapping the existing medieval was decided to be built due to the constraints of the terrain, removing some old medieval towers or substituting other by bastions. This can be appreciated in the first graphic document of the fortifications, previous to 1530, preserved in the Archives of Simancas<sup>5</sup>.

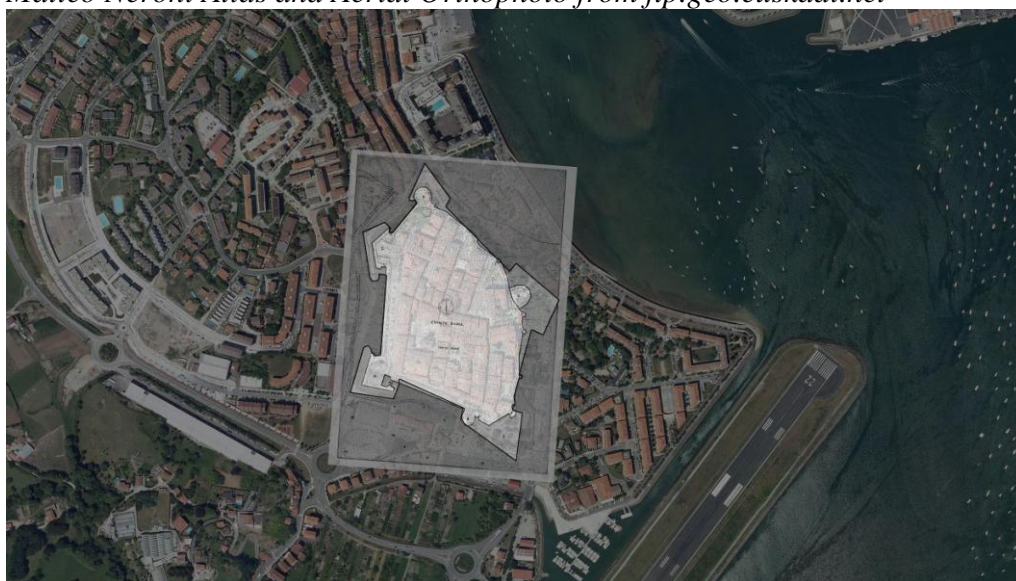
**Figure 2.** *Own Production: Overlay of Fuenterrabía Plan Published on the Matteo Neroni Atlas and Aerial Orthophoto from ftp.geo.euskadi.net*

Years passed and Philip II came to the throne. It would be the architect of a series of fortifications that would astonish the world<sup>3</sup>, as the citadel of Antwerp. In 1571 he ordered to the Fratin design a same style pentagonal citadel in Pamplona. He visited Fuenterrabía together with the viceroy Vespasian Gonzaga -expert poliorceta-, and decided to build a new more capable bastion in the south, the stronghold of San Felipe, as well as numerous repairs on the fortified place. He designed a trace that the prestigious engineer Tiburcio Spanochi changed or adjusted later, around 1580. In 1603, he wrote a

report on the state of the fortifications once he was appointed Senior Engineer of the Spanish Kingdoms. It formed the basis for a new improvement project made by the engineer Jerome de Soto after Spanochi died in 1609. No other works were carried out during the reign of Philip IV, until the siege of 1638. Some exterior works were done following that fact: a ravelin in front of the gate of St. Nicholas and a tenaille in the northeastern part. It would be the beginning of a new modernization of the walled enclosure that would be developed throughout the seventeenth century, but it is beyond the subject of this investigation.

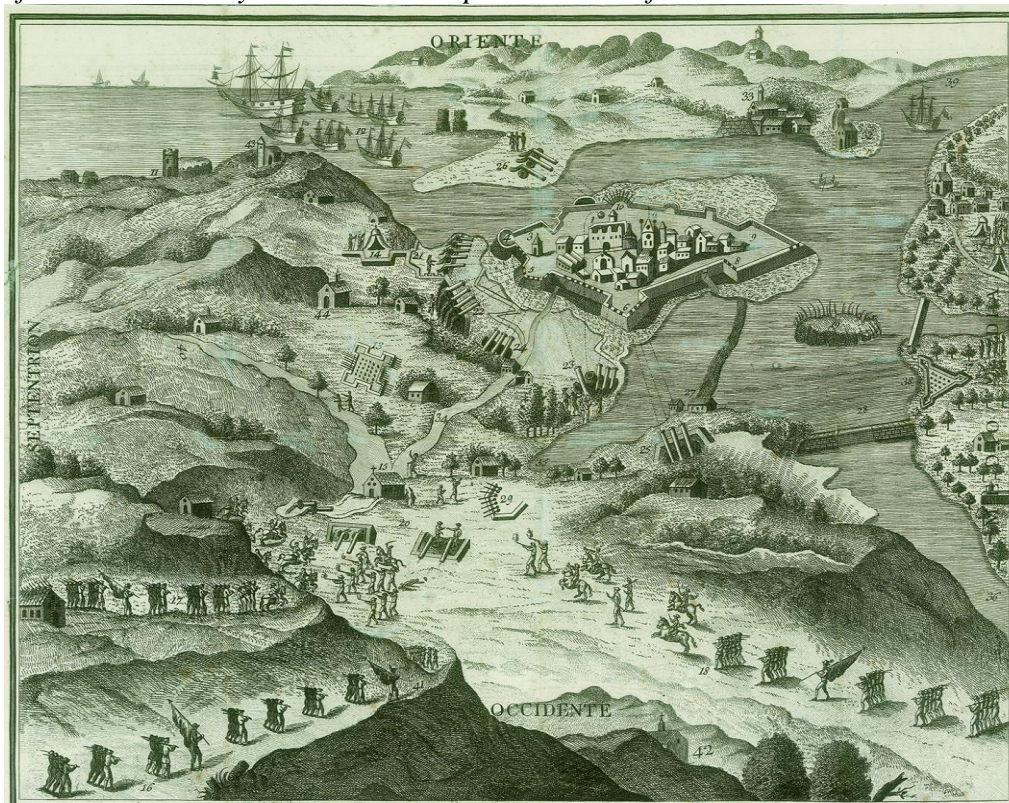
**Figure 5.** *View of the Stronghold of the City of Hondarribia during the Assault of the French Army in 1638. Municipal Archives of Hondarribia*

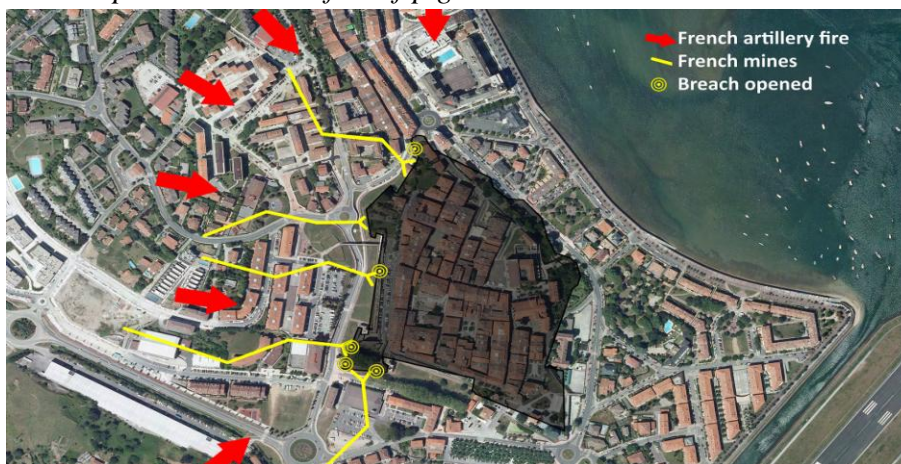
**Figure 6.** *French Attacks. Own Production: Warfare Diagrams Overlaid with Aerial Orthophoto Extracted from ftp.geo.euskadi.net*

The French prepared mines with which they blew the missing part of the bastion of the Queen and at dawn of 4th September. Even the transit of cavalry was possible through the breach, and to prevent the besieged from defending it, the French fired to distance them allowing the attackers to climb the ruins. The combat was fierce in the breach, but the besieged forced the French to withdraw. The defenders put a cannon in the casamate of the gabions facing the bastion of the Queen and, as attackers were being fired also from the bastion of Saint Mary, they dug three trenches to be covered in both sides. They built a gallery that reached the surroundings of the breach, where they were also mining the rampart. The French spoiled their own gallery and a cannon from the rampart in the bastion of Leiva definitely destroyed it. In the bastion of the gabions, the French had blasted a mine while from inside defenders arranged a stronghold and started building a trench to defend themselves in case the enemies ruined the bastion and entered that way.
