The shear characteristic and failure mechanism study of infilled rock joints with constant normal load

Abstract. In order to evaluate the shear deformation characteristics, the direct shear tests for the rock-like specimens with regular sawtooth were carried out in the laboratory. The different asperity angles and different normal stress conditions were considered and the dilatancy characteristics and the corresponding failure modes were analyzed accordingly. The uncommon asperity angle of 25°, 40° and 55° have been selected to compare with the common angles, which can study the differences in detail. Studies show that when the normal stress keeps constant, the peak shear strength increases first and decreases with the increasing asperity angle afterwards. It is because the force causing sawtooth damage under tensile failure is less than the force under shear failure. When the asperity angle keeps constant, the greater the normal stress, the greater the peak shear strength. The larger the normal displacement of dilatancy angle and dilatancy are caused by larger asperity angle. According to the verification, the test results are in good agreement with the analytical results. It sho

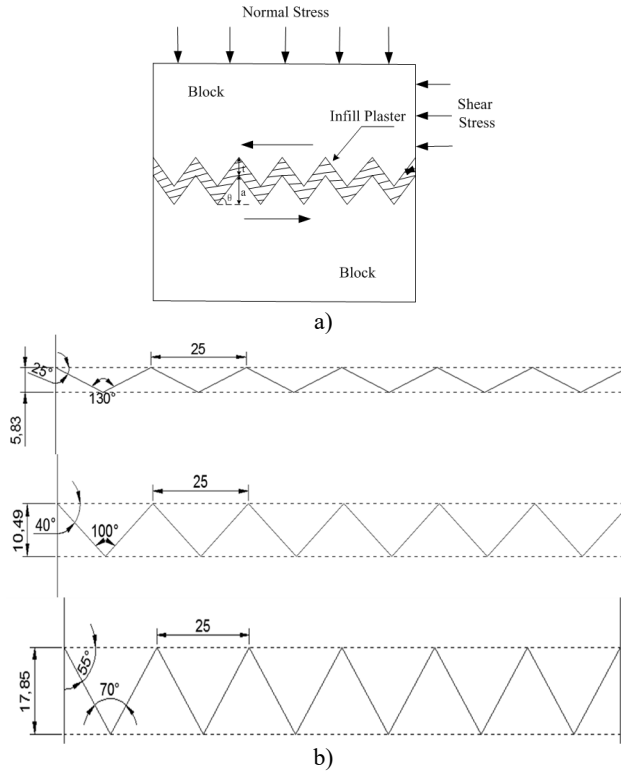
Fig. 1. Experimental models: a) the specimen containing infilled plaster, b) $\theta = 25^\circ, 40^\circ$ and 55° with no infilled plaster

In the test, the blocks were a mixture of 42.5 Portland cement, fine sands which particle size less than 2 mm and water with a weight ratio of 2:2:1. The specimen size is 150 mm×150 mm×150 mm, the width of a single sawtooth is 25 mm, the number of the sawtooth is 6, which means the height varies with the asperity angle. The asperity angles θ of the structure

surface was 25°, 40° and 55°, as shown in Fig. 1. The plaster is used for 1:2 filling, that is t/a was 0.5. In order to improve the accuracy of the test results, the specimens were layered in the pouring process and tamped in a timely manner. At the same time, the specimens were kept in the curing box for 28 days after standing in the mold for 24 hours to increase the stability of the specimens. The basic mechanical parameters of the plaster are shown in Table 1.

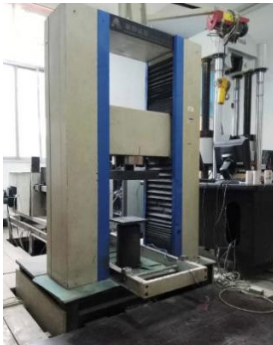
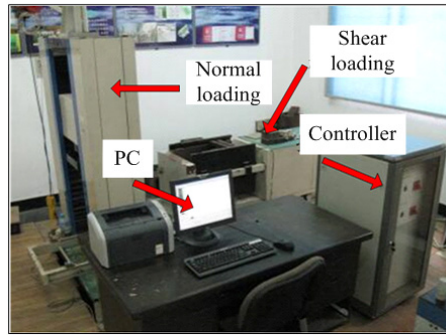
Fig. 2. RYL-600 rock shear rheometer test machine: a) normal loading, b) parts of the test machine

RYL-600 rock shear rheometer testing machine, which is composed of normal and shear loading systems, control system and PC system, is shown in Fig. 2. The maximum vertical and horizontal loads of the machine were 600 kN and 300 kN. To diminish friction effects, the top and lateral surfaces of the block were lubricated before testing. In the test, the shear mechanical characteristics of regular sawtooth surfaces with different asperity angles of 25°, 40° and 55° under different normal stresses were evaluated. Since the specimen is easily fractured under high normal pressure, the test was conducted at normal pressures of 30 kN (1.33 MP), 50 kN (2.22 MP), 80 kN (3.56 MP) 120 kN (5.33 MP). The normal loading rate was 100 N/S and the test plan is shown in Table 2. Shear begins after the normal load has stabilized for 30 minutes. A constant

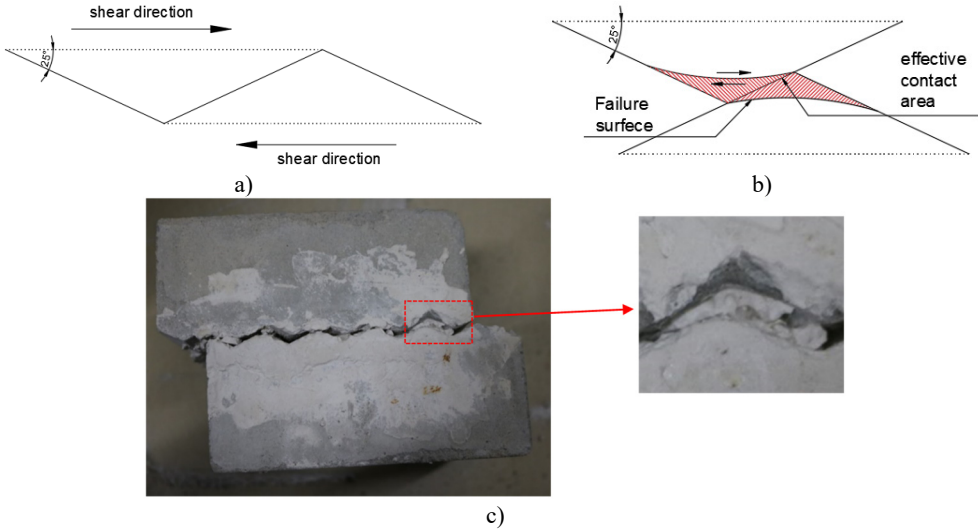
Fig. 3. a) The sawtooth of A-1, b) sliding failure schematic, c) profiles and degraded surfaces for specimen A-1

When the asperity angle is 25° and the normal stress is 1.33 MPa or 2.22 MPa, the shear displacement curve basically displays a sliding failure curve. The specimen slips along the joint surface and the sawtooth tip wears while it is not sheared. The asperity angle does not change, and the joint surface undergoes the dilatancy effect is more obvious than other asperity angles. In the area close to the joint surface, the block is squeezed which is mainly caused by shear damage. The sawtooth before shearing is shown in Fig. 3(a), it shows that the failure surface mostly performs arc shape after direct shear test and the sliding failure schematic is shown in Fig. 3(b). On the other hand, the specimen A-1 is mainly caused by the sliding failure, as shown in Fig. 3(c). The sawtooth portion of the specimen structural surface was ground, and the surface was worn, but there is not any damage basically. It should be noted that the climbing effect is obvious during the practical destruction.

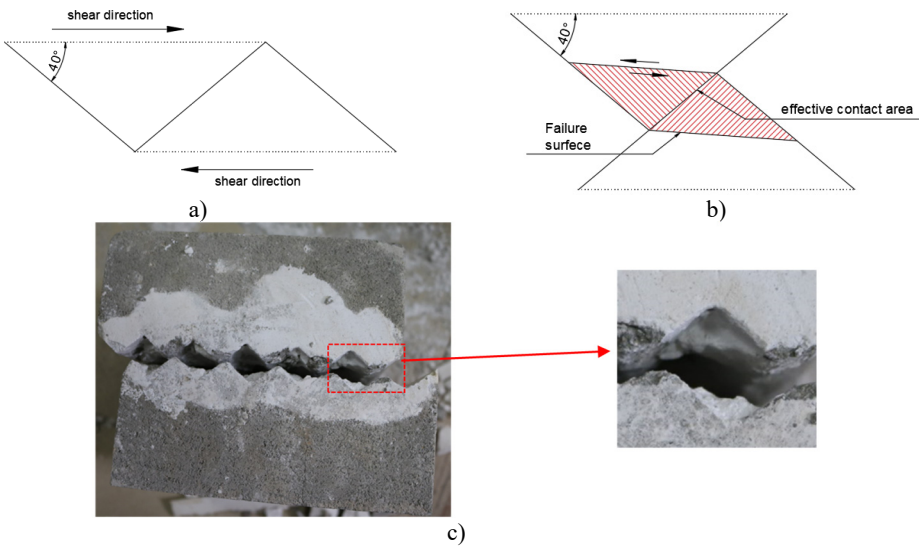
Fig. 4. a) The sawtooth of A-2, b) Shear failure schematic, c) profiles and degraded surfaces for specimen A-2

The difference between the shear failure and the sliding failure is obvious. The sawtooth before shearing is shown in Fig. 4(a). Simultaneously with the normal stress increases, the constraints of the specimen are larger and the dilatancy effect is smaller. In the meantime, the infilled plaster is squeezed more seriously. The sawtooth tip of the specimen undergoes a significant shear failure under the shear force, and the damage mainly occurred in the middle of the sawtooth. The failure surface nearly a horizontal line after the direct shear test and the sliding failure schematic is shown in Fig. 4(b). As shown in Fig. 4(c), infilled plaster is almost completely destroyed, and the basic level of the surface is destroyed as well. For the specimen A-2, the shear failure is mainly induced. Under the low normal stress condition, the failure mode of the specimen mainly changes from sliding failure to shear failure with the increase of the asperity angles.

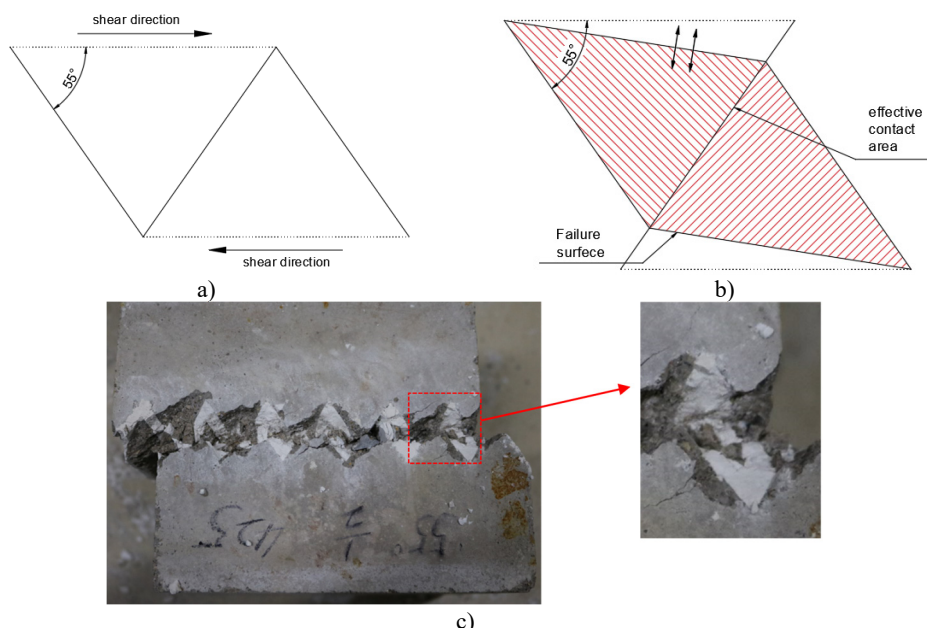
Fig. 5. a) The sawtooth of B-3, b) tensile failure schematic, c) profiles and degraded surfaces for specimen B-3

When the asperity angle of the specimen is large such as 55° or the normal stress is 5.33 MPa, the main damage occurred is a tensile failure. The sawtooth portion of the specimen is directly sheared from the location of the bottom, and there are obvious traces of cracks and sawtooth damage. At the same time, the cutting effect is more obvious during the practical damage process. When the normal stress and the asperity angle are large, the effective contact area of the sawtooth increased, resulting in increasing friction between the upper and bottom block. Also, the force between the sawtooth form a bending moment. The bending moment and friction induce the formation of the final pull to crack afterwards. Compared with shear failure, the destruction of tensile failure is more severe. As shown in Fig. 5, the infilled joints are squeezed closely with the increasing damage area. For the specimen B-3, the tensile failure mainly occurs.

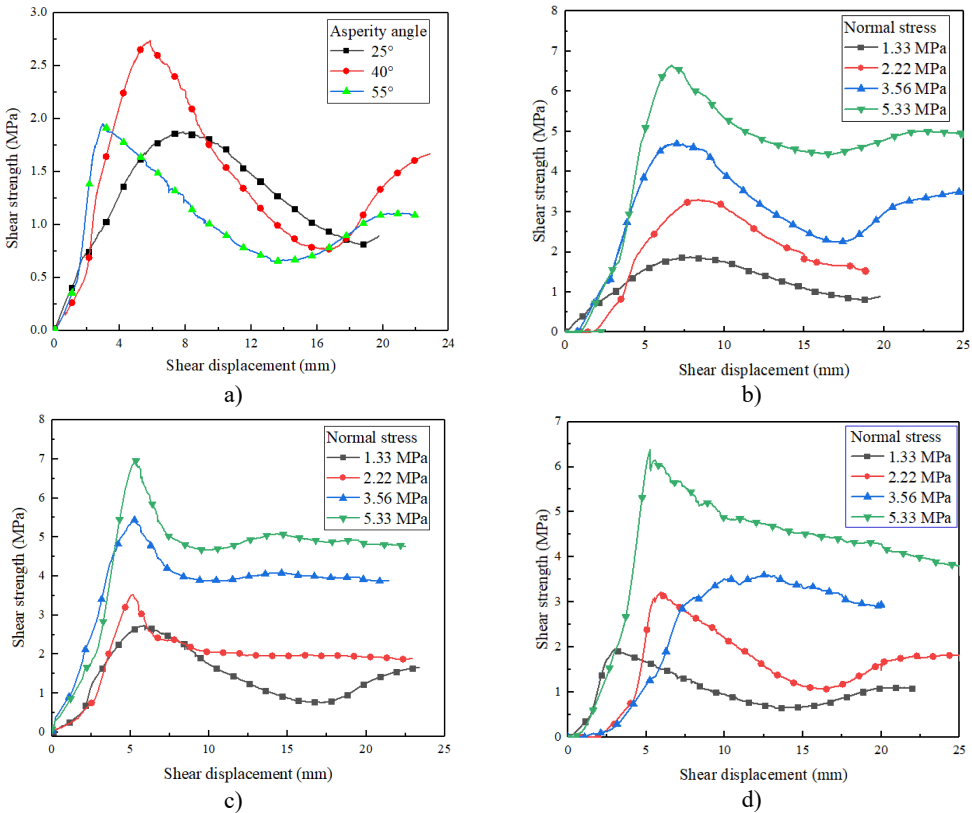
Fig. 6. Typical shear stress-displacement curves: a) asperity angles under the normal stress of 1.33 MPa, b) asperity angle of 25° under different normal stresses, c) asperity angle of 40° under different normal stresses, d) asperity angle of 55° under different normal stresses

Fig. 6(a) depicts different shear stress-displacement curves of asperity angles under the normal stress of 1.33 MPa. During the early stage of shear displacement, the shear strength increases rapidly, basically showing a linear relationship. And the slope increased by the increasing asperity angles. When the peak shear strength was reached, the shear stresses begin to decrease as the shear displacement increases. After the participation curve undulating wavy and the second peak is lower than the first one. When the asperity angle is 25° , 40° and 55° , the peak shear displacement are 7.65 mm, 5.81 mm and 2.99 mm, respectively. It can be seen that under the same normal stress, the larger the asperity angle is, the smaller the peak shear displacement is. Fig. 6(a) depicts different shear stress-displacement curves of normal stresses under the asperity angle of 40° .

In the early stage of micro fracture compaction, the faster the shear stress rises, the greater the normal stress is. The entire residual curves do not show significant fluctuations. However, the residual strength of the specimen with 1.33 MPa is relatively small, while the specimens with 2.22 MPa, 3.56 MPa and 5.33 MPa display obvious residual strengths. Under the same normal stress, the residual strength is proportional to the normal stress. The peak shear displacements of

2.22 MPa, 3.56 MPa and 5.33 MPa curves also increase with the increase of normal stress. As shown in Fig. 6(b) and 6(c), the trend of shear stress-displacement curves is almost the same. But in Fig. 6(d), the shear stress-displacement curves are a little different which due to the tensile failure mode.

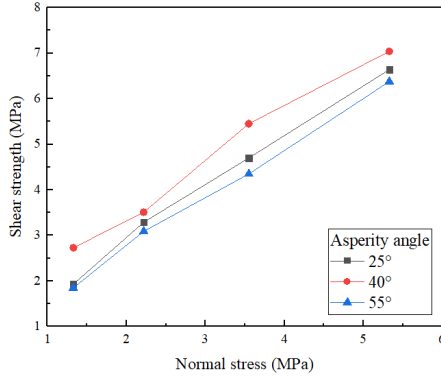
Fig. 7. Normal stress-peak shear strength at different asperity angles

Fig. 7 depicted that the peak shear strength of the same asperity angle increases with the increase of normal stress. There is a linear relationship between the peak shear strength and normal stress. However, under the same normal stress, the peak shear strength was not increased with the increase of asperity angle. The peak shear strength at the asperity angle of 40° is the greatest, while the difference between 25° and 50° is not obvious. The overall trend is that the curve increases first and then decrease. And the effective contact area becomes greater with the increasing asperity angles. Since the force causing sawtooth damage under tensile failure is less than the force under shear failure, the peak shear strength of 55° is smaller than that of 40°. Besides, the peak shear strength of 25° is smaller than that of 40° resulted from the failure mode changes from sliding to shear. In addition, the shear force at failure is increasing by increasing angle.

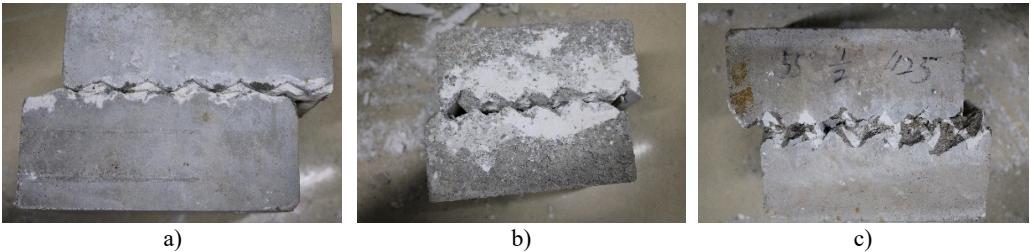
Fig. 8. View of specimens: a) A-1, b) C-2, c) B-3

The obvious tensile cracks can be seen in Fig. 8(c). At the same time, the asperity angle of 55° shear effect is more intense, pulling a wider range of cracks. This is because the infilled plaster is relatively soft and squeezed to produce a stress component perpendicular to the sawtooth surface. It induces a large tensile stress at the bottom of the sawtooth. Thin specimen coupled with weak tensile strength can result in the tension damage as well. The surface and side of the specimen

with the asperity angle of 25° are almost nondestructive, and the failure mode is sliding failure. The failure surface of the specimen with the asperity angle of 40° mostly occurred in the middle of sawtooth, and the failure mode is a shear failure.

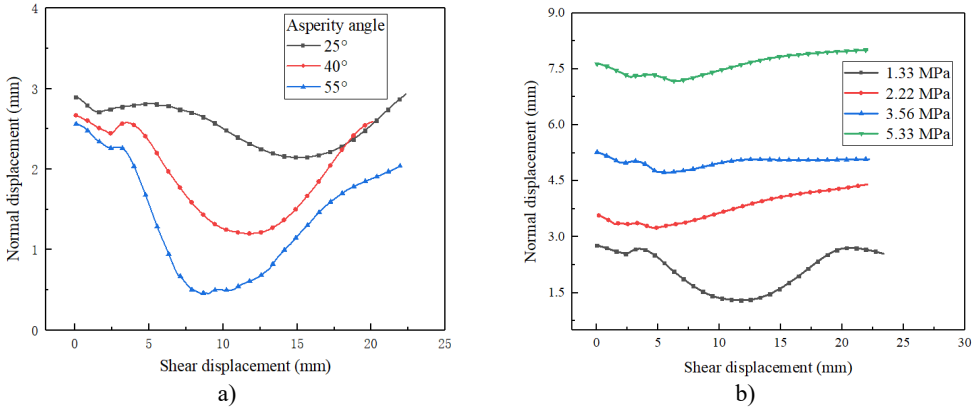
Fig. 9. Typic dilatancy curves: a) asperity angles under the normal stress of 1.33 MPa, b) asperity angle of 40° under different normal stresses

The normal displacement of the specimen changes mainly because the upper part of the specimen sliding along the sawtooth surface and the infilled plaster is squeezed. Under the same normal stress, the specimens with three different asperity angles have a steady decrease with the increase of shear displacement before reaching the peak shear strength. When the peak shear strength is reached, the normal displacement increases abruptly, and the curve shows a small area of the bulge, due to the sudden compression of the specimen. After that, the normal displacement continues to decrease, reaching the minimum when reaching the residual strength. Finally, the normal displacement continues to increase until it is approximately equal to the initial normal displacement, as shown in Fig. 9(a). This stage is mainly because sawtooth was cut after the grinding, the sawtooth of the upper part enter into the next recess of the bottom part, along with the sawtooth surface sliding caused by the increase normal displacement. It can be concluded that the larger the asperity angle is, the larger the normal displacement of dilatancy angle and dilatancy are. The dilatancy curve of the same asperity angle specimen will also be affected by the normal stress. Under the same asperity angle, when the displacement about 5 mm, the specimen reached the peak shear strength. After that, the normal displacement of the specimen increased with the increase of the normal stress.

With the same asperity angle of 40° , the dilatancy curves show similar trends with different normal pressures, as shown in Fig. 9(b). However, greater normal stress results in greater normal displacement. This is because the infilled plaster locates between the upper part and the bottom part of the specimen. When the normal stress is increased, the greater pressure acts on the plaster and the plaster is squeezed more severely, which causes greater normal displacement. Therefore, the infilled plaster contributes more to normal displacement.

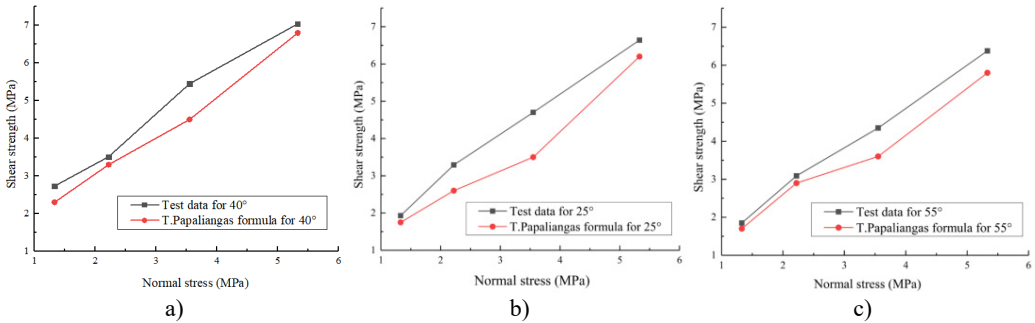
Fig. 10. The test results are compared with T. T. Papaliangas formula with different asperity angles: a) the asperity of 25°, b) the asperity of 40°, c) the asperity of 55°

where $0 < t/a < c$, t is the thickness of filling material, and a is the average roughness of discontinuity. As shown in Table 1, c and m are constants gained by experiments, but $c = 1.5$ and $m = 1$ determined by a series of experiments for peak shear strength. Combined with Barton formula shows, $T_{min} = C_0 + \sigma_n \tan \varphi_0$, which C_0 and φ_0 are the Cohesion and Friction angle of the infilled plaster. In the formula above, T_{min} is only affected by the normal stress while T_{max} is affected by many factors. All specimen prepared for this test have the ratio $t/a = 0.5$, and the n value can be obtained by numerical model and it equals to $2/3$. Based on the comparison, the laboratory test results are in good agreement with the analytical model, as illustrated in Fig. 10.

The results of the experiment are mainly consistent with the trend of the analytical results, and the comparison curve of 55° is highly consistent among the three asperity angles. However, the analytical results are smaller than the test results, which is because the value of c and m in the Papaliangas formula in this experimental model is small. Besides, the mechanical parameters of plaster are different from plaster used in the analytical model. At low asperity angles, the infilled plaster is squeezed into a half horizontal plane during shear. At high asperity angle, the effect of roughness on the peak shear strength will be enhanced and the impact of the infilled plaster on the
