Advanced Science Letters
Vol. XXXXXXXXX

Frame effects on OITC of fixed and open glass windows

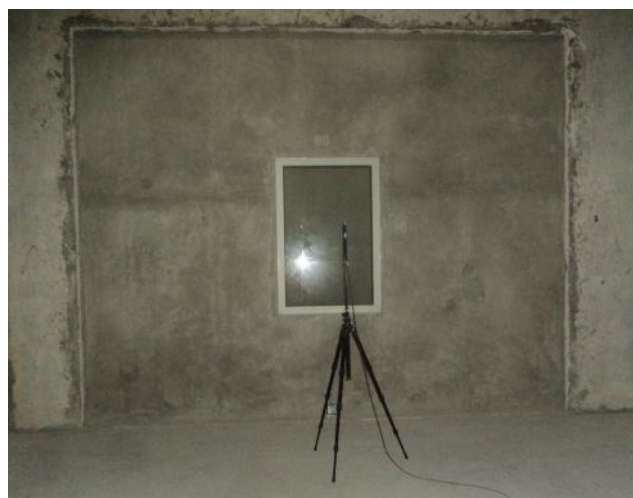
Fig. 2. Front view of composite wall specimen.

- Glass type and opening dimension on the tested wall were determined as fixed variables. It based on earlier studies where thickness and dimension played important roles in the decrease or increase of OITC. Thicker glass owns higher OITC than thinner ones¹². Larger glass dimension decreases OITC than smaller ones¹². A fixed glass thickness of 5 mm and an opening on the wall of 800 mm x 1200 mm were determined (Fig.1,2,3).

- In the composite wall system, a filler wall was developed. It was suggested to use filler wall with OITC of roughly 15 above the predicted OITC of the tested specimen. In this case, lightweight bricks plastered one side with a total thickness of 113 mm were used (Fig.1, and Fig. 2). The filler wall was tested prior to specimen installation, which gave STC 37 and OITC 34. For a reference, an open window gave STC 10¹⁴. This study used reference of STC due to unavailability of reference of OITC.
