Multi-instrument multi-scale experimental damage mechanics for fibre reinforced composites

To cite this article: Stepan V Lomov *et al* 2018 *IOP Conf. Ser.: Mater. Sci. Eng.* **406** 012057

Abstract. Reliable investigation of damage in fibre reinforced composites requires concurrent *in-* and *ex-situ* application of multiple instruments at different scale: digital image correlation, acoustic emission registration, optical/electron microscopy, C-scan, X-ray imaging and micro-computed tomography. The multi-instrument experimental mechanics allows detailed damage monitoring and inspection.

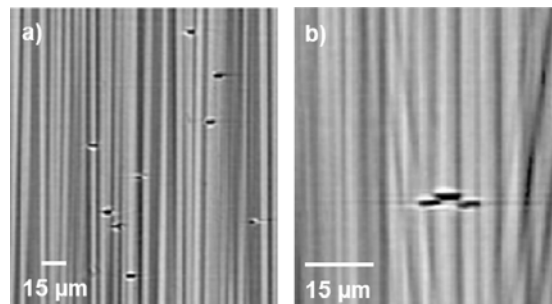
Figure 1. Two types of fibre break cluster found in the synchrotron radiation CT: (a) a diffuse cluster and (b) a co-planar cluster (reprinted from Elsevier with permission).

In [1], a composite laminate was strained and then held at displacement to scan the specimen. Several such steps were done at different load/strain levels to monitor how fibre breaks develop and cluster together. This study revealed new insights into the types of clusters that develop appear (see Figure 1). About 70% of the clusters were found to be co-planar (see Figure 1b) compared to 20-30% in model predictions. This discrepancy between experiments and models has triggered a new body of research trying to identify its potential causes.

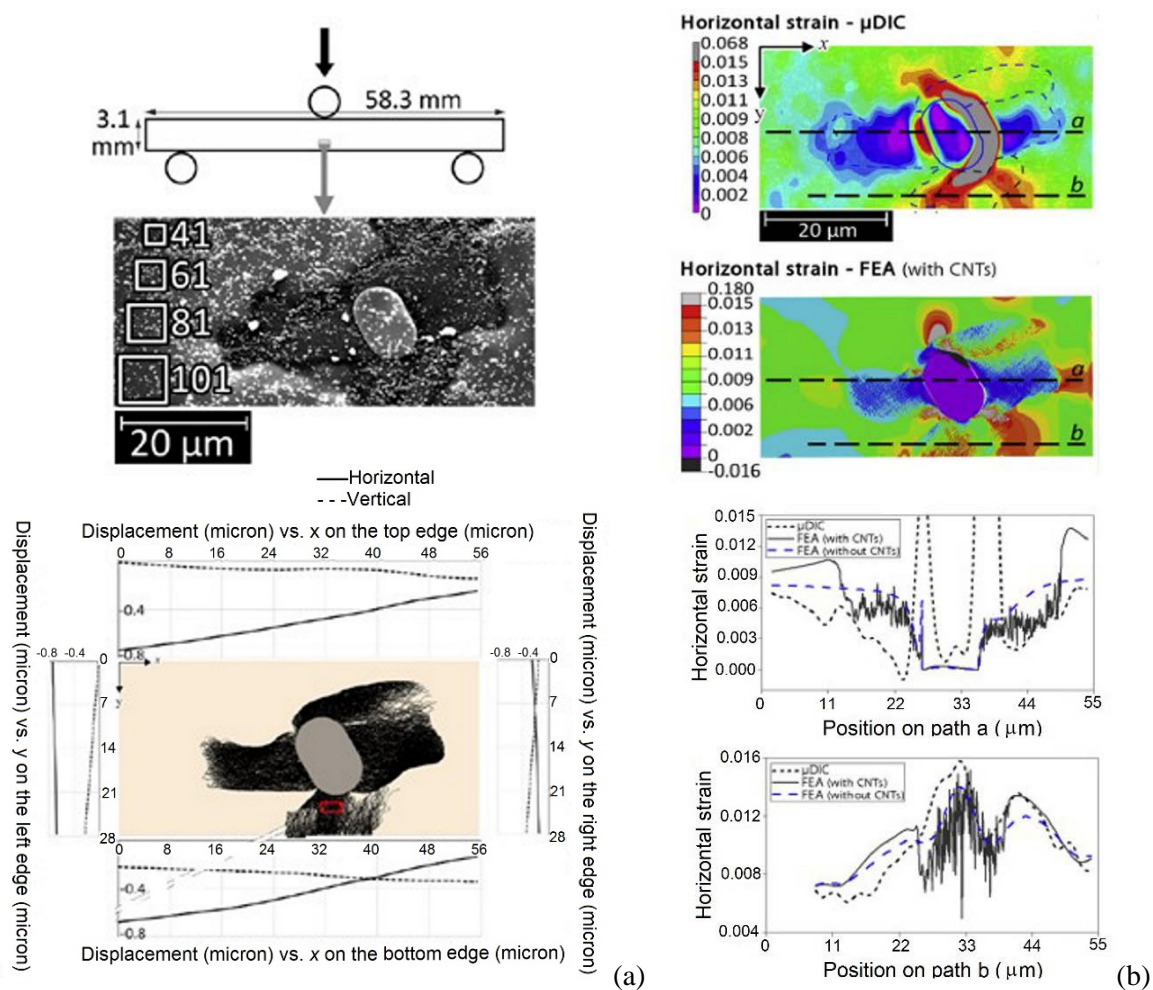
Figure 2. Micro-DIC discovering fibre debonding: (a) schematics on the specimen in three-point bending, region of interest (ROI) and FE model simulating CNTs grown on the surface of the fibre, with the DIC-measured displacements profiles on each edge of the ROI; “horizontal” and “vertical” correspond to the image orientation; (b) DIC-measured and calculated strain fields and profiles [2]

Figure 2 illustrates results of the measurements. Features such as fibre, matrix, aligned CNT forest, and debonded regions at the fibre/matrix interface were detected. Openings as small as 35 nm in the debonded regions near the fibres were measured. The image correlation uncertainty in the displacement analysis was found to be below 5 nm, as estimated from the standard deviation confidence of the match. The micro-DIC results were compared with predictions of a two-scale numerical model, and a good agreement between the two was observed.

Micro-DIC measurements revealed propagation of the debond around and/or along the fibre, which manifested itself in a non-linear trend in the opening of the debonded region as function of the applied deformation.

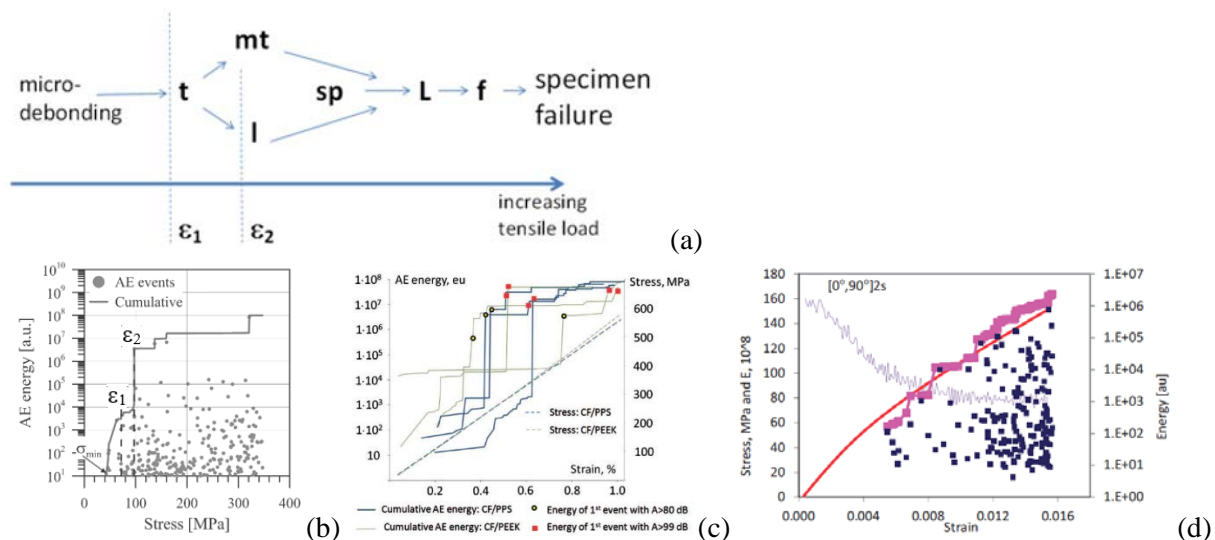
Figure 3. Damage thresholds in cross-ply and textile laminates identified with AE: (a) a sequence of damage modes (*t*: transverse cracks in yarns/plies and the matrix (*mt*); *l*: micro-delaminations; *sp*: longitudinal splitting; *L*: macro-delaminations; *f*: fibre breakage) [16]; (b) typical AE identification of the damage thresholds in a woven glass/epoxy laminate [9]; (c) damage thresholds in carbon/PPS and carbon/PEEK woven laminates [5]; (d) stress-strain, stiffness-strain and AE energy diagrams for tensile loading of flax quasi-UD woven laminates [6]

The sequence of damage events in cross-ply and textile laminates [16] (Figure 3) suggests a presence of two thresholds of the applied load. The first, designated as ϵ_1 , corresponds to the onset of the transverse cracking (*t*-cracks), which may not at this stage span the whole width of the specimen, being limited by the yarn crimp and/or presence of stitching in the textile reinforcement structure. The second, designated as ϵ_2 , corresponds to, on one hand, the onset of local delaminations (*l*-cracks) and, on the other hand, to the formation of “strong” transverse cracks, which span the width of the specimen.

The damage thresholds can be identified using acoustic emission (AE) registration during the tensile loading, namely, a curve of cumulative energy (*E*) of the AE events. The damage threshold ϵ_1 is related to the first increase of the $E(\epsilon)$ curve, and the damage threshold ϵ_2 – to the second sharp increase of this

curve. This approach was used in 2005-2018 for various textile composites; Figure 3 gives examples for such measurements for composites with carbon, glass and flax fibres with thermoset and thermoplastic matrices. The AE registration allows quantification of the influence of the reinforcement architecture, matrix ductility or fibre properties on the damage initiation behaviour of the composite.

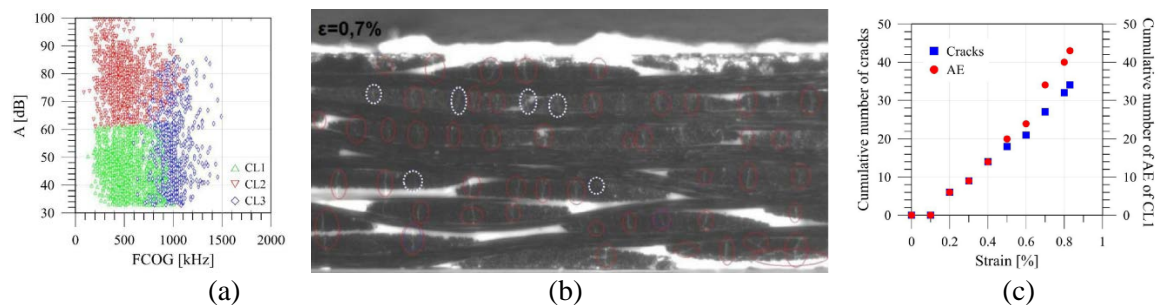
Figure 4. Concurrent use of AE and edge microscope, tension of carbon/PPS woven laminates: (a) clusters of AE events; (b) cracks observed at the specimen edge; (c) correlation between the number of cracks in an observation zone of 5 mm length and the number of AE events [4].

However, use of the cumulative AE energy remains a heuristic approach for the identification of damage thresholds. To be convincing, it is better supported by direct evidence of the damage. In [3] microscope observation of the specimen edge was combined with AE for carbon/PPS woven laminates, in [17] – for carbon/epoxy woven laminates. The crack development observed in a small central portion of the specimen edge was connected to the AE events located in the same zone of the specimen. The number of new intra-yarn matrix cracks generated at a certain load level was compared to the number of acoustic event localized in the zone of observation, with a good agreement found between the number of AE events with low amplitude and low frequency and the number of observed cracks (Figure 4a-c).

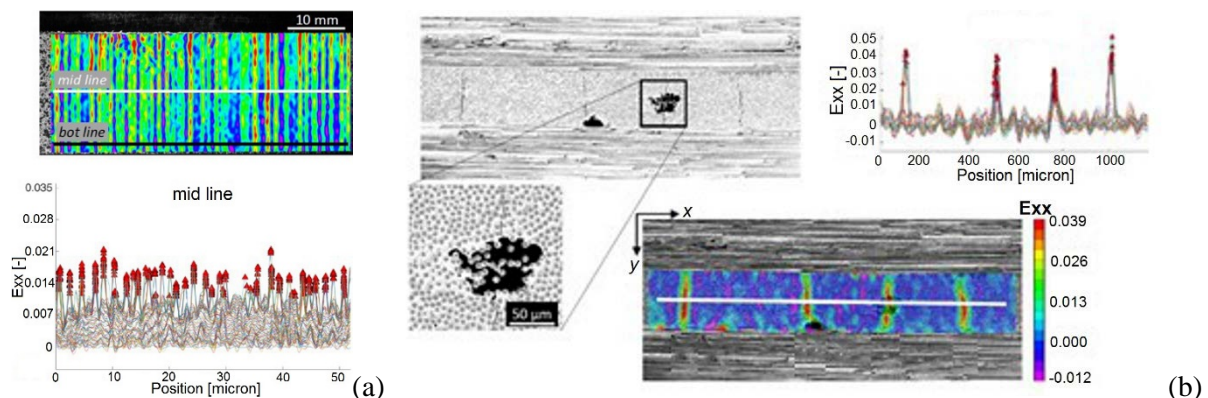
Figure 5. DIC-enhancement of the edge crack registration: (a) cracks identified as peaks on the strain profile; (b) cracks related to voids in 90° plies [8].

The observation of cracks on the specimen edge can be enhanced with the use of DIC. In [8], the cracks were monitored via identification of peaks in the strain profile on the specimen surface in each deformation step, which is carried out semi-automatically. The method was applied to study the influence of voids on the cracking process (Figure 5).

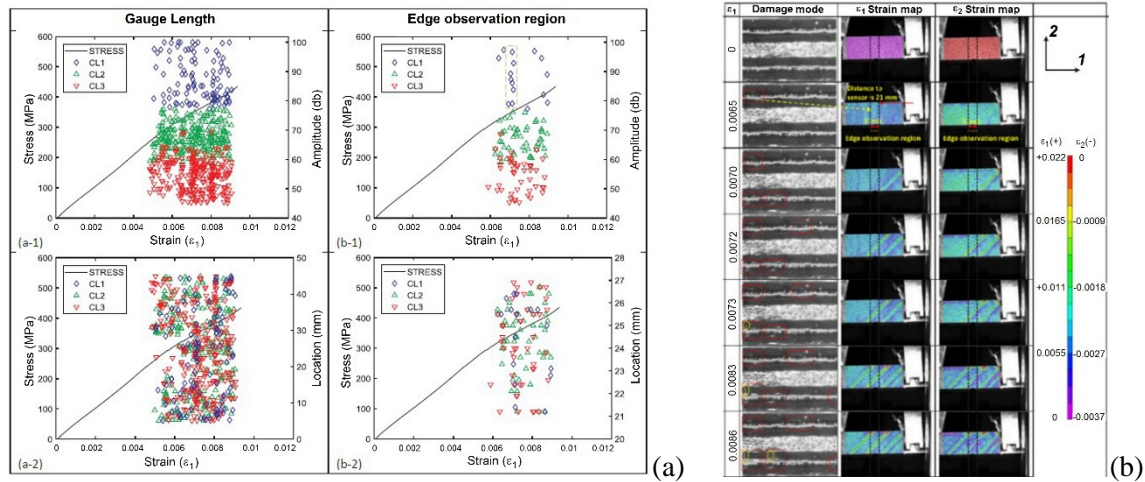
Figure 6. Concurrent use of AE (a), edge microscopy and surface DIC (b) for damage identification during tension of carbon/epoxy QI laminates [7].

presents the necessity of multi-instrument optical observations for damage-mode identification and correlation with AE registrations: concurrent use of AE registration, optical edge observations and surface strain mapping by DIC (Figure 6).

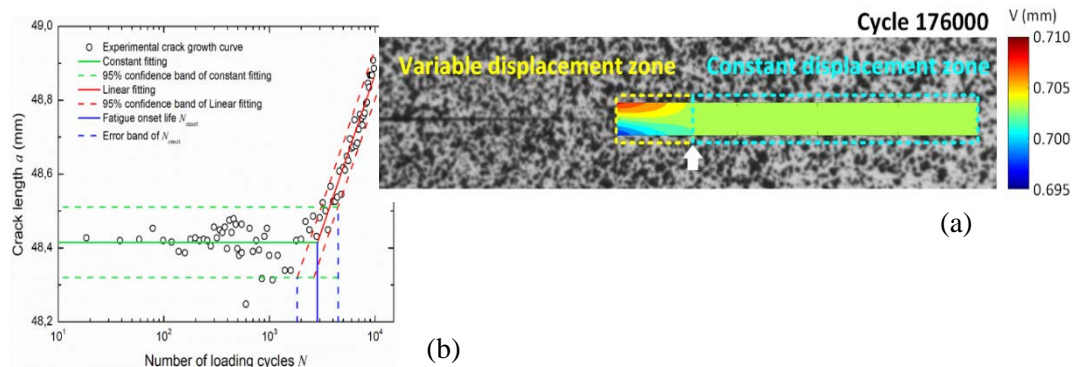
Figure 7. DIC-based method for tracking a fatigue Mode I crack: (a) detection of the crack tip position (white arrow); (b) identification of fatigue onset life N_{onset} [10].

Optical methods are effectively used for following tracking damage development in fatigue loading. In [9] a DIC-based method is proposed to characterize Mode I fatigue delamination onset and propagation in laminated composites. Images of the fatigue delamination on one side of the specimen were automatically recorded at a maximum displacement at specific fatigue cycles. The displacement field around a delamination crack is obtained and further processed to determine the position of the crack tip (Figure 7a). With this method the delamination length can be measured automatically in each cycle with a precision on the order of few hundreds of micrometers. The fatigue delamination onset life is then determined by detecting the increase of the delamination length, and the fatigue delamination propagation rate is calculated. The proposed method produces more conservative fatigue life measurements in comparison with the 5% compliance increase method in ASTM D6115 (Figure 7b).

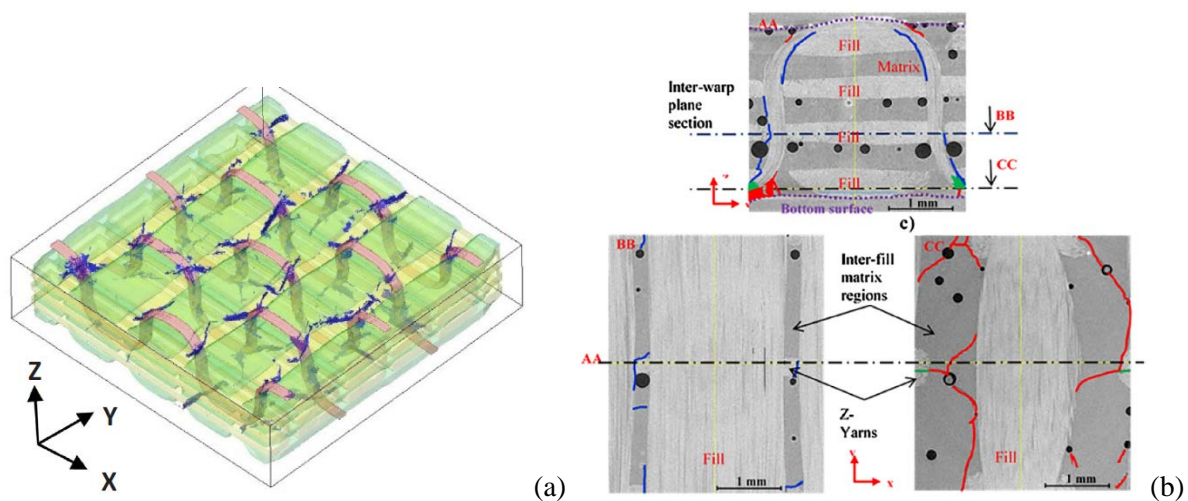
Figure 8. Thermal fatigue of a 3D woven carbon/epoxy composites in the presence of voids: (a) cracks identified using micro-CT; (b) details of the crack morphology [11]

In [11] a carbon fibre/epoxy matrix composite material reinforced with a non-crimp 3D orthogonal woven preform was investigated. The aim was to characterize the damage mechanisms – i.e. matrix cracking – induced by thermal cycling. Qualitative and quantitative descriptions of the morphology and the evolution of cracks with thermal cycling are carried out through the analysis of μ CT scans of samples at different cycle numbers. Through suitable image processing, which is of general and wide application, qualitative and quantitative descriptions of the initial porosity, of morphology and evolution of matrix cracking up to 1400 thermal cycles were performed (Figure 8a).

In addition, since the specimens have a certain level of porosity due to the infusion process, a complete description of this defect is carried out, and its influence on the damage mechanisms induced by thermal cycling is analysed. At first sight, the presence of pores seems to facilitate the propagation of cracks, pores acting as “attractors” when they are in the vicinity of the crack path (Figure 8b).
