PERFORMANCE OF NO VIBRATION / NO ADMIXTURE MASONRY GROUT CONTAINING HIGH REPLACEMENT OF PORTLAND CEMENT WITH FLY ASH AND GROUND GRANULATED BLAST FURNACE SLAG

James P. Mwangi, Ph.D., S.E.¹, Craig Baltimore, Ph.D., S.E.² and Eric W. Bateman³

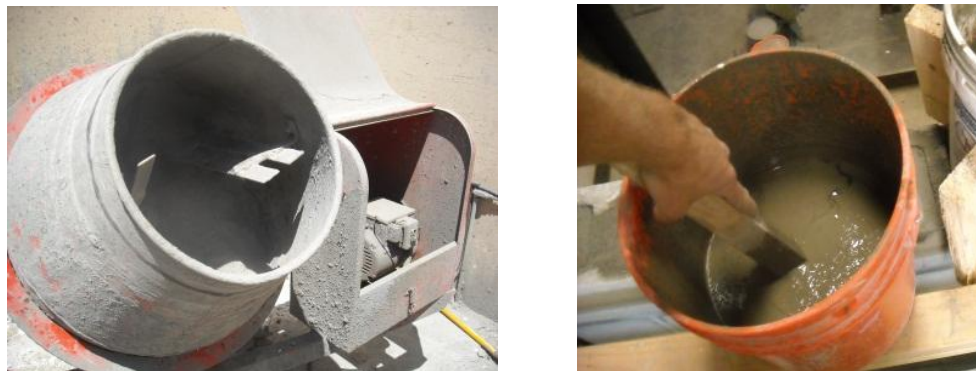
The material proportions were batched by volume and mixed in a mechanical mixer in accordance with ASTM C476 as seen in Figure 2.

Figure 2: Grout Materials Mixing in (a) Mechanical Mixer and (b) Re-Mixing in Bucket

The walls were grouted between 77 and 81 days after the walls were erected. The materials were batched by volume and mixed in a mechanical mixer in accordance with ASTM C476 as shown in Figure 2. The slump test, following ASTM C1019, was conducted for the conventional grouts or a slump flow test, following ASTM C1611, was conducted for the experimental grouts. The grout was poured into the grout column through a funnel at the top. A flashlight was used to check if there was any seepage from the grout into the adjacent grout columns and none was observed in all columns. For the conventional grout columns with mechanical consolidation, the mechanical internal-type vibrator was lowered into the center and all the way to the bottom of the column before the grout was poured. Once approximately one third of the grout column was poured, the vibrator was turned on and left for 5 seconds and slowly lifted out one third of the way. This was repeated until the grout column was completely grouted and vibrated. Figure 8 shows the grouting and vibration operations.

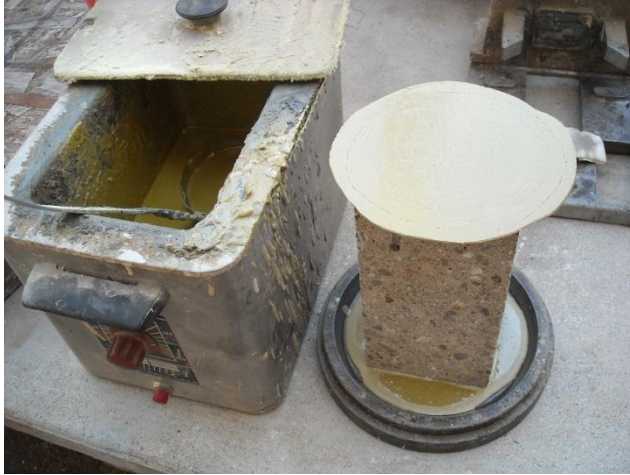
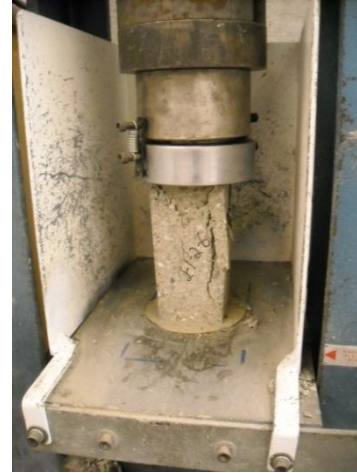
The specimens were capped and tested in compression in accordance with ASTM C1019 as shown in Figure 5.

Figure 5: (a) Capping of Grout Compression Specimens and (b) Compression Testing

The retrieved compression specimens were capped and prepared for testing in accordance with ASTM C1552 and ASTM C1314, as shown in Figure 5.

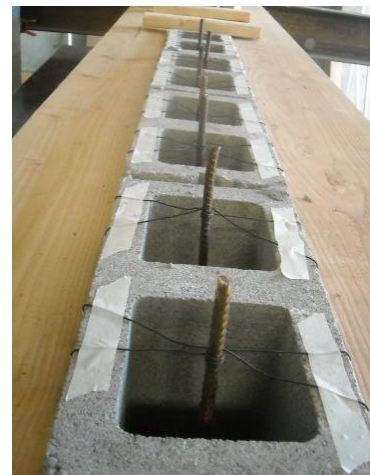
Four walls were constructed by professional masons in one lift for the Wall Experiment. All the walls were built in running bond using double square core, single wythe 203x203x406 mm (8x8x16 in.) nominal CMU, and 19 courses 3.86 m (12.67 ft) in height. Full mortar bedding was used to prevent the grout from flowing into adjacent grout columns. The walls were labeled 1, 2, 3, and 4. Walls 1, 2, and 3 were used for the evaluation of compression strengths and visual inspection of the flow characteristics around the mortar fins and reinforcement of the grouts at varying heights along the wall. Wall 4 was used for the evaluation of the bond between the reinforcement and grouts at varying heights along the wall. Walls 1, 2, and 3 were 1.2 m (4.0 ft) (nominal) wide and consisted of six grout columns. The walls had two 16 mm (#5) horizontal reinforcement bars placed at 0.61 m (2.0 ft) on center vertically. Wall 4 was 1.63 m (5ft-4in) (nominal) wide and consisted of eight grout columns. The wall had one 10 mm (#3) vertical reinforcing bar placed as close to the in the middle of each grout column as possible, throughout the entire height of the column as shown in Figure 6.

Figure 6: Wall Construction (a) Horizontal Steel Placement and (b) Vertical Steel Placement

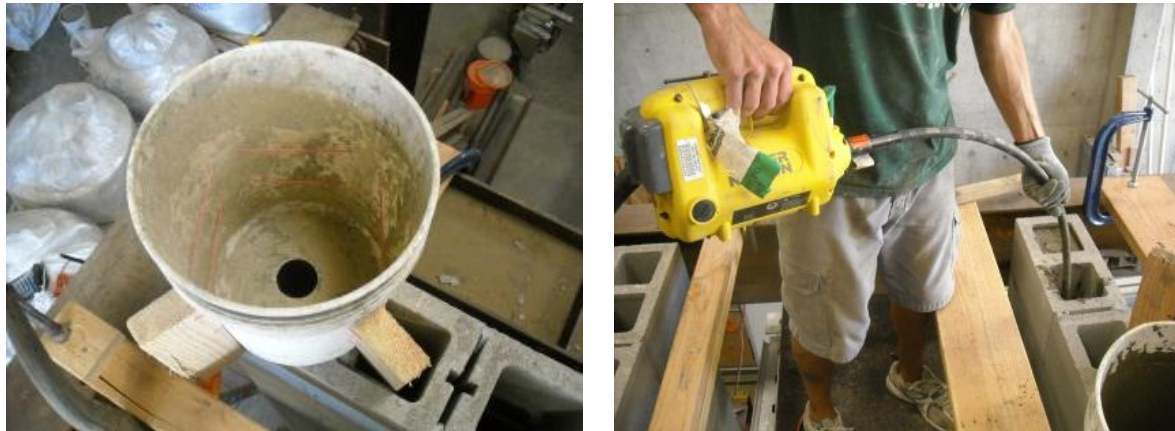
Figure 8: (a) Grout Funnel Leading into One Grout Column and (b) Mechanical Vibration

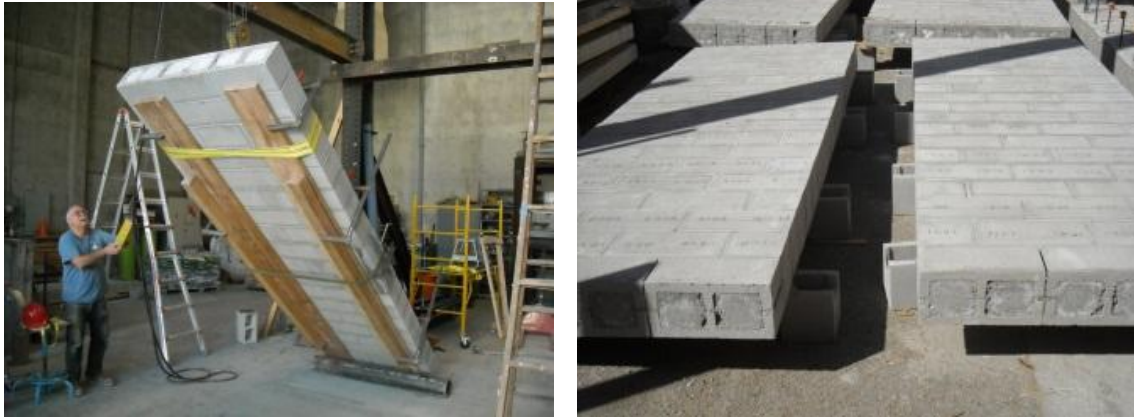
The walls were lowered to a horizontal position approximately 70 days after being grouted using an overhead crane as shown in Figure 9

Figure 9: (a) Lowering the Wall and (b) Lowered Walls

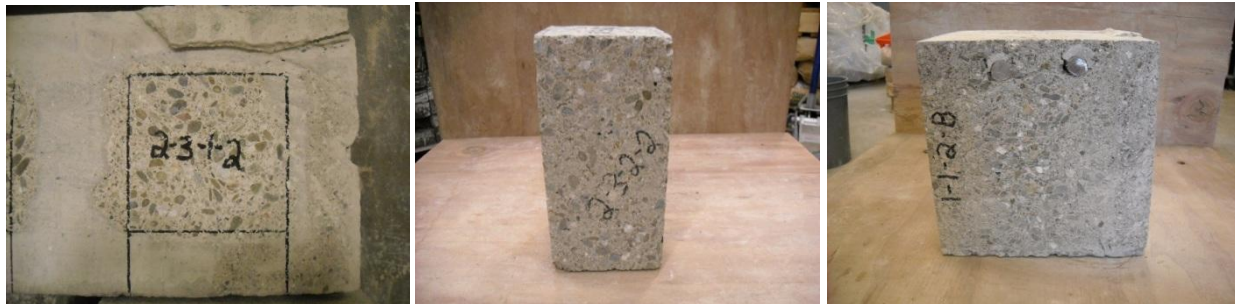
A 508 mm (20 in.) diamond blade wet saw was used to cut the compression specimens into 102x102x203 mm (4x4x8 in.) (nominal) grout units and the consolidation specimens once across the middle of the grout cell in order to see the consolidation characteristic around the reinforcement as shown in Figure 4. In total, 96 compression test specimens and 96 consolidation specimens were retrieved from the walls. Figure 11 shows wall compression and consolidation specimens.

Figure 11: (a), (b), Side of Compression Specimen and (c) Consolidation Specimen
