# Analysis of Vibration Attenuation and Energy Consumption of Blasting Demolition Chimney: A Case Study

Shuren WANG, Jiyun ZHANG, Jingtao LI, Fuli KONG, Junqi FAN

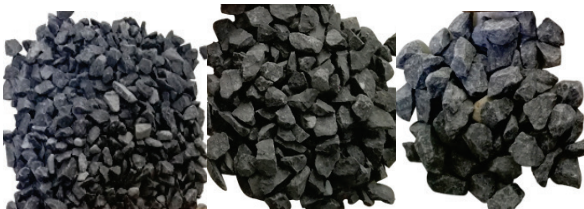
(c) Three kinds of particle sizes of the loose gravel deposits  
Figure 2 Loose gravel accumulation body and the chimney

Due to site restrictions, the chimney was demolished by directional blasting in two stages. As shown in Fig. 2, the first blasting cut was located at the inspection platform provided by the chimney at an elevation of 93 m. The chimney above this position had a weight of 1366.67 t and with the height of gravity center 128.8 m. The second blasting cut was located at the elevation of 25 m, the chimney had a weight of 2815.9 t and with the height of gravity center 47.06 m within the range of 93 m.

To reduce the impact of the vibration velocity caused by the chimney blasting and its touchdown on the ground, within the scope of two times of the diameter of the chimney collapse center line, three kinds of particle sizes of the graded gravel were used to construct a loose gravel accumulation body with the thickness of 3-6 m and the length of 90 m, which was a right-angled trapezoid

considering the characteristics of the chimney' collapse and touchdown, as shown in Fig. 2. The loose accumulation body had the characteristics of disordered accumulation, clear edges and corners, irregular shape, more particle grading, and large porosity.
