Article

Fatigue Behavior of PBO FRCM Composite Applied to Concrete Substrate

Keywords: fatigue; bond; modified beam test; fiber-reinforced cementitious matrix (FRCM)

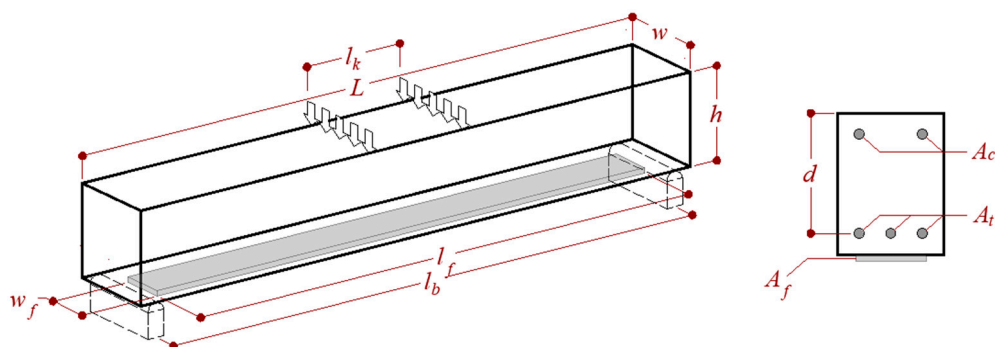
Figure 1. Bending test set-up of the experimental tests collected.

To the best of the authors' knowledge, five studies that analyzed the effect of various parameters on the fatigue life of FRCM-strengthened RC beams with different geometries subjected to a bending test set-up (see Figure 1) are currently available in the literature [1,35,38–40]. The geometrical characteristics of the specimens presented in those five studies are reported in Table 1 with reference to the parameters depicted in Figure 1.

Table 1. Geometrical parameters depicted in Figure 1.

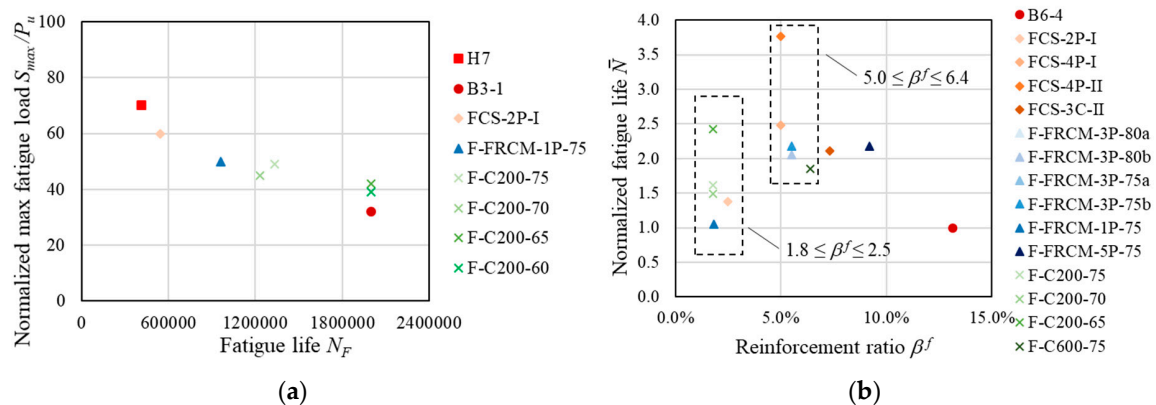
Figure 2. State of the art analysis: (a) relationship between normalized maximum applied fatigue load and fatigue life; (b) relation between normalized fatigue life and reinforcement ratio.

Figure 2a shows the relationship between the fatigue life, N_F , and the normalized maximum applied fatigue load, S_{max}/P_u , of specimens characterized by reinforcement ratios, β^f , between 1.8% and 3.3% and that were not subjected to long-term sustained load before the fatigue test. Figure 2a shows that high S_{max}/P_u values determined a significant reduction of the beam fatigue life with respect to that of specimens subjected to low values of S_{max}/P_u . Specimens B3-1, F-C200-60, and F-C200-65 did not fail after the target number of cycles, i.e., 2 million cycles, was attained. This shows that S_{max}/P_u lower than or approximately equal to 40% did not lead to fatigue failure within 2M cycles, which can be attributed to a stress level in the steel reinforcement lower than the corresponding fatigue limit or endurance.

Figure 2b shows the relationship between the reinforcement ratio, β^f , and the normalized fatigue life, \bar{N} , of specimens subjected to a maximum fatigue load, S_{max} , in the range 40%–60% of the corresponding quasi-static monotonic ultimate load, P_u . Specimens showing a premature failure ($\bar{N} < 1$, [1]) were not included in Figure 2b. Although the results reported showed a certain scatter (typically observed in fatigue tests), comparison of \bar{N} between specimens characterized by low reinforcement ratios ($1.8 \leq \beta^f \leq 2.5$) with that of moderately reinforced specimens ($5.0 \leq \beta^f \leq 6.4$) suggests a general increase of the normalized fatigue life, \bar{N} , with the increase of the reinforcement ratio, β^f . However, specimens with a reinforcement ratio $\beta^f > 6.4$ did not show an increase of \bar{N} with respect to specimens with $5.0 \leq \beta^f \leq 6.4$ (Figure 2b). This result could be attributed to the occurrence of FRCM-concrete debonding that initiated at cracked cross-sections of specimens with a high reinforcement ratio. Indeed, experimental results showed that increasing the number of fiber layers does not lead to a proportional increase of the FRCM capacity, since the failure mode may vary and premature debonding may occur [9]. As pointed out in [40], the capacity of the FRCM composite of reducing the stress in the steel reinforcement is affected by the composite-concrete stress-transfer characteristics, which mainly depend on the matrix-fiber impregnation capability [42,43] and on the matrix compatibility with the substrate [35].

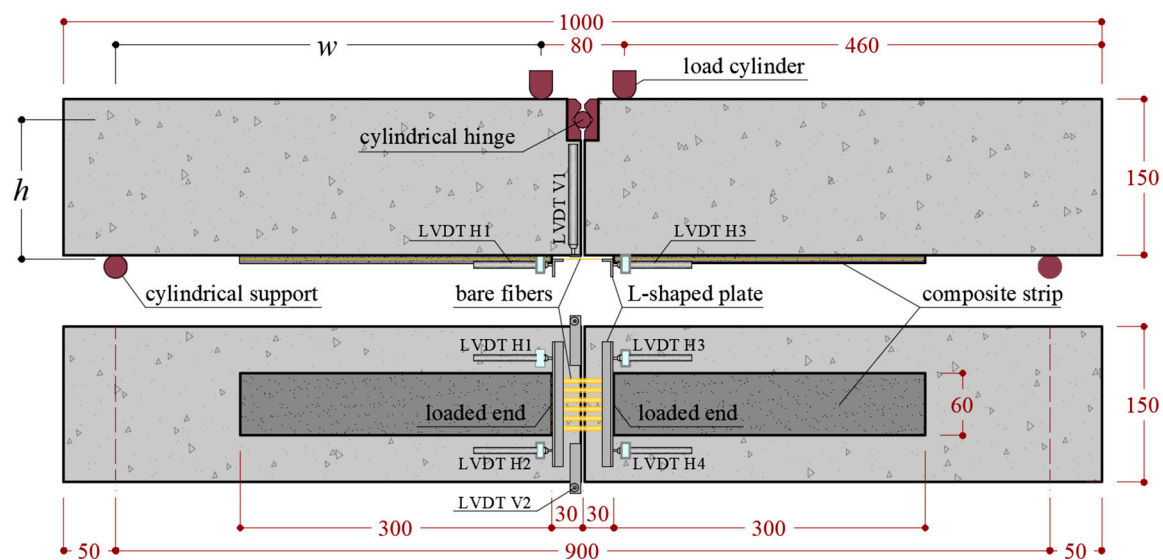
Figure 3. Modified beam test geometry (dimensions in mm).

Each specimen (see Figure 3) consisted of two concrete prisms that formed a beam as they were joined by a cylindrical hinge (at the midspan of the beam) placed near the compression side and by a FRCM strip applied at the bottom (tension) side. The midspan concrete discontinuity in the modified beam simulates the presence and opening of a flexural crack. Employing two separate prisms connected by the cylindrical hinge and by the composite strip, the position of the compression and tensile stress resultants at the midspan cross-section is always known, which allows the uncertainties associated with the definition of the stress resultant in the compressed concrete in continuous or notched beam tests to be eliminated [29,44]. This test was originally proposed to study the bond behavior of steel bars embedded in concrete [45] and was subsequently extended to the study of externally bonded [46] and near surface mounted [47] FRP composites. Recently, it was adopted to study the bond behavior of FRCM composites applied to concrete and masonry substrates to investigate the effect of interface normal stresses on the specimen capacity [24,25].

In this paper, the concrete prisms had nominal dimensions equal to 150×150 (cross-section) \times 500 (length) mm^3 . The concrete average compressive strength was measured on six 150 mm side cubes cast from the same batch of concrete used to cast the prisms and was equal to 37.9 MPa (coefficient of variation, CoV, equal to 6.02%). The FRCM composite was comprised of an open-mesh unbalanced PBO textile embedded within two layers of cement-based mortar. The PBO textile had a regular rectangular mesh with a clear space between bundles of 5 mm in the main (longitudinal) directions and 15 mm in the transverse direction. The area of each longitudinal bundle was 0.46 mm^2 and each specimen strip included 6 longitudinal yarns, resulting in an overall fiber cross-sectional area $A_f = 2.76 \text{ mm}^2$. The composite overall bonded length and width were 600 mm (300 mm on each prism) and 60 mm, respectively. Close to the beam midspan, a 60 mm long portion of textile was not embedded within the matrix, i.e., the fibers were left bare [24]. This discontinuity in the matrix allowed for a direct measurement of the relative slippage between fibers and matrix at the beginning of the bonded region of each prism (termed loaded end in Figure 3).

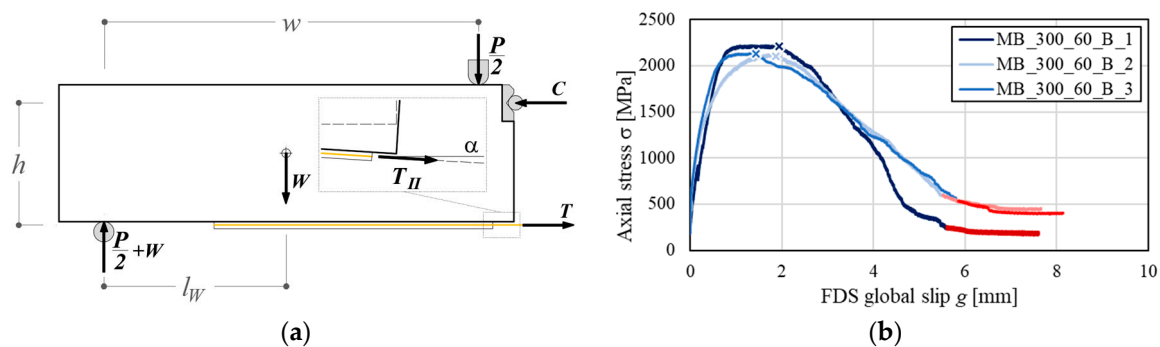
Figure 4. Modified beam tests: (a) free body diagram; (b) σ - g responses at fully debonded side (FDS) of quasi-static monotonic tests (the peak stresses σ^* are indicated with a “x” marker whereas the curve portions characterized by first derivative values within the range $(-200,0)$ are depicted in red).

Quasi-static monotonic tests were first conducted to obtain the specimen load carrying capacity. Tests were performed by monotonically increasing the vertical displacement (stroke) of the machine head at a constant rate of 0.2 mm/min. The fiber axial force parallel to the strip direction at the loaded end, T_{II} , associated with the load P applied by the testing machine, was computed by enforcing the equilibrium of the free-body diagram of Figure 4a:

The peak and friction stresses of all quasi-static monotonic tests are reported in Table 3 together with their average values for the three specimens and corresponding coefficient of variation (CoV). Following the procedure proposed in [23,52,53], σ_f was computed as the average of the applied stress within the range of g where the first derivative of $\sigma(g)$ with respect to g was within $(-200,0)$. This range is highlighted in Figure 4b at the tail of each curve.

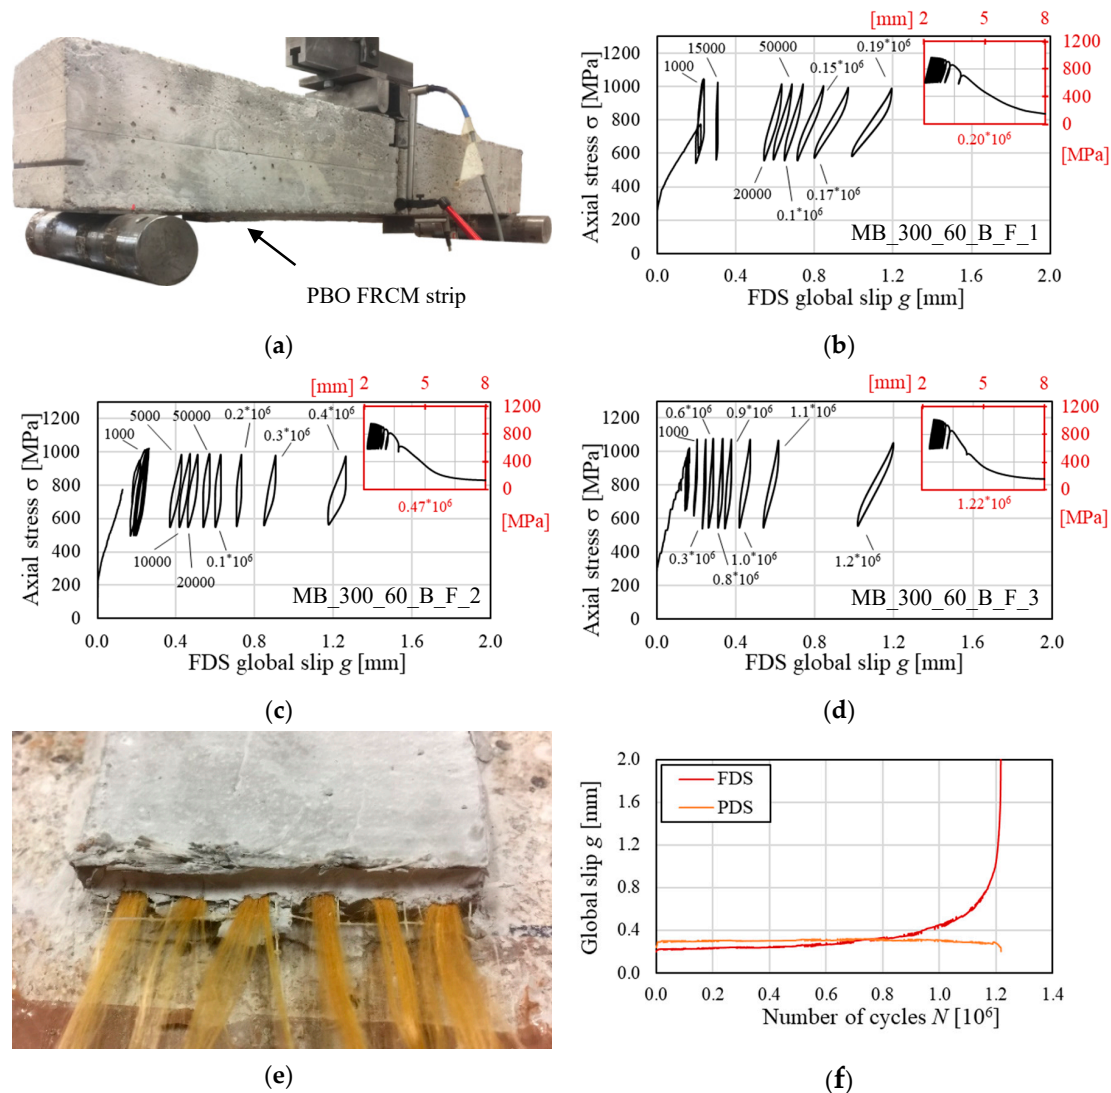
Figure 5. (a) Photo of specimen MB_300_60_B_F_3 before the beginning of the test. Load responses of specimen (b) MB_300_60_B_F_1, (c) MB_300_60_B_F_2, and (d) MB_300_60_B_F_3. (e) Failure of PBO fibers and (f) global slip vs. number of cycles for specimen MB_300_60_B_F_3.

Specimens MB_300_60_B_F_1, 2, and 3 were subjected to a fatigue test. A photo of specimen MB_300_60_B_F_3 before the beginning of the test is shown in Figure 5a. The main geometrical properties and the number of cycles at failure, N_F , of each specimen are reported in Table 4.

The three specimens subjected to the fatigue test failed due to matrix-fiber debonding and eventual rupture of the fibers at the strip loaded ends (failure mode c in Section 2.1). Figure 5b–d show the load responses of the specimens subjected to fatigue cycles in terms of axial stress, σ , in the fibers versus global slip, g , on FDS. In particular, Figure 5b–d feature the following portion of the response: (i) the load response associated with the initial quasi-static monotonic test, (ii) representative 10-cycle

The global slip, g , computed as the average of the displacements of the two LVDTs on each specimen side (i.e., FDS and PDS) is depicted with respect to the number of cycles, N , for specimen MB_300_60_B_F_3 in Figure 5f. The global slip on the FDS was consistent with the global slip on the PDS up to approximately 0.55×10^6 cycles, which indicates that the two strips on each side of the specimen behaved symmetrically during the first part of the test. As the number of cycles increased, g started to increase on the FDS, whereas it remained approximately constant on the PDS. When it exceeded 0.90×10^6 , the specimen entered the non-steady state, where the crack growth rate on the FDS that can be linked to dg/dN increased rapidly until failure of the specimen.

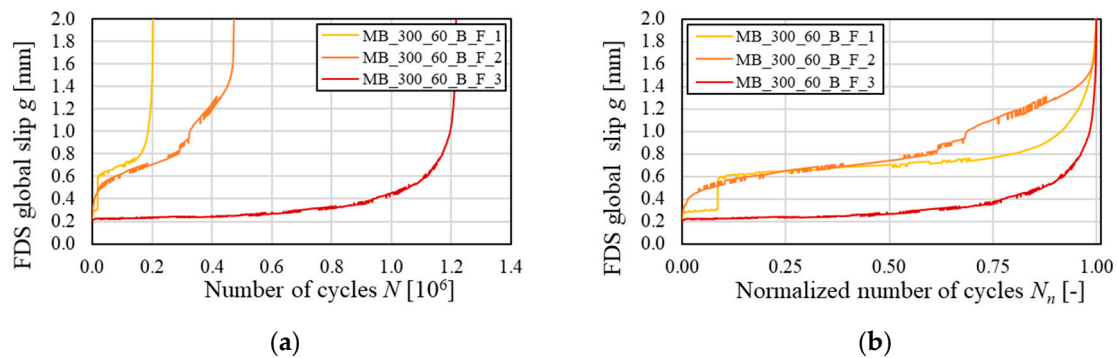
Figure 6. FDS global slip vs. (a) number of cycles and (b) normalized number of cycles for specimen subjected to fatigue test.

Although the same failure mode occurred for all specimens, the number of cycles at failure, N_F , was different (see Table 4). Figure 6a shows the global slip on the FDS versus the number of cycles for all specimens subjected to fatigue, whereas Figure 6b shows the same FDS global slip with respect to the normalized number of cycles $N_n = N/N_F$. Specimen MB_300_60_B_F_1 failed after the lowest number of cycles, i.e. $N_F = 0.20 \times 10^6$ (Table 4). Specimens MB_300_60_B_F_2 and 3 failed at N_F equal to 0.47×10^6 and 1.22×10^6 , respectively, which are still limited compared to the target fatigue life of 2×10^6 cycles. In general, specimens that experienced high values of FDS global slip at a low number of cycles provided a short fatigue life. This might indicate that the specimen degradation occurred progressively and not as a consequence of sudden damage. In specimen MB_300_60_B_F_1, an instantaneous increase of the FDS global slip from 0.3 mm to 0.6 mm was observed at the beginning of the test due to the opening of a matrix crack along the textile plane at the loaded end. This type of crack, which was not observed in other specimens subjected to either fatigue or quasi-static monotonic loading, was attributed to poor adhesion between the internal, i.e., in contact with the substrate, and external matrix layer. However, the presence of the crack affected the response of the specimen, which showed a FDS g - N response during the steady stage with a slope similar to that of specimen MB_300_60_B_F_2 and significantly higher than that of specimen MB_300_60_B_F_3 (see Figure 6a). The steady stage ended when the FDS global slip attained approximately 0.15, 0.45, and 0.80 mm for specimens MB_300_60_B_F_1, _2, and _3, respectively.
