Conference Paper, Published Version

LABORATORY OBSERVATIONS ON THE USE OF GEOBAGS AS SCOUR COUNTERMEASURE FOR WINGWALL ABUTMENTS

RECEP KORKUT¹, ROBERT ETTEMA¹, BRIAN BARKDOLL²

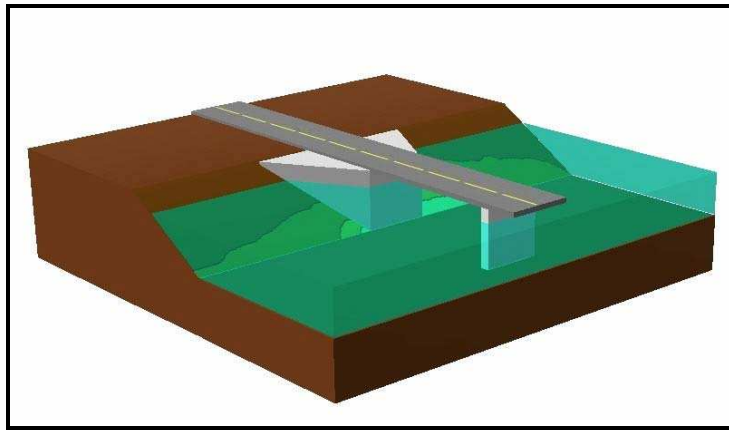
Figure 1. A wingwall abutment.

The experiments were conducted using wing-wall abutments, of the overall form depicted in Figure 1. They were conducted with the assumption that the channel bank upstream and the downstream of the abutment has eroded back to expose the abutment fully. This condition likely aggravates abutment scour since the abutment becomes more exposed to the approach flow and thereby increases local flow velocities and turbulence.

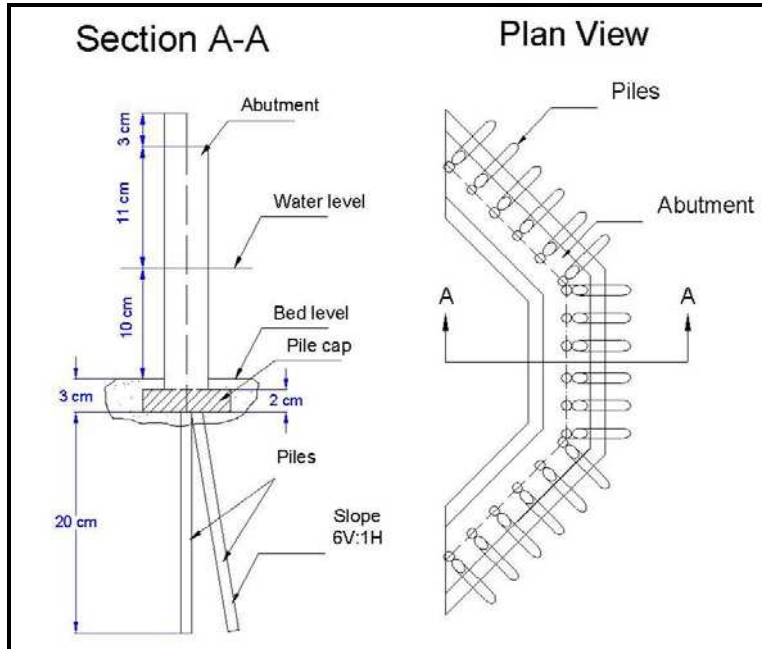
Figure 2. Model dimensions of the 45°, pile-supported, wingwall abutment used in experiments

The wingwall abutment used for the experiments had wingwalls set at 45° to the bridge axis, and was pile-supported. It retained an erodible embankment, and was aligned perpendicular to flow. Figure 2 shows the dimensions of the abutment used.

Table 1. List of experiments-involving geobags using the form of wingwall abutment shown in Figure 2.

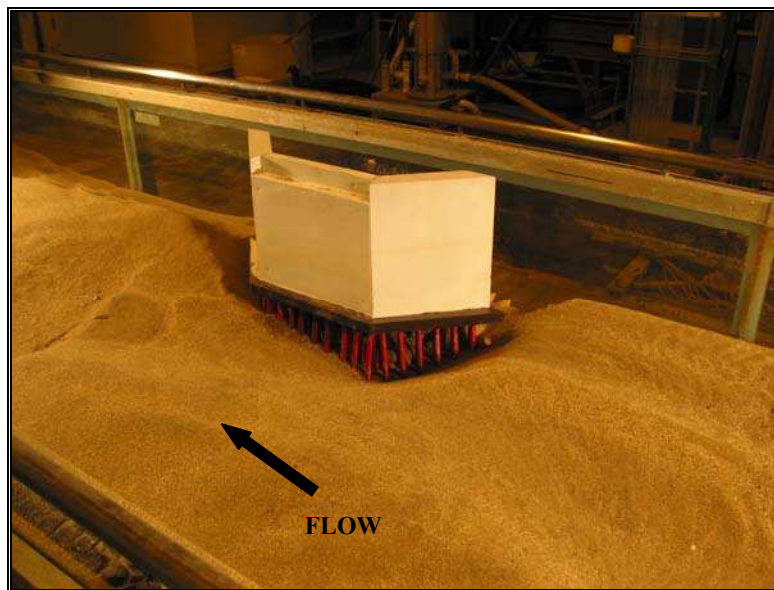
Figure 3. Scour development when only the erodible embankment was armored.

A total of twelve experiments were conducted. Table 1 lists and describes them. Full details concerning the experiments are given in Korkut (2004). The earlier experiments in the series sought to illuminate the flow field around the wingwall abutment, and to see how scour developed and the embankment retained by the abutment eventually failed. Those experiments also gave baseline data on scour at an unprotected wingwall abutment (Figure 3). The subsequent experiments were conducted to evaluate and heuristically develop a geobag deployment that would prevent scour from developing at the abutment as well as upstream and downstream of the abutment. Figures 4 and 5 show the initial deployment of geobags as an apron, and then the disruption of the apron by scour.

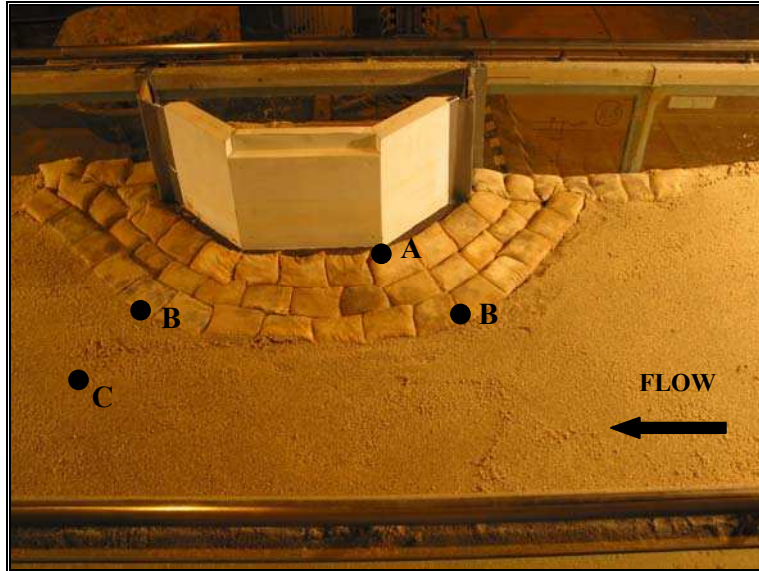
Figure 4. Geobag apron placed in similar deployment as often used for riprap layout used by the Iowa DOT abutments; the geobags were unconnected; and, the embankment sideslope was protected. Points A, B, and C mark the locations of the maximum scour depth observed in the experiments.

The experiments show that geobags can reduce scour depth immediately at an abutment. However, scour may occur at the perimeter of the apron formed of geobags, or a short distance downstream from the apron. Figure 4 indicates the scour locations. Accordingly, scour depths were measured at three locations:

1. maximum scour depth measured in front of the abutment (A in Figure 4);
2. maximum scour depth measured in front of the apron protection (B in Figure 4);
and,
3. maximum scour depth measured far from the abutment (C in Figure 4).

Geobags configured in a riprap configuration as commonly used by the Iowa Department of Transportation for bridges are shown in Figure 4. The results indicate that the apron of geobags did not entirely eliminate scour at the abutment, because of edge erosion along the perimeter of the apron, and subsequent erosion of sediment from beneath the exposed pile cap. Scour at the abutment was eliminated when the geobags were deployed with additional geobags placed under the pile cap to prevent the winnowing erosion of embankment soil through the exposed region beneath the pile cap (Experiment 7). However, though the abutment was protected, the bed scoured downstream of the geobag apron, with scour depths exceeding the maximum scour depth at the abutment for the baseline case (Experiment 1).

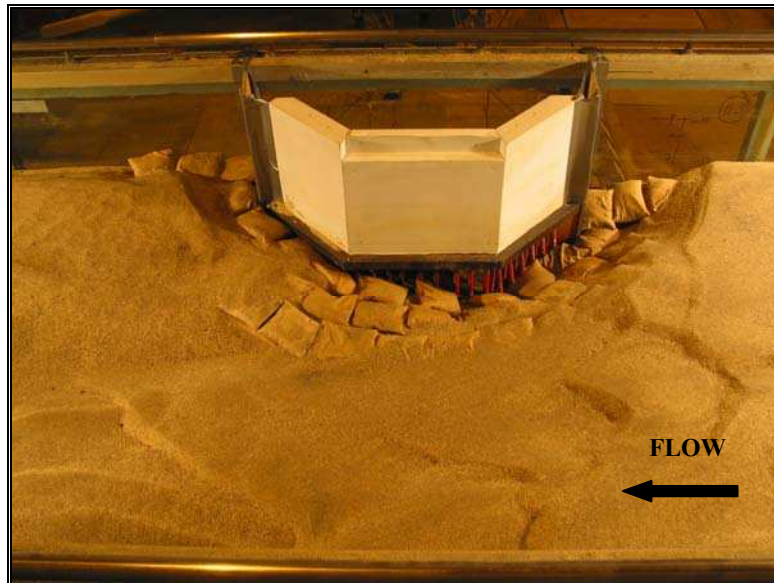
Figure 5. The scour hole developed for the geobag configuration shown in Figure 4.

Also, the protection provided for the embankment sideslope enabled the side slopes to remain stable. The experiments listed in Table 1 showed that the edge failure is the principal factor that results in the failure of the geobag apron, as in Figure 5. Such failure can be eliminated or substantially reduced by connecting the geobags forming the apron, and by ensuring that the pile cap remains well protected.

1. Geobags are a promising alternative to riprap for use as a bridge abutment-scour countermeasure.
2. It is necessary to connect the geobags placed as an apron around an abutment. The initiation of the failure of geobag apron shown in Figure 5 was due to the failure of an individual geobag placed in front of the abutment.
3. It is necessary to place geobags (or riprap) immediately under the pile cap in order to prevent the winnowing of embankment sediment from beneath the pile cap.
4. Geobags may serve as a useful alternative to a geo-synthetic filter cloth placed beneath a riprap apron, because geobags are more readily placed than is a filter cloth, especially in flowing water.

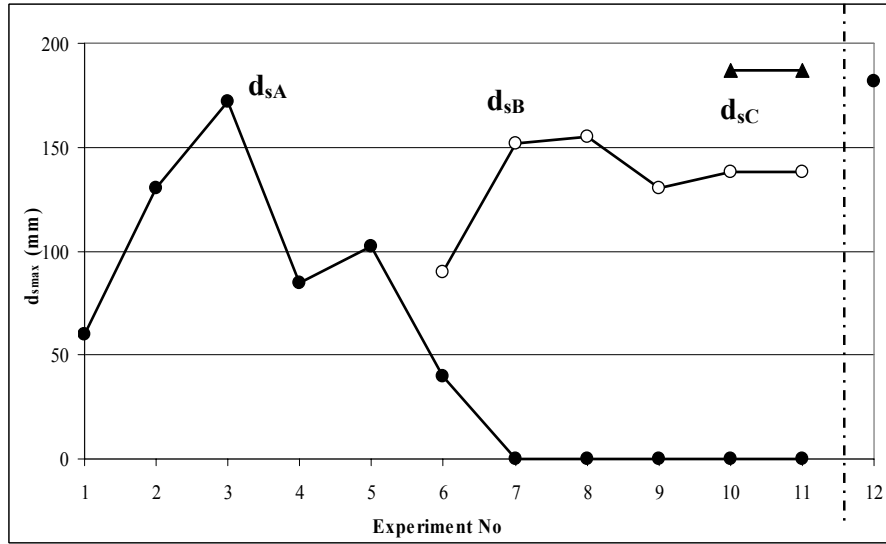
Figure 6. The maximum scour depths measured for three locations as indicated in Figure 4: A in front of abutment, B. in front of apron, and C. downstream from the apron. Experiment details are in Table 1.

The results of the experiments are plotted in Figure 6, which shows how appropriate geobag use may reduce scour-depth at the abutment (d_{sA}), but with the consequence of shifting scour to positions B (d_{sB}) and C (d_{sC}); positions indicated in Figure 4).

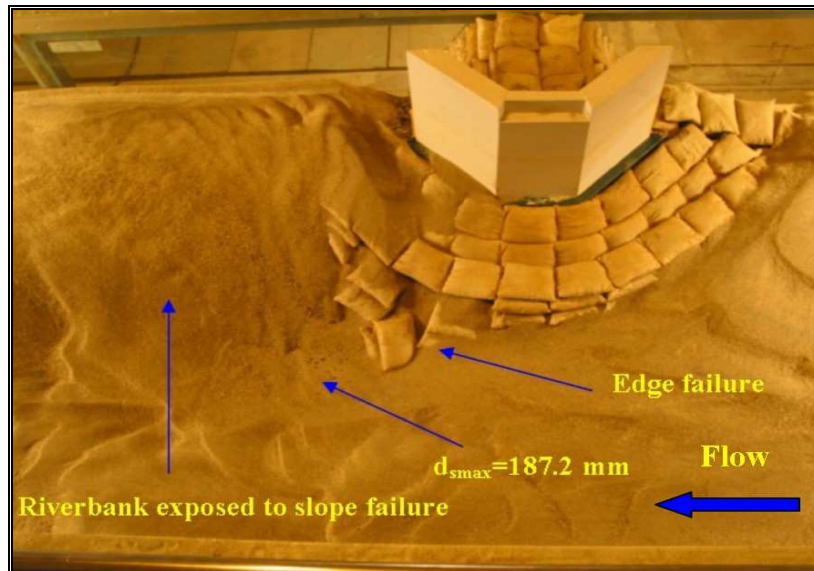
Figure 7: The deep scour depth led to both edge failure and the slope failure of the apron toe and the downstream riverbank, respectively.

Scour cannot be eliminated completely by scour countermeasures, but instead is pushed away from an abutment. Figure 7 shows that no scour developed at the abutment itself, but significant scour occurred near the downstream edge of the apron of geobags. It is important, therefore, to be careful as to where the scour shifts. It should not be shifted towards the riverbank, or to a neighboring pier. Doing so would cause further problems such as the failure of the riverbank or the total scour around the pier. The experiments show that it is necessary to protect the following regions of the river bed and banks near an abutment:
